Asbestos Management Report

130 South Street
 Lancing
 BN15 8AU

Reference: C-25021

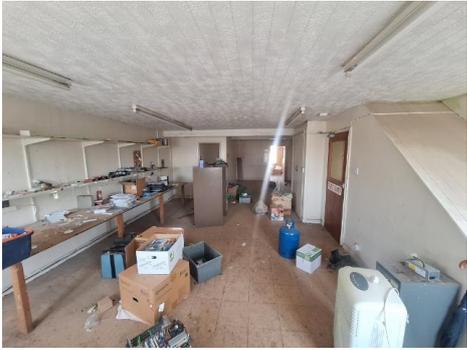
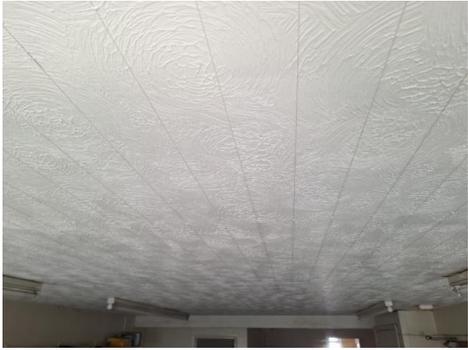
Building:	130 South Street	Floor	1st Floor
Location ID	002	Location	Storage room 2
Sample Number	S001	Extent	40 m ²
Item / Position	Ceiling	Material	Textured Coating
Product Type	Asbestos reinforced composites etc.	Scores	1
Condition	Good Condition		0
Surface Treatment	Sealed		1
Asbestos Type	Chrysotile		1
Material Assessment	Very Low		3
Substrate	Bonded to plasterboard	Accessibility	Medium
Main Photo		Close Up Photo

Recommendation	<p>Label & manage (NON-LICENSED) Manage by the way of regular visual inspections to form part of your management plan This is a requirement for non-domestic premises as per CAR2012 Reg 4. Avoid drilling or cutting into the material. This material is not licensed however may still be notifiable to the HSE prior to removal works taking place. All works must conform to the Control of Asbestos Regulations 2012.</p>		
Comments	<p>Plasterboard ceiling with smooth painted finish, solid plastered walls, plasterboard internal walls, timber floor. Timber and plasterboard beam cladding.</p> <p>Bonded to plasterboard</p>

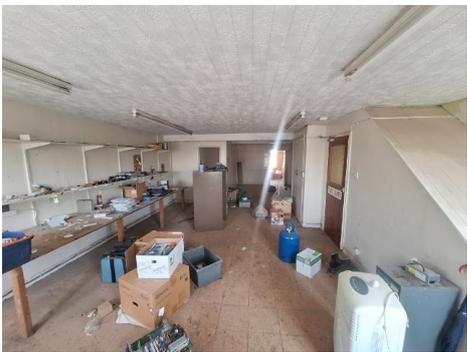
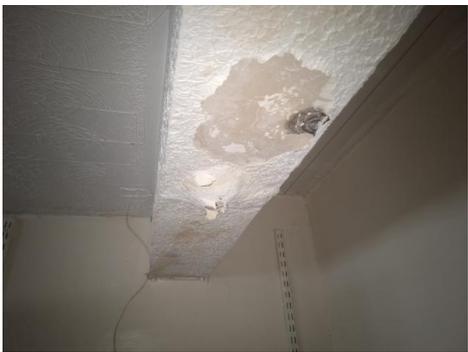
Building:	130 South Street	Floor	1st Floor
Location ID	002	Location	Storage room 2
Sample Number	S002	Extent	6 m ²
Item / Position	Beam cladding	Material	Textured Coating
Product Type	Asbestos reinforced composites etc.	Scores	1
Condition	Medium Damage		2
Surface Treatment	Sealed		1
Asbestos Type	Chrysotile		1
Material Assessment	Low		5
Substrate	Bonded to plasterboard	Accessibility	Medium
Main Photo		Close Up Photo

Recommendation	<p>Remove - NON-Licensed Material Removal by an asbestos contractor. This material is not licensed however may still be notifiable to the HSE prior to removal works taking place. All works must conform to the Control of Asbestos Regulations 2012.</p>		
Comments	<p>Plasterboard ceiling with smooth painted finish, solid plastered walls, plasterboard internal walls, timber floor. Timber and plasterboard beam cladding. Bonded to plasterboard</p>

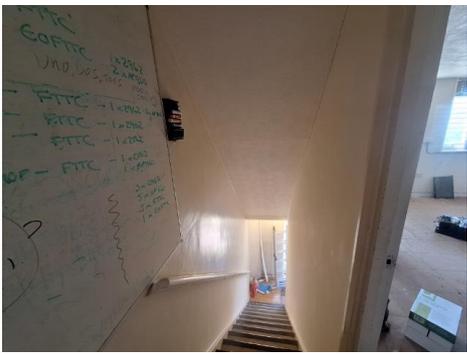
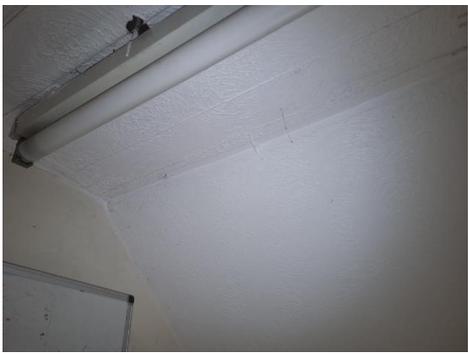
Building:	130 South Street	Floor	1st Floor
Location ID	005	Location	Stairwell
Sample Number	X001	Extent	4 m ²
Item / Position	Ceiling	Material	Textured Coating
Product Type	Asbestos reinforced composites etc.	Scores	1
Condition	Good Condition		0
Surface Treatment	Sealed		1
Asbestos Type	Chrysotile		1
Material Assessment	Very Low		3
Substrate	Bonded to plasterboard	Accessibility	Medium
Main Photo		Close Up Photo

Recommendation	<p>Label & manage (NON-LICENSED) Manage by the way of regular visual inspections to form part of your management plan This is a requirement for non-domestic premises as per CAR2012 Reg 4. Avoid drilling or cutting into the material. This material is not licensed however may still be notifiable to the HSE prior to removal works taking place. All works must conform to the Control of Asbestos Regulations 2012.</p>		
Comments	<p>Plasterboard ceiling with smooth painted finish, solid plastered walls, plasterboard internal walls, timber floor with thermoplastic floor tiles.</p> <p>Modern stair nosing.</p> <p>Bonded to plasterboard</p>

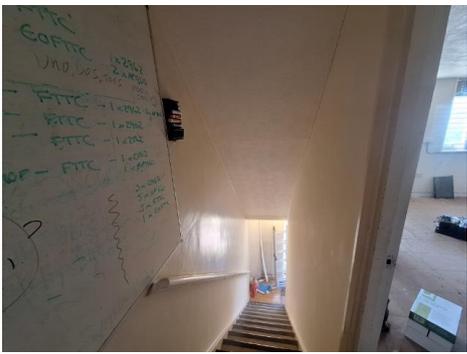
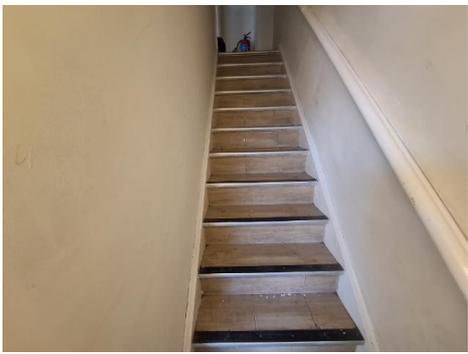
Building:	130 South Street	Floor	1st Floor
Location ID	005	Location	Stairwell
Sample Number	S003	Extent	4 m ²
Item / Position	Floortiles	Material	Thermoplastic Floor Tile
Product Type		Scores	-
Condition			-
Surface Treatment			-
Asbestos Type	No asbestos detected		-
Material Assessment	N/A		
Substrate	Bonded to timber	Accessibility	-
Main Photo		Close Up Photo

Recommendation	No action required		
Comments	Plasterboard ceiling with smooth painted finish, solid plastered walls, plasterboard internal walls, timber floor with thermoplastic floor tiles. Modern stair nosing. Bonded to timber

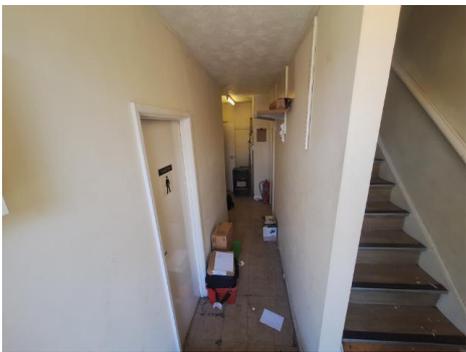
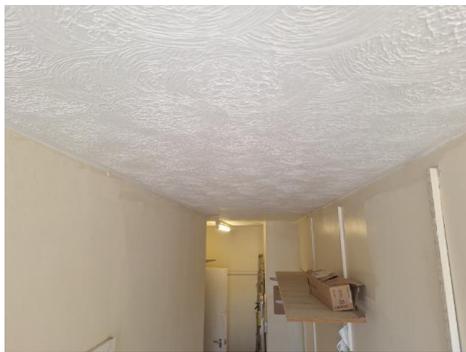
Building:	130 South Street	Floor	Ground Floor
Location ID	006	Location	Hallway
Sample Number	S004	Extent	8 m ²
Item / Position	Ceiling	Material	Textured Coating
Product Type	Asbestos reinforced composites etc.	Scores	1
Condition	Good Condition		0
Surface Treatment	Sealed		1
Asbestos Type	Chrysotile		1
Material Assessment	Very Low		3
Substrate	Bonded to plasterboard	Accessibility	Medium
Main Photo		Close Up Photo

Recommendation	<p>Label & manage (NON-LICENSED) Manage by the way of regular visual inspections to form part of your management plan This is a requirement for non-domestic premises as per CAR2012 Reg 4. Avoid drilling or cutting into the material. This material is not licensed however may still be notifiable to the HSE prior to removal works taking place. All works must conform to the Control of Asbestos Regulations 2012.</p>		
Comments	<p>Plasterboard ceiling with smooth painted finish, solid plastered walls, concrete floor with vinyl floor tiles. Bonded to plasterboard</p>

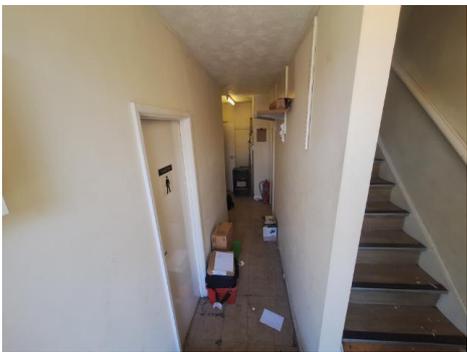
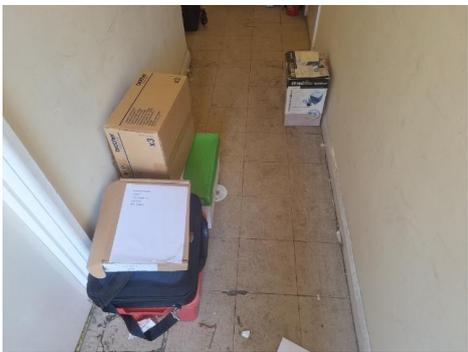
Building:	130 South Street	Floor	Ground Floor
Location ID	006	Location	Hallway
Sample Number	S005	Extent	6 m ²
Item / Position	Floortiles and bitumen adhesive	Material	Vinyl Floor Tile
Product Type	Asbestos reinforced composites etc.	Scores	1
Condition	Good Condition		0
Surface Treatment	Self Sealed		0
Asbestos Type	Chrysotile		1
Material Assessment	Very Low		2
Substrate	Bonded to concrete	Accessibility	High
Main Photo		Close Up Photo

Recommendation	<p>Label & manage (NON-LICENSED) Manage by the way of regular visual inspections to form part of your management plan This is a requirement for non-domestic premises as per CAR2012 Reg 4. Avoid drilling or cutting into the material. This material is not licensed however may still be notifiable to the HSE prior to removal works taking place. All works must conform to the Control of Asbestos Regulations 2012.</p>		
Comments	<p>Plasterboard ceiling with smooth painted finish, solid plastered walls, concrete floor with vinyl floor tiles. Bonded to concrete</p>

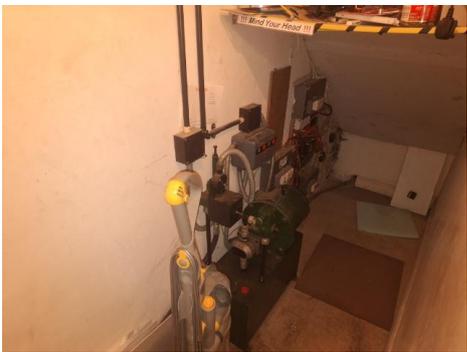
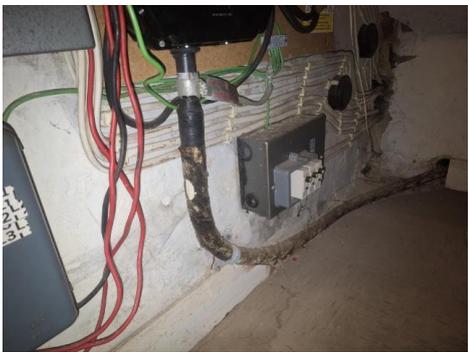
Building:	130 South Street	Floor	Ground Floor
Location ID	007	Location	Understairs cupboard
Sample Number	P	Extent	1 no
Item / Position	Old cable wrap	Material	Bituminous Product
Product Type	Asbestos reinforced composites etc.	Scores	1
Condition	Good Condition		0
Surface Treatment	Self Sealed		0
Asbestos Type	Presumed Chrysotile		1
Material Assessment	Very Low		2
Substrate	Unable to sample due to live supply.	Accessibility	Low
Main Photo		Close Up Photo

Recommendation	Inaccessible Items / Strongly Presumed Inaccessible item. Isolation, access and sampling will be required prior to any works which may disturb the presumed item.		
Comments	Unable to sample due to live supply.

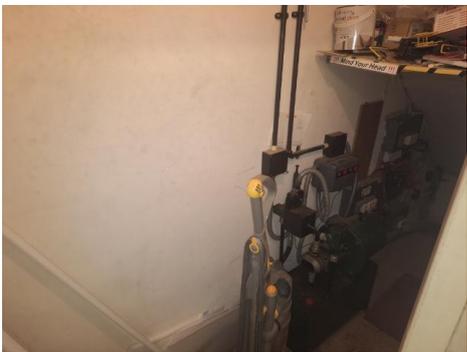
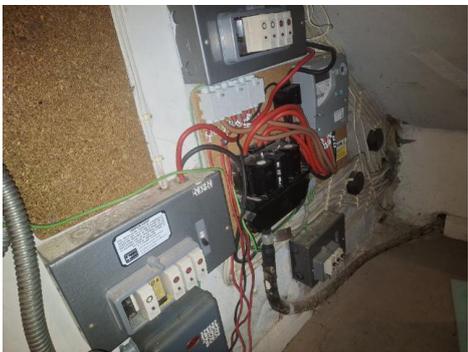
Building:	130 South Street	Floor	Ground Floor
Location ID	007	Location	Understairs cupboard
Sample Number	P	Extent	14 no
Item / Position	Old fuse guards	Material	Gaskets (rope/woven)
Product Type	Asbestos insulating board, millboards, gaskets & ropes etc.	Scores	2
Condition	Good Condition		0
Surface Treatment	Partially Unsealed		2
Asbestos Type	Presumed Chrysotile		1
Material Assessment	Low		5
Substrate	Unable to sample due to live supply.	Accessibility	Low
Main Photo		Close Up Photo

Recommendation	Inaccessible Items / Strongly Presumed Inaccessible item. Isolation, access and sampling will be required prior to any works which may disturb the presumed item.		
Comments	Unable to sample due to live supply.

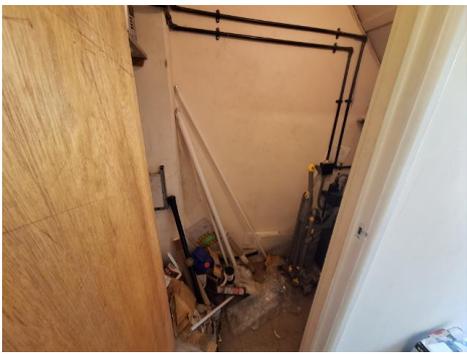
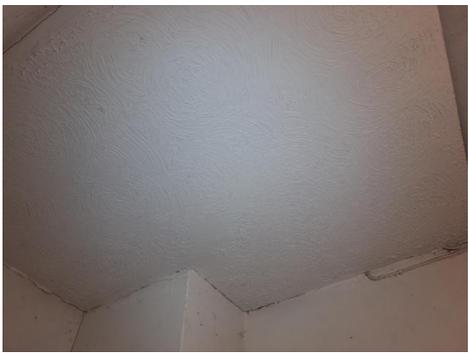
Building:	130 South Street	Floor	Ground Floor
Location ID	007	Location	Understairs cupboard
Sample Number	X004	Extent	1 m ²
Item / Position	Ceiling	Material	Textured Coating
Product Type	Asbestos reinforced composites etc.	Scores	1
Condition	Good Condition		0
Surface Treatment	Sealed		1
Asbestos Type	Chrysotile		1
Material Assessment	Very Low		3
Substrate	Bonded to plasterboard	Accessibility	Medium
Main Photo		Close Up Photo

Recommendation	<p>Label & manage (NON-LICENSED) Manage by the way of regular visual inspections to form part of your management plan This is a requirement for non-domestic premises as per CAR2012 Reg 4. Avoid drilling or cutting into the material. This material is not licensed however may still be notifiable to the HSE prior to removal works taking place. All works must conform to the Control of Asbestos Regulations 2012.</p>		
Comments	<p>Plasterboard ceiling with smooth painted finish, solid plastered walls, concrete floor with vinyl floor tiles. AIB stair backing and batons. AIB panels covering hole in boxing. Old electrics. Bonded to plasterboard</p>

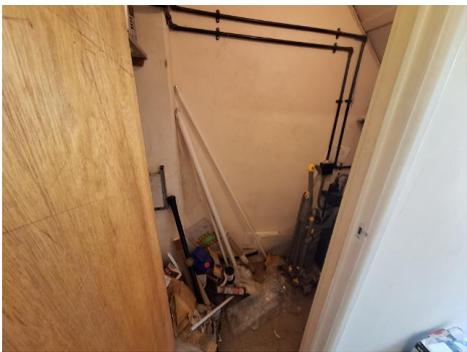
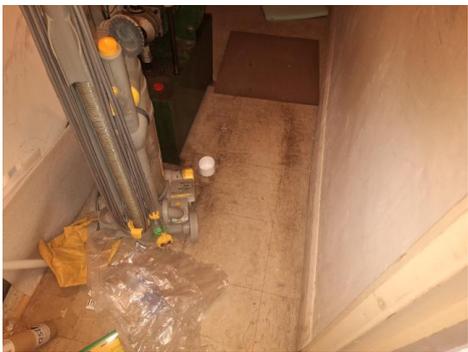
Building:	130 South Street	Floor	Ground Floor
Location ID	007	Location	Understairs cupboard
Sample Number	X005	Extent	4 m ²
Item / Position	Floortiles and bitumen adhesive	Material	Vinyl Products
Product Type	Asbestos reinforced composites etc.	Scores	1
Condition	Good Condition		0
Surface Treatment	Self Sealed		0
Asbestos Type	Chrysotile		1
Material Assessment	Very Low		2
Substrate	Bonded to concrete	Accessibility	High
Main Photo		Close Up Photo

Recommendation	<p>Label & manage (NON-LICENSED) Manage by the way of regular visual inspections to form part of your management plan This is a requirement for non-domestic premises as per CAR2012 Reg 4. Avoid drilling or cutting into the material. This material is not licensed however may still be notifiable to the HSE prior to removal works taking place. All works must conform to the Control of Asbestos Regulations 2012.</p>		
Comments	<p>Plasterboard ceiling with smooth painted finish, solid plastered walls, concrete floor with vinyl floor tiles. AIB stair backing and batons. AIB panels covering hole in boxing. Old electrics. Bonded to concrete</p>

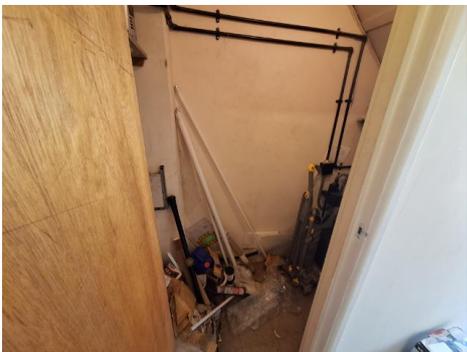
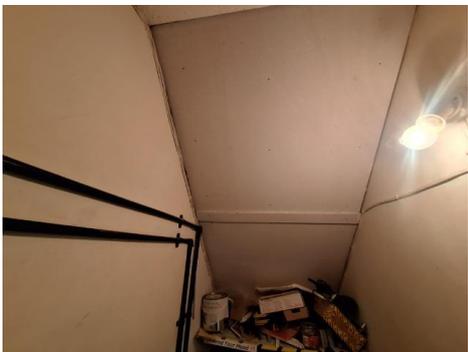
Building:	130 South Street	Floor	Ground Floor
Location ID	007	Location	Understairs cupboard
Sample Number	S006	Extent	3.5 m ²
Item / Position	Dairy backing and batons	Material	Insulating Board
Product Type	Asbestos insulating board, millboards, gaskets & ropes etc.	Scores	2
Condition	Good Condition		0
Surface Treatment	Partially Unsealed		2
Asbestos Type	Amosite, Chrysotile		2
Material Assessment	Low		6
Substrate	Nailed to timber	Accessibility	High
Main Photo		Close Up Photo

Comments	<p>Plasterboard ceiling with smooth painted finish, solid plastered walls, concrete floor with vinyl floor tiles. AIB stair backing and batons. AIB panels covering hole in boxing. Old electrics. Nailed to timber</p>

Recommendation	<p>Label & manage (LICENSED) Manage by the way of regular visual inspections to form part of your management plan This is a requirement for non-domestic premises as per CAR2012 Reg 4. Avoid drilling or cutting into the material. This material is licensed therefore is subject to a 14 notification to the HSE prior to removal works taking place. All works must conform to the Control of Asbestos Regulations 2012.</p>

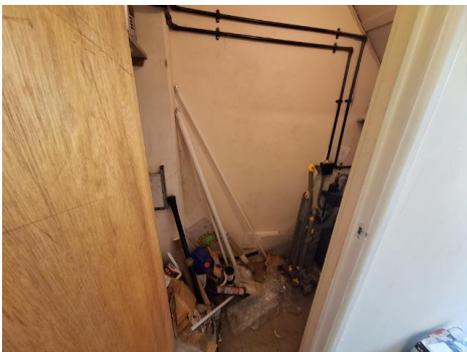
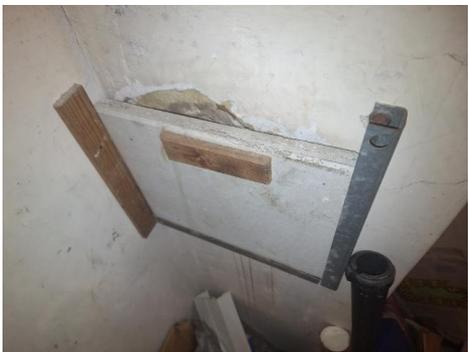
Building:	130 South Street	Floor	Ground Floor
Location ID	007	Location	Understairs cupboard
Sample Number	S007	Extent	2 no
Item / Position	Panels	Material	Insulating Board
Product Type	Asbestos insulating board, millboards, gaskets & ropes etc.	Scores	2
Condition	Good Condition		0
Surface Treatment	Partially Unsealed		2
Asbestos Type	Amosite, Chrysotile		2
Material Assessment	Low		6
Substrate	Nailed to timber	Accessibility	High
Main Photo		Close Up Photo

Recommendation	<p>Label & manage (LICENSED) Manage by the way of regular visual inspections to form part of your management plan This is a requirement for non-domestic premises as per CAR2012 Reg 4. Avoid drilling or cutting into the material. This material is licensed therefore is subject to a 14 notification to the HSE prior to removal works taking place. All works must conform to the Control of Asbestos Regulations 2012.</p>		
Comments	<p>Plasterboard ceiling with smooth painted finish, solid plastered walls, concrete floor with vinyl floor tiles. AIB stair backing and batons. AIB panels covering hole in boxing. Old electrics. Nailed to timber</p>

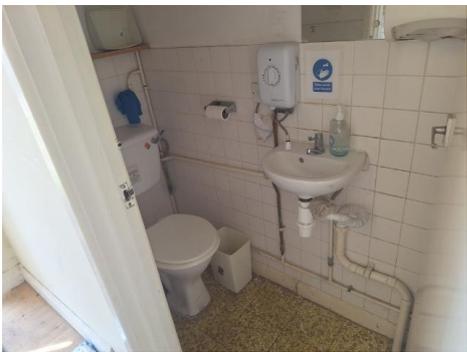
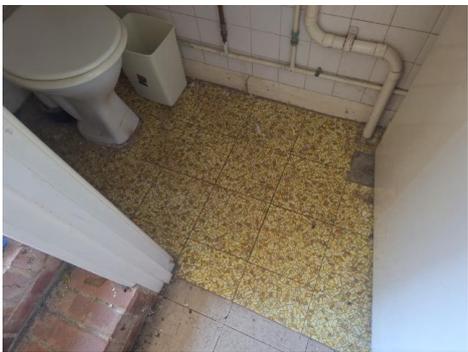
Building:	130 South Street	Floor	Ground Floor
Location ID	008	Location	Men's wc
Sample Number	X005	Extent	2 m ²
Item / Position	Floortiles and bitumen adhesive	Material	Vinyl Floor Tile
Product Type	Asbestos reinforced composites etc.	Scores	1
Condition	Good Condition		0
Surface Treatment	Self Sealed		0
Asbestos Type	Chrysotile		1
Material Assessment	Very Low		2
Substrate	Bonded to concrete	Accessibility	High
Main Photo		Close Up Photo

Recommendation	<p>Label & manage (NON-LICENSED) Manage by the way of regular visual inspections to form part of your management plan This is a requirement for non-domestic premises as per CAR2012 Reg 4. Avoid drilling or cutting into the material. This material is not licensed however may still be notifiable to the HSE prior to removal works taking place. All works must conform to the Control of Asbestos Regulations 2012.</p>		
Comments	<p>Plasterboard ceiling with smooth painted finish, solid plastered walls, concrete floor with vinyl floor tiles beneath linoleum tiles.</p> <p>Ceramic toilet cistern with ceramic soil pipe.</p> <p>Timber boxing.</p> <p>Bonded to concrete</p>

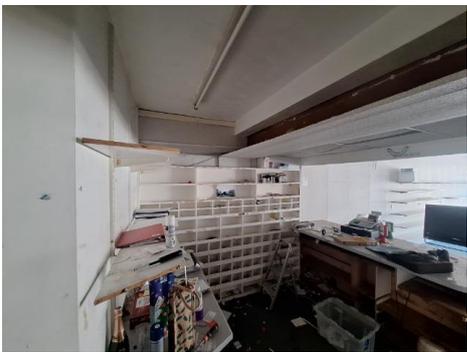
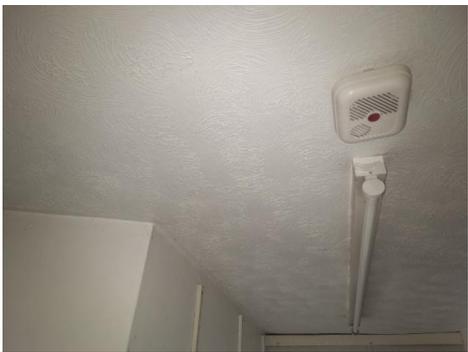
Building:	130 South Street	Floor	Ground Floor
Location ID	009	Location	Main retail area
Sample Number	X004	Extent	4 m ²
Item / Position	Boxing	Material	Textured Coating
Product Type	Asbestos reinforced composites etc.	Scores	1
Condition	Good Condition		0
Surface Treatment	Sealed		1
Asbestos Type	Chrysotile		1
Material Assessment	Very Low		3
Substrate	Bonded to plasterboard	Accessibility	Medium
Main Photo		Close Up Photo

Recommendation	<p>Label & manage (NON-LICENSED) Manage by the way of regular visual inspections to form part of your management plan This is a requirement for non-domestic premises as per CAR2012 Reg 4. Avoid drilling or cutting into the material. This material is not licensed however may still be notifiable to the HSE prior to removal works taking place. All works must conform to the Control of Asbestos Regulations 2012.</p>		
Comments	<p>Plasterboard ceiling with smooth painted finish, solid plastered walls with timber cladding and woodchip wallpaper covering, concrete floor with vinyl floor tiles beneath carpet. Timber beam cladding and boxing. Bonded to plasterboard</p>

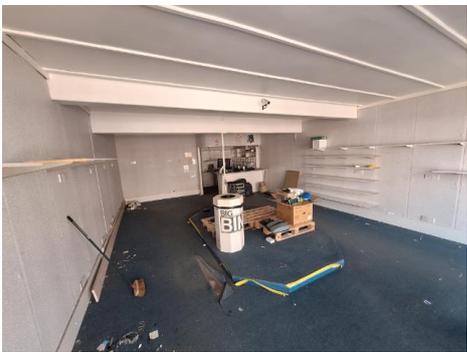
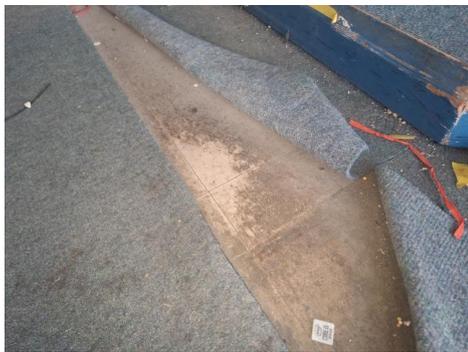
Building:	130 South Street	Floor	Ground Floor
Location ID	009	Location	Main retail area
Sample Number	X005	Extent	55 m ²
Item / Position	Floortiles and bitumen adhesive	Material	Vinyl Floor Tile
Product Type	Asbestos reinforced composites etc.	Scores	1
Condition	Good Condition		0
Surface Treatment	Self Sealed		0
Asbestos Type	Chrysotile		1
Material Assessment	Very Low		2
Substrate	Bonded to concrete	Accessibility	Medium
Main Photo		Close Up Photo

Recommendation	<p>Label & manage (NON-LICENSED) Manage by the way of regular visual inspections to form part of your management plan This is a requirement for non-domestic premises as per CAR2012 Reg 4. Avoid drilling or cutting into the material. This material is not licensed however may still be notifiable to the HSE prior to removal works taking place. All works must conform to the Control of Asbestos Regulations 2012.</p>		
Comments	<p>Plasterboard ceiling with smooth painted finish, solid plastered walls with timber cladding and woodchip wallpaper covering, concrete floor with vinyl floor tiles beneath carpet. Timber beam cladding and boxing. Bonded to concrete</p>

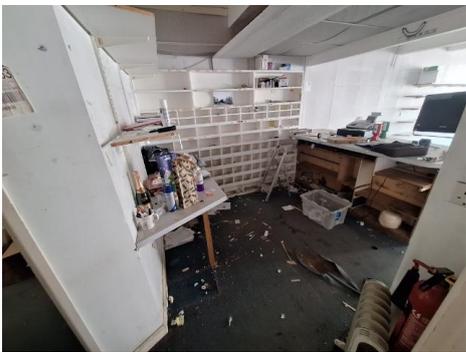
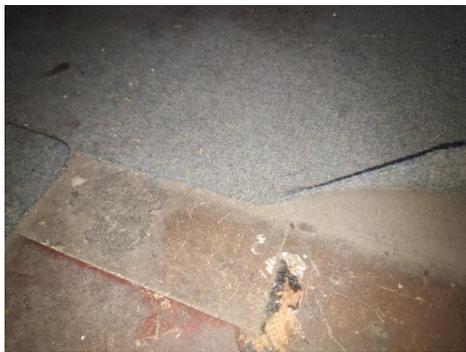
Building:	130 South Street	Floor	Ground Floor
Location ID	009	Location	Main retail area
Sample Number	S008	Extent	10 m ²
Item / Position	Floortiles and bitumen adhesive	Material	Vinyl Floor Tile
Product Type	Asbestos reinforced composites etc.	Scores	1
Condition	Good Condition		0
Surface Treatment	Self Sealed		0
Asbestos Type	Chrysotile		1
Material Assessment	Very Low		2
Substrate	Bonded to concrete	Accessibility	Medium
Main Photo		Close Up Photo

Recommendation	<p>Label & manage (NON-LICENSED) Manage by the way of regular visual inspections to form part of your management plan This is a requirement for non-domestic premises as per CAR2012 Reg 4. Avoid drilling or cutting into the material. This material is not licensed however may still be notifiable to the HSE prior to removal works taking place. All works must conform to the Control of Asbestos Regulations 2012.</p>		
Comments	<p>Plasterboard ceiling with smooth painted finish, solid plastered walls with timber cladding and woodchip wallpaper covering, concrete floor with vinyl floor tiles beneath carpet. Timber beam cladding and boxing. Bonded to concrete</p>

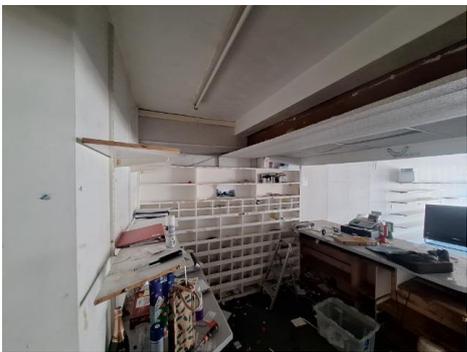
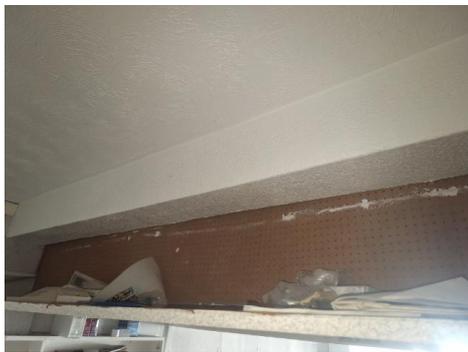
Building:	130 South Street	Floor	Ground Floor
Location ID	009	Location	Main retail area
Sample Number	S009	Extent	10 m ²
Item / Position	Boxing	Material	Textured Coating
Product Type	Asbestos reinforced composites etc.	Scores	1
Condition	Good Condition		0
Surface Treatment	Sealed		1
Asbestos Type	Chrysotile		1
Material Assessment	Very Low		3
Substrate	Bonded to plasterboard	Accessibility	Medium
Main Photo		Close Up Photo

Recommendation	<p>Label & manage (NON-LICENSED) Manage by the way of regular visual inspections to form part of your management plan This is a requirement for non-domestic premises as per CAR2012 Reg 4. Avoid drilling or cutting into the material. This material is not licensed however may still be notifiable to the HSE prior to removal works taking place. All works must conform to the Control of Asbestos Regulations 2012.</p>		
Comments	<p>Plasterboard ceiling with smooth painted finish, solid plastered walls with timber cladding and woodchip wallpaper covering, concrete floor with vinyl floor tiles beneath carpet. Timber beam cladding and boxing. Bonded to plasterboard</p>

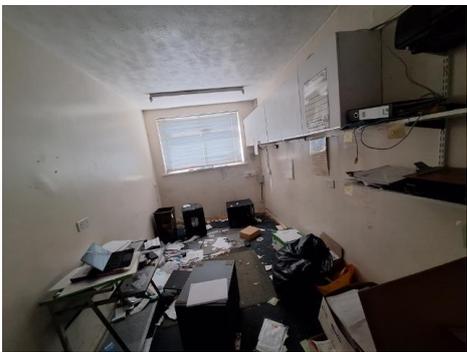
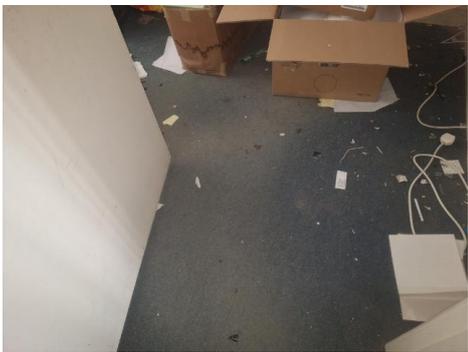
Building:	130 South Street	Floor	Ground Floor
Location ID	010	Location	Office
Sample Number	P	Extent	15 m ²
Item / Position	Floortiles and bitumen adhesive	Material	Vinyl Floor Tile
Product Type	Asbestos reinforced composites etc.	Scores	1
Condition	Good Condition		0
Surface Treatment	Self Sealed		0
Asbestos Type	Presumed Chrysotile		1
Material Assessment	Very Low		2
Substrate	Carpet is glued down.	Accessibility	Low
Main Photo		Close Up Photo

Recommendation	Inaccessible Items / Strongly Presumed Inaccessible item. Isolation, access and sampling will be required prior to any works which may disturb the presumed item.		
Comments	Carpet is glued down.

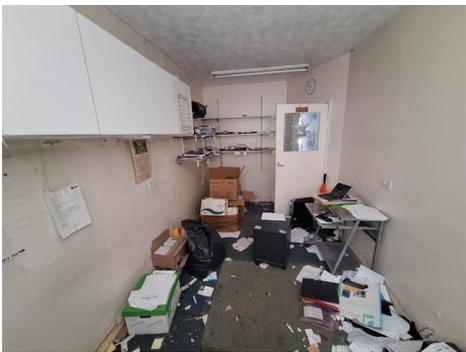
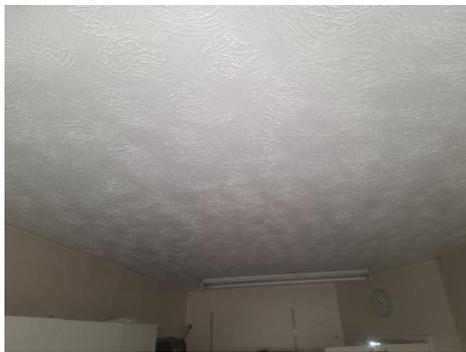
Building:	130 South Street	Floor	Ground Floor
Location ID	010	Location	Office
Sample Number	X004	Extent	15 m ²
Item / Position	Ceiling	Material	Textured Coating
Product Type	Asbestos reinforced composites etc.	Scores	1
Condition	Good Condition		0
Surface Treatment	Sealed		1
Asbestos Type	Chrysotile		1
Material Assessment	Very Low		3
Substrate	Bonded to plasterboard	Accessibility	Medium
Main Photo		Close Up Photo

Recommendation	<p>Label & manage (NON-LICENSED) Manage by the way of regular visual inspections to form part of your management plan This is a requirement for non-domestic premises as per CAR2012 Reg 4. Avoid drilling or cutting into the material. This material is not licensed however may still be notifiable to the HSE prior to removal works taking place. All works must conform to the Control of Asbestos Regulations 2012.</p>		
Comments	<p>Plasterboard ceiling with textured coating, solid plastered walls, concrete floor with vinyl floor tiles beneath carpet.</p> <p>Bonded to plasterboard</p>

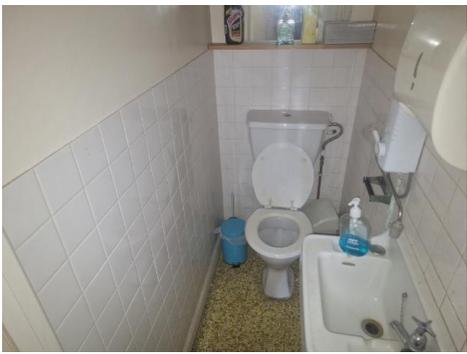
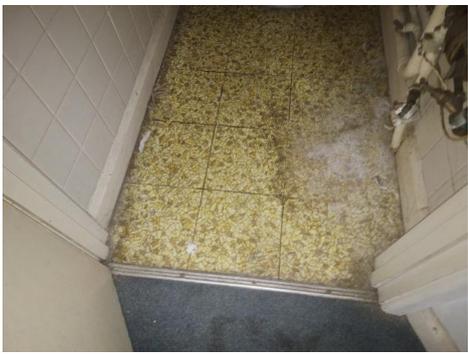
Building:	130 South Street	Floor	Ground Floor
Location ID	011	Location	Female wc
Sample Number	P	Extent	2 m ²
Item / Position	Floortiles and bitumen adhesive	Material	Vinyl Floor Tile
Product Type	Asbestos reinforced composites etc.	Scores	1
Condition	Good Condition		0
Surface Treatment	Self Sealed		0
Asbestos Type	Presumed Chrysotile		1
Material Assessment	Very Low		2
Substrate	Potentially under linoleum tiles.	Accessibility	Low
Main Photo		Close Up Photo

Recommendation	Inaccessible Items / Strongly Presumed Inaccessible item. Isolation, access and sampling will be required prior to any works which may disturb the presumed item.		
Comments	Timber ceiling, solid plastered walls with a ceramic covering, concrete floor with linoleum tiles. Ceramic toilet cistern with ceramic soil pipe. Potentially under linoleum tiles.
