## Project

**Project Name:** 4521 - Shoreham-By-Sea

**Project Date:** 15/07/2024

**Inspection Standard:** MSCC5 Sewers & Drainage GB (SRM5 Scoring)

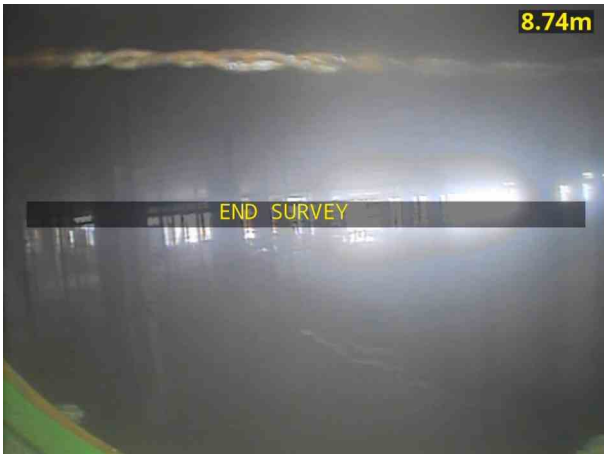
| Item No. | Inspection Direction | PLR | Client's Job Ref | Contractor's Job Ref |
|---|---|---|---|---|
| 9 | Upstream | LINE 2X | | |

1\_S18\_Upstream\_Line 2.jpg, 00:00:32, 8.74 m  
Finish node, other special chamber, reference: Line 2, OPEN  
IN BASEMENT

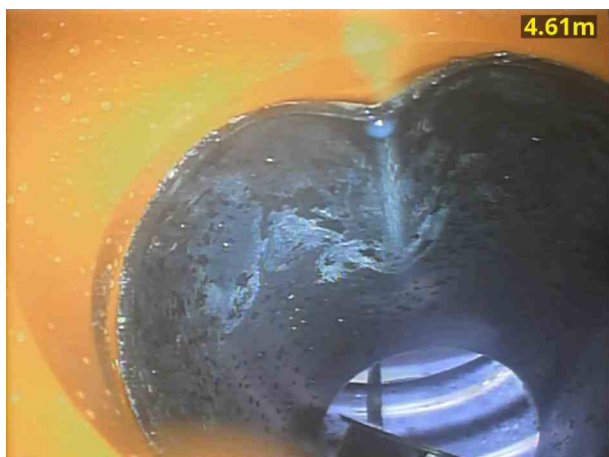
| Item No. | Inspection Direction | PLR | Client's Job Ref | Contractor's Job Ref |
|---|---|---|---|---|
| 19 | Upstream | LINE 1X | | |

| Section | PLR | Grade | Description |
|---|---|---|---|
| 19 | LINE 1X | 3 | Deformed sewer or drain, 10% |

2\_S16\_Upstream\_LINE 1.jpg, 00:00:22, 4.60 m  
Deformed sewer or drain, 10%, IN GULLY ENTRANCE
