**Project:**  
17 Heene Terrace, Worthing

**Drawing Title:**  
Proposed Plans, Sections & Elevations

**Drawing No:**  
(21)000

**Drawing Status:**  
Planning

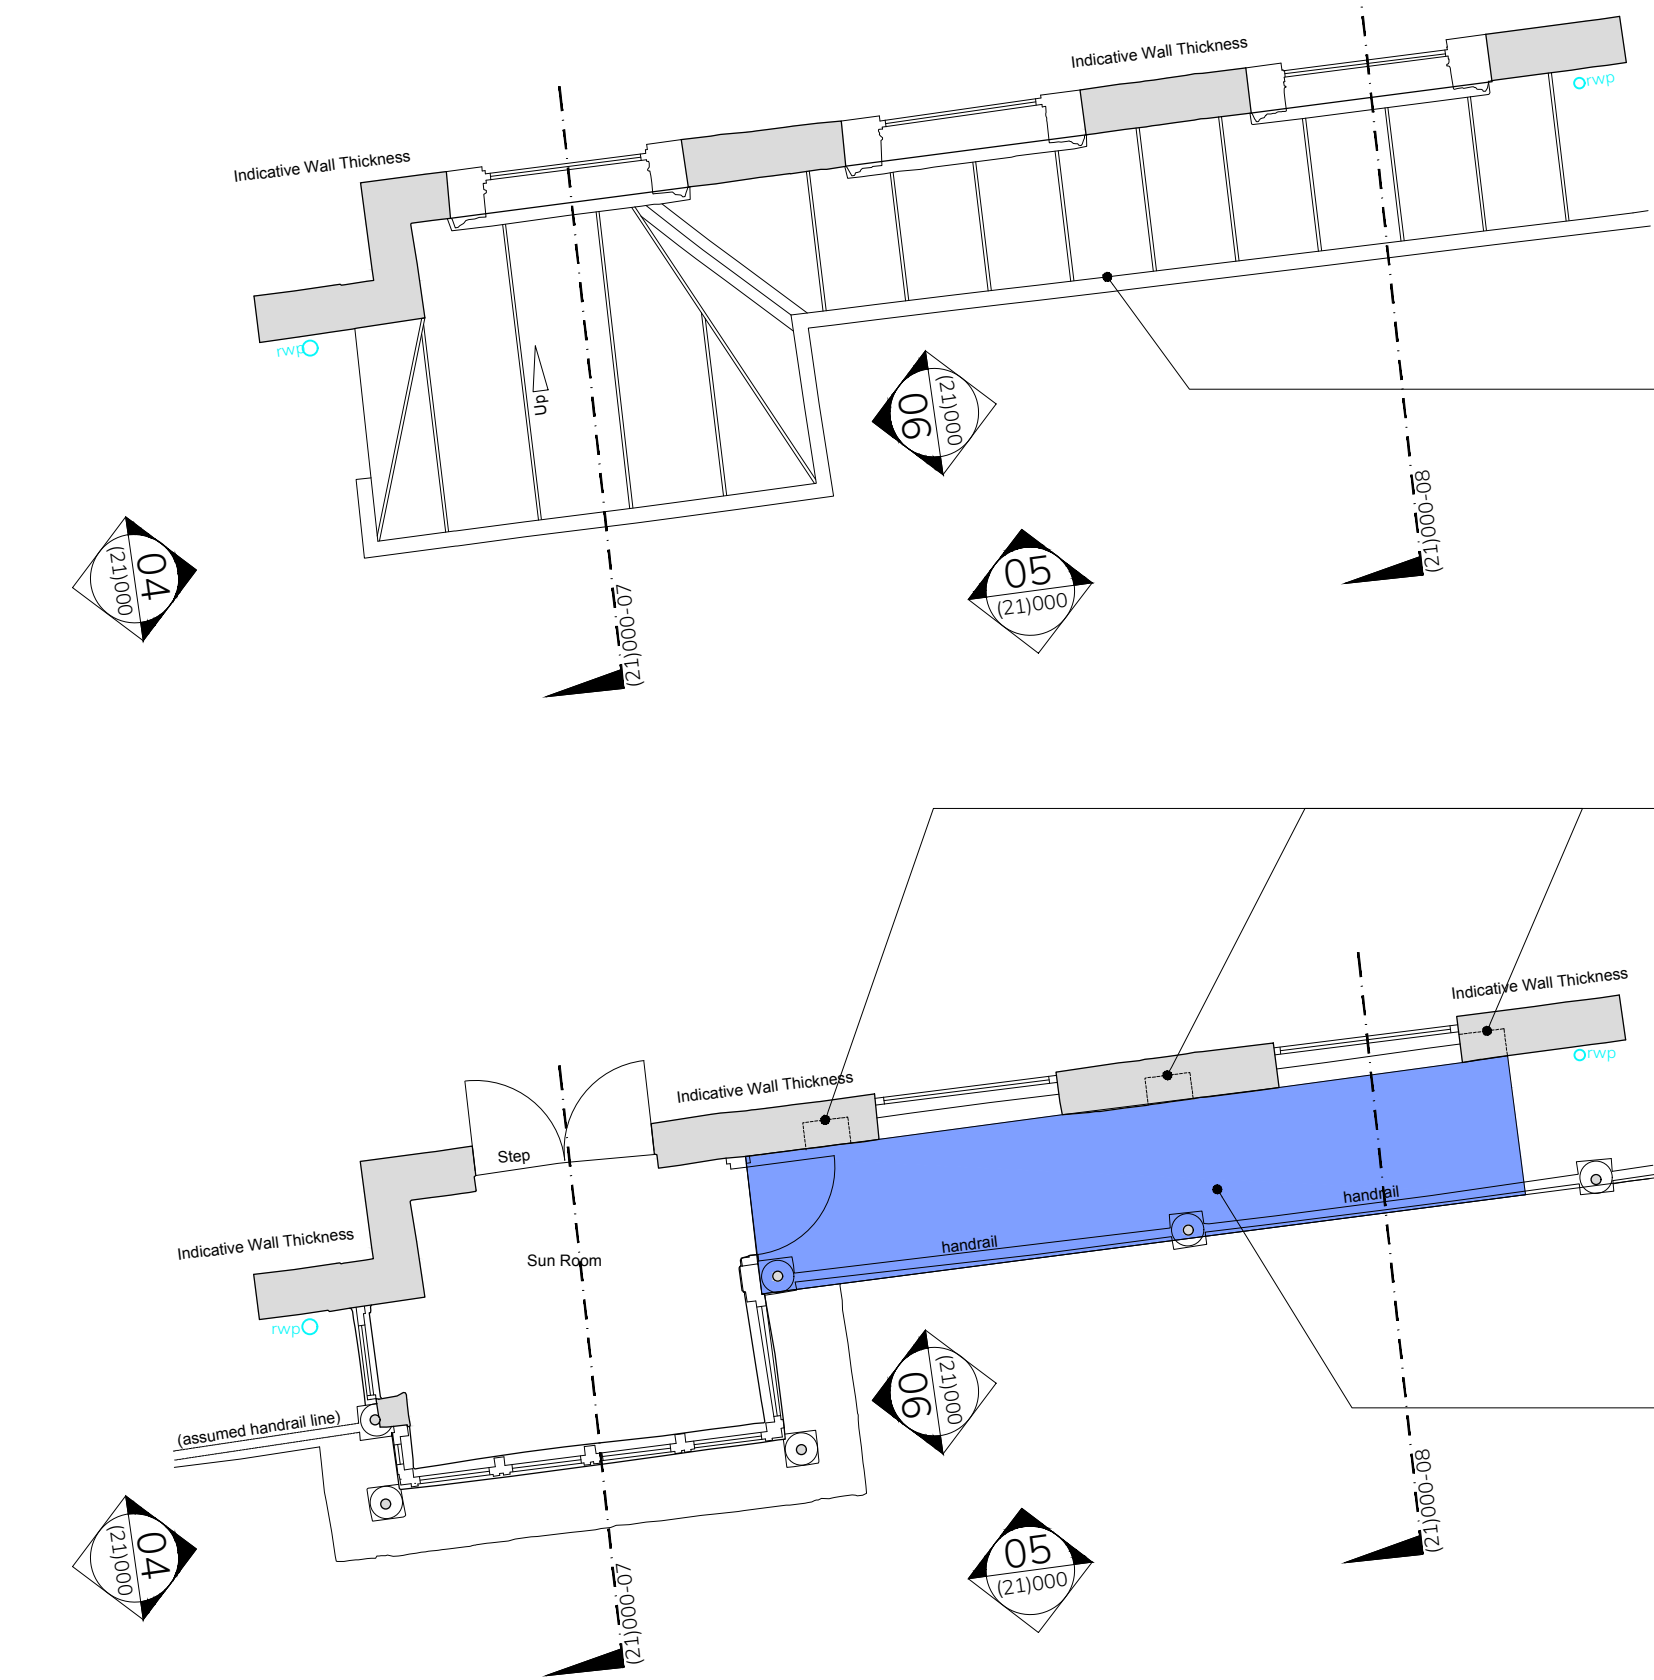
01-As Existing 1:50  
Second Floor (Balcony Roof) Plan

Code 5 rolled lead sheet roof, with welded joints. Roof to be installed in strict accordance with Lead Sheet Association approved details including all accessories, underlays, and sundries necessary to comply with approved details for each required junction. Penetration Oil to be applied to all leadwork immediately after installation and before the lead gets wet to prevent white carbonate staining of adjacent materials

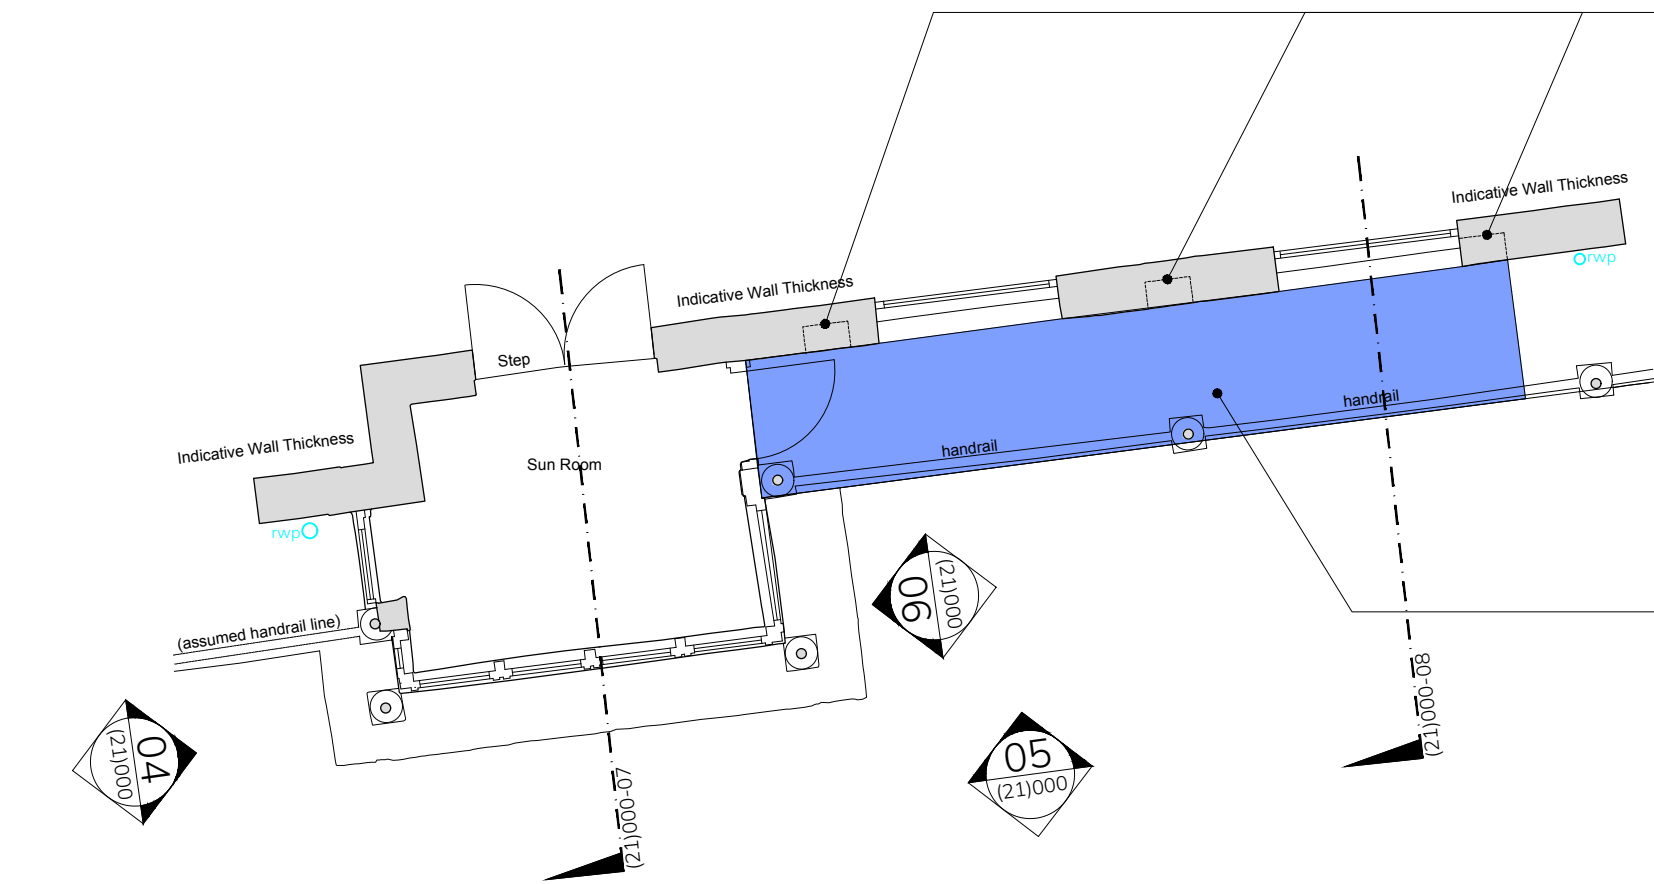
02-As Existing 1:50  
First Floor (Balcony) Plan

Blue hatch denotes extent of concrete slab. Slab extends beyond existing cracking to allow for tongues to be cast into main facade either side of window openings.

300mm wide x 100mm thick tongues of concrete slab cast 180mm into wall as per structural engineer's details.
