# Heene Terrace

## Design & Repair Statement

17 Heene Terrace  
Worthing  
BN11 3NR

September 2026

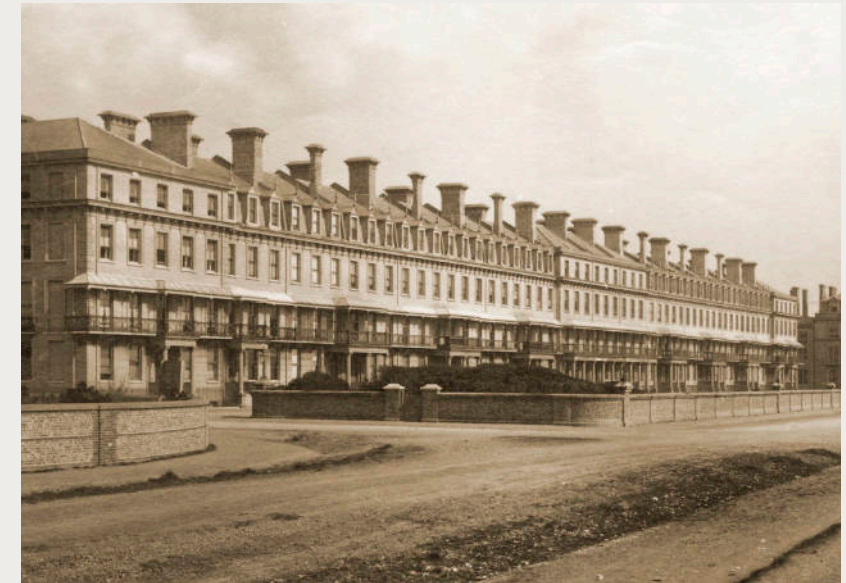
Figure 1: Historic photograph of Heene Terrace c.1893, showing the original canopy to the bookend element adjacent to No. 17. (Reproduced with permission of West Sussex Record Office, Catalogue No: PP/WSL/WGP000913). A larger copy of this image is provided as Appendix A.

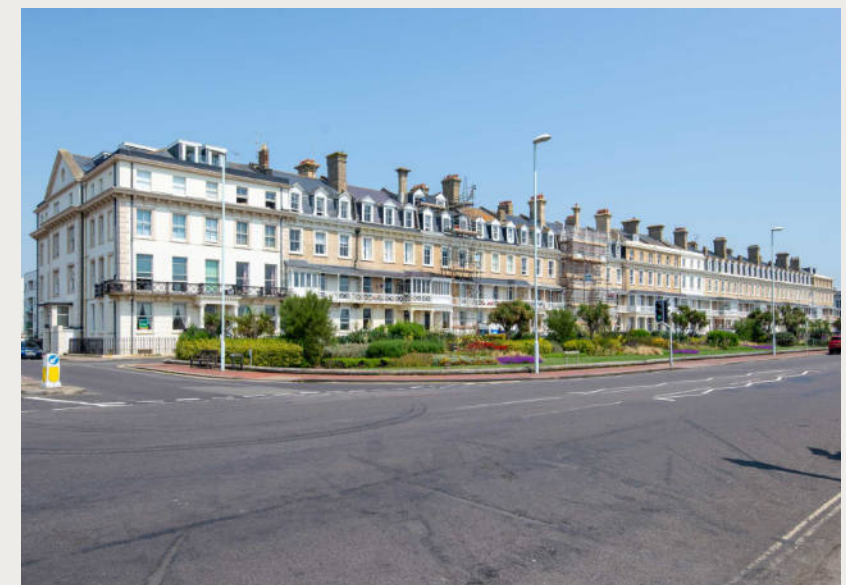
Figure 2: Contemporary image of Heene Terrace showing the missing canopy to the western bookend.

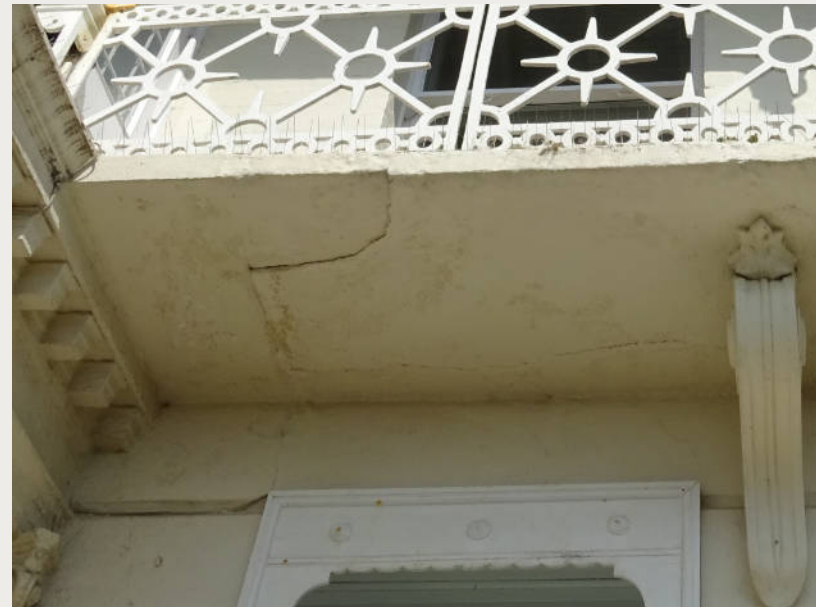
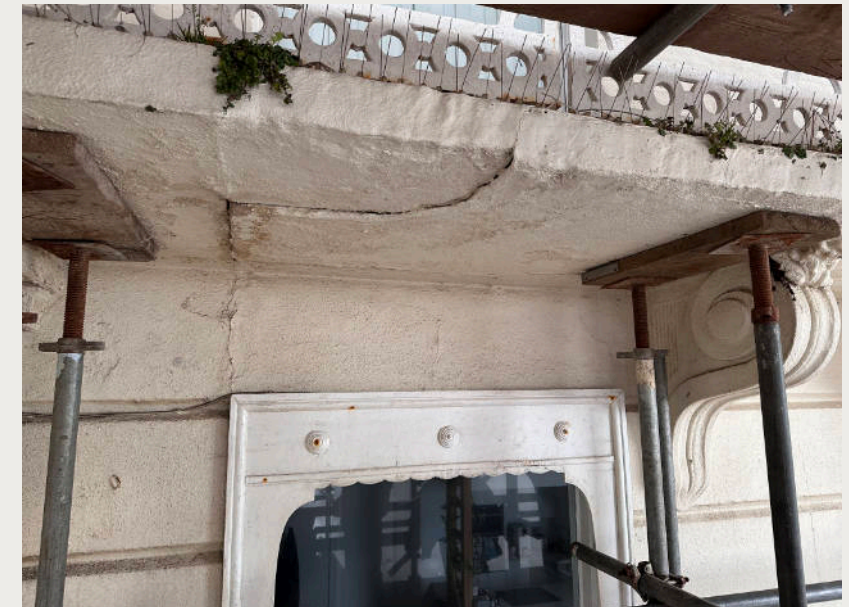
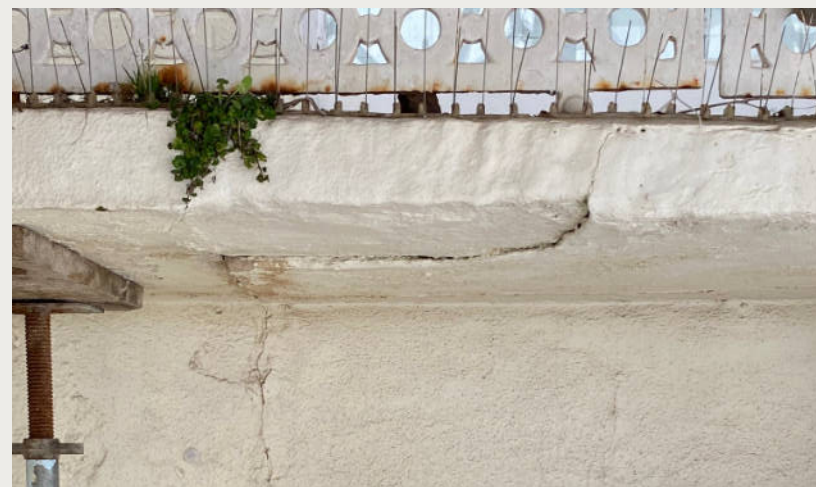
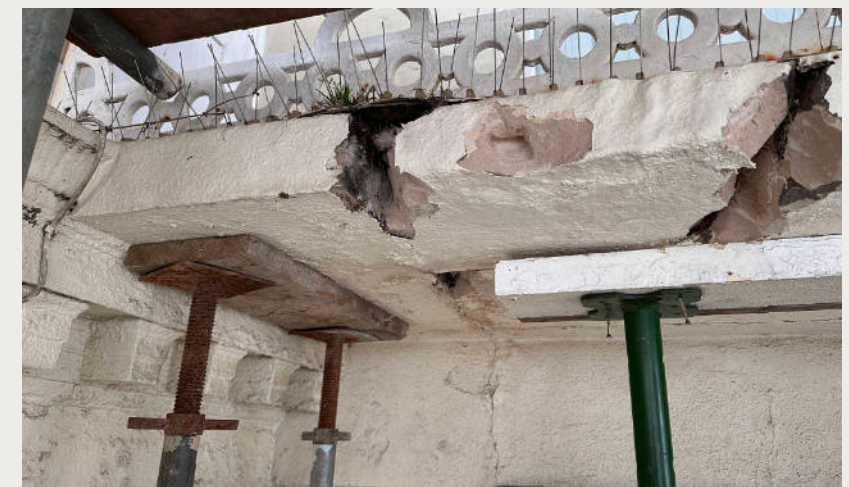
The slab appears to have been formed from a number of stone segments rather than a single continuous piece of stone. Where part of the slab has now been removed, a tongue-and-groove junction running front to back is visible between the stone elements. Due to the paint and tile finishes, it is not currently possible to determine the overall size of each individual stone unit.

Before the current works commenced, the slab had visibly cracked and had become unsafe.

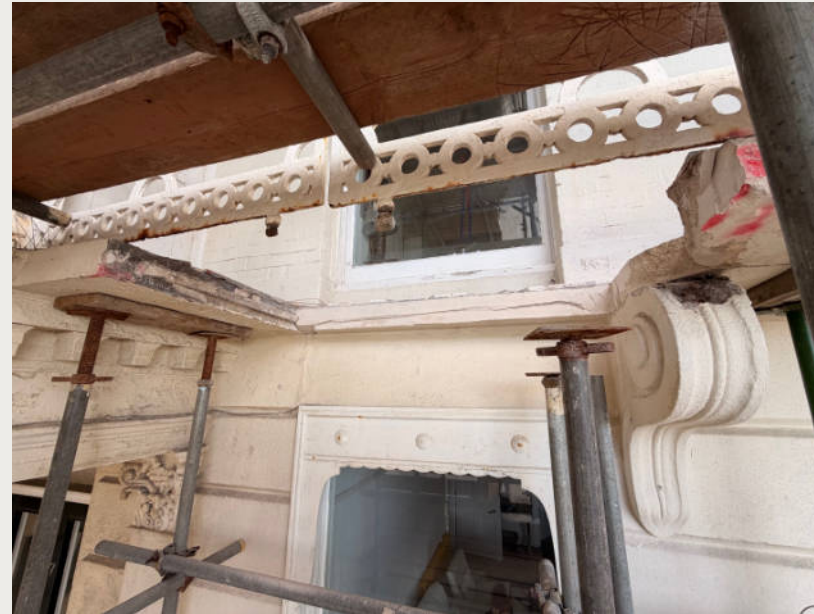
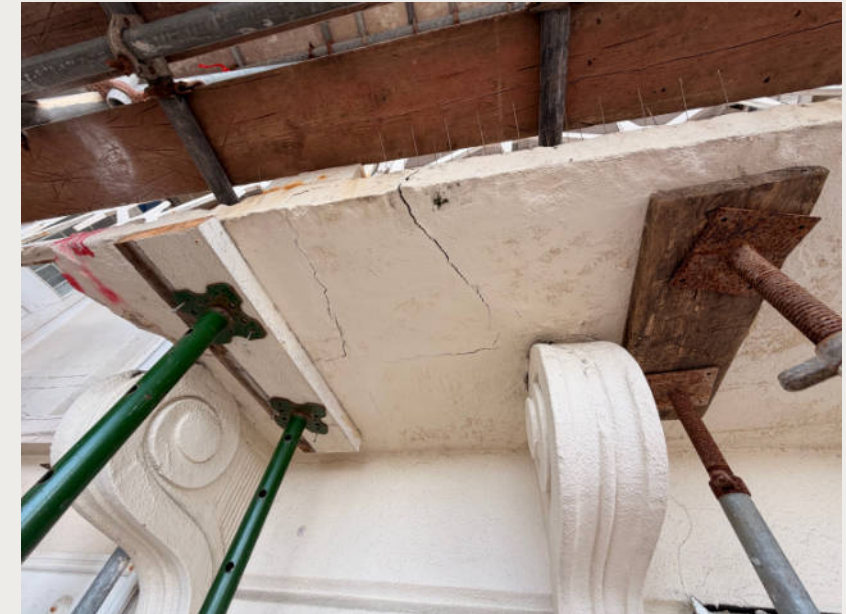
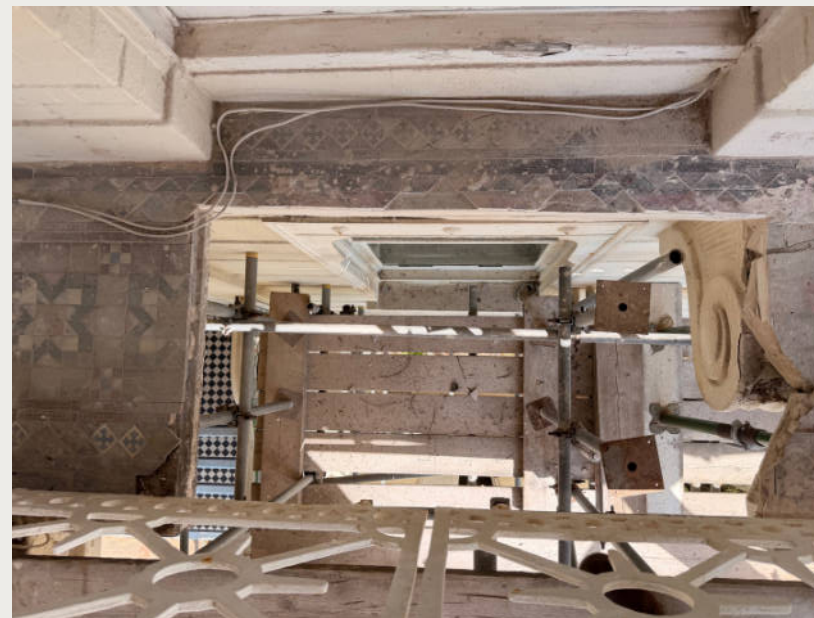
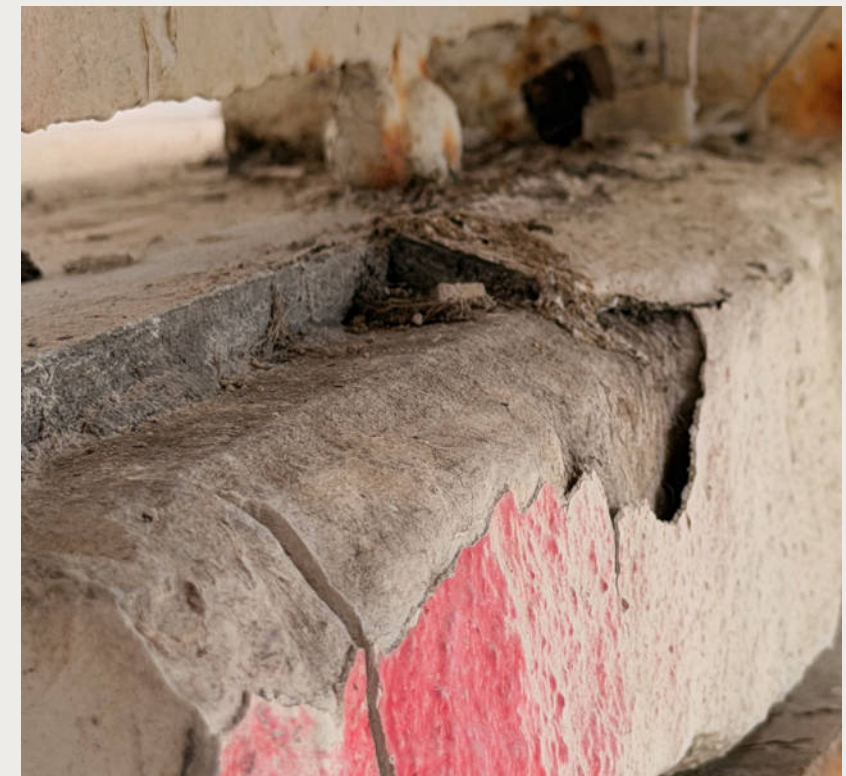
Following the initial identification of cracking, the condition of the balcony slab became progressively worse. The slab is located directly above the main entrance to the basement flat, adjacent to windows serving living accommodation, and close to the public footway. Given this location, the building owner had no practical option but to urgently remove the stone elements that were at risk of collapse.

The removal of the worst affected stone exposed additional cracking beyond the areas that had initially appeared most compromised. As a result, part of the retained slab is also now understood to be structurally compromised and no longer viable as a permanent structural element.

The remaining areas of slab have been temporarily supported with props to prevent further movement or collapse of the stone while the permanent repair strategy is developed and agreed.

As the worst affected area cracked and deteriorated, it also caused damage to one of the console brackets directly below.

The revised proposal is therefore to replace the damaged sections of the balcony slab in reinforced concrete. This approach allows the failed and structurally compromised areas to be replaced while retaining the vast majority of the Portland stone slab that is embedded within the main façade.

The new reinforced concrete slab will be secured to the building in two ways. First, the remaining stone slab will be cut back in line with the main façade, and 12mm stainless steel dowel bars will be fixed into this retained stone and cast into the new slab. Secondly, as the dowels alone would not provide sufficient restraint to tie the new slab back into the building, three 300mm wide by 100mm high pockets will be formed in the main façade, into which tongues from the new concrete slab will be cast. The overall width of the concrete slab is dictated by the need for this pockets to be located either side of the existing window openings.

The damaged console bracket will receive a plastic repair in an appropriate lime mortar with the existing profiles and features recreated prior to repainting.

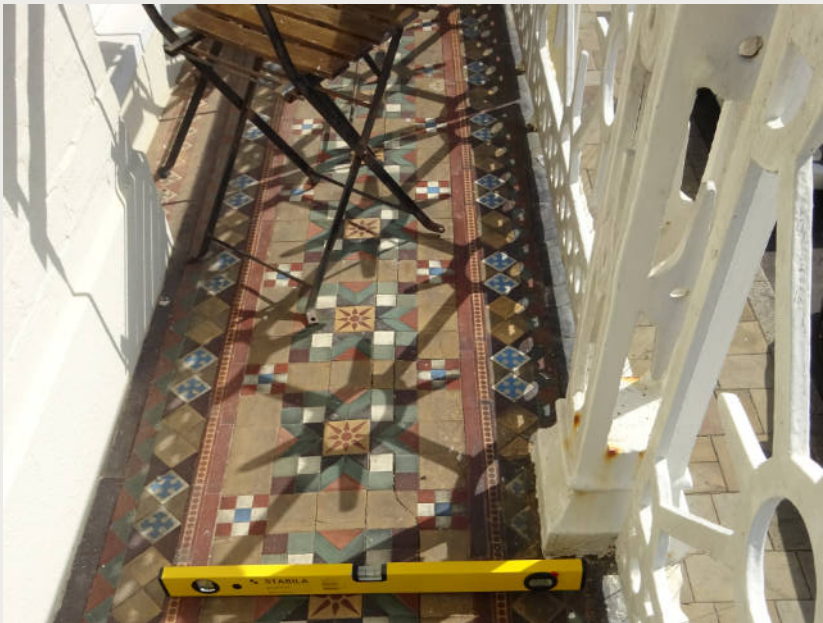
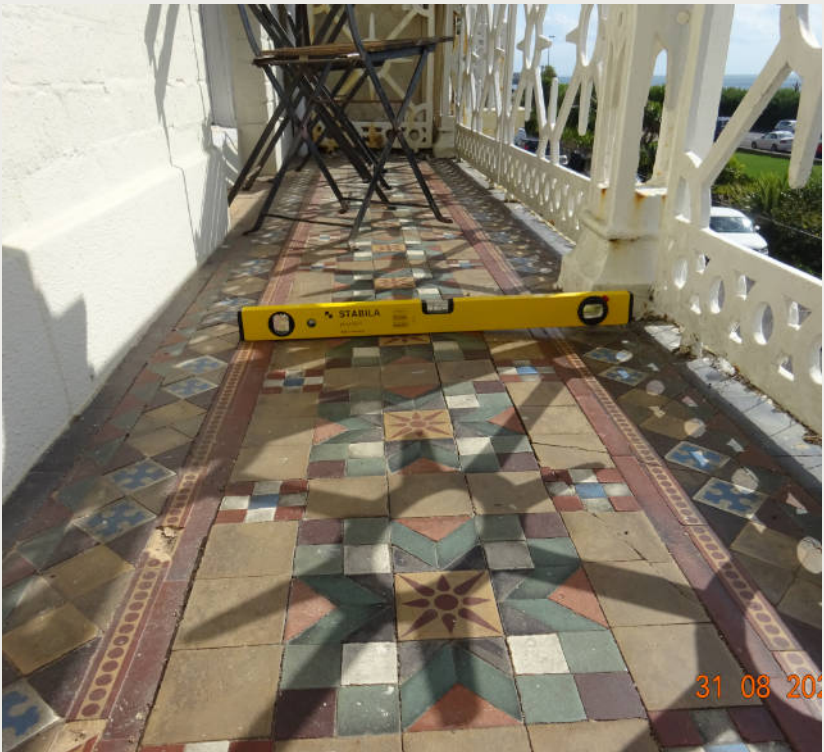
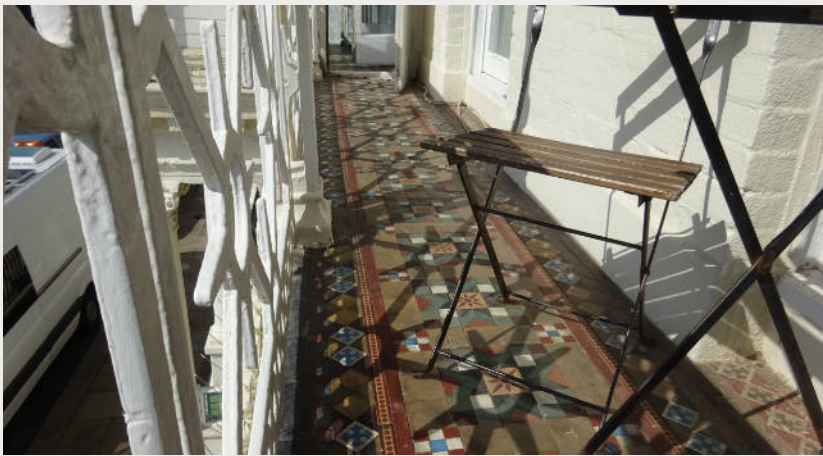
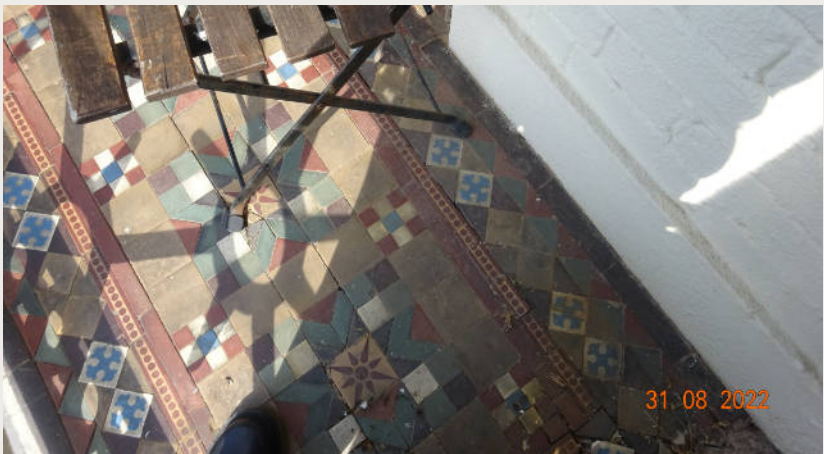
The overall effect was a formal geometric tile pavement with plain geometric field tiles and decorative patterned tiles forming borders and repeated motifs.

The tiles appear to be Victorian geometric encaustic or encaustic-style clay floor tiles. Some of the decorative inserts appear to have inlaid or impressed coloured patterns rather than applied surface decoration

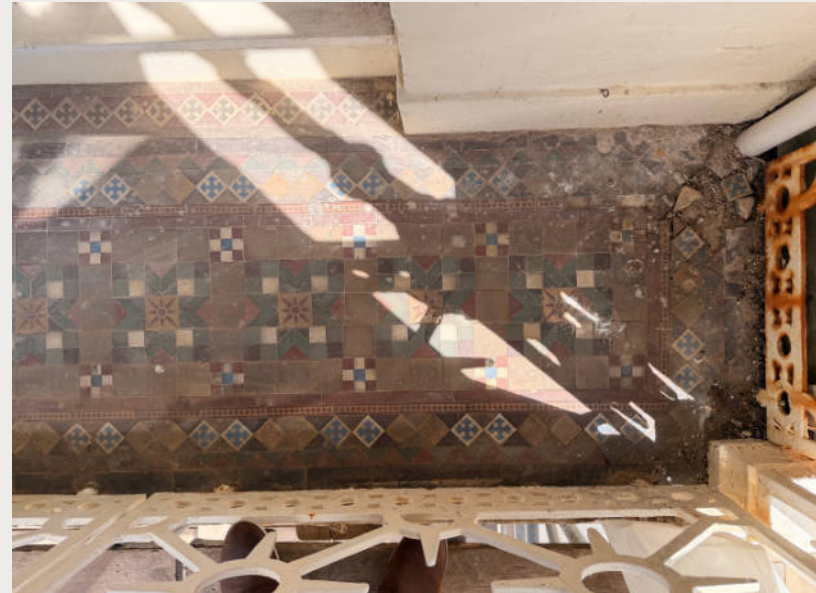
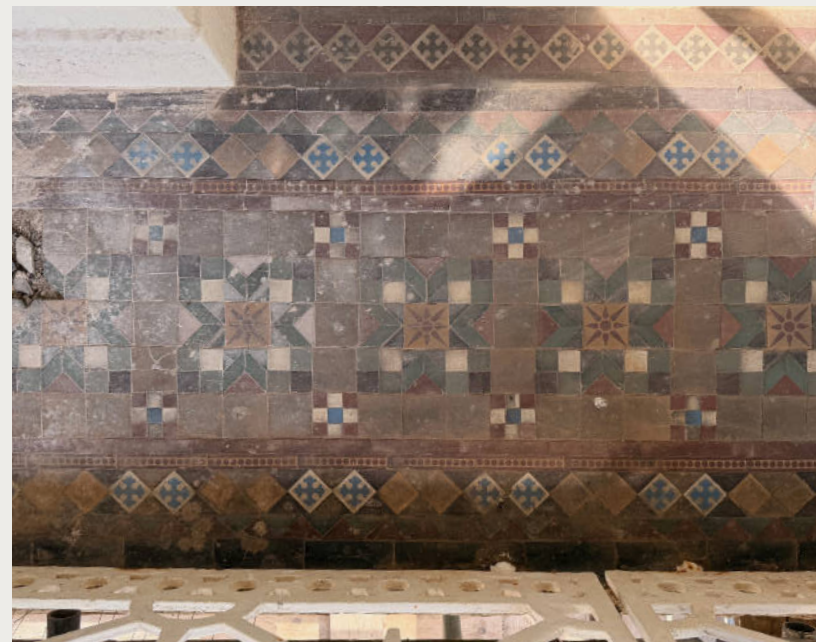
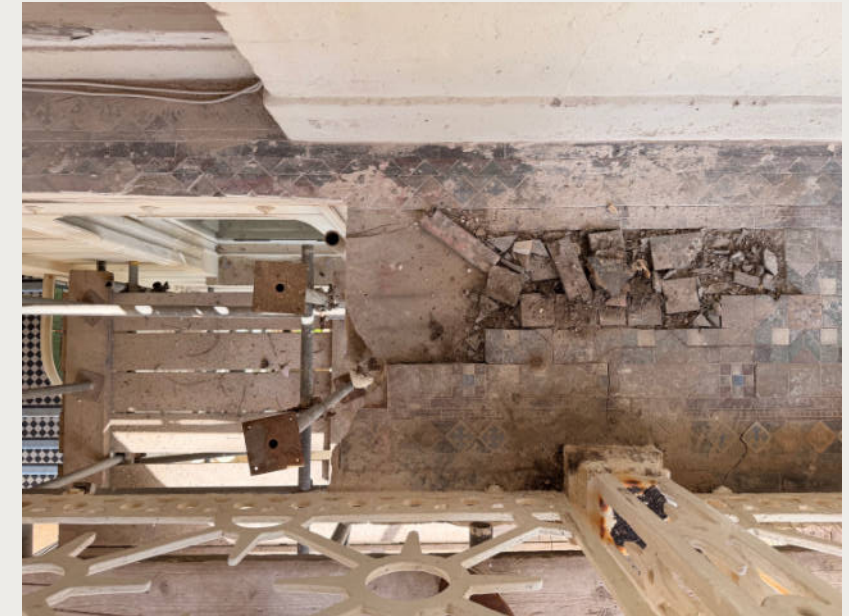
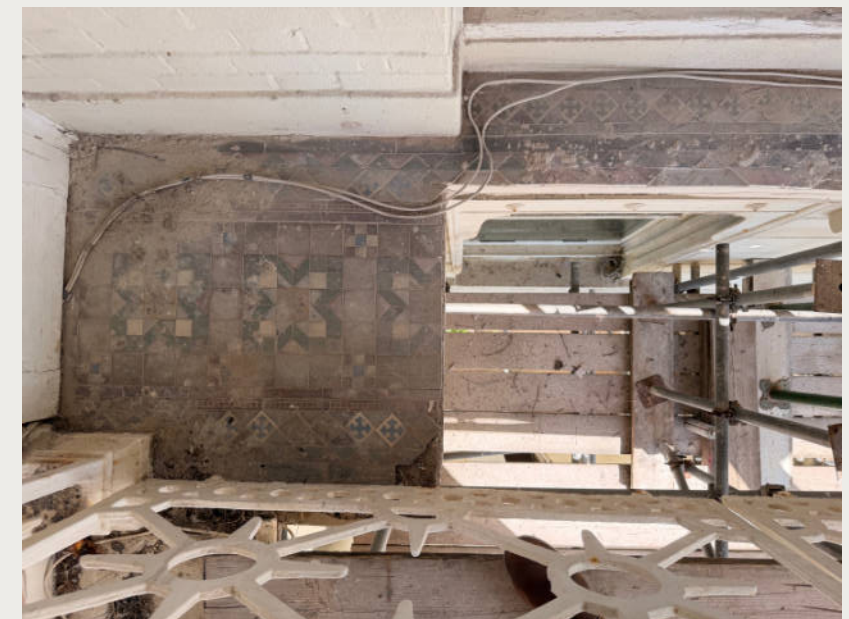
Some tiles are cracked and damaged, particularly where this damage corresponds with cracking and movement in the Portland stone slab below. In these locations, the condition of the tiling appears to be directly related to the failure of the underlying slab rather than isolated failure of the tile surface.

Where the most severely affected portion of the stone slab was removed for safety reasons, the tiles above this area were also substantially damaged. It is understood that these damaged tiles were removed and disposed of at the same time as the defective stone from this area.

While the loss of these tiles is unfortunate, the surviving tiling across the wider balcony provides a clear basis for understanding the original pattern, setting-out, colour range, borders and decorative motifs. The retained tiles will therefore be used to inform the proposed repair and reinstatement strategy.

Prior to any further removal, the existing tile pattern will be photographed, recorded and shown on the revised drawings. Particular care will be taken to record the central field pattern, decorative motif tiles, borders, edge conditions, grout lines and relationship with the balustrade fixings.

Tiles within the affected areas will then be carefully lifted where this can reasonably be achieved without avoidable damage. The removal methodology will follow a cautious conservation approach, with tiles released by hand wherever practicable and particular care taken to avoid damage to adjacent retained tiles. Where individual tiles are already cracked, firmly bonded or otherwise incapable of being lifted intact, this will be recorded.

The retained tiled areas will remain undisturbed. Lifted original tiles will be reinstated, with replacement tiles introduced only where existing tiles have been lost or cannot be reused. The repaired areas will be set out to follow the surviving tiled surface, including its border arrangement, decorative motifs, grout widths, edge conditions and falls.

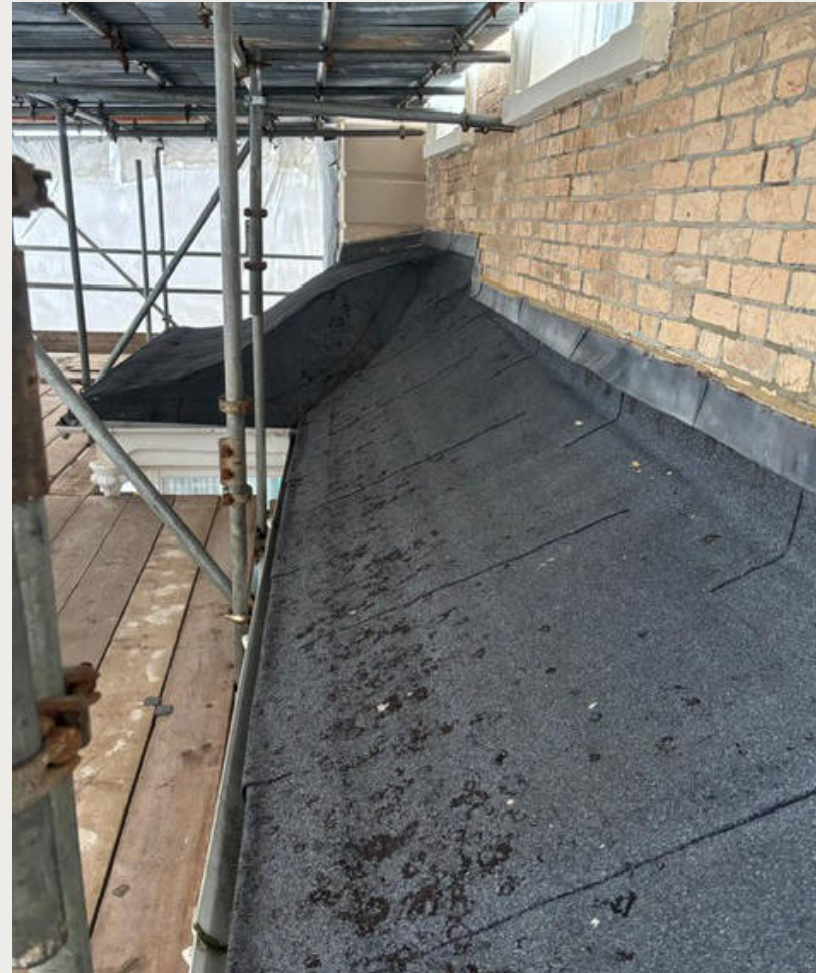
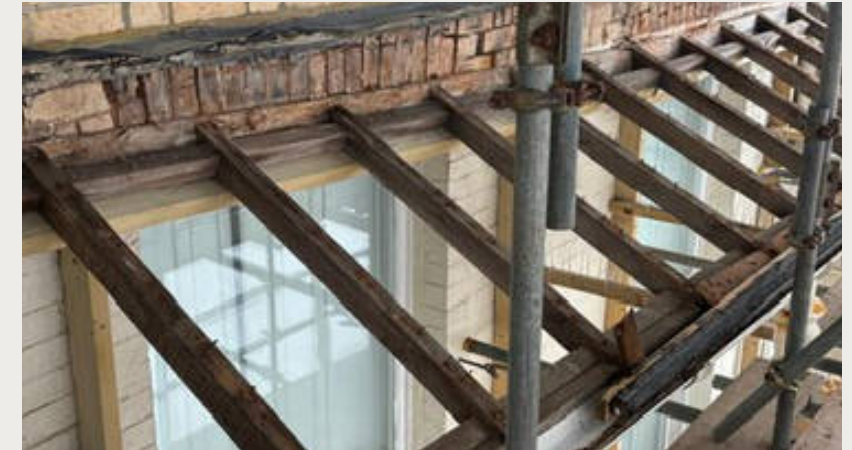
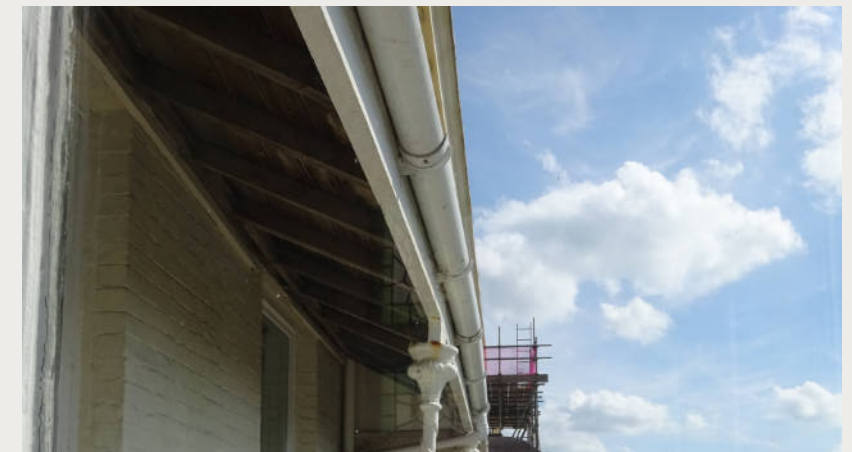
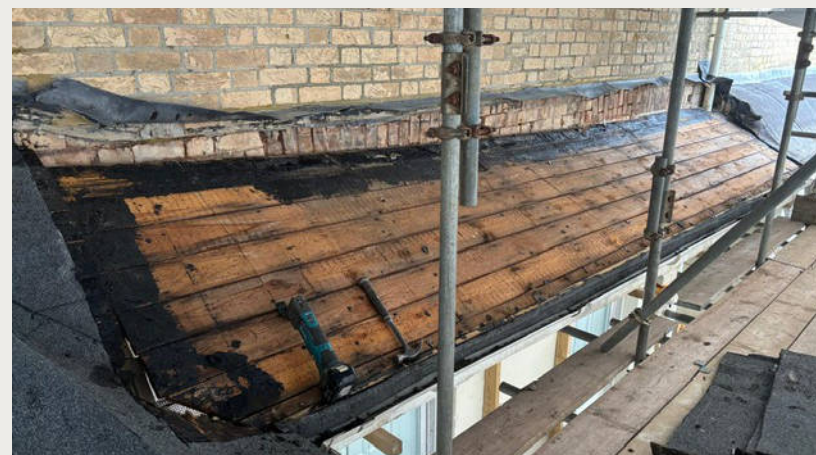
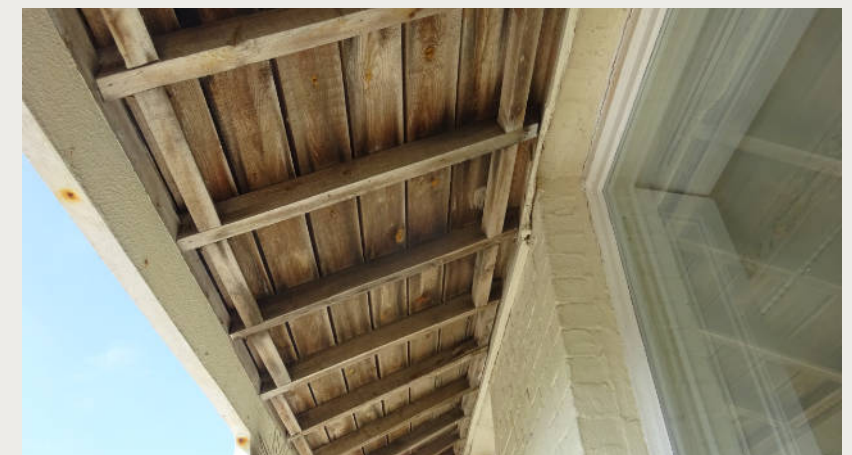
This pre-works arrangement was a clear departure from the original canopy construction seen across much of the wider terrace. The original arrangement appears to have comprised curved rafters, which remains visible on the majority of surviving balcony canopies elsewhere on Heene Terrace. The original roof finish was likely lead, although many other properties currently have a felt finish.

The pre-works canopy at No. 17 therefore did not represent an intact original condition. It appears to have been a later simplified alteration, both in terms of its straight rafter profile and its felt roof covering.

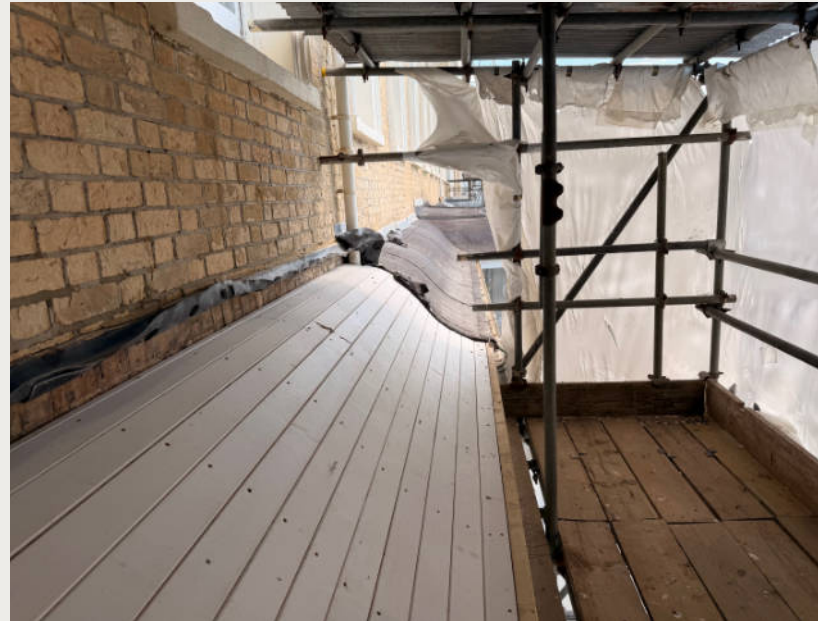
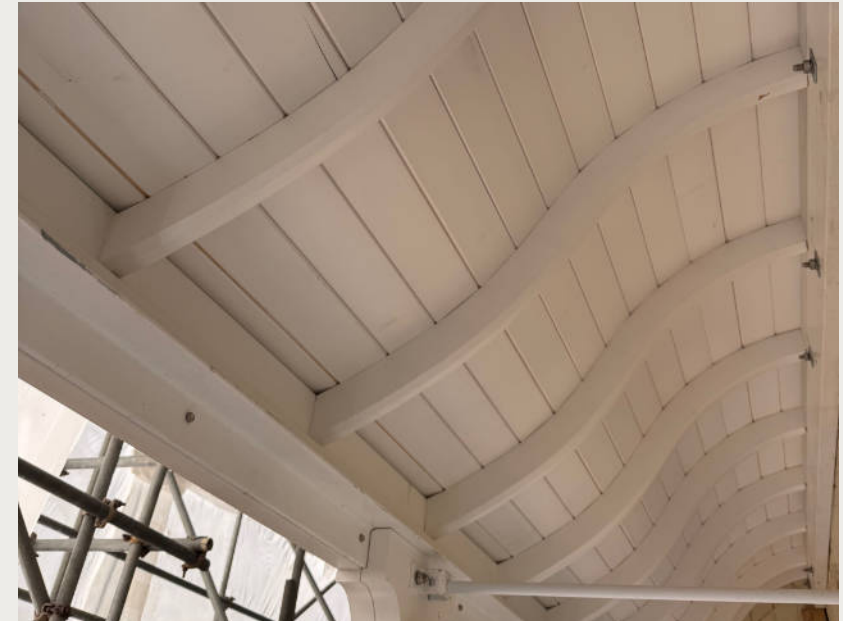
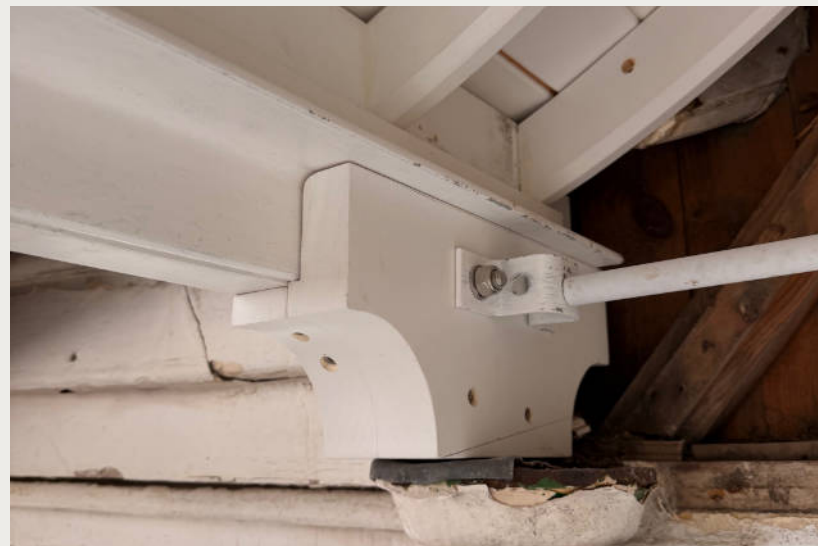
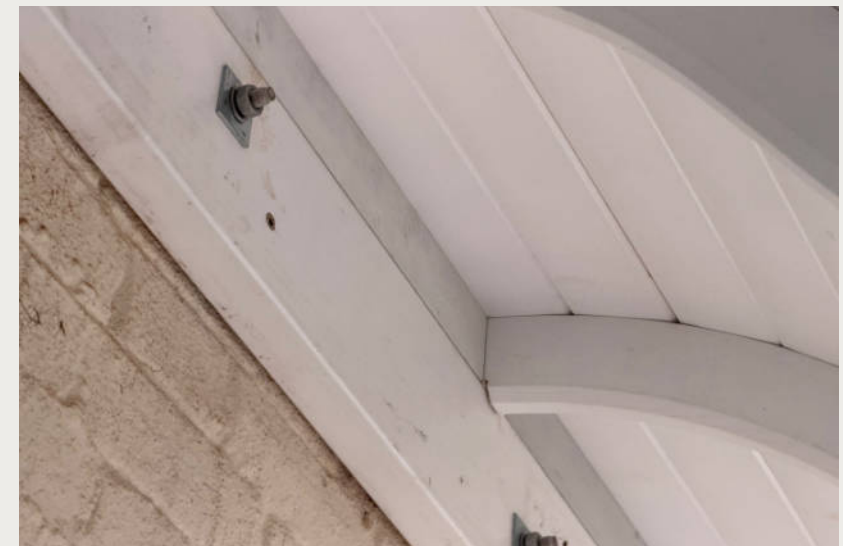
The pre-existing canopy roof structure has been removed and a replacement timber canopy structure has been installed.

The replacement structure is formed with curved timber rafters with chamfered edges. These are understood to have been templated from the surviving canopy structure at No. 16 Heene Terrace and are intended to match the original rafter profile found elsewhere along the terrace.

At eaves level, a new timber beam has been installed and is supported from the cast iron columns below. Curved timber brackets have also been installed to reflect the bracket detail found on other canopy structures along the wider terrace.

A metal angle section has been installed to the inner face of the eaves beam. Metal ties have also been installed between the eaves beam and the main façade, fixed to the eaves beam with a second layer of curved timber brackets rebated around the metal angle section. These elements were installed as a temporary measure to provide additional support until the replacement balcony slab works are complete.

The proposed works retain the replacement curved timber canopy form, which more closely reflects the historic canopy form found elsewhere on Heene Terrace than the pre-works straight pitched felt roof arrangement.

Where the eaves beam does not currently bear centrally on the cast iron columns below, this will be corrected when the columns are removed and reinstated. The removal and reinstatement of the columns is required in any event to allow the balcony slab replacement works to be undertaken.

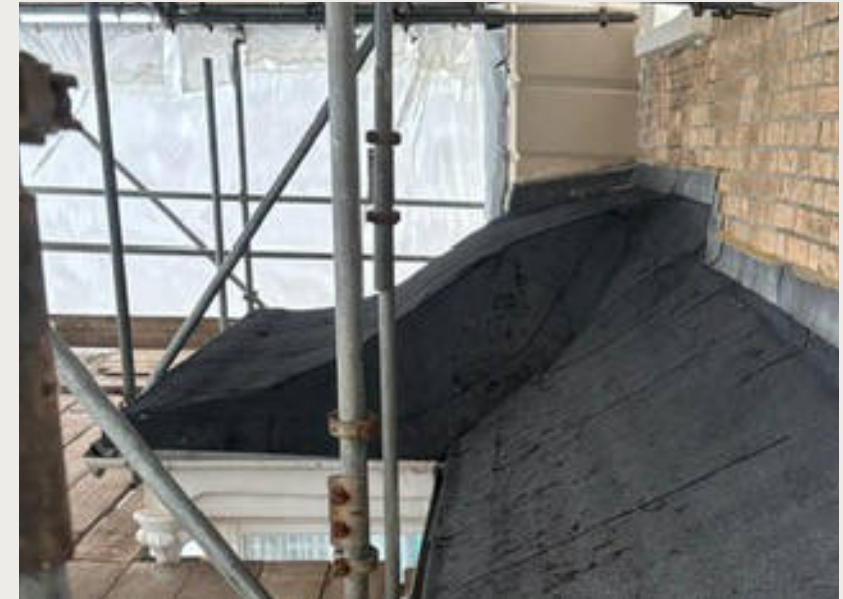
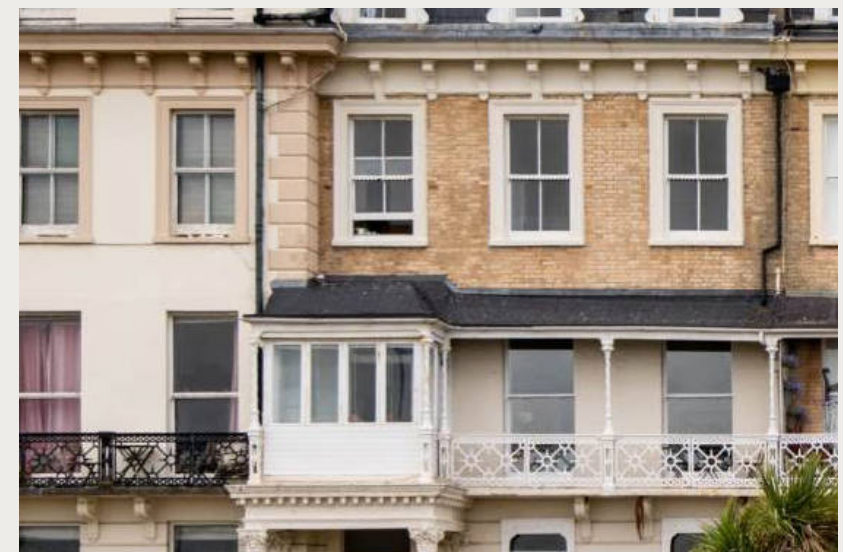
Prior to the current works, the sunroom roof had the same built-up felt roof finish as the adjacent balcony canopy. This finish is not considered to reflect the original canopy roof finish, which is understood to have been leadwork to match the surviving canopy roofs elsewhere on the terrace.

The sunroom also has a plastered ceiling supported on expanded metal lath fixed to the rafters. Comparison with the wider terrace suggests that this ceiling was not original. The original arrangement is likely to have been open to the underside of the sarking boards above, consistent with the surviving open canopy structures elsewhere on Heene Terrace.

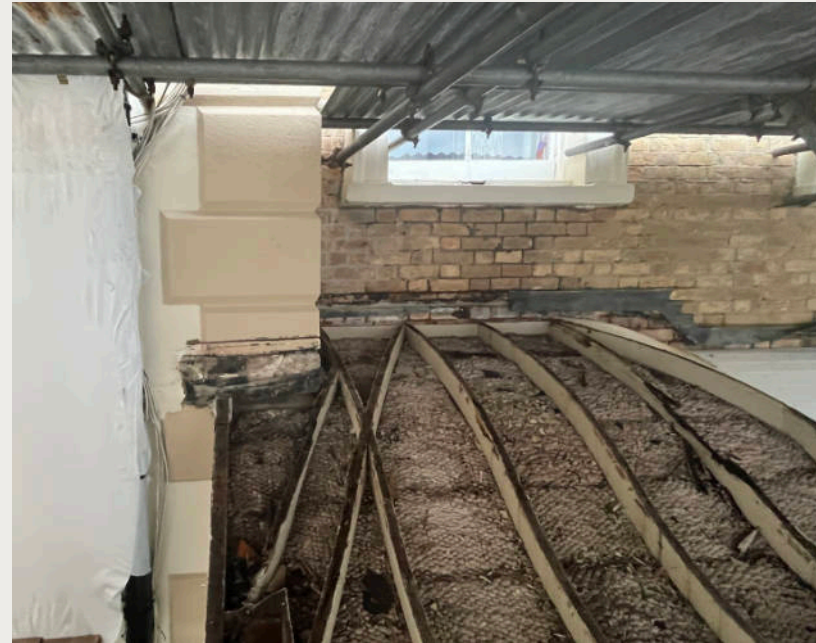
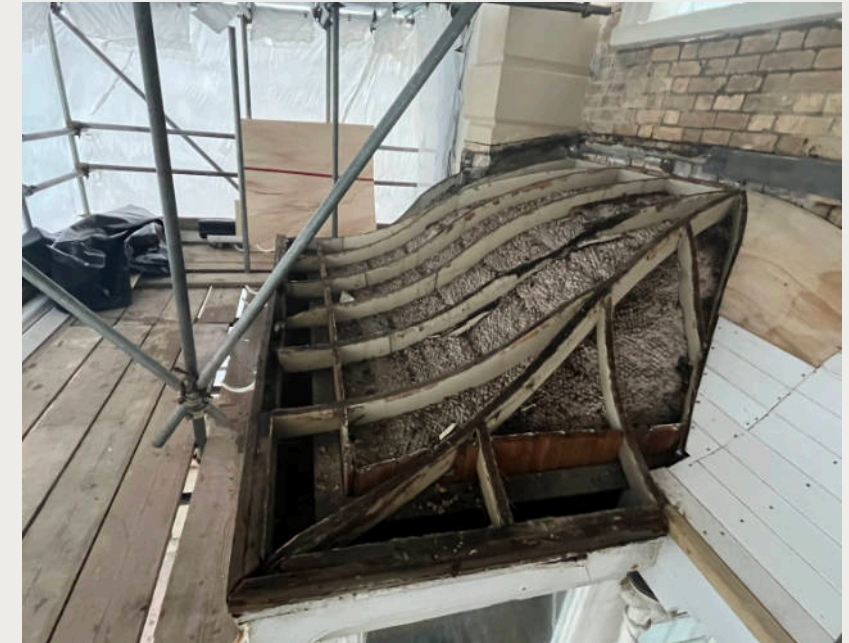
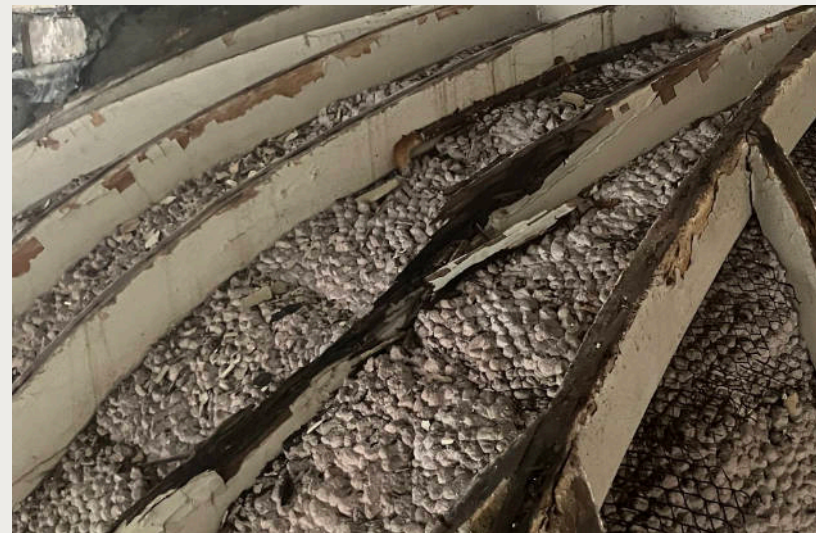
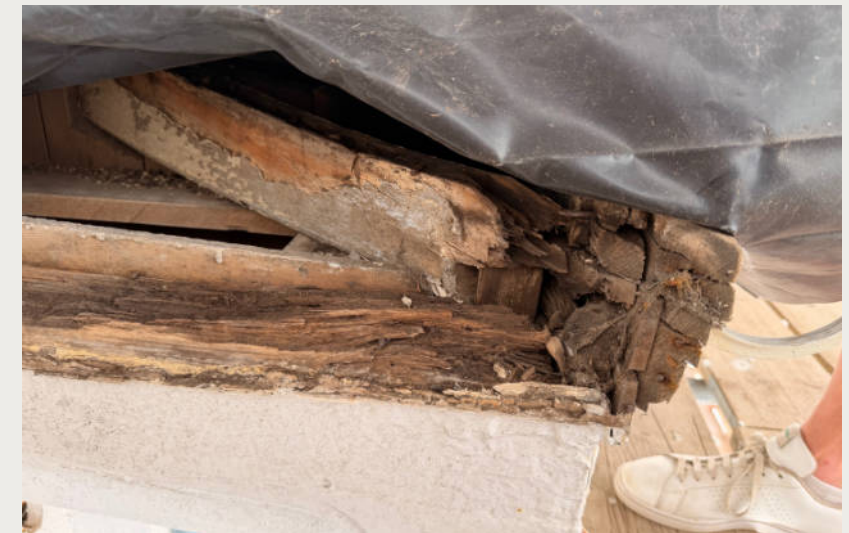
This opening-up has revealed that many of the existing rafters are rotten and have deteriorated to the point that they are not salvageable. Substantial areas of the eaves timberwork are also rotten and require wholesale replacement.

The current condition therefore confirms that, while the sunroom enclosure itself can largely be retained, the pre-existing roof structure is in poor condition and is not suitable to be retained as a sound basis for the proposed roof repair works.

The plaster ceiling remains in place. It is possible that the enclosure of the roof structure by this ceiling may have led to the deterioration of the roof as no ventilation was provided to the void above, something that would have been unnecessary with the original open roof structure.

New timber rafters will be formed to match the existing curved roof profile. The existing rafters will be used as templates for the new rafters where their condition allows, so that the replacement structure follows the established form of the existing sunroom roof.

Rotten areas of the eaves timber beams will be replaced on a like-for-like basis to match the existing arrangement.

The existing plaster ceiling and expanded metal lath will be removed. This will allow the repaired roof structure to be expressed internally as a timber canopy structure, consistent with the likely original open canopy arrangement elsewhere on the terrace.

The Code 5 lead roof finish proposed to the balcony canopy will be extended across the sunroom roof. This will replace the pre-works felt covering with a more faithful and historically appropriate roof finish, consistent with the lead-covered canopy roofs elsewhere on Heene Terrace.

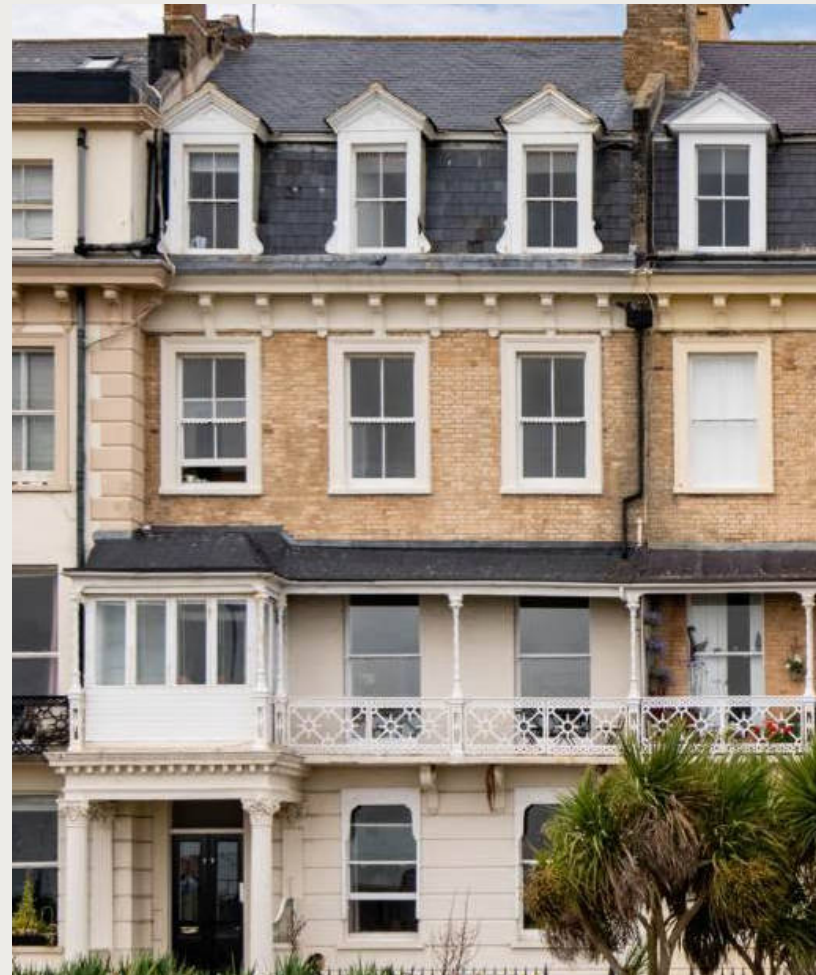
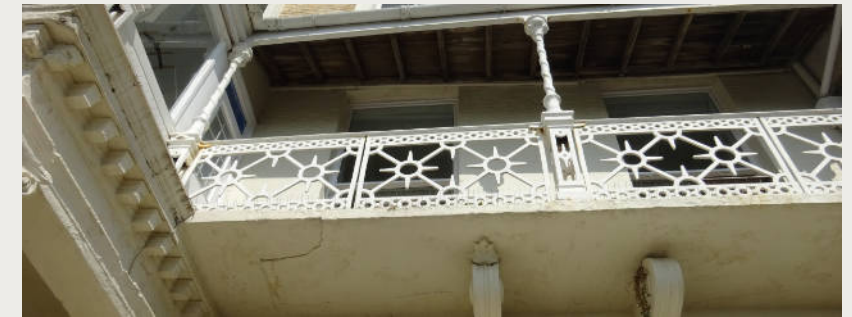
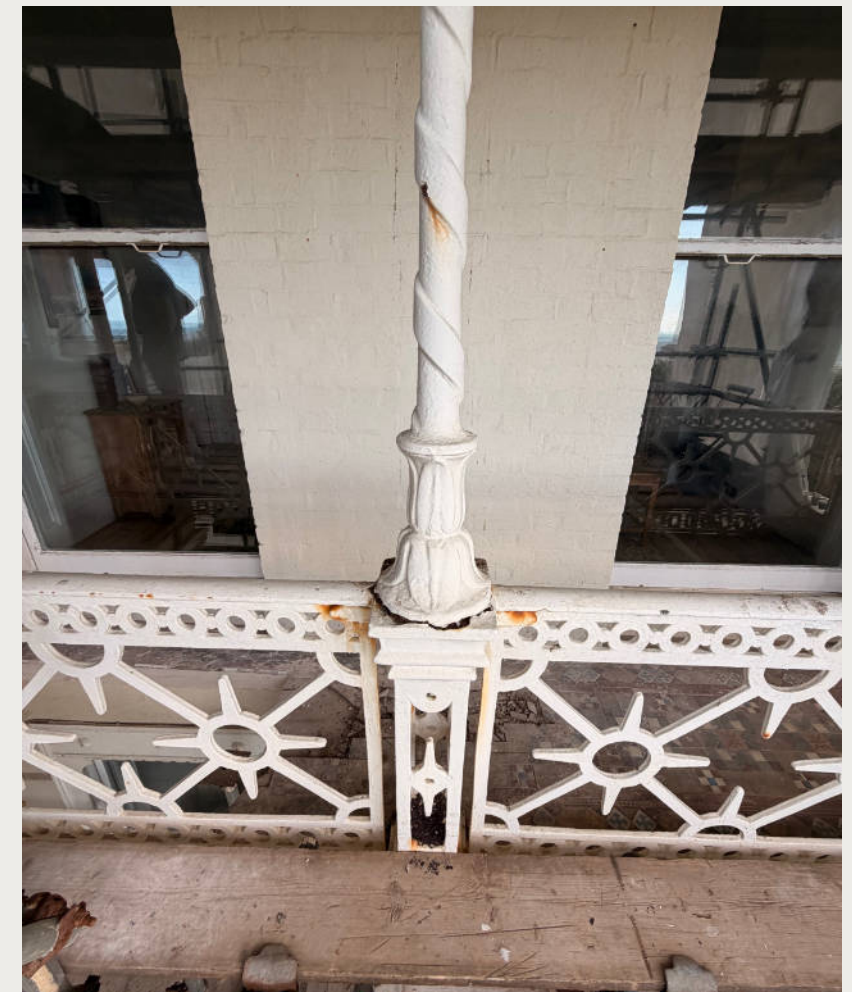
The square corner posts and spiral columns around the sunroom remain in place and continue to support the roof above.

No works have been undertaken to the ironwork as part of the current repair works. The condition of the ironwork is therefore unchanged from the pre-works condition.

The existing ironwork to the balcony and canopy is to be retained, protected and repaired where required. The balcony balustrade and canopy supporting posts will need to be temporarily removed where necessary to allow the balcony slab repair and replacement works to be undertaken safely.
