# Heene Terrace

## Design & Repair Statement

17 Heene Terrace  
Worthing  
BN11 3NR

September 2026

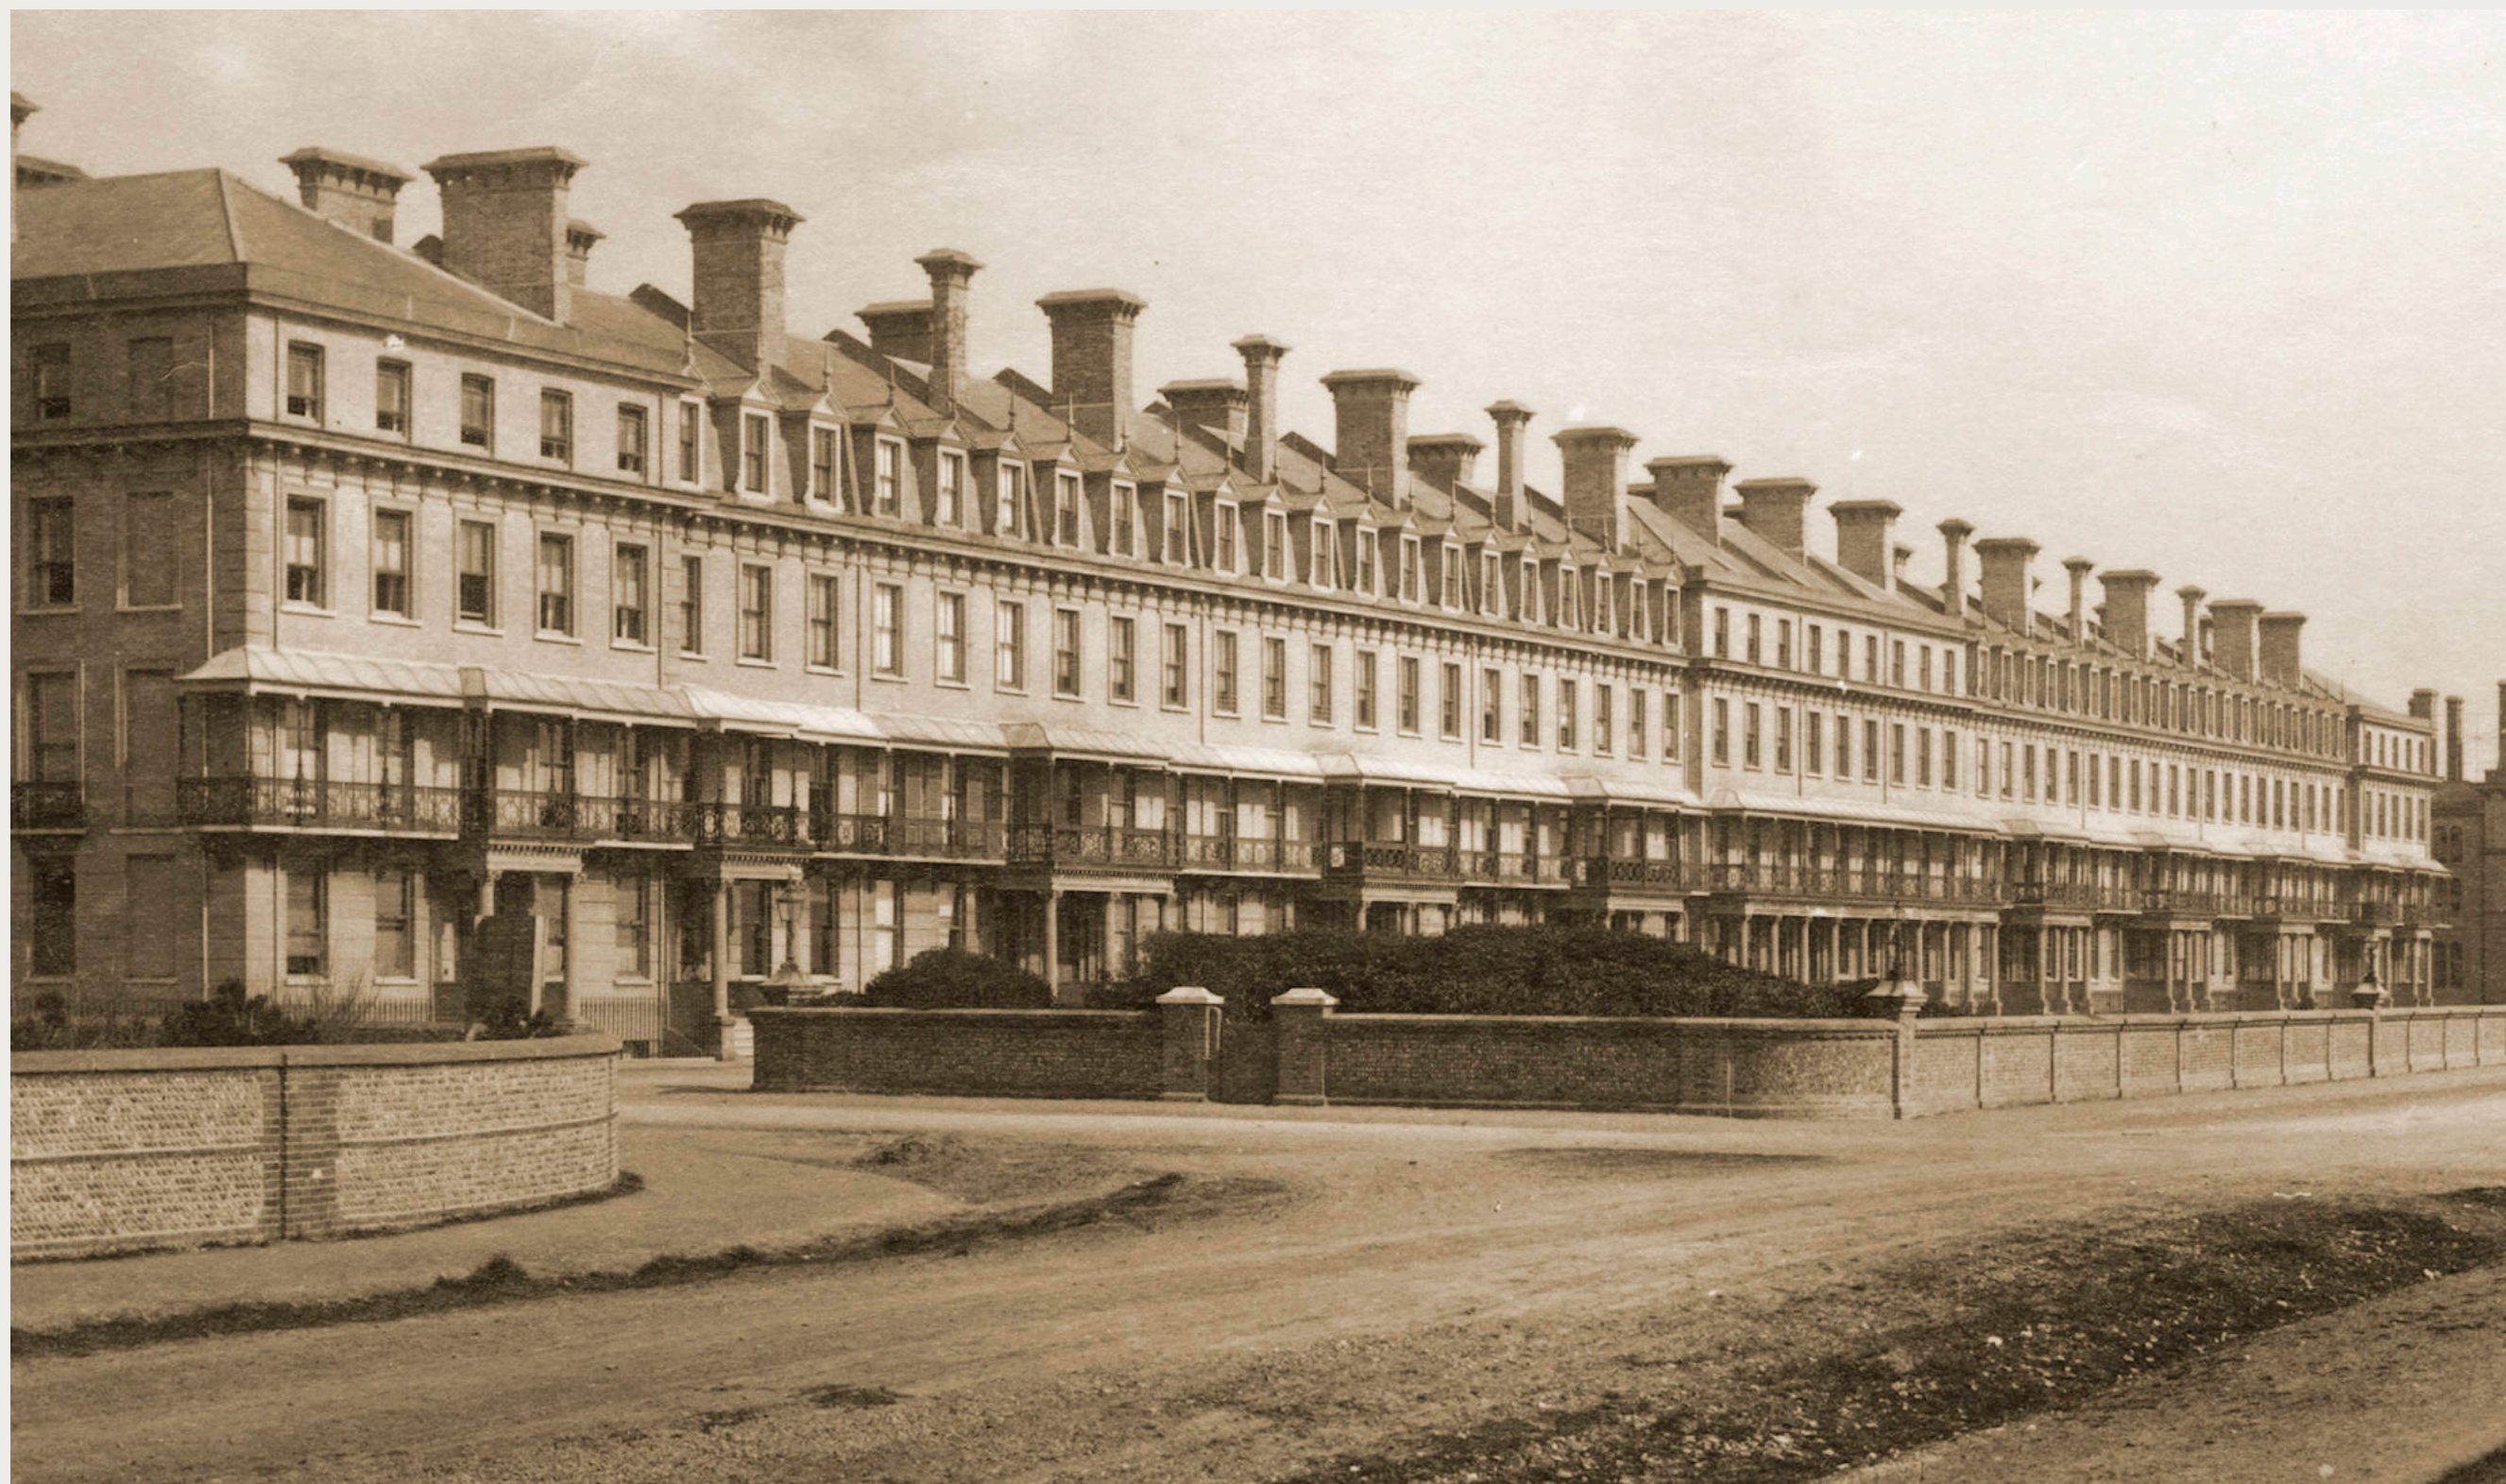
Reproduced with permission of West Sussex Record Office. Catalogue No: PP/WSL/WGP000913
