**Proposed residential development  
HMRC Government Offices  
Barrington Road  
Goring-by-Sea  
Worthing  
BN12 4XH**

**GROUND INVESTIGATION REPORT**

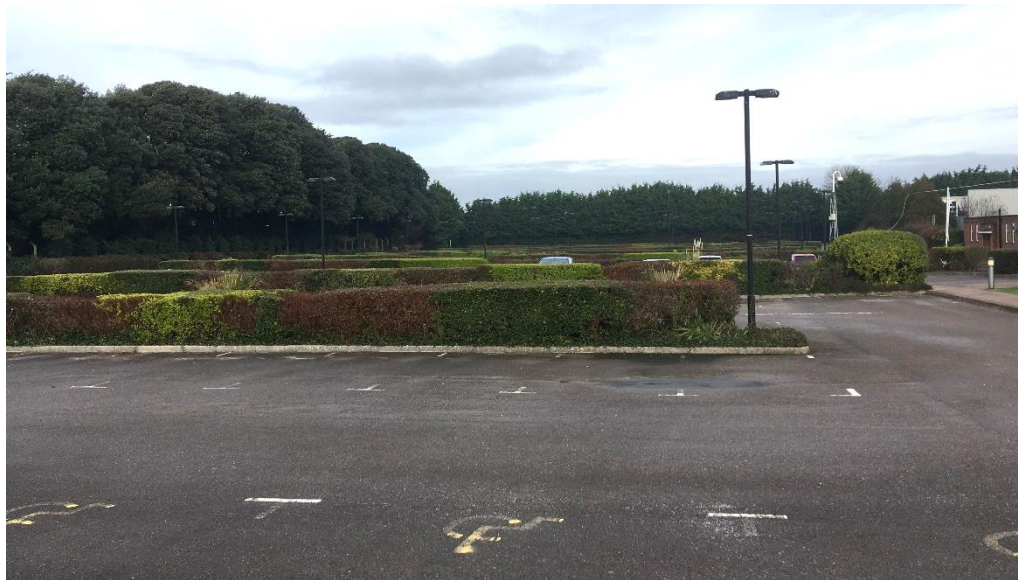
*Photograph 01 - View of the large car park in the western section of the site. View looking north.*

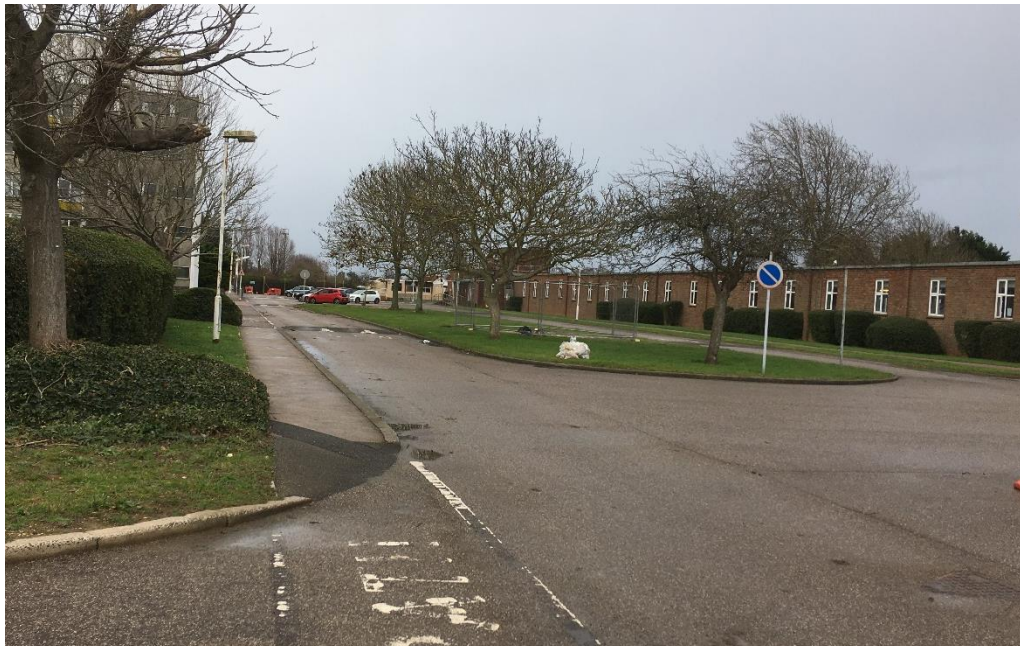
*Photograph 02 - View of the centre of the site looking east and showing the single storey building to the south of the access road.*

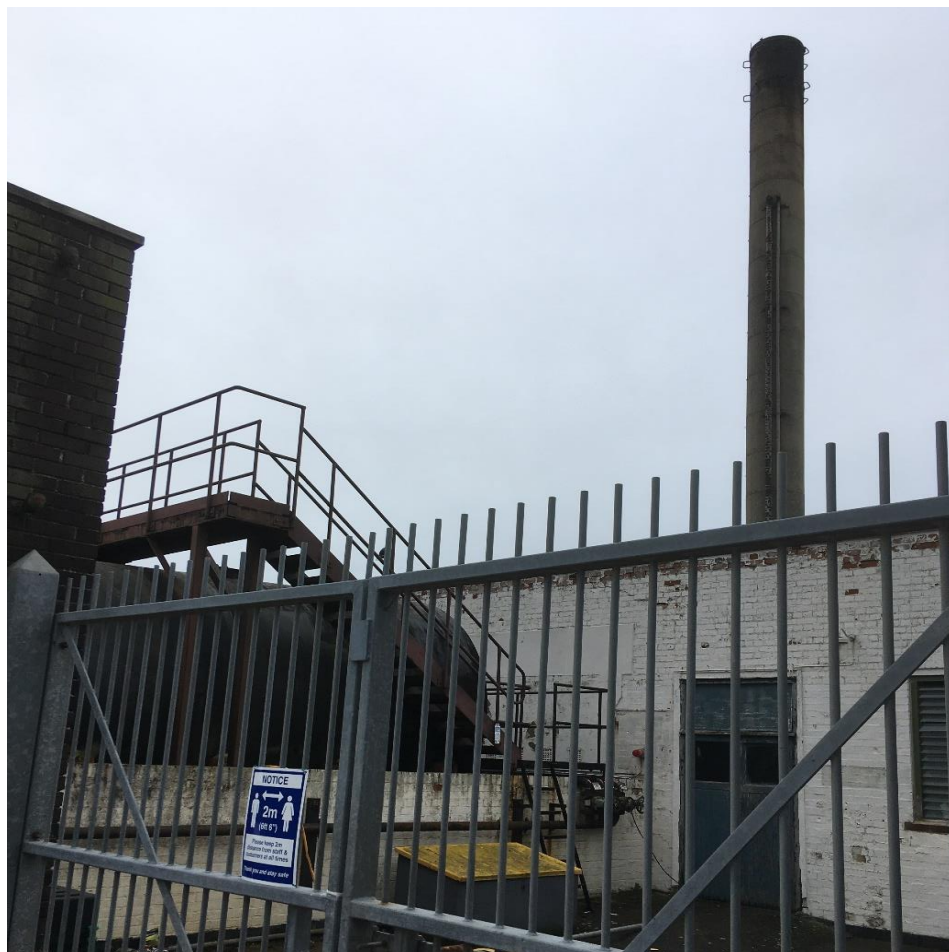
*Photograph 03- View of the maintenance area showing oil tank, typical building and chimney on site. View looking north-west.*

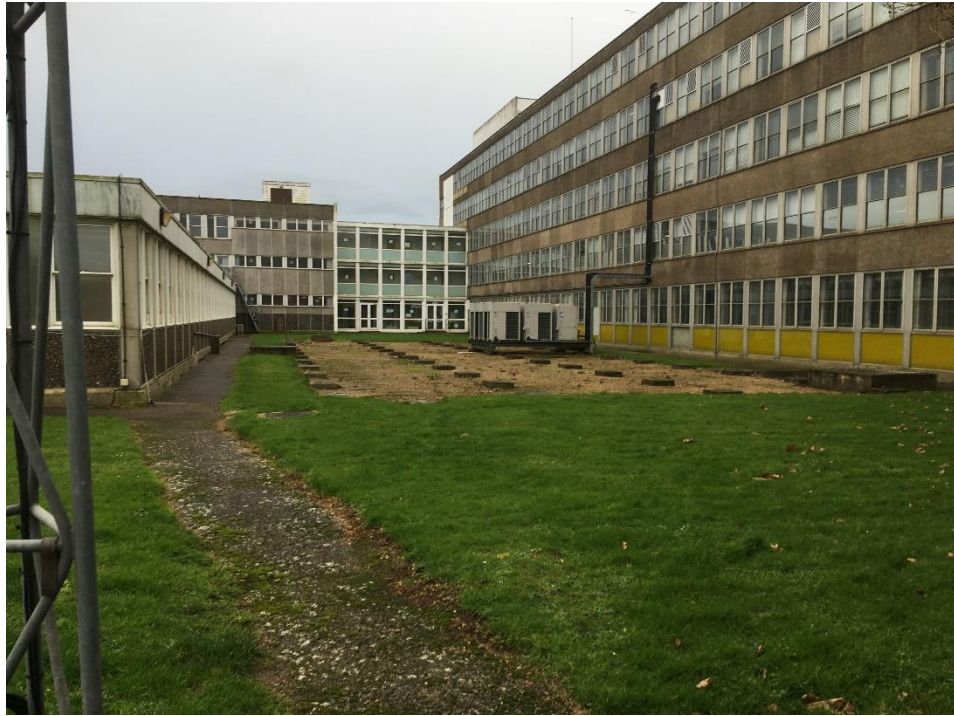
*Photograph 04 - View of part of the main complex to the north of the site. View looking south*

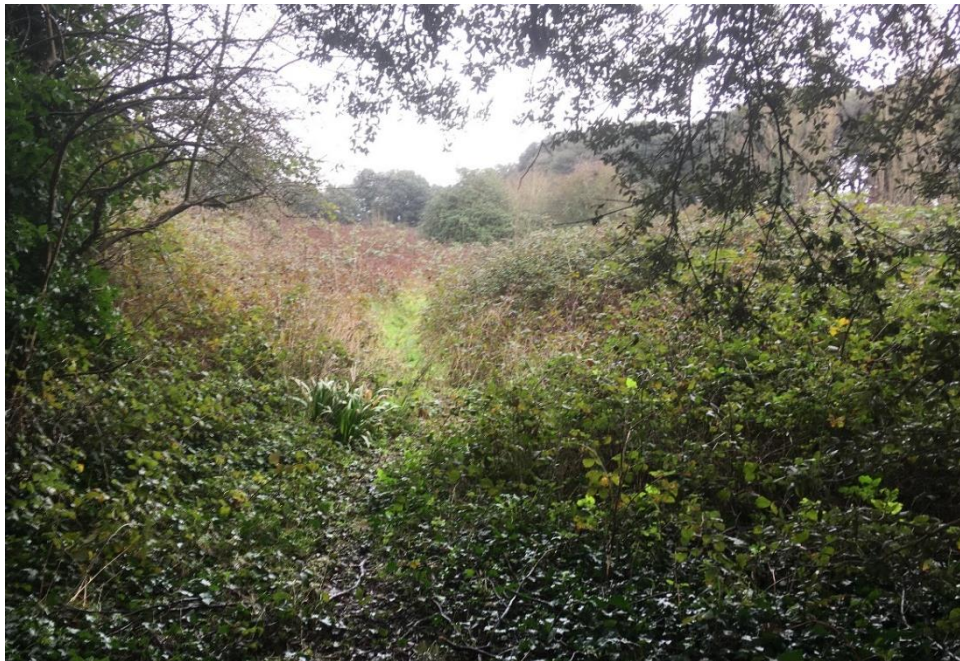
*Photograph 05 - View of the scrubland area to the west of the main site. View looking south east.*
