## Verification Report

Plots 66-67 and 107-109

Barrington Road, Worthing

September 2025

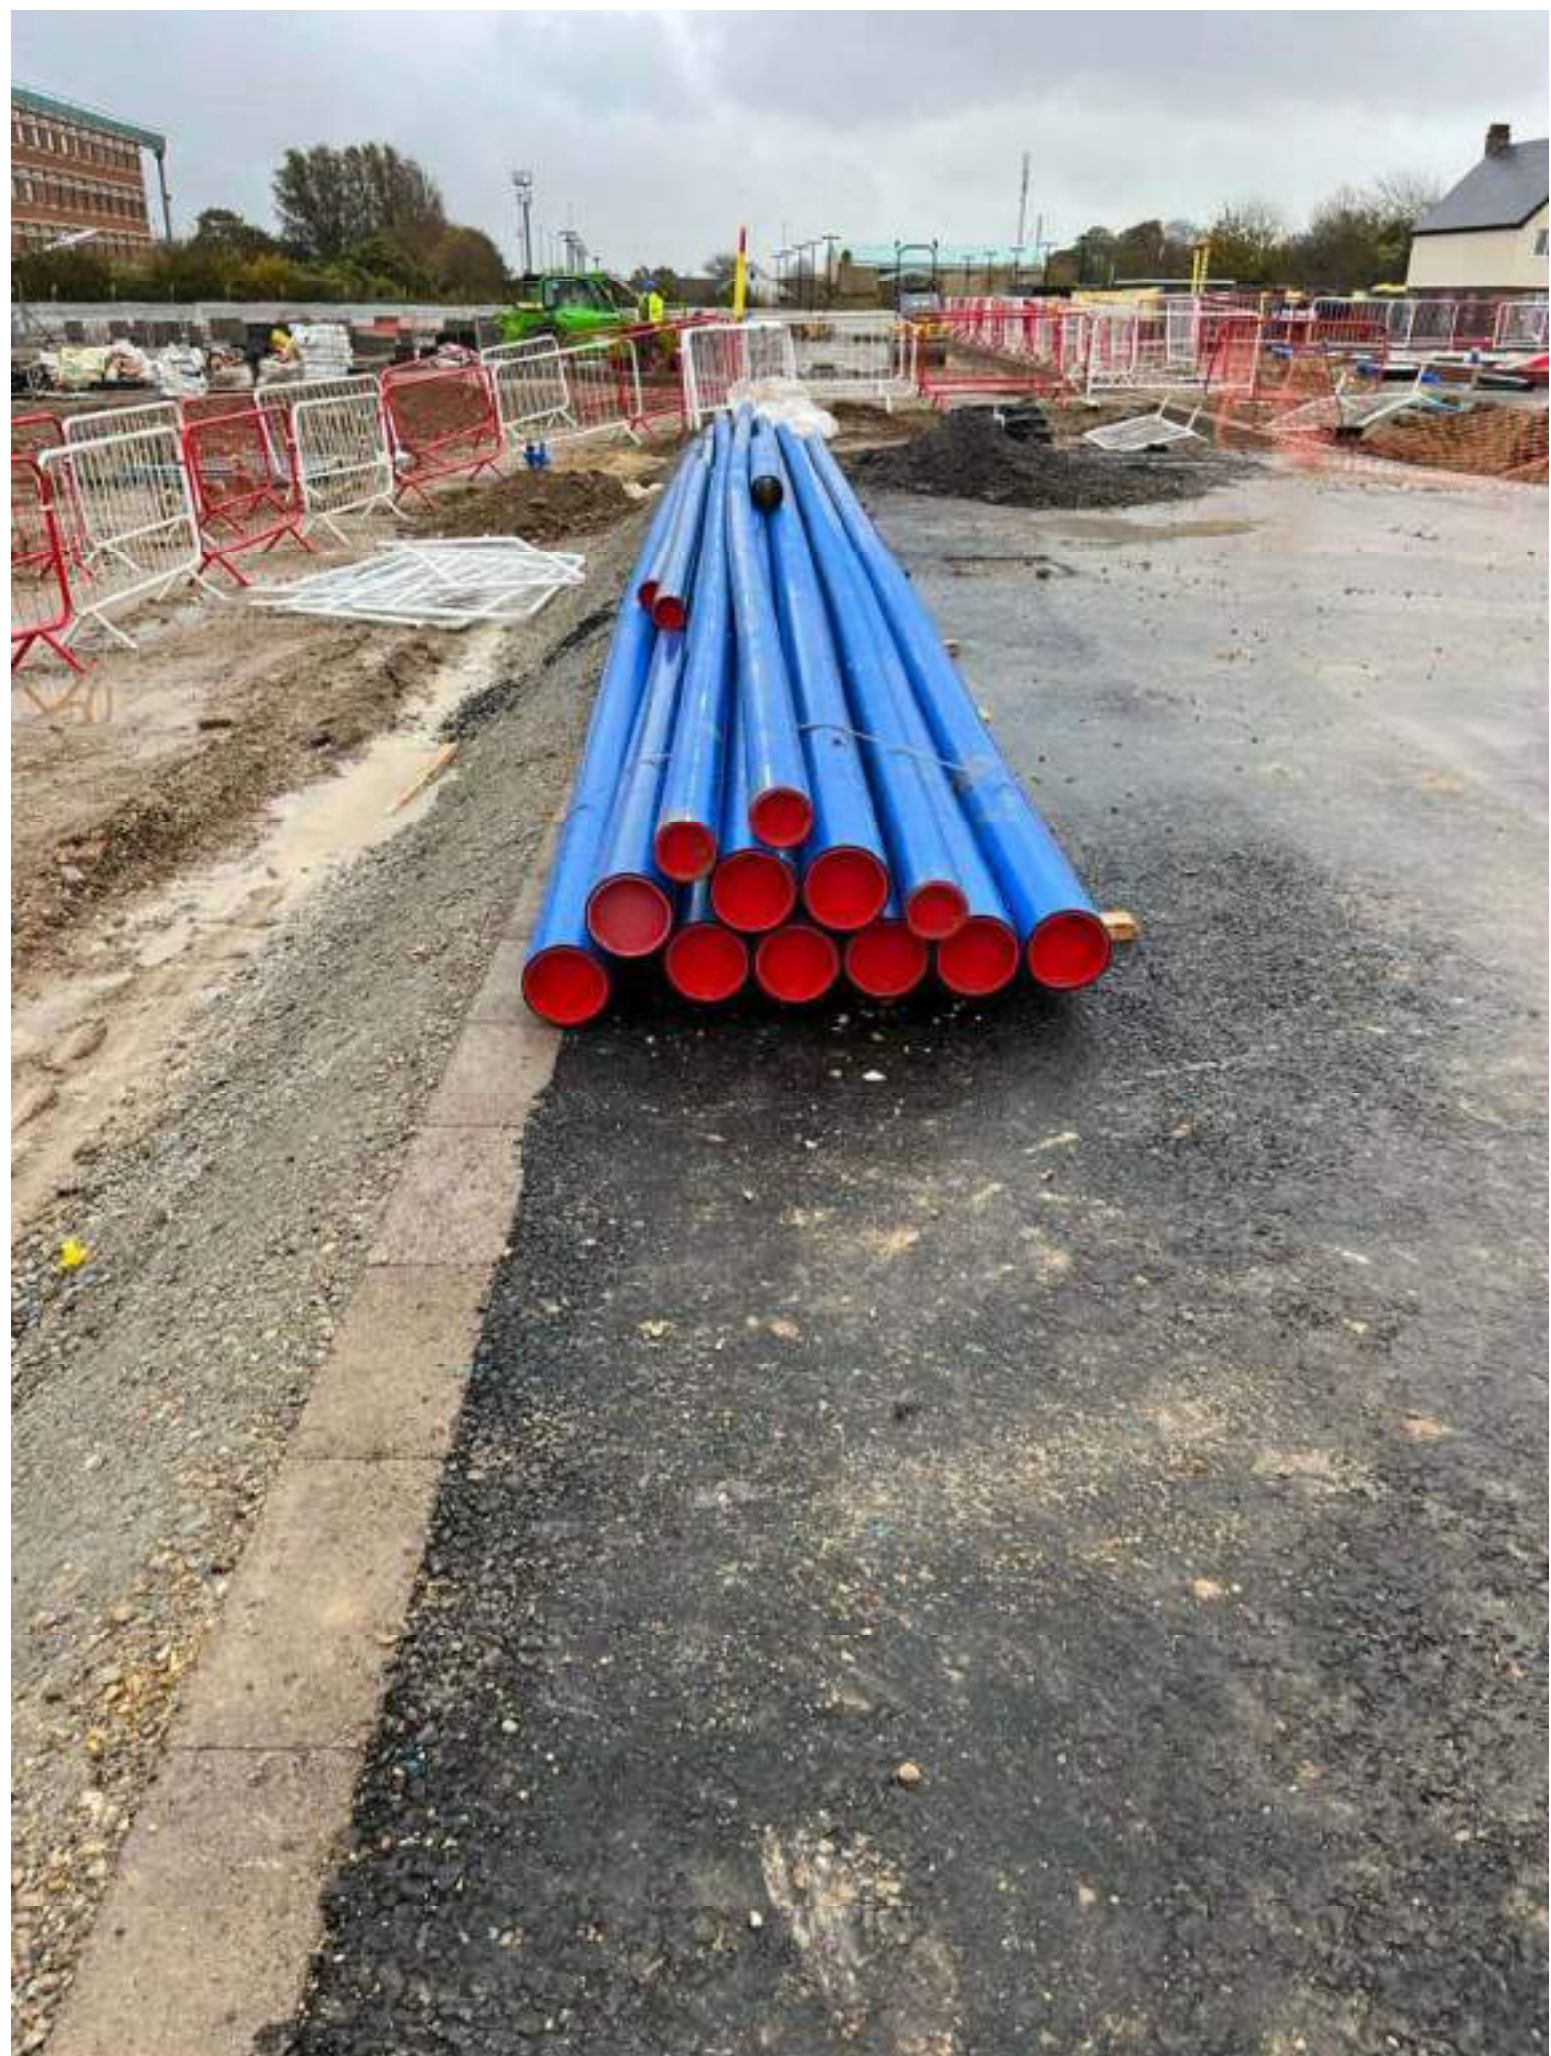
PLOT 40

- 4.3.3 The photographs do not show any evidence of significant hydrocarbon contamination in areas of PE pipework, and protective barrier pipe can be identified by a thick brown line along blue pipework in the relevant plots. It should be noted that an oily sheen can be seen on perched water in one of the trenches exposing the protective barrier pipe, supporting the use of the pipe in this area.

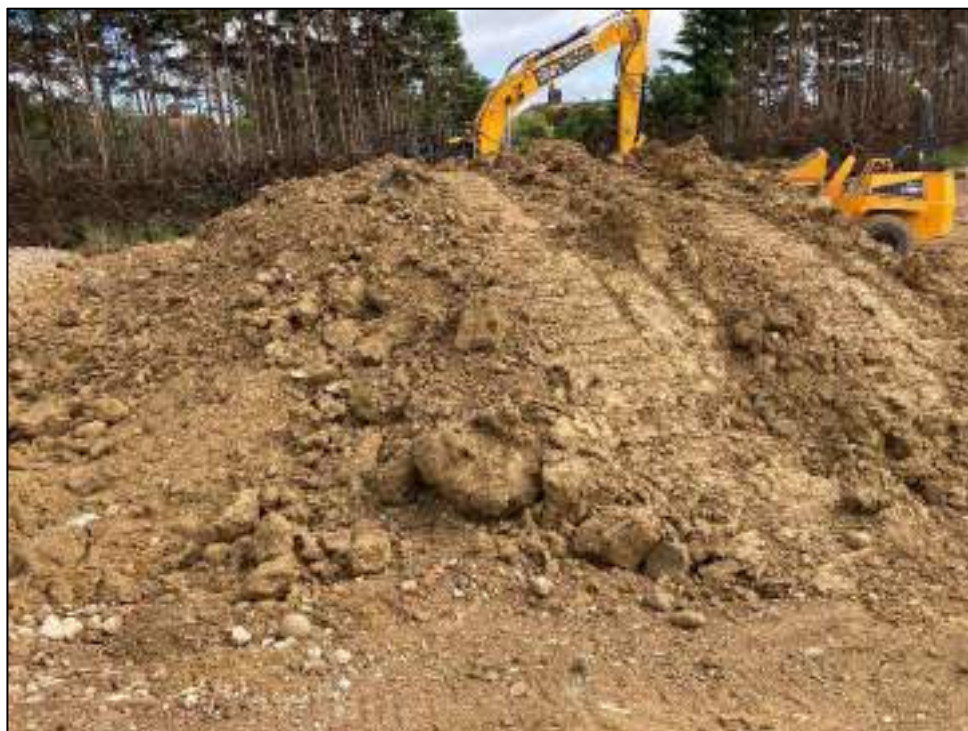
Figure 1: Billingshurst soil stockpile SL01

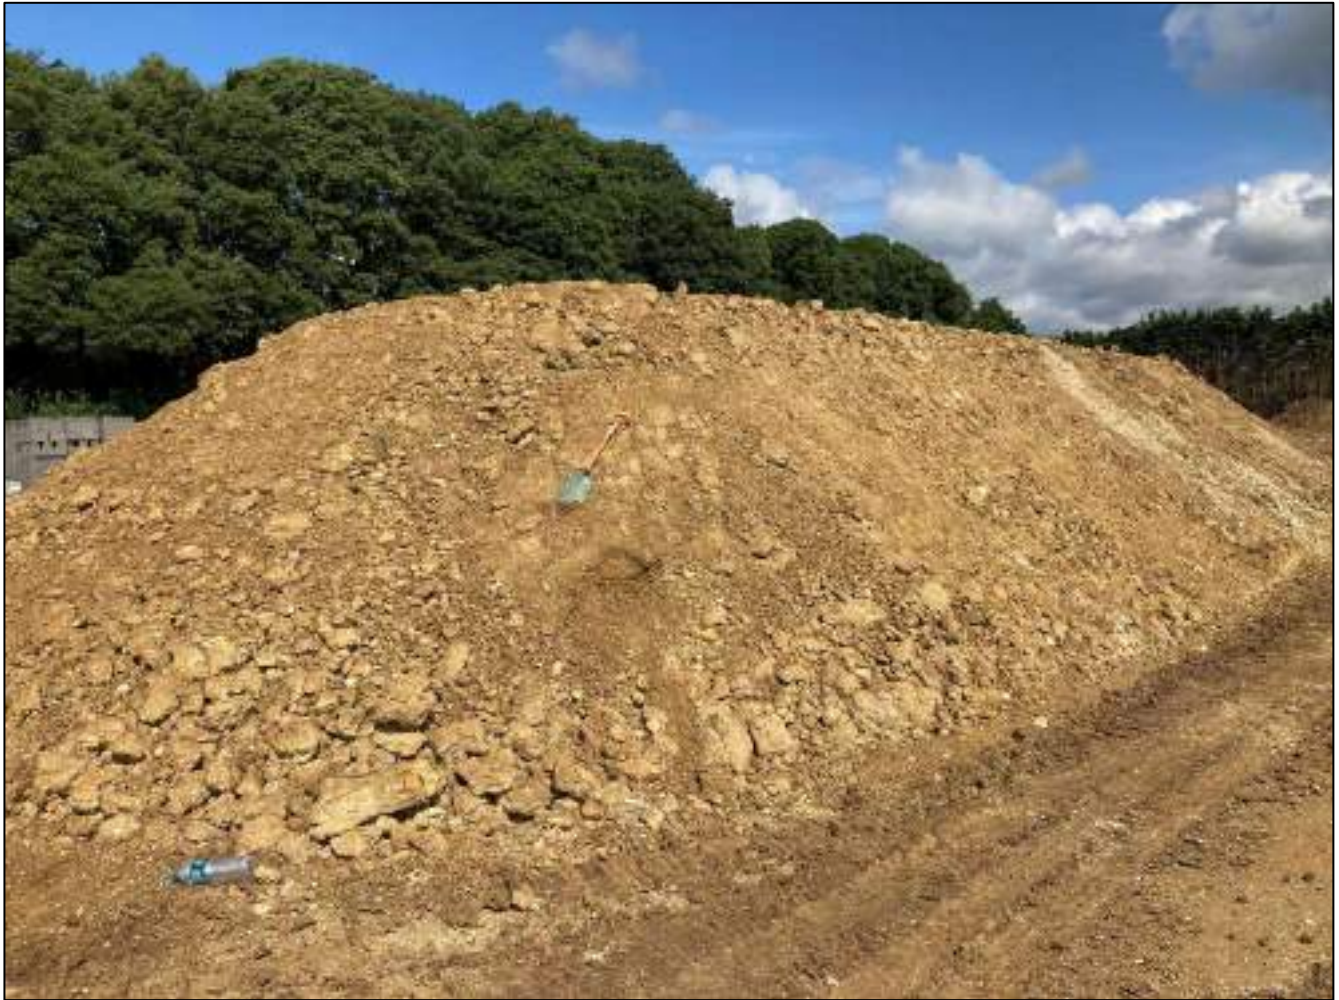
*Figure 2: Billingshurst soil stockpile SL02*

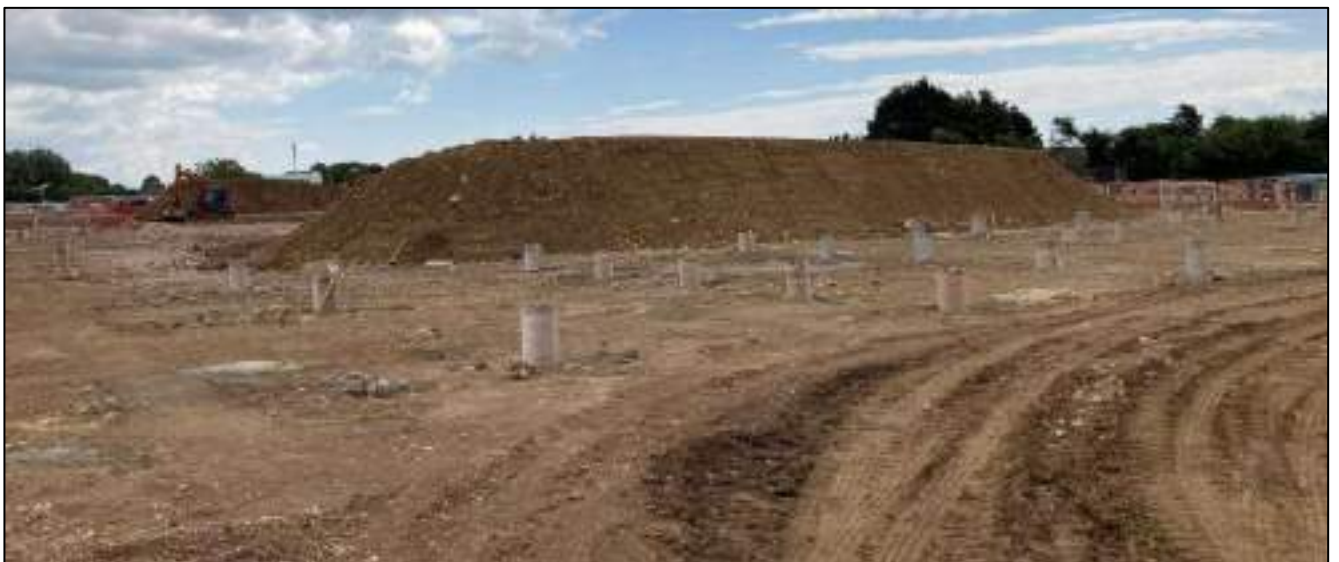
*Figure 3: Billingshurst soil stockpile SL03*

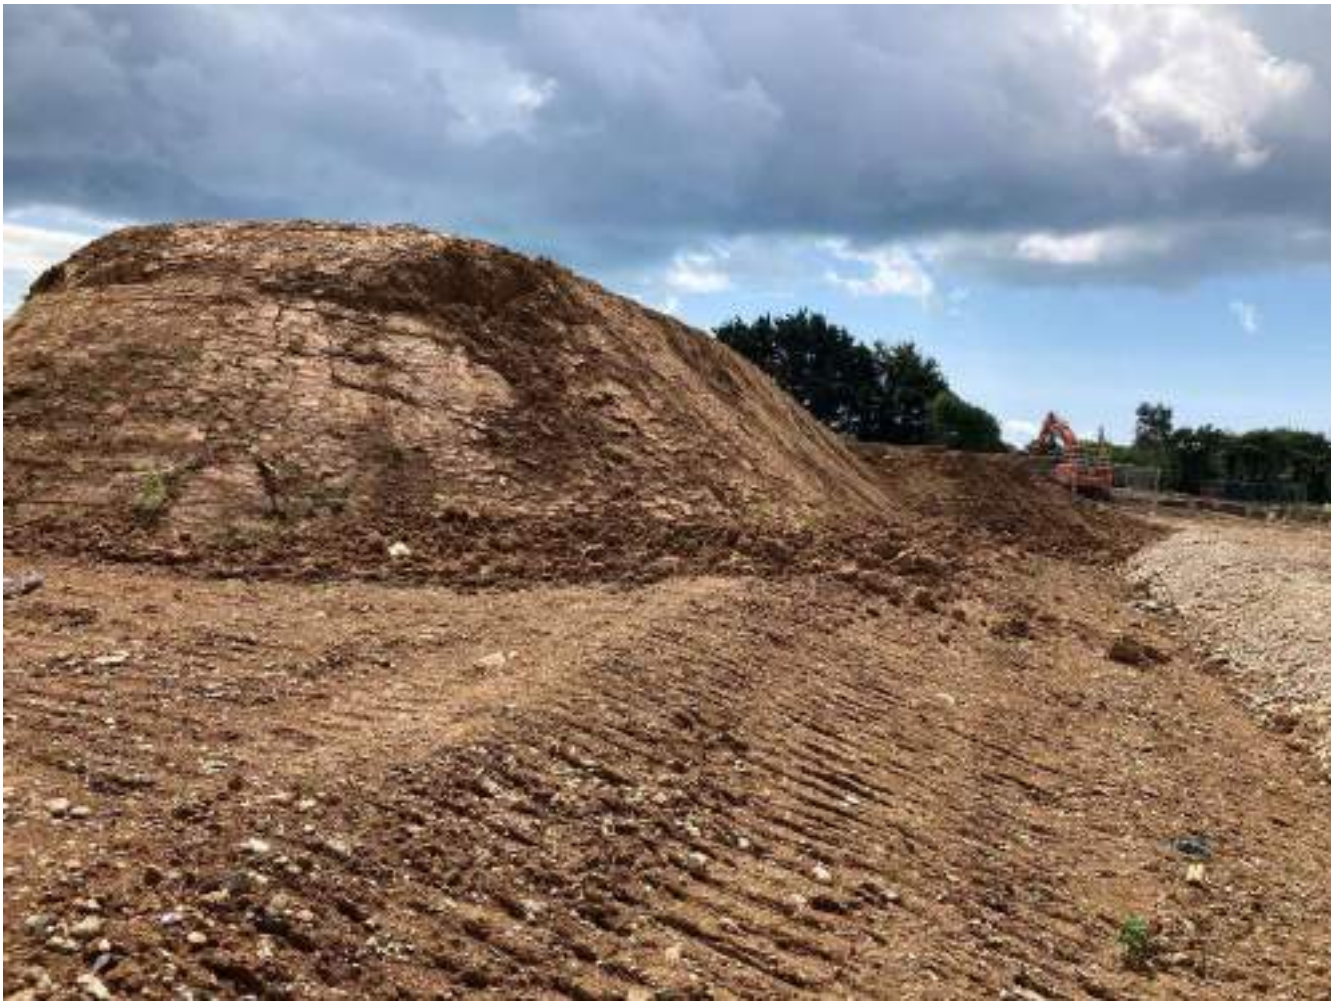
Figure 4: Billingshurst soil stockpile SL04/05

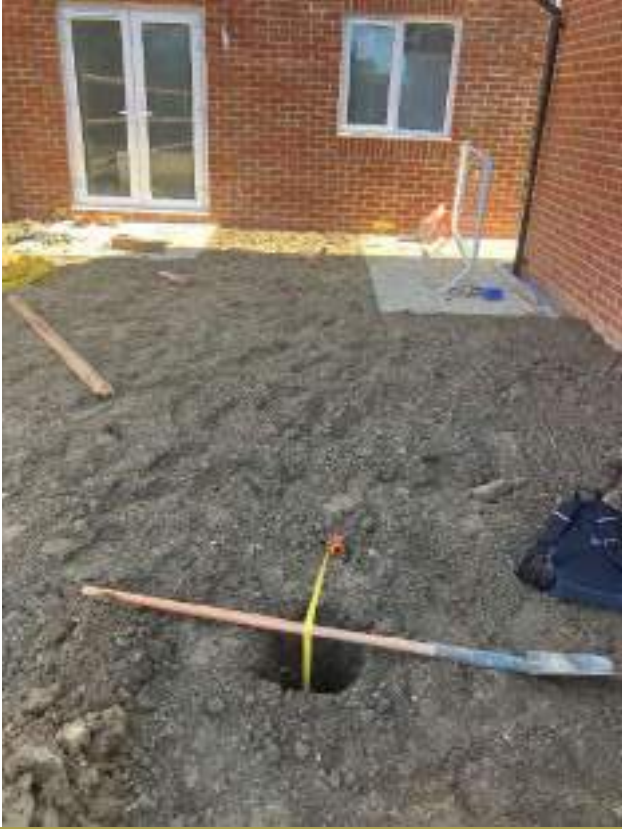
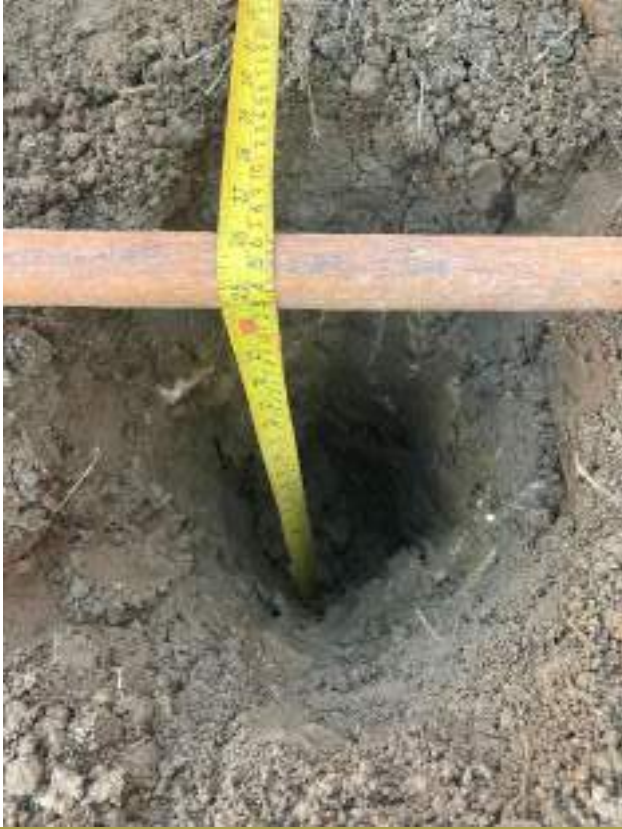
| Physical Suitability | No undesirable or injurious objects were observed within any of the materials inspected, such as sharps, metals, plastics or over-sized materials, except for occasional gravel sized fragments of brick and concrete within the subsoil. | | |

| Conclusion | The physical suitability and cover system thickness has <b>passed</b> verification and is considered to have met the remedial specifications. |

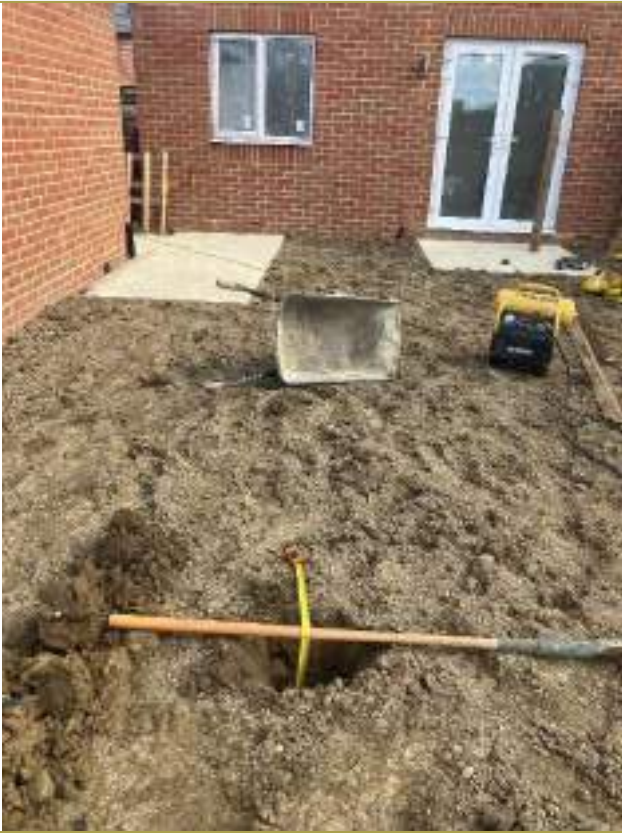
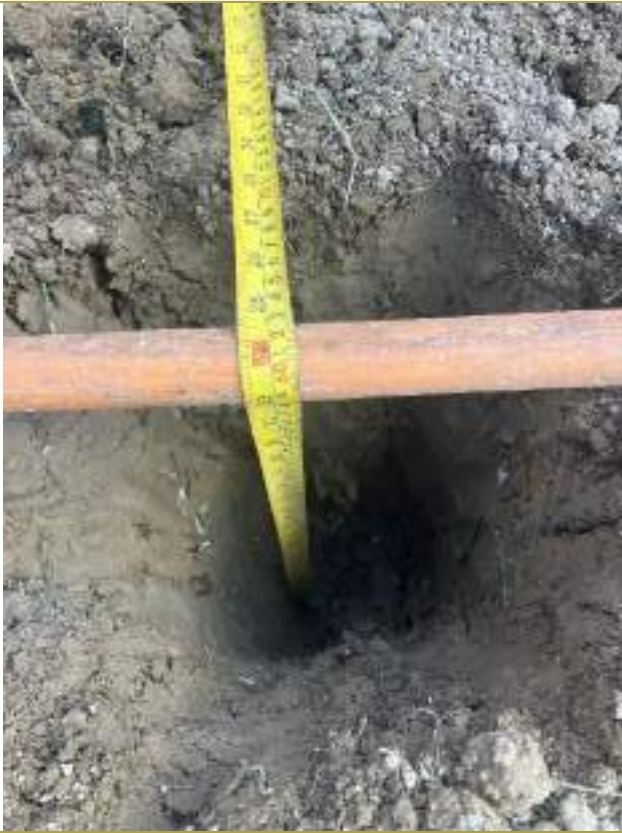
| Physical Suitability | No undesirable or injurious objects were observed within any of the materials inspected, such as sharps, metals, plastics or over-sized materials, except for occasional gravel sized fragments of brick and concrete within the subsoil. | | |

| Conclusion | The physical suitability and cover system thickness has <b>passed</b> verification and is considered to have met the remedial specifications. |

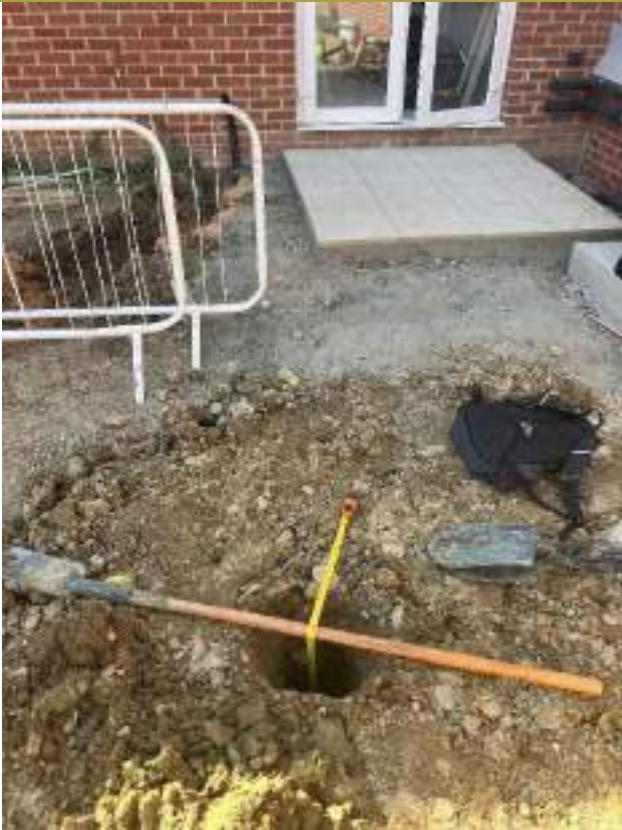
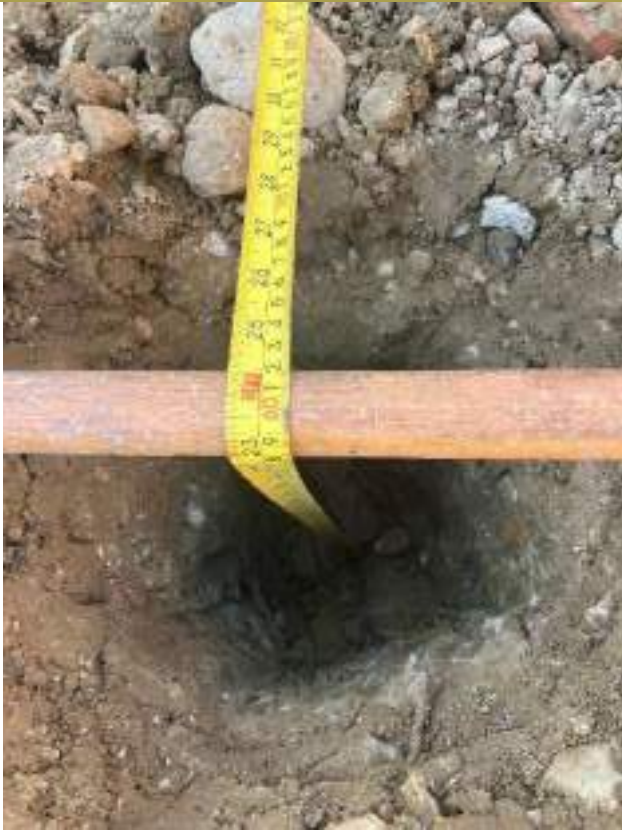
| Physical Suitability | No undesirable or injurious objects were observed within any of the materials inspected, such as sharps, metals, plastics or over-sized materials, except for occasional gravel sized fragments of brick and concrete within the subsoil, and cobble sized fragments at surface. | | |

| Conclusion | The physical suitability and cover system thickness has <b>passed</b> verification and is considered to have met the remedial specifications. |

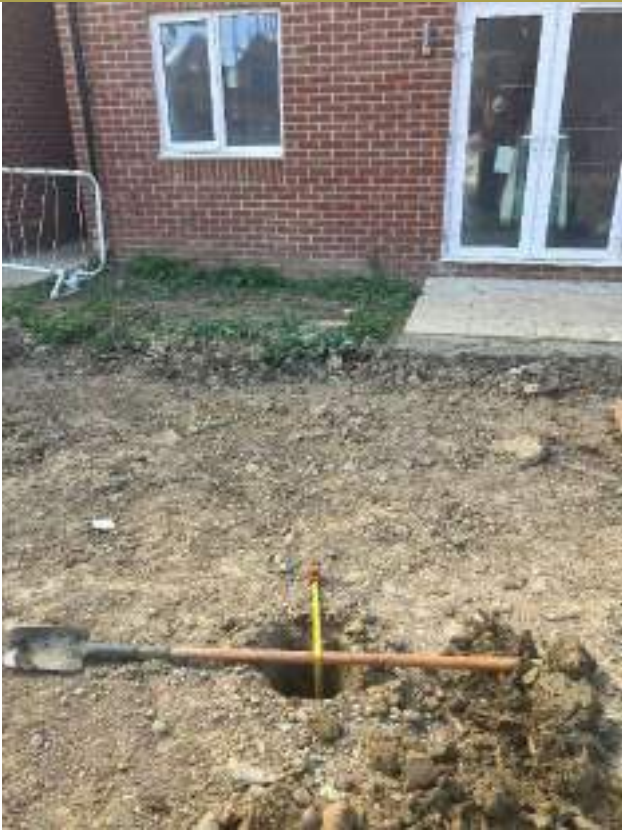
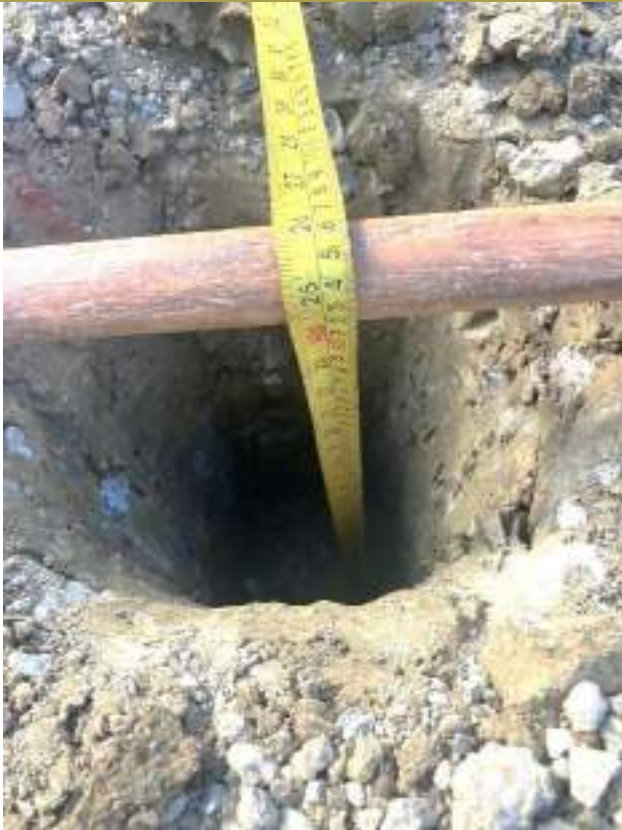
| Physical Suitability | No undesirable or injurious objects were observed within any of the materials inspected, such as sharps, metals, plastics or over-sized materials, except for occasional gravel sized fragments of brick and concrete within the subsoil, and cobble sized fragments at surface. | | |

| Conclusion | The physical suitability and cover system thickness has <b>passed</b> verification and is considered to have met the remedial specifications. |

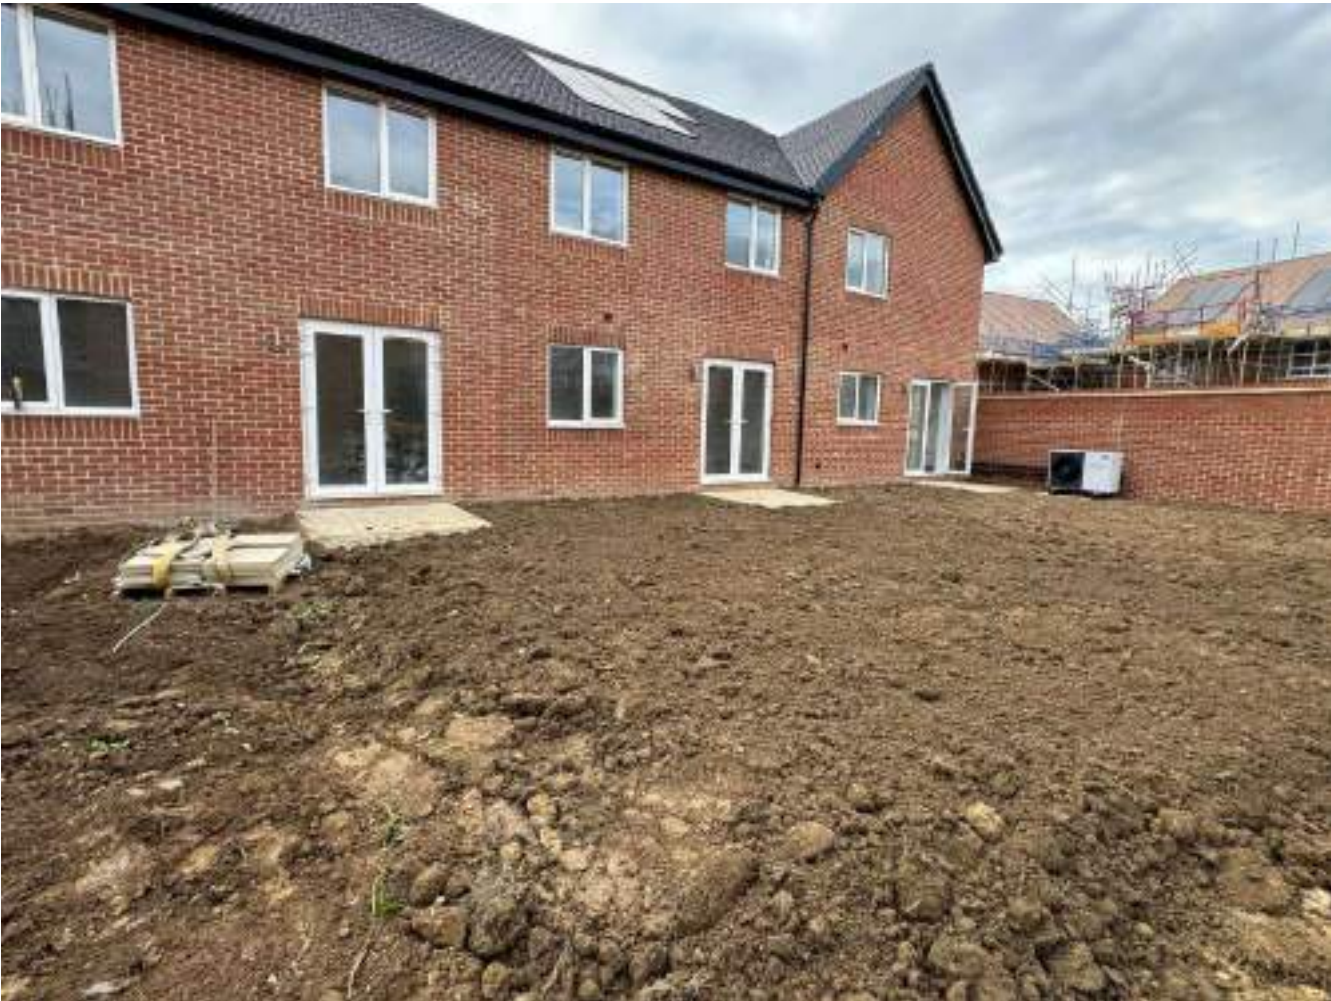
Plots 107 – 109: contractor supplied photo following placement of topsoil. Dates 24.09.2025
