## Verification Report

Plots 87-89, 103-106, 129 Residential Development

Barrington Road, Worthing

November 2025

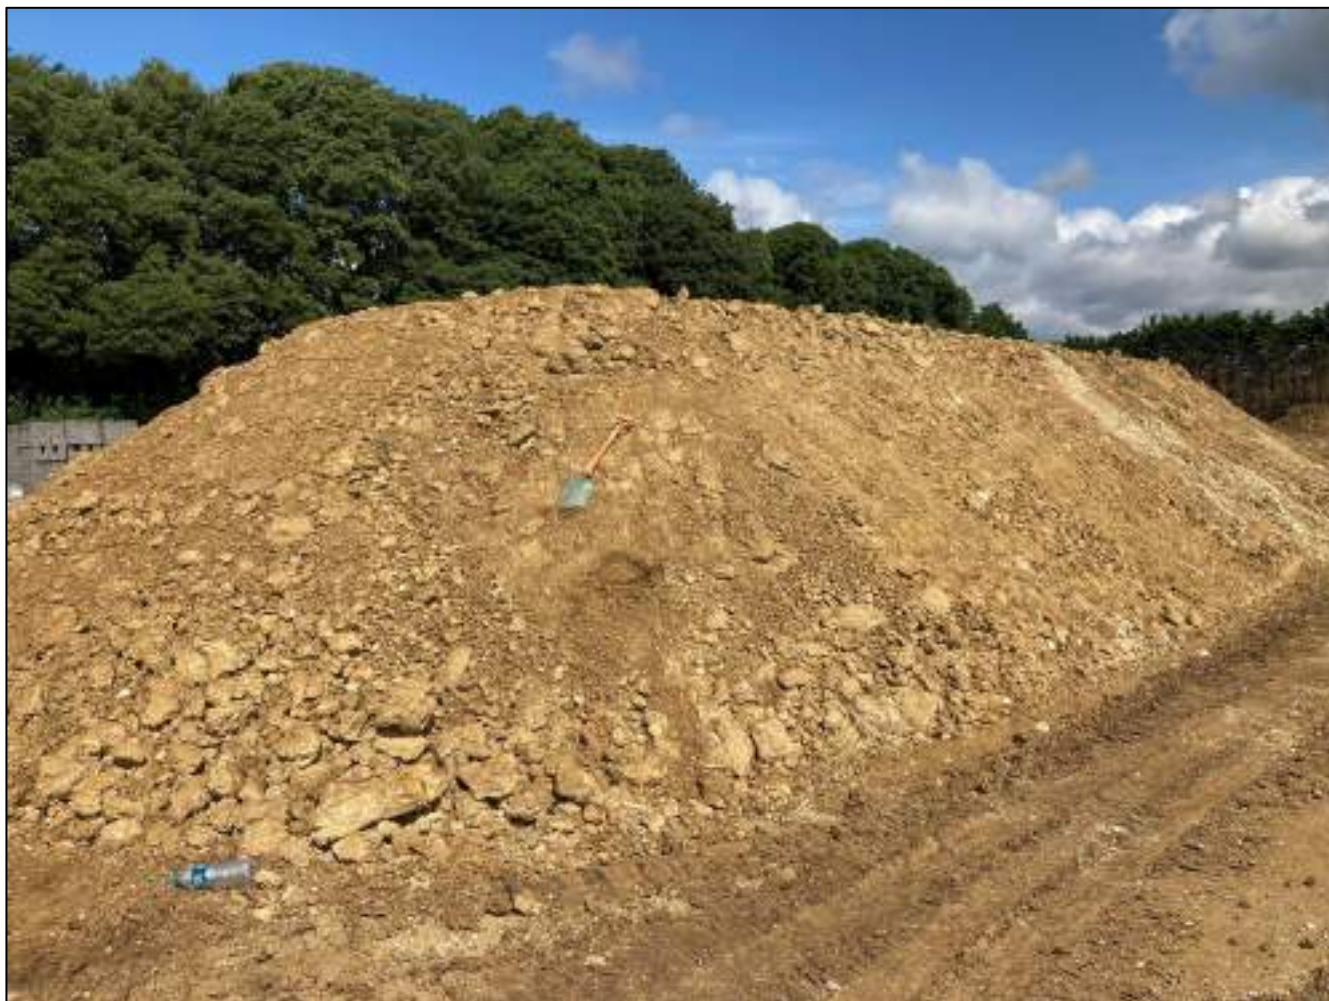
*Figure 2: Billingshurst soil stockpile SL02*

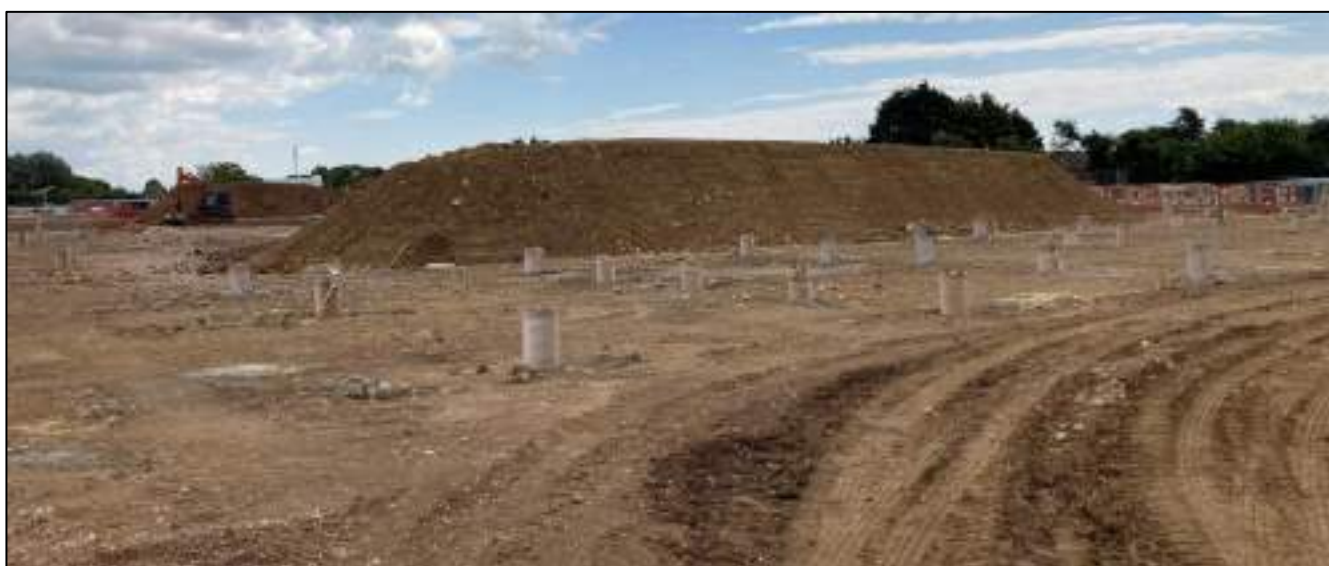
*Figure 3: Billingshurst soil stockpile SL03*

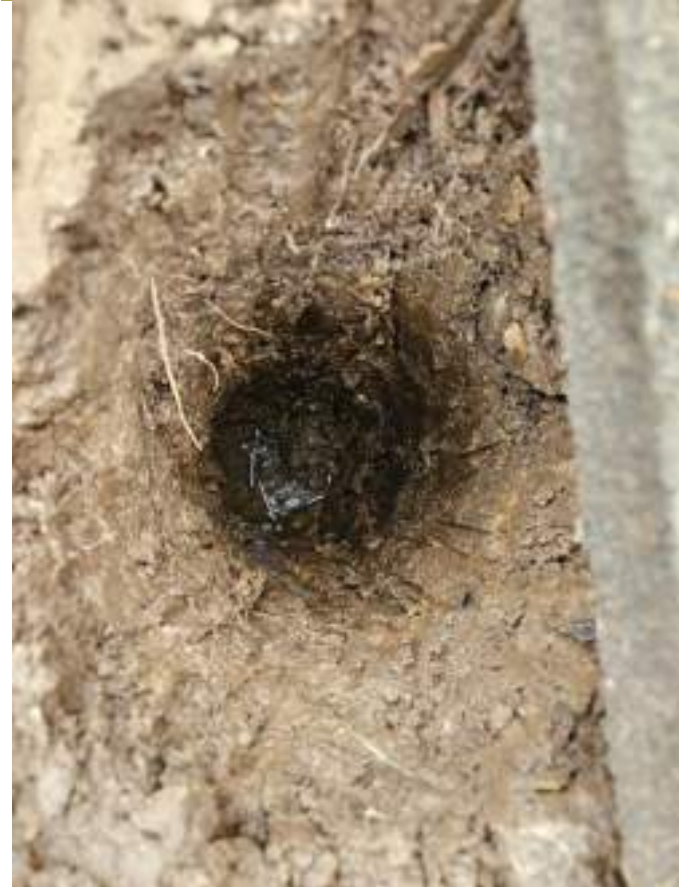
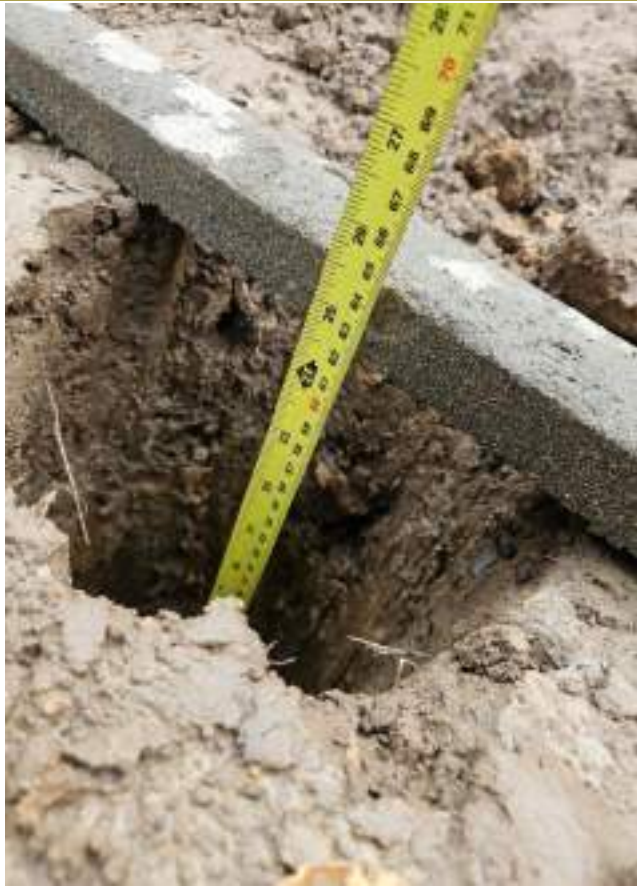
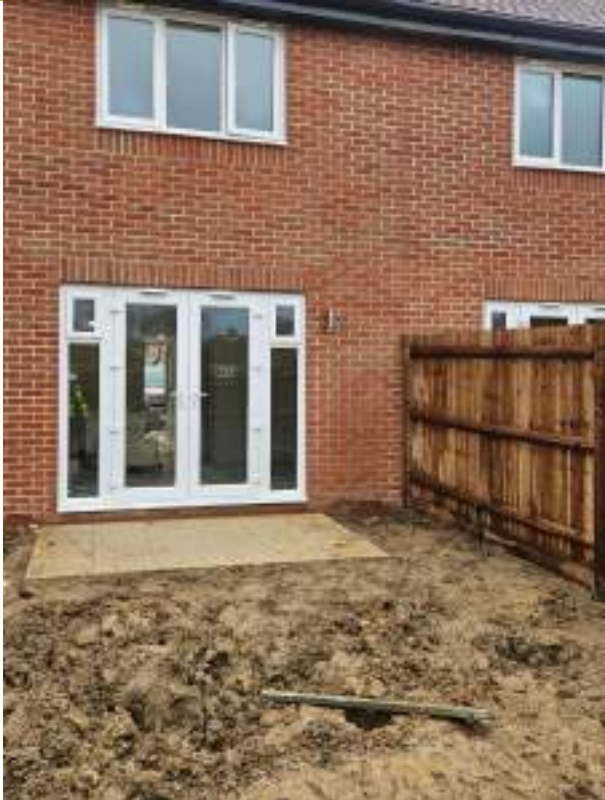
| Physical Suitability | No undesirable or injurious objects were observed within any of the materials inspected, such as sharps, metals, plastics or over-sized materials, except for a few cobble-sized fragments of brick and concrete within the subsoil. | | |

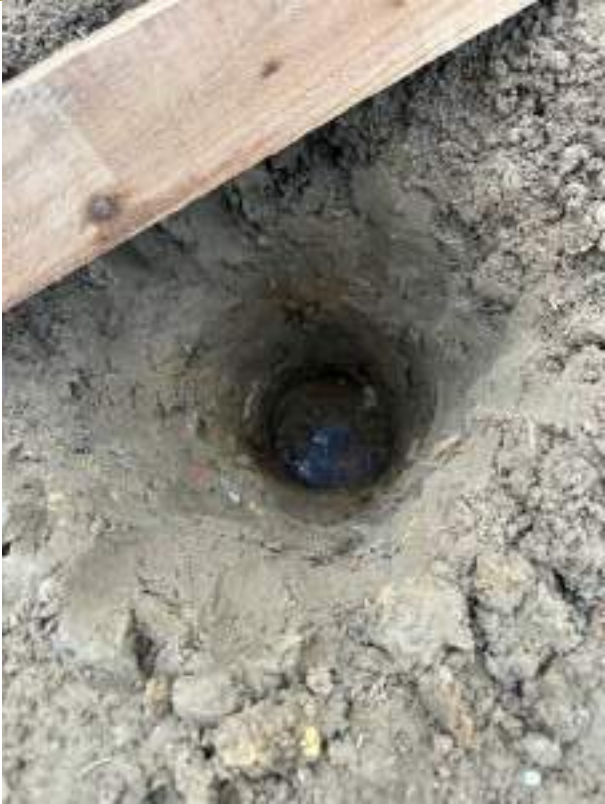
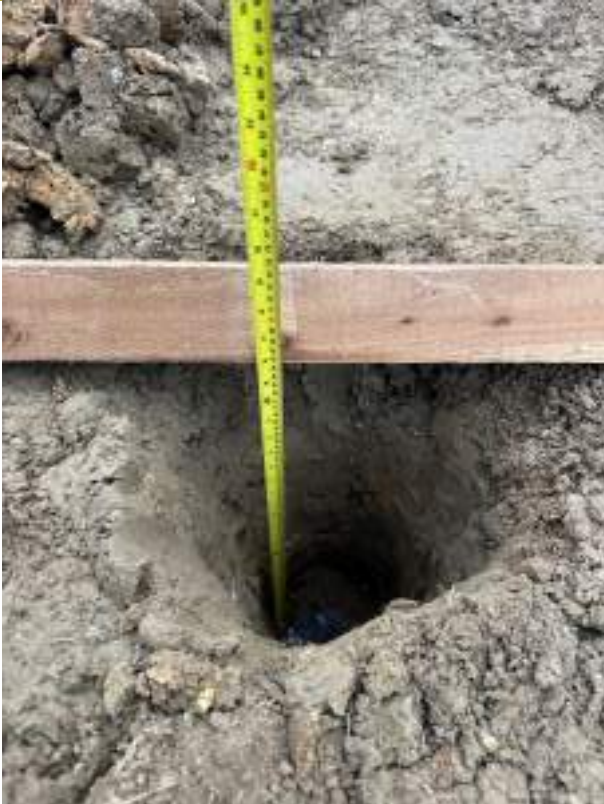
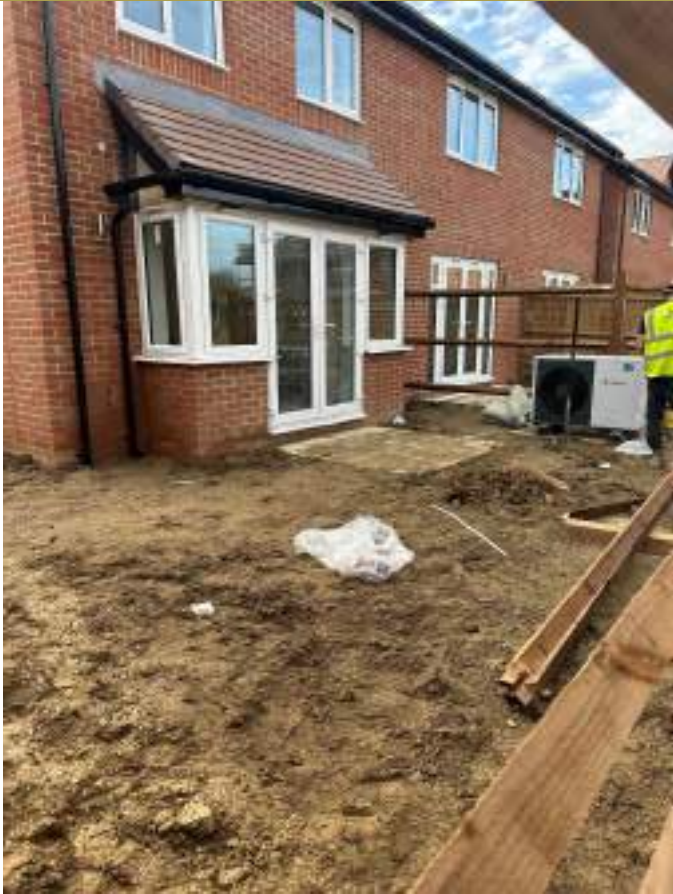
| Physical Suitability | No undesirable or injurious objects were observed within any of the materials inspected, such as sharps, metals, plastics or over-sized materials, except for a few cobble-sized fragments of brick and concrete within the subsoil. | | |

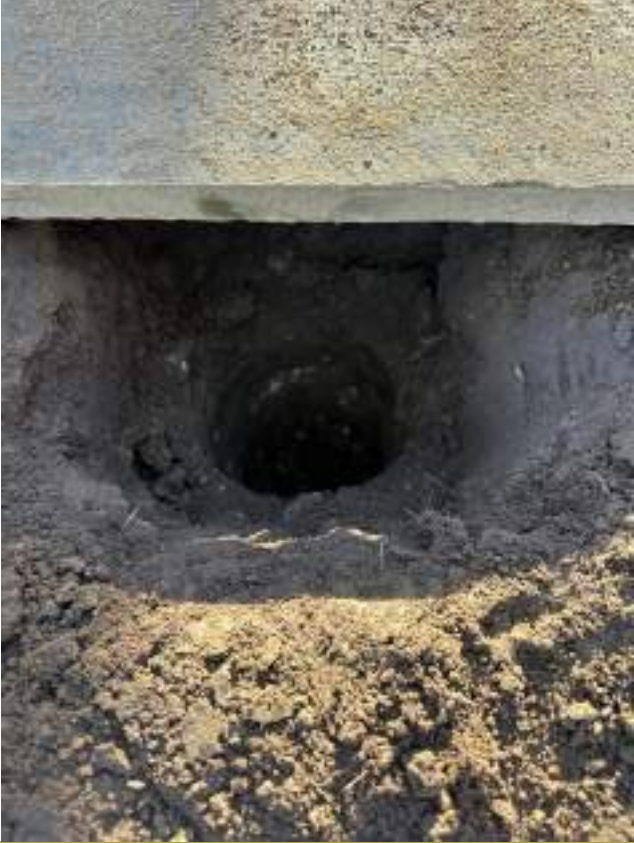
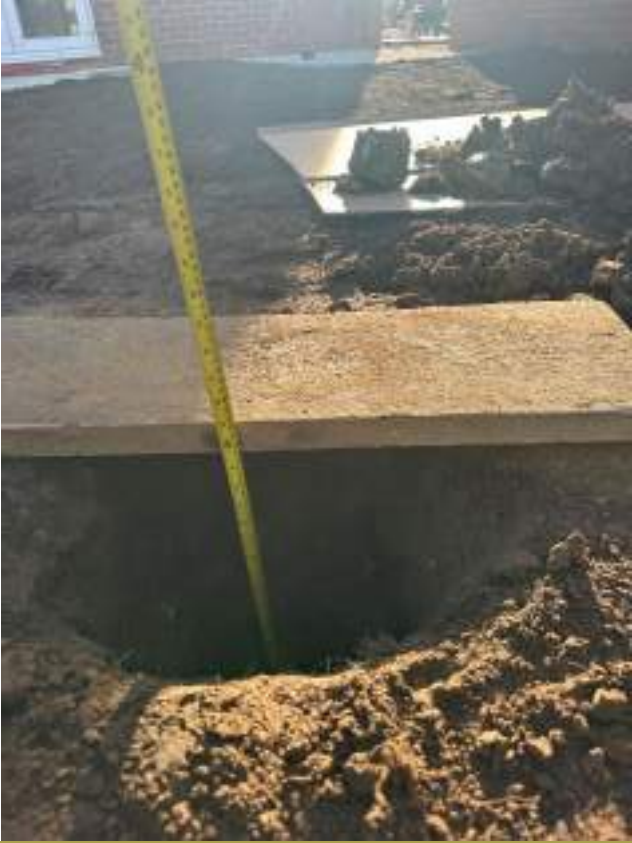
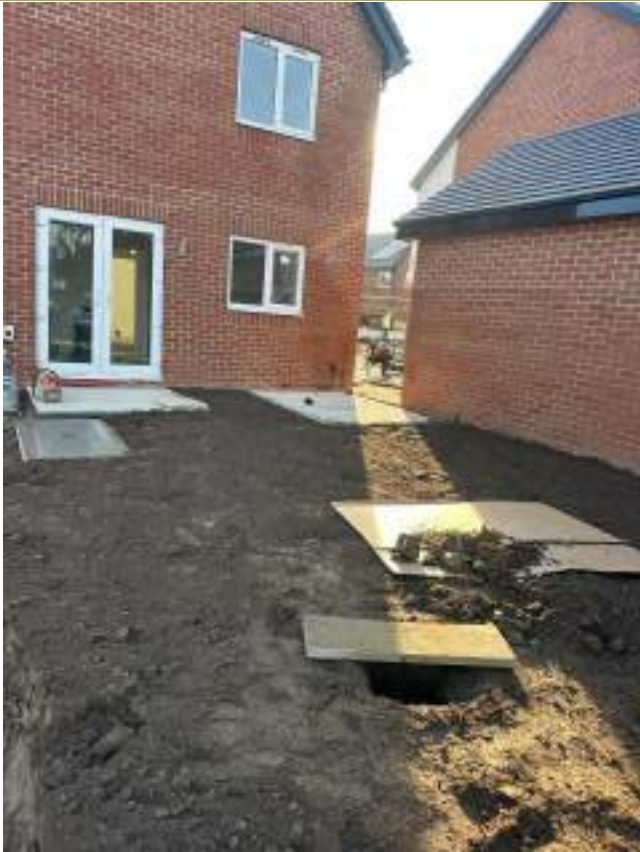
| Physical Suitability | No undesirable or injurious objects were observed within any of the materials inspected, such as sharps, metals, plastics or over-sized materials, except for a few cobble-sized fragments of brick and concrete within the subsoil. | | |

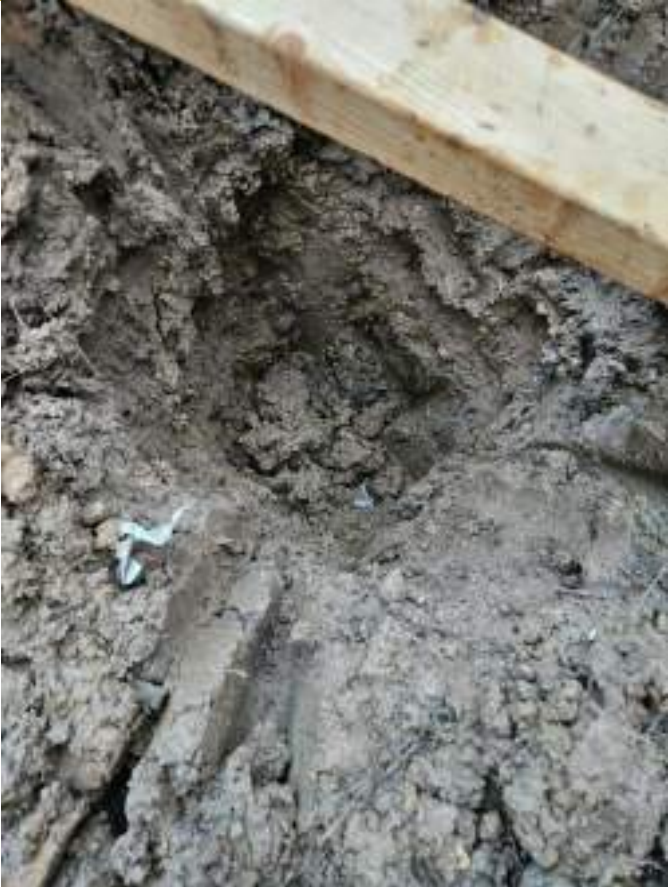
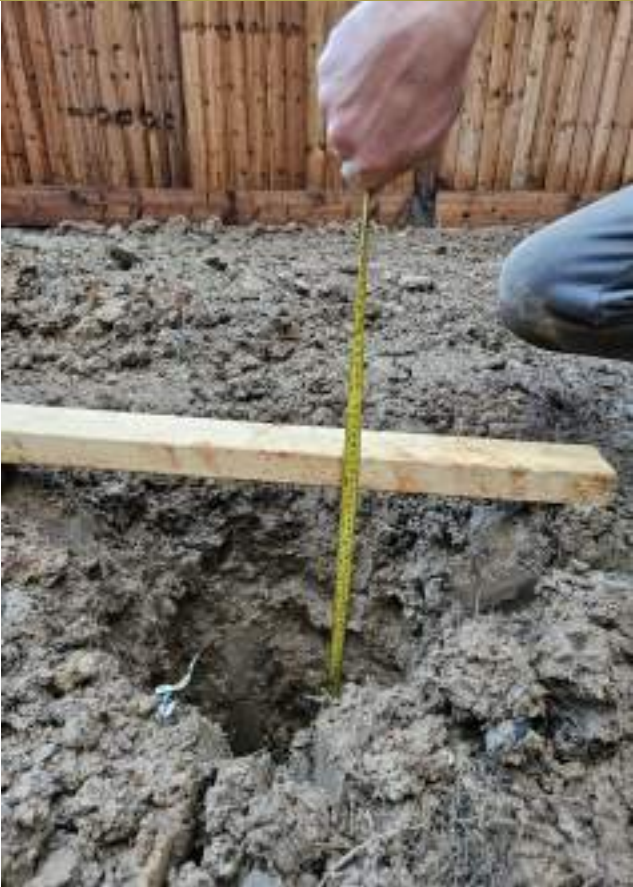
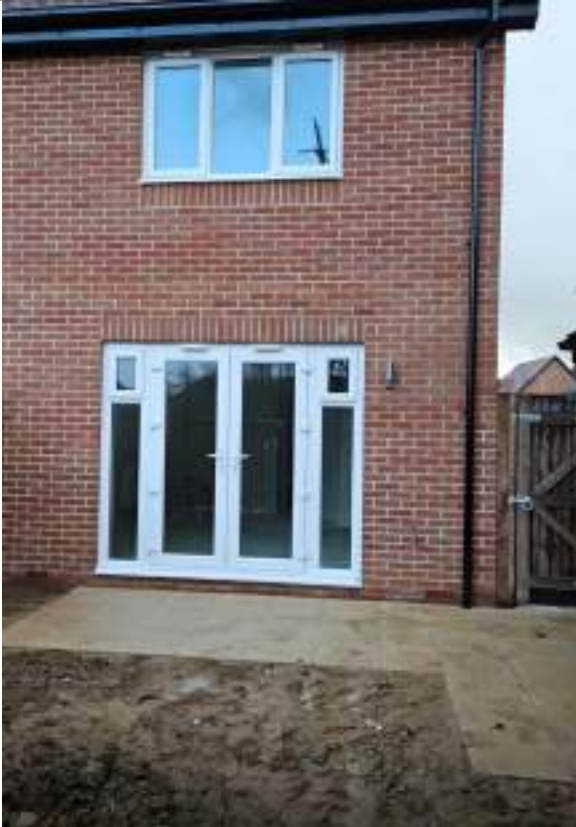
| Physical Suitability | No undesirable or injurious objects were observed within any of the materials inspected, such as sharps, metals, plastics or over-sized materials, except for a few cobble-sized fragments of brick and concrete within the subsoil. | | |

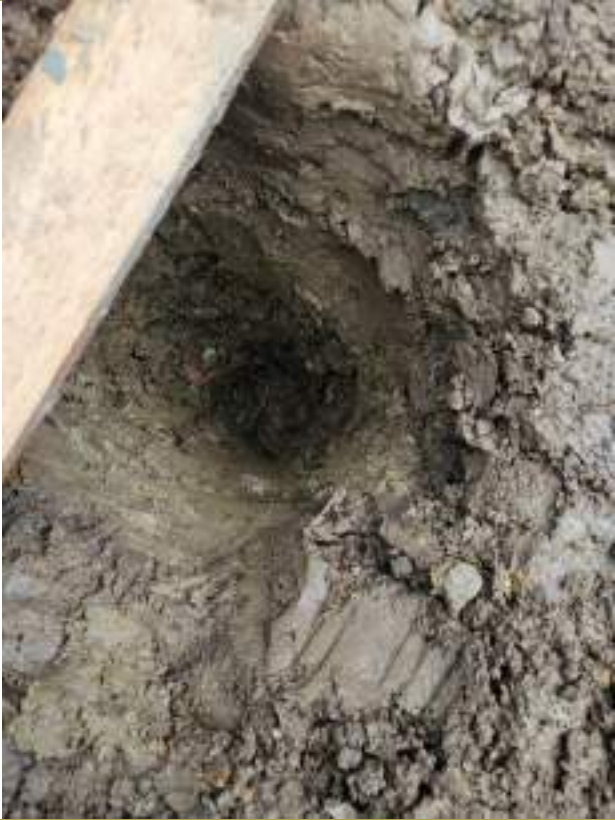
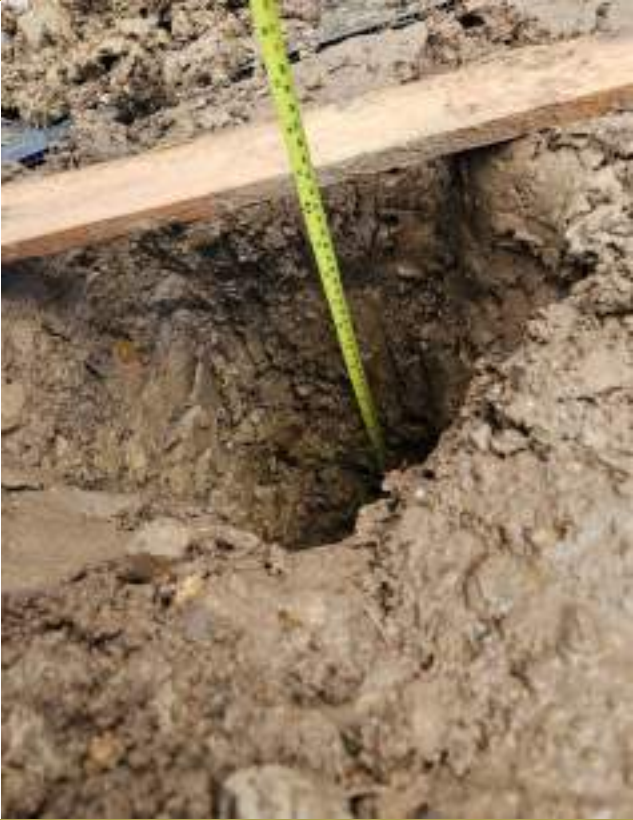
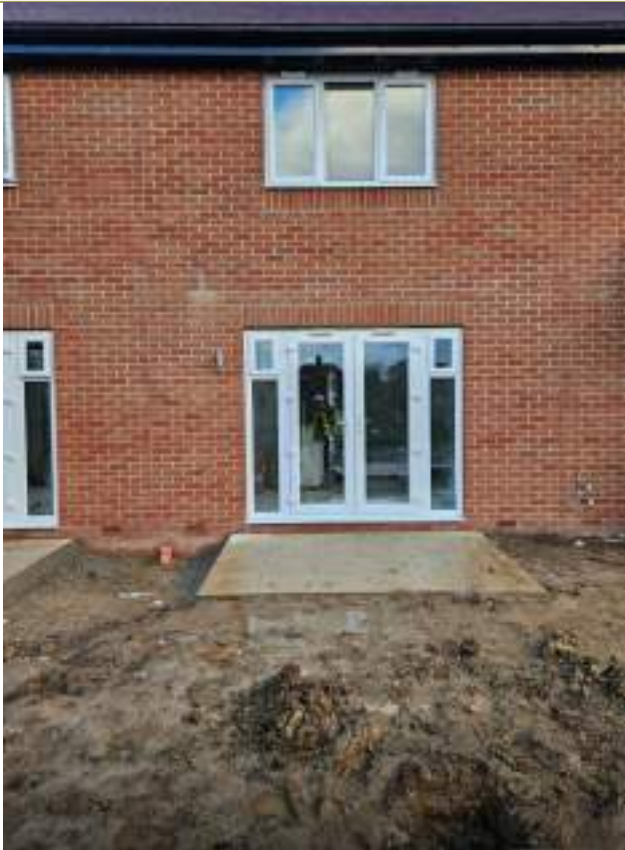
| Physical Suitability | No undesirable or injurious objects were observed within any of the materials inspected, such as sharps, metals, plastics or over-sized materials, except for a few cobble-sized fragments of brick and concrete within the subsoil. | | |

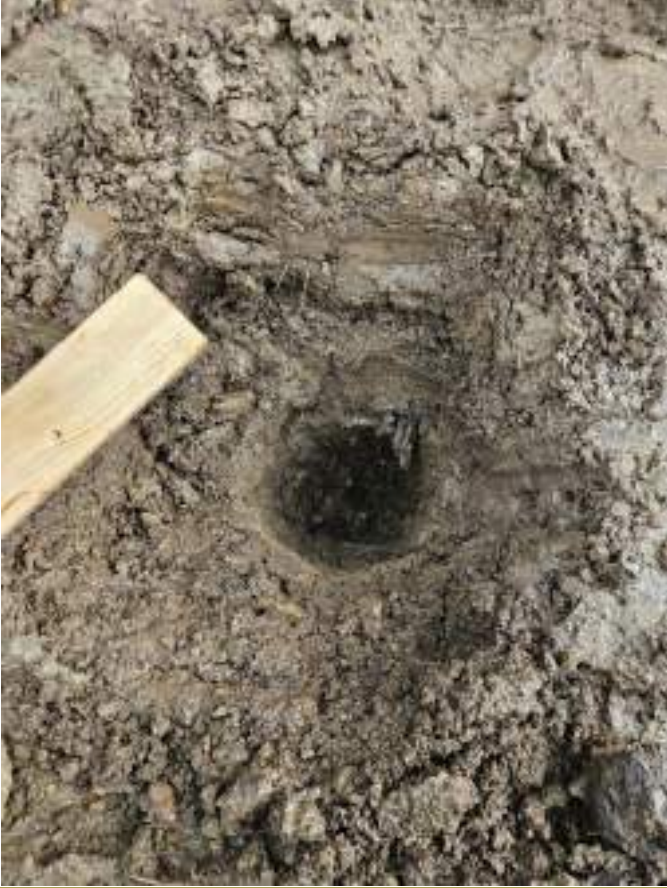
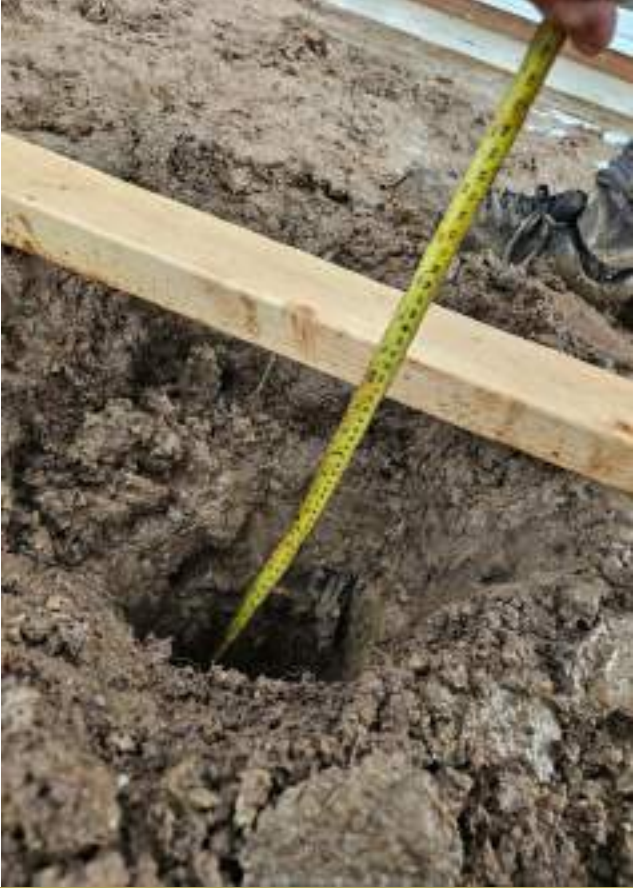
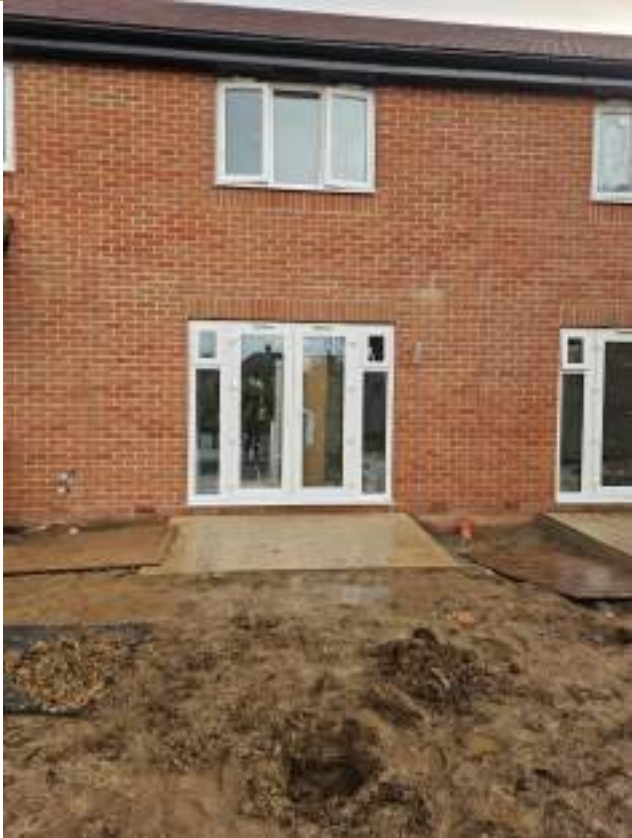
| Physical Suitability | No undesirable or injurious objects were observed within any of the materials inspected, such as sharps, metals, plastics or over-sized materials, except for a few cobble-sized fragments of brick and concrete within the subsoil. | | |

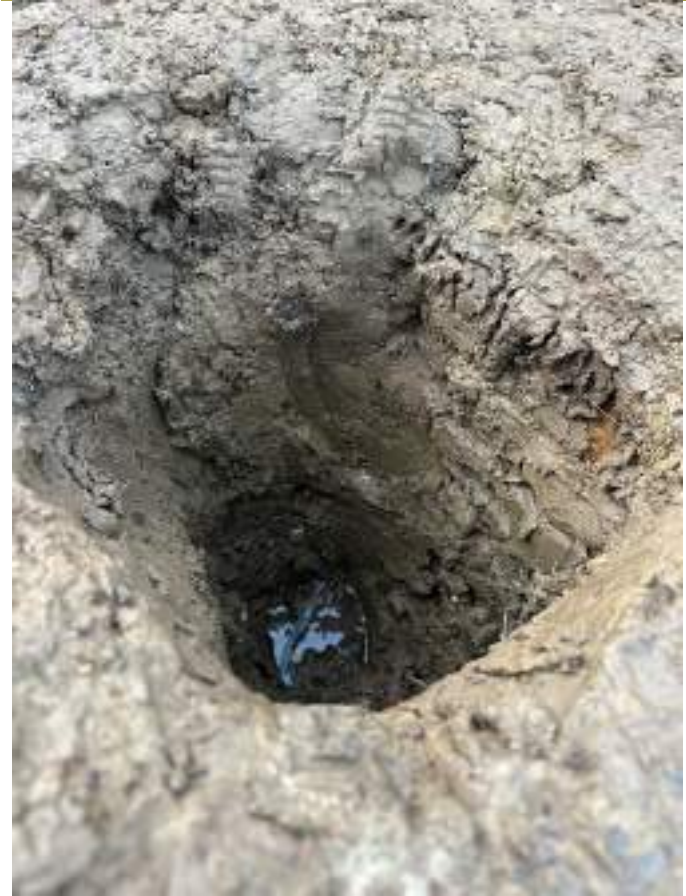
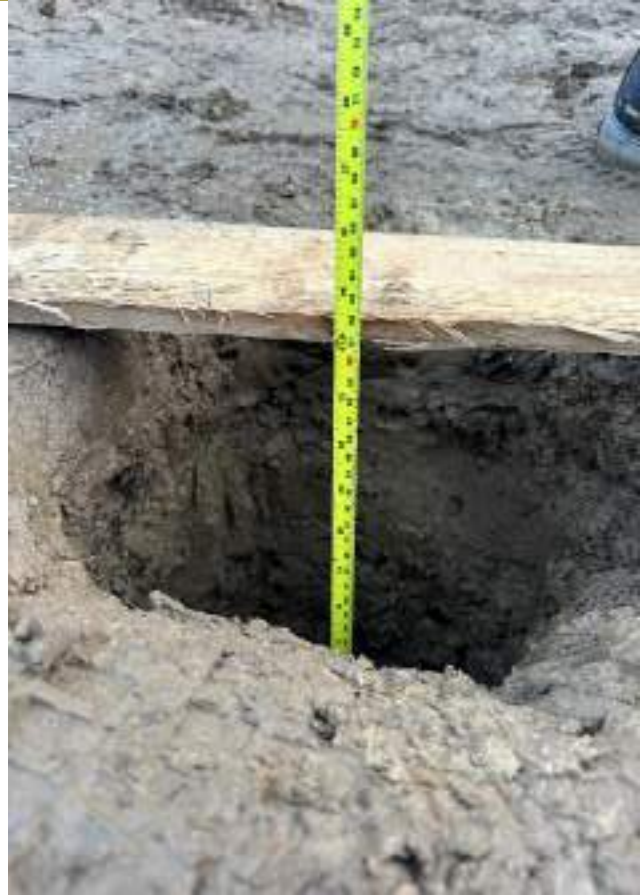
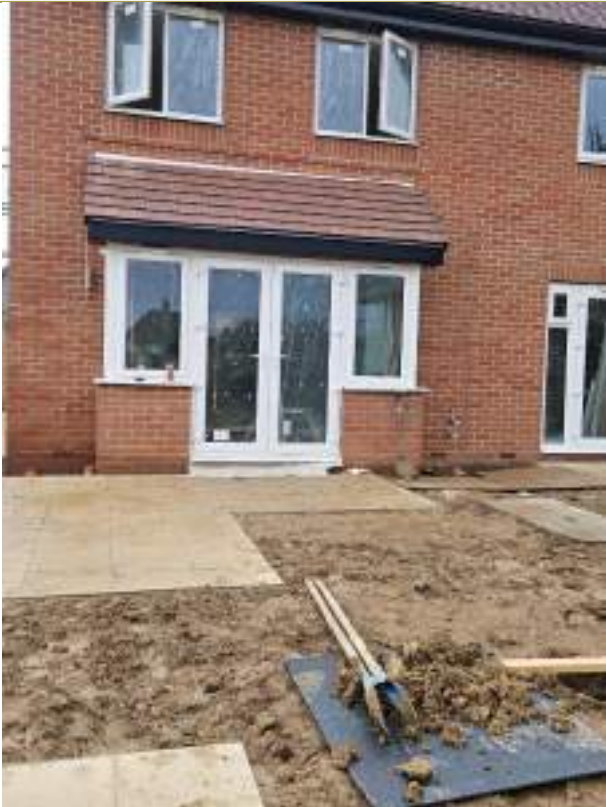
| Physical Suitability | No undesirable or injurious objects were observed within any of the materials inspected, such as sharps, metals, plastics or over-sized materials, except for a few cobble-sized fragments of brick and concrete within the subsoil. | | |

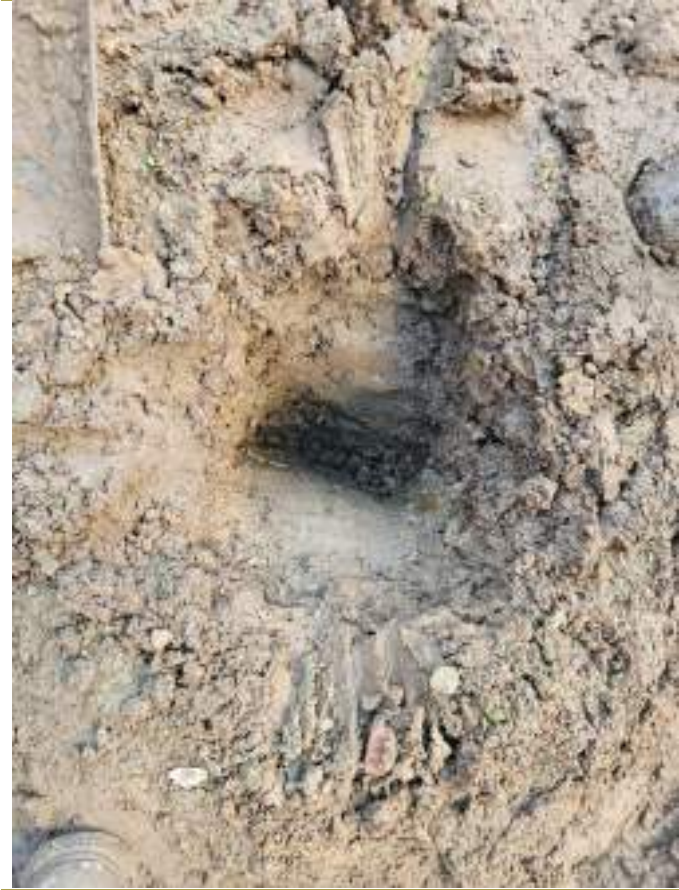
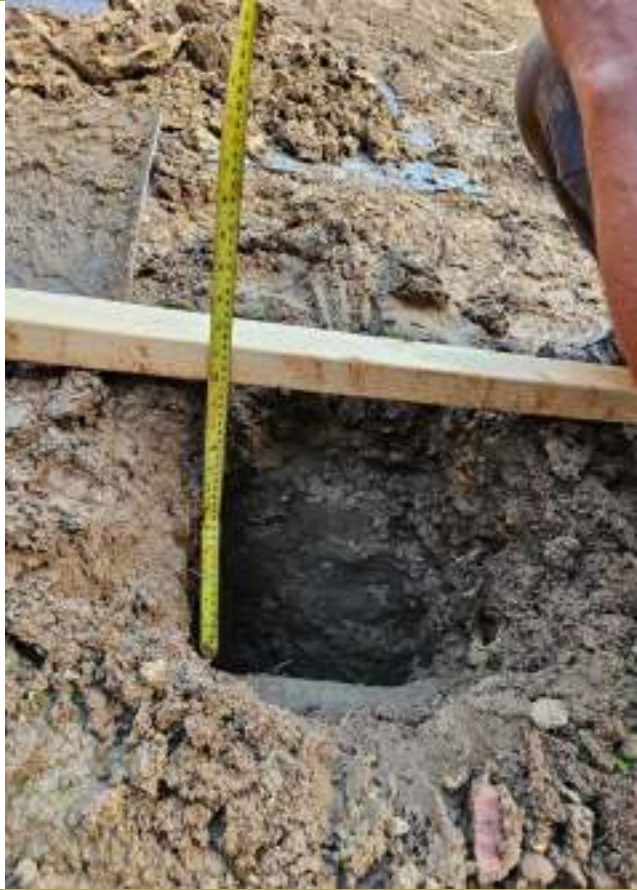
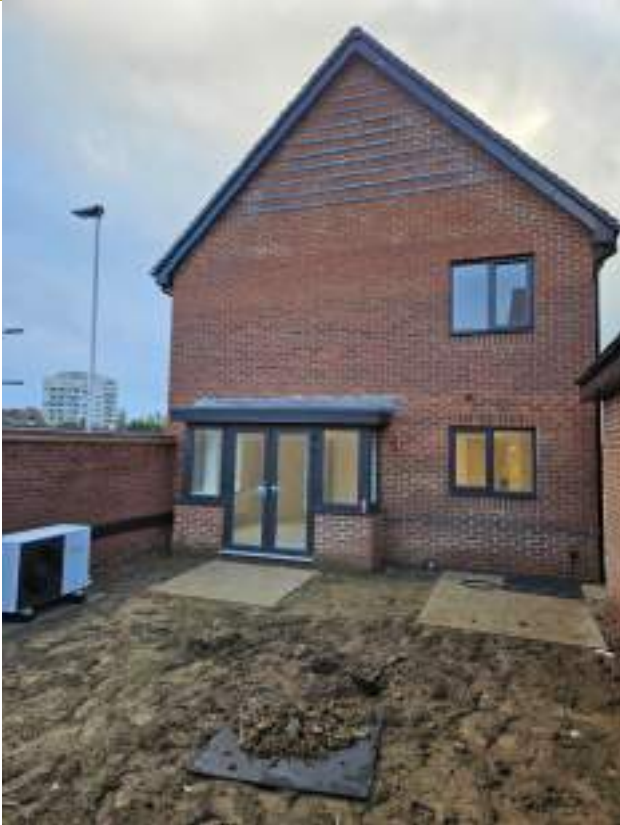
| Physical Suitability | No undesirable or injurious objects were observed within any of the materials inspected, such as sharps, metals, plastics or over-sized materials, except for a few cobble-sized fragments of brick and concrete within the subsoil. | | |
