## Verification Report

Plots 110-112, 117-118, 125-128 Residential Development

Barrington Road, Worthing

Document no.: STV5959-R25-Rev\_A

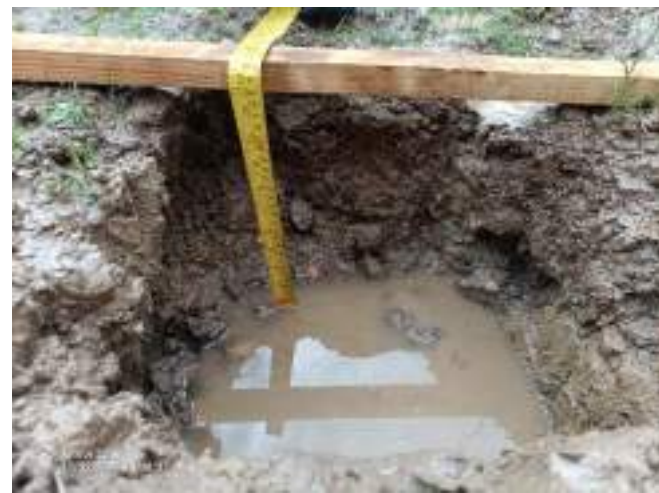
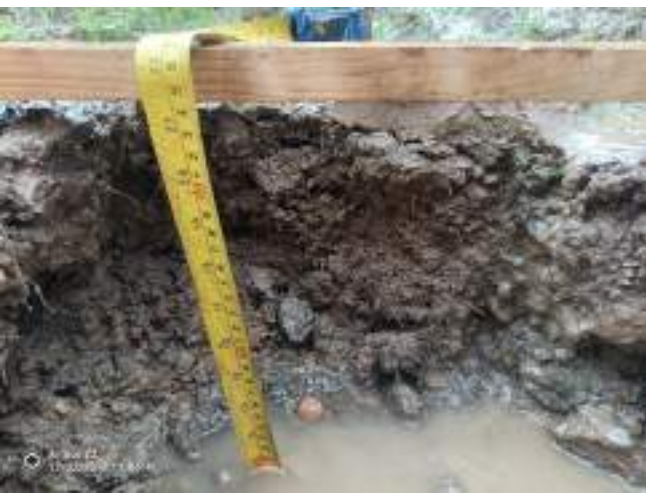
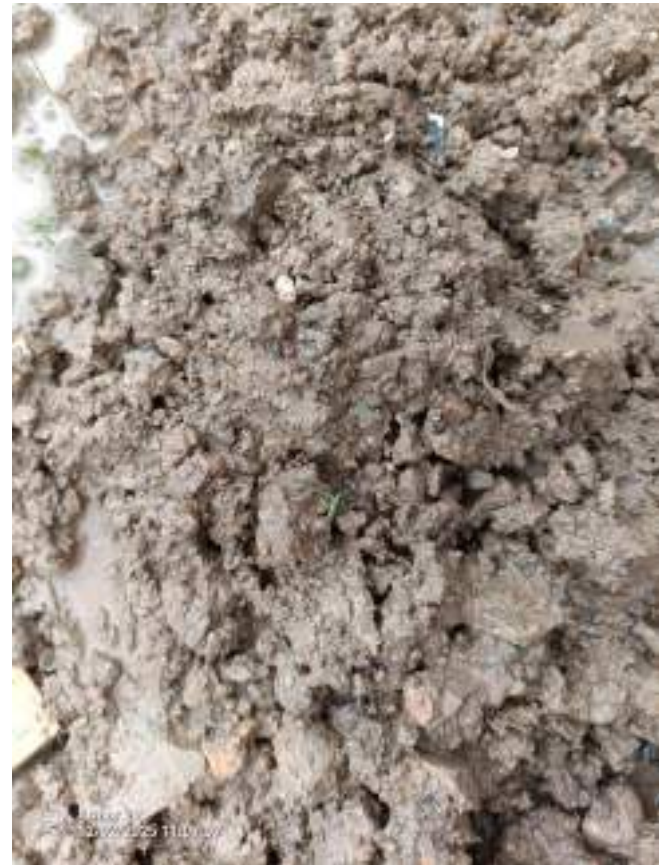
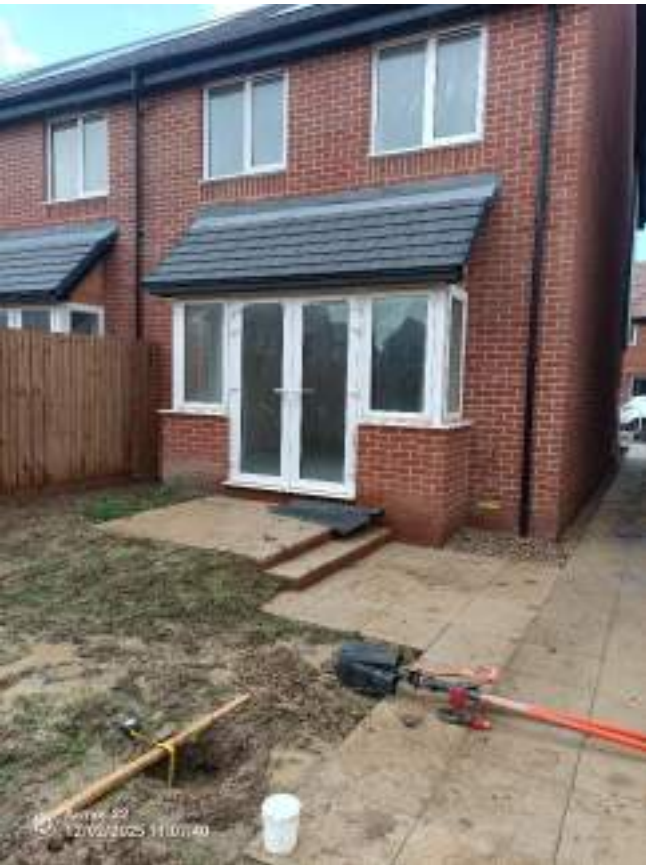
| Physical Suitability | No undesirable or injurious objects were observed within any of the materials inspected, such as sharps, metals, plastics or over-sized materials, except for a few cobble-sized fragments of brick and concrete within the subsoil. | | |

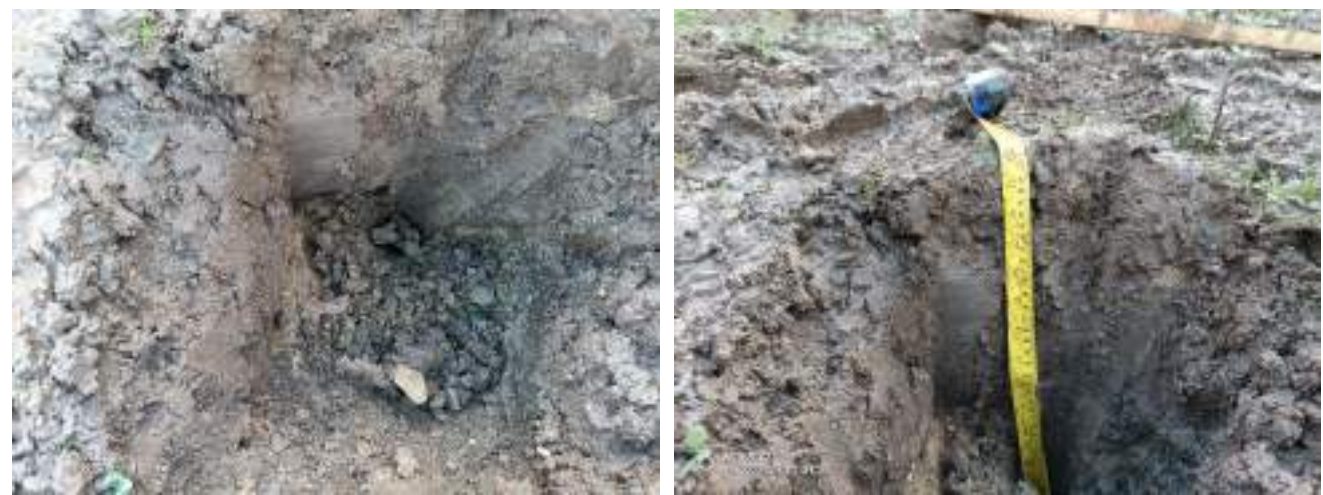
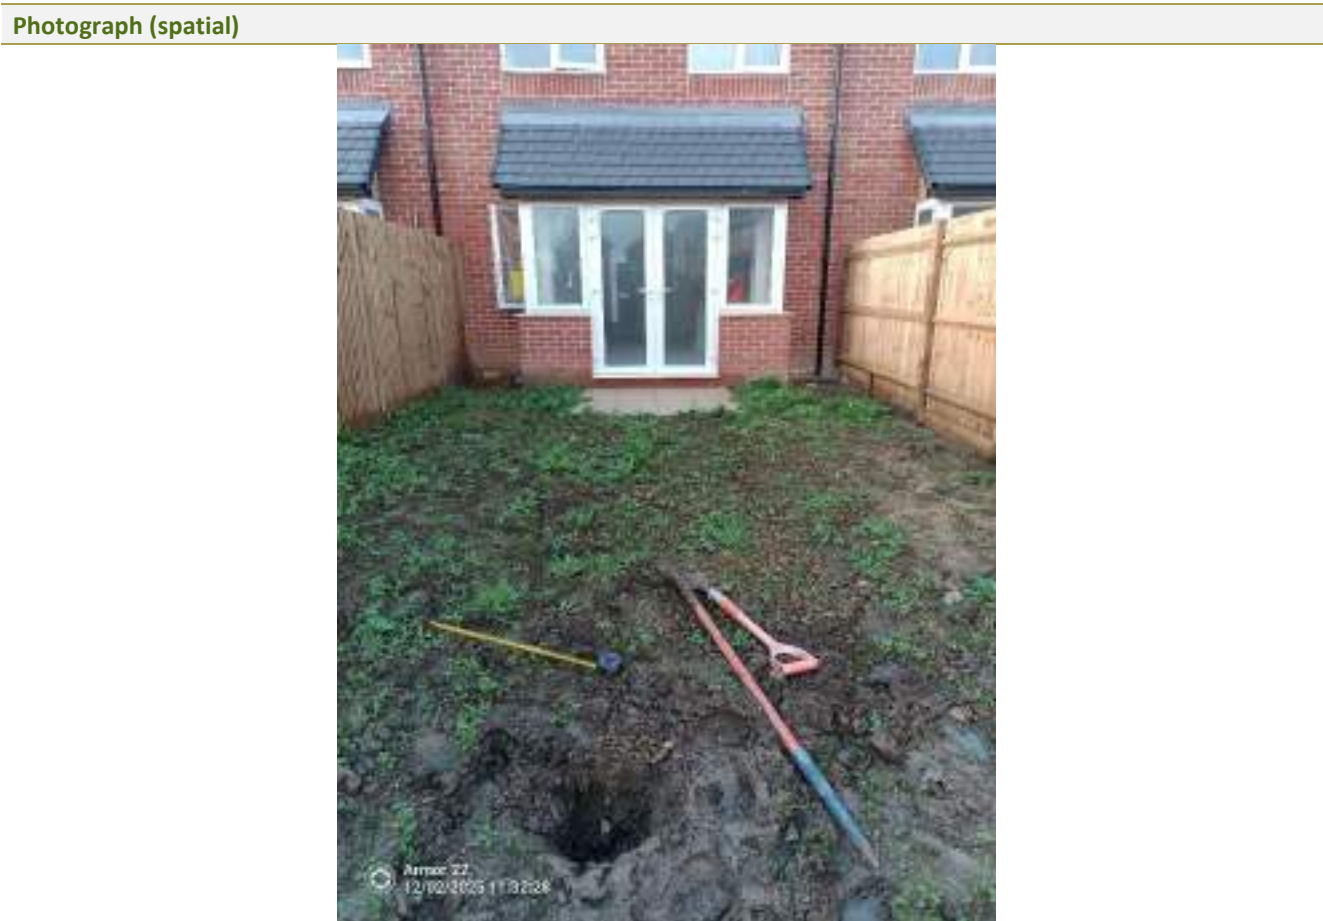
| Physical Suitability | No undesirable or injurious objects were observed within any of the materials inspected, such as sharps, metals, plastics or over-sized materials, except for a few cobble-sized fragments of brick and concrete within the subsoil. | | |

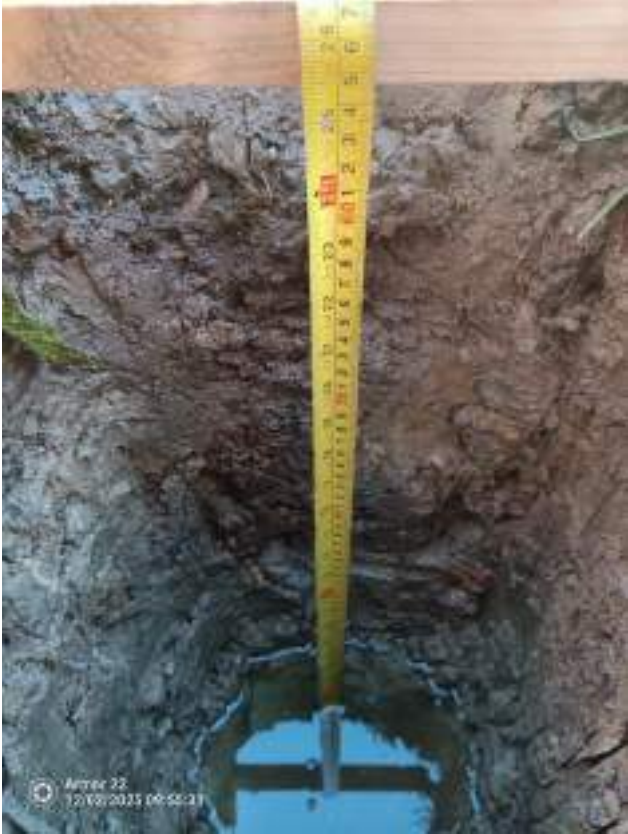
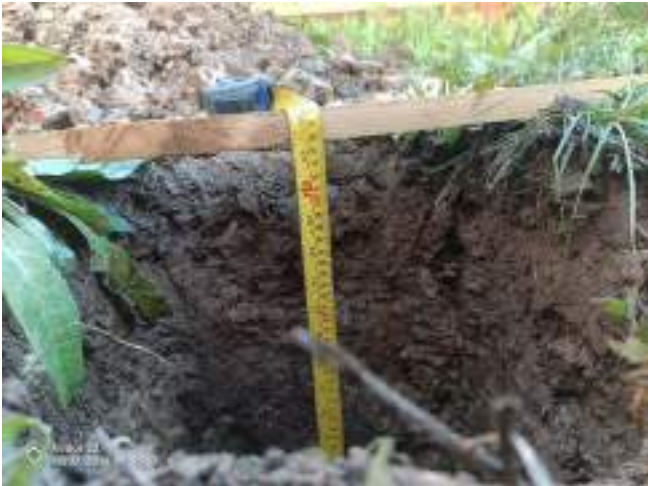
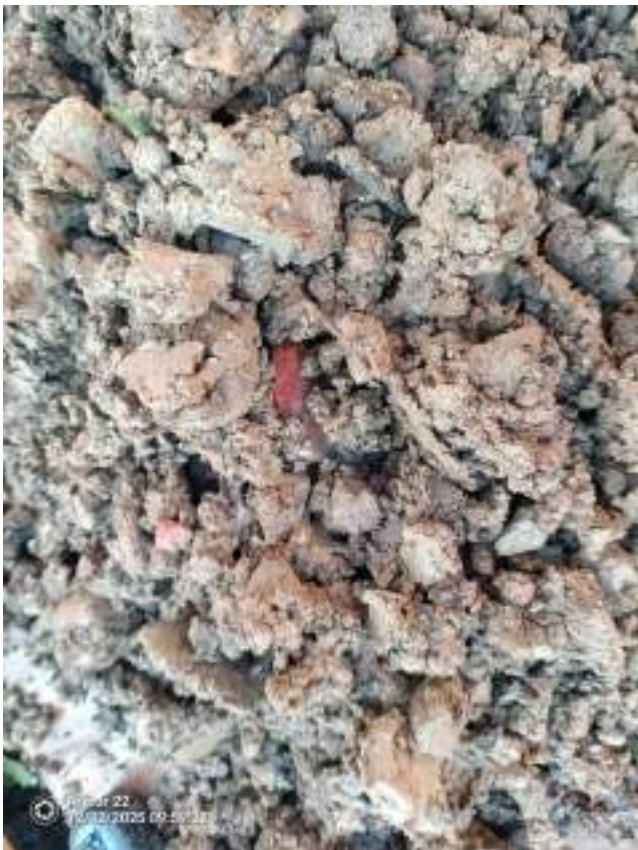
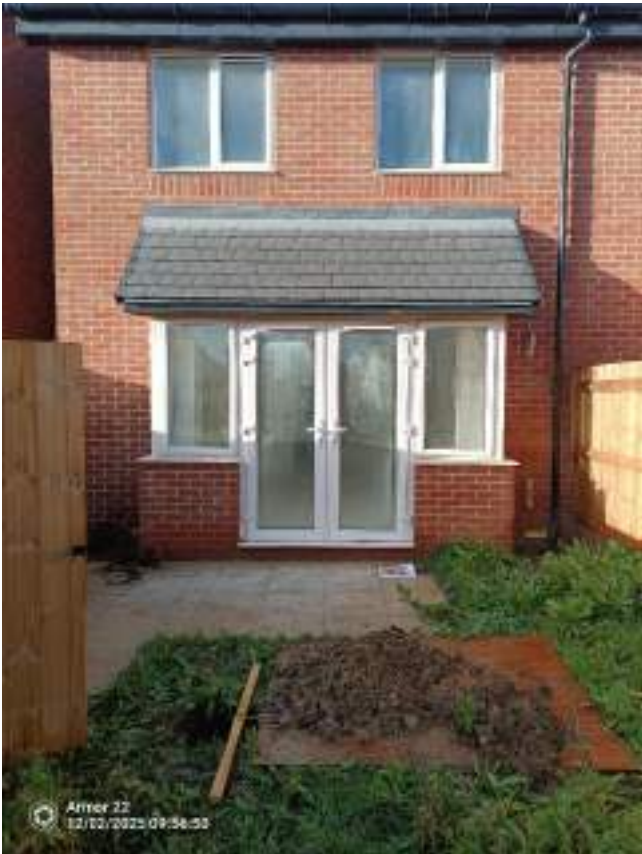
| Physical Suitability | No undesirable or injurious objects were observed within any of the materials inspected, such as sharps, metals, plastics or over-sized materials, except for a few cobble-sized fragments of brick and concrete within the subsoil. | | |

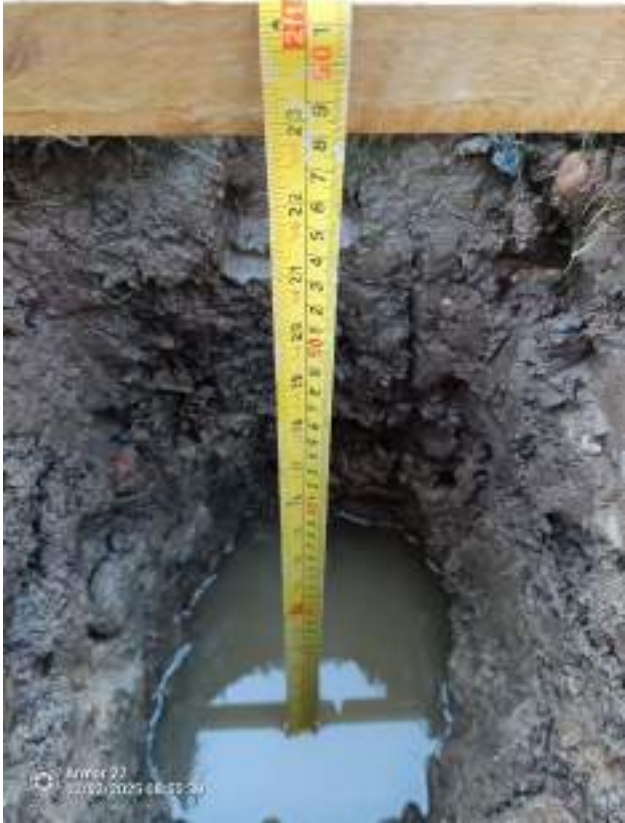
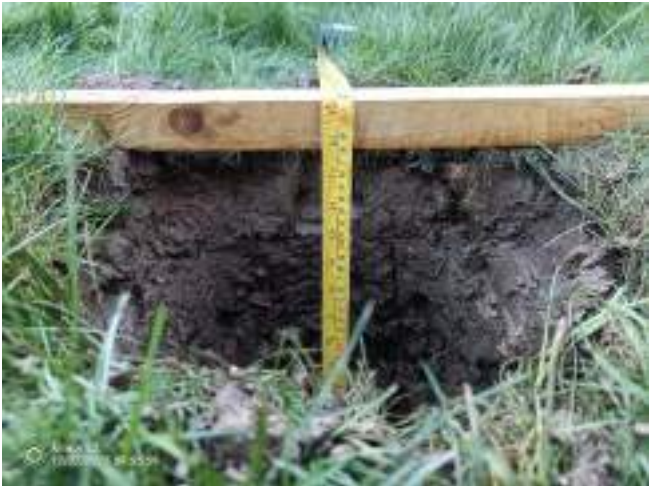
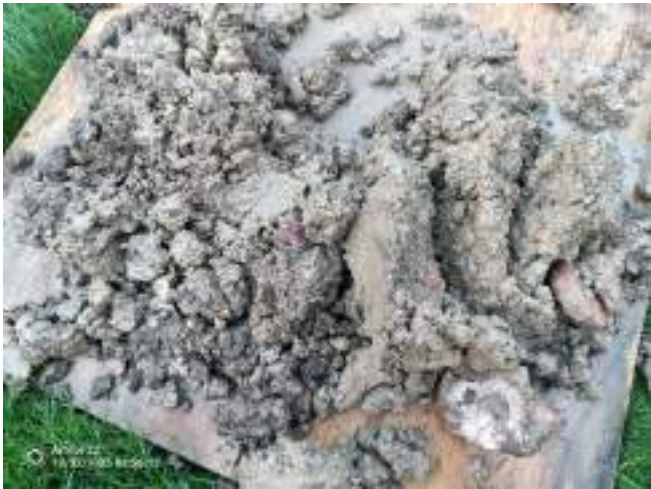
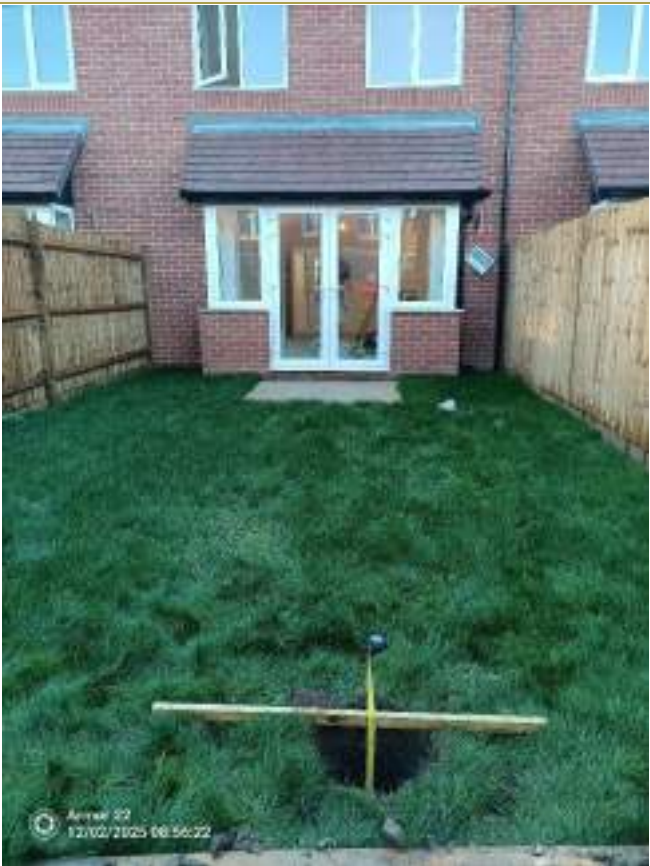
| Physical Suitability | No undesirable or injurious objects were observed within any of the materials inspected, such as sharps, metals, plastics or over-sized materials, except for a few cobble-sized fragments of brick and concrete within the subsoil. | | |

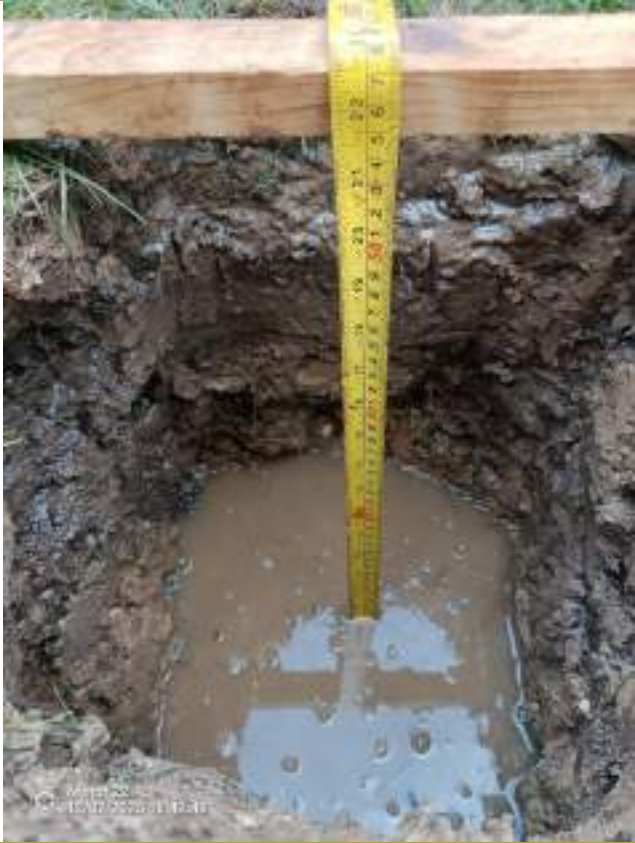
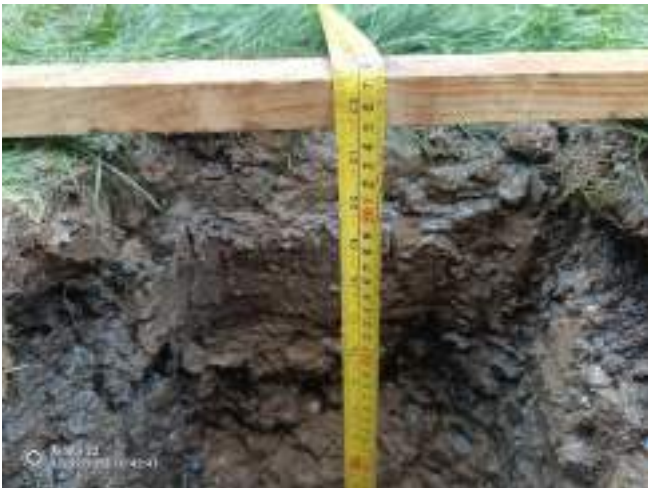
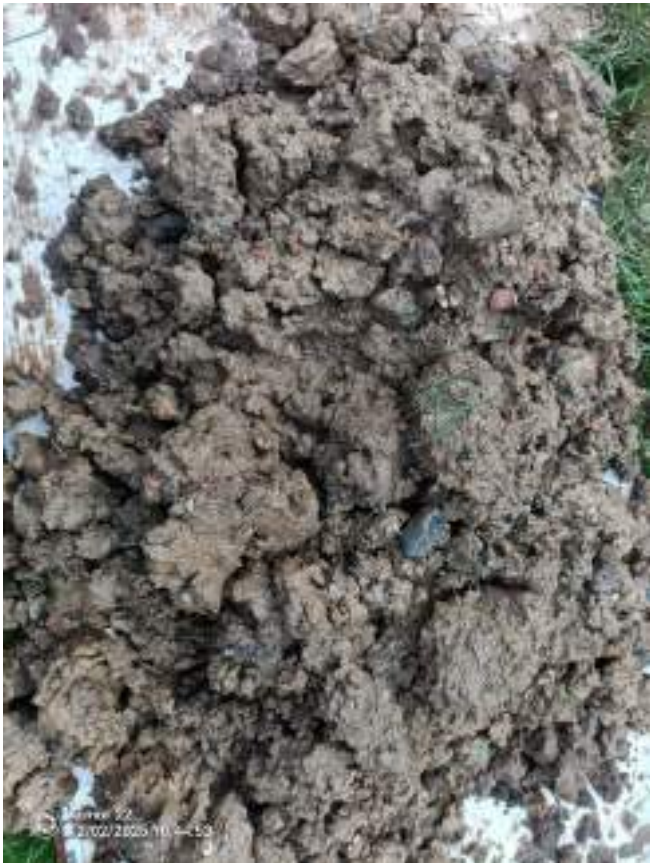
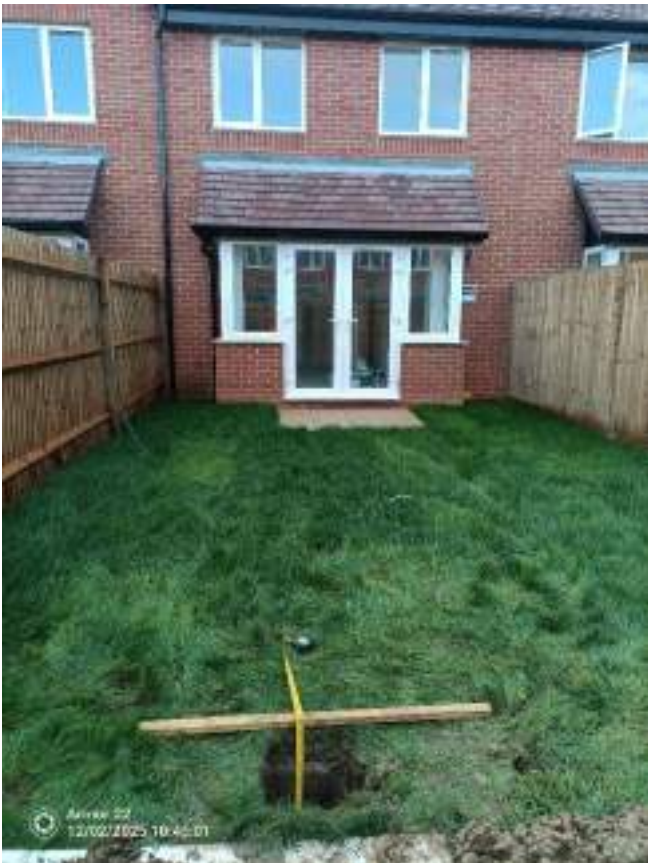
| Physical Suitability | No undesirable or injurious objects were observed within any of the materials inspected, such as sharps, metals, plastics or over-sized materials, except for a few cobble-sized fragments of brick and concrete within the subsoil. | | |

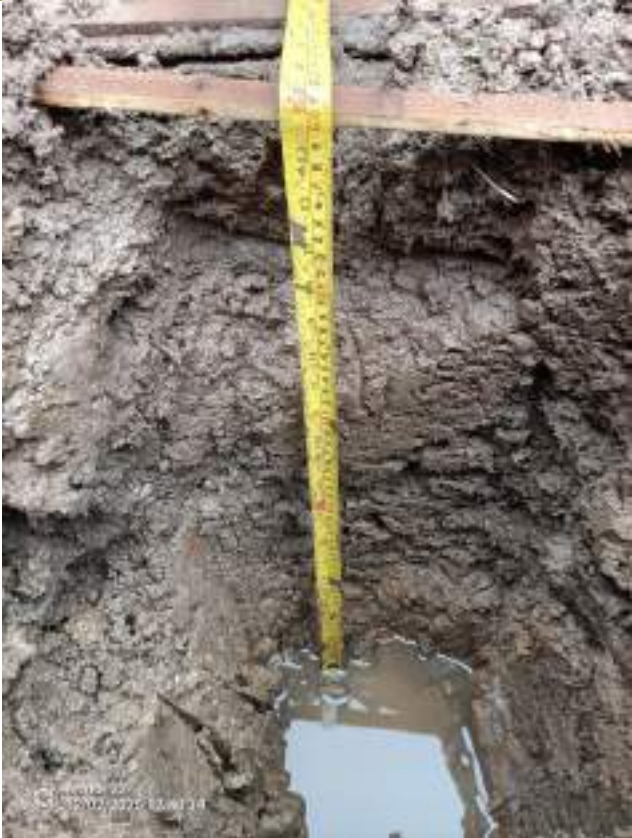
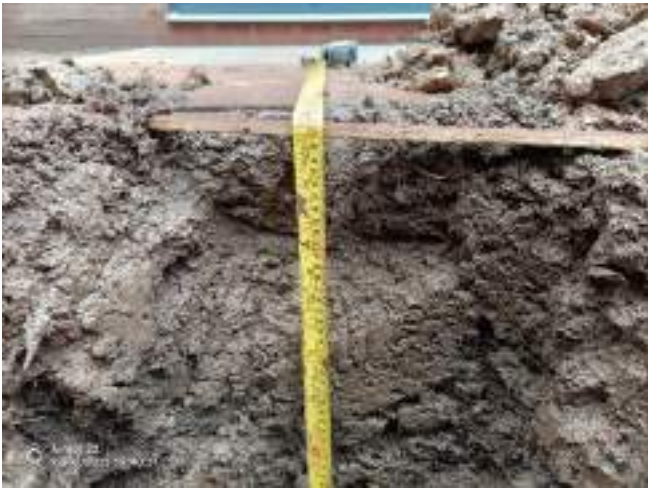
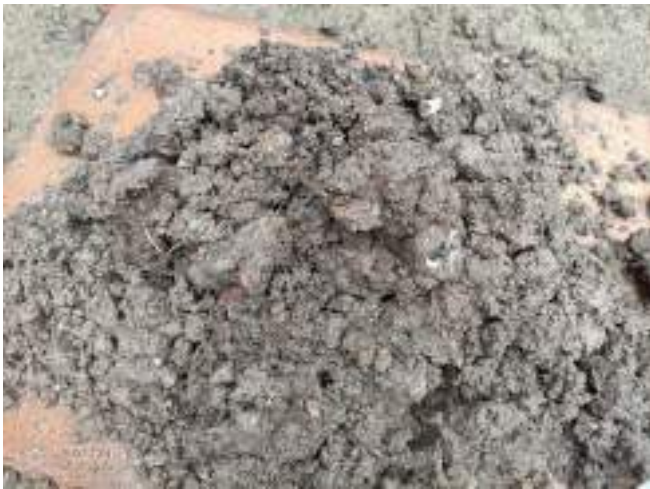
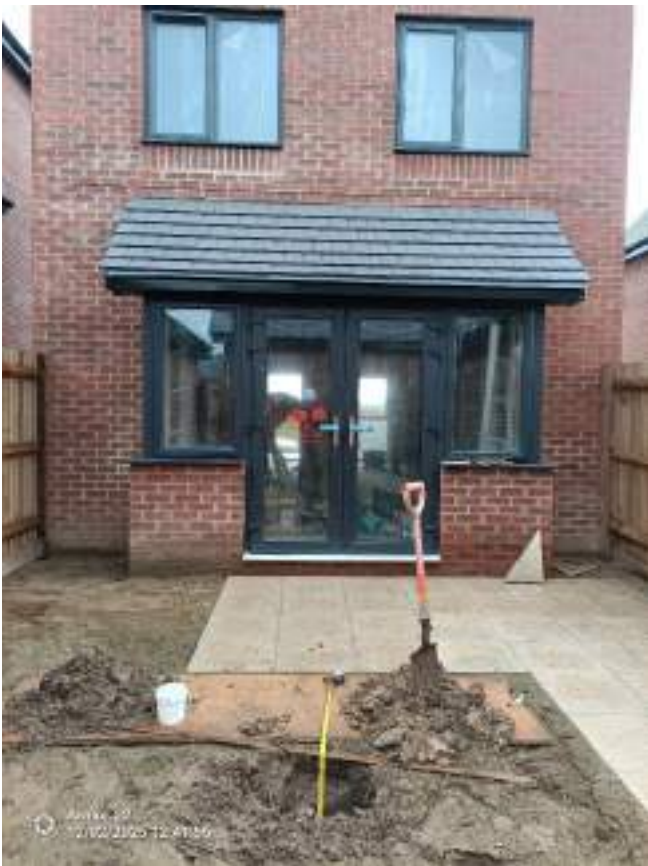
| Physical Suitability | No undesirable or injurious objects were observed within any of the materials inspected, such as sharps, metals, plastics or over-sized materials, except for a few cobble-sized fragments of brick and concrete within the subsoil. | | |

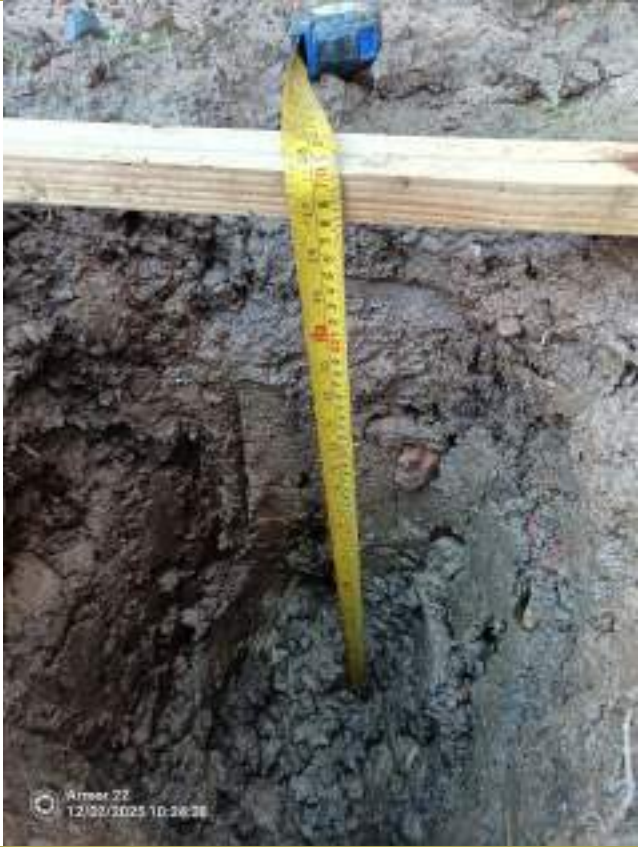
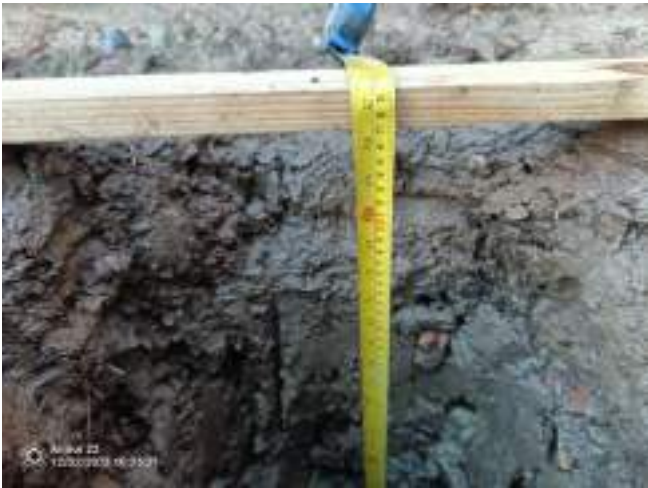
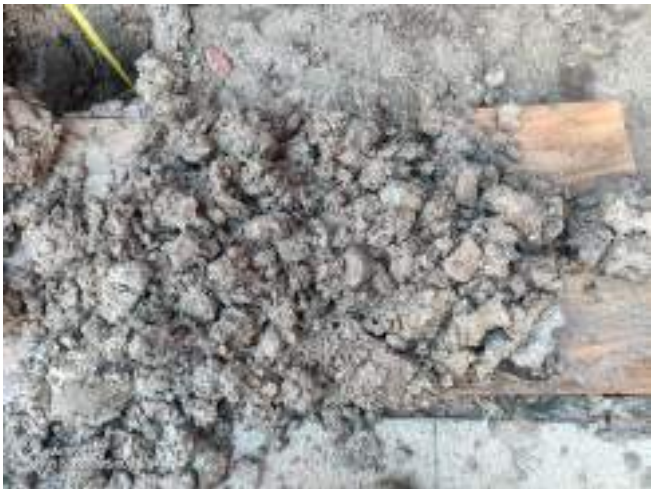
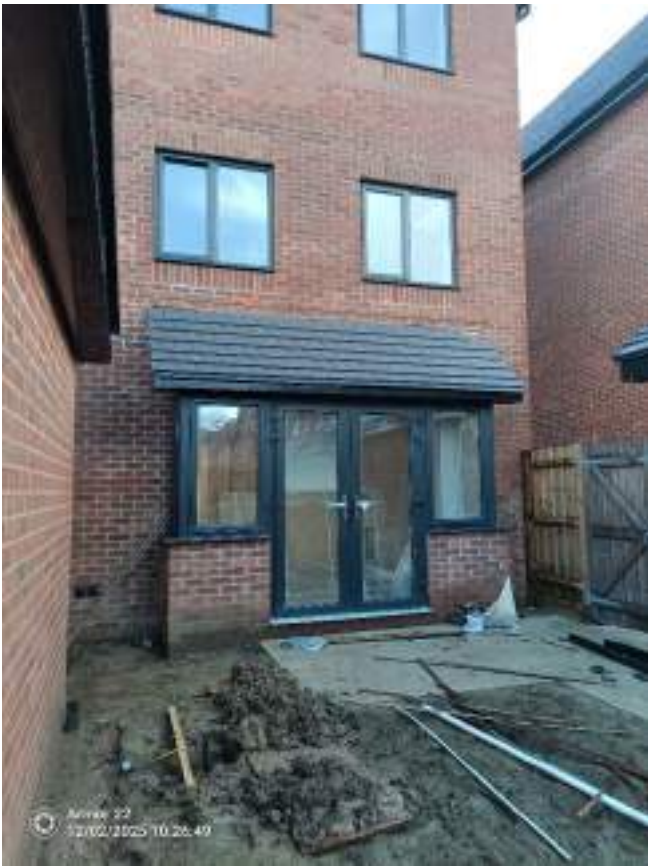
| Physical Suitability | No undesirable or injurious objects were observed within any of the materials inspected, such as sharps, metals, plastics or over-sized materials, except for a few cobble-sized fragments of brick and concrete within the subsoil. | | |

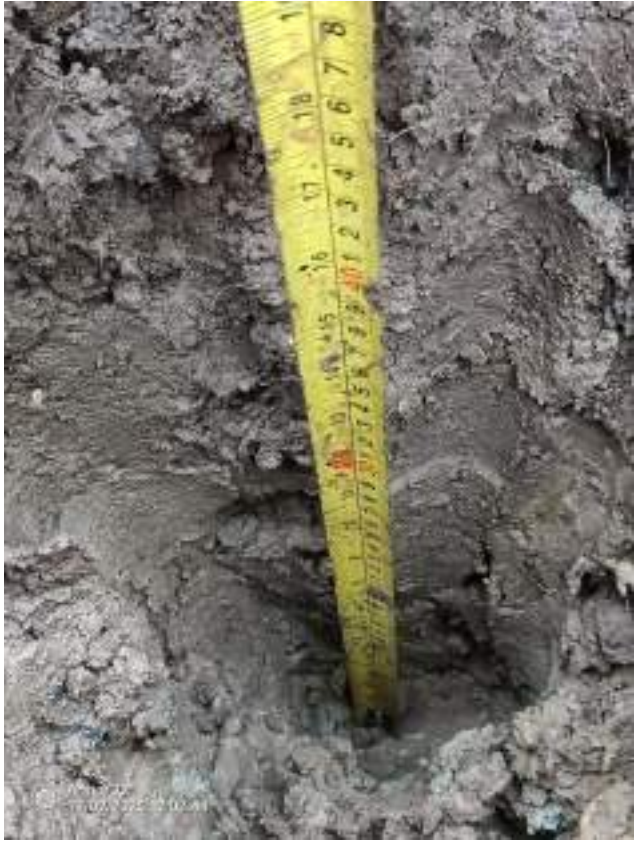
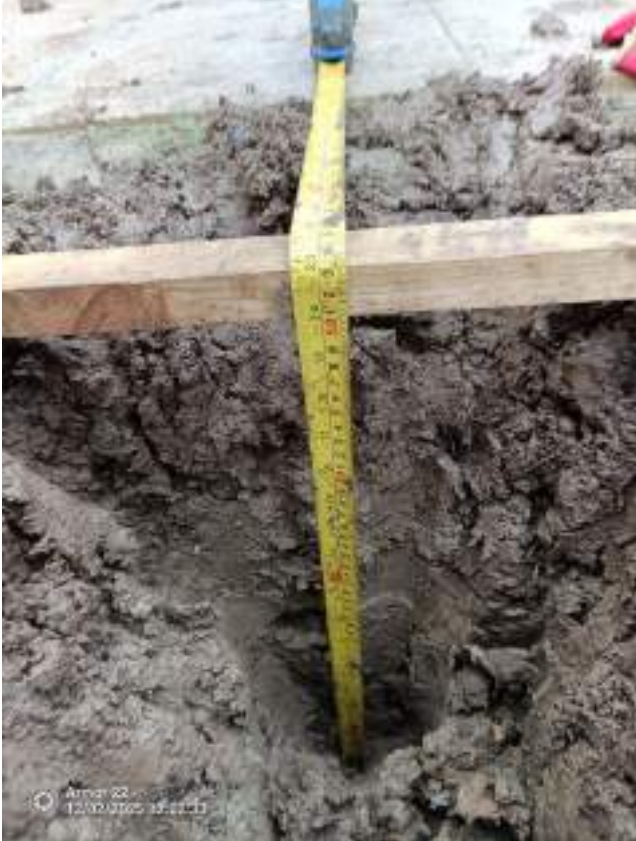
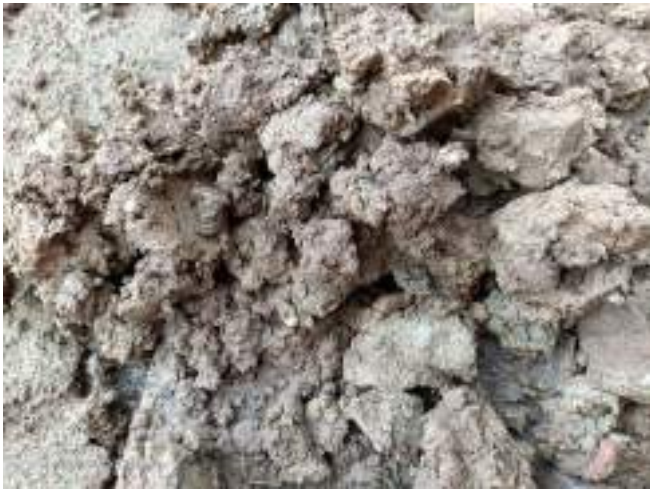
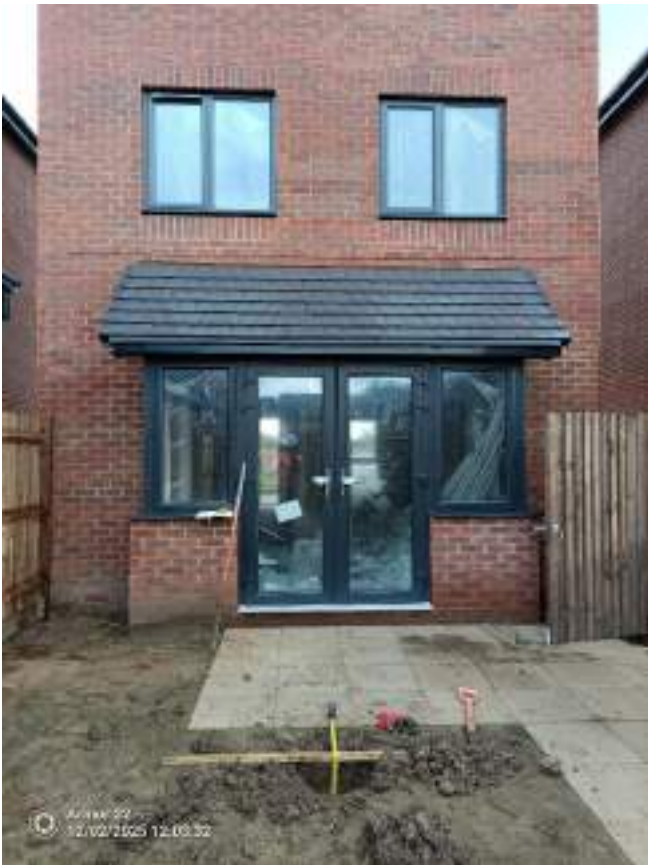
| Physical Suitability | No undesirable or injurious objects were observed within any of the materials inspected, such as sharps, metals, plastics or over-sized materials, except for a few cobble-sized fragments of brick and concrete within the subsoil. | | |

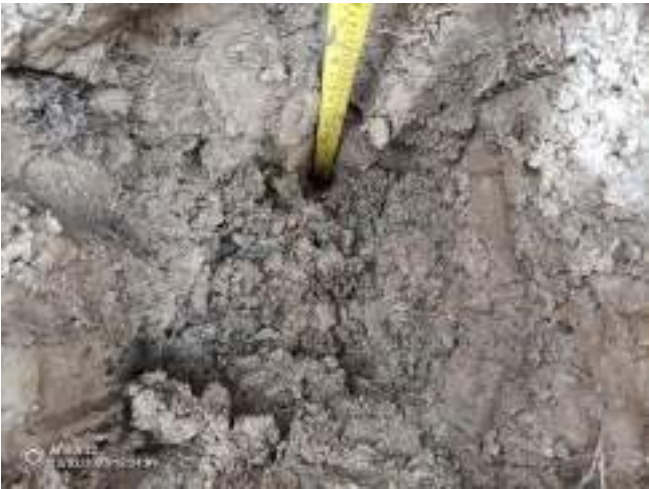
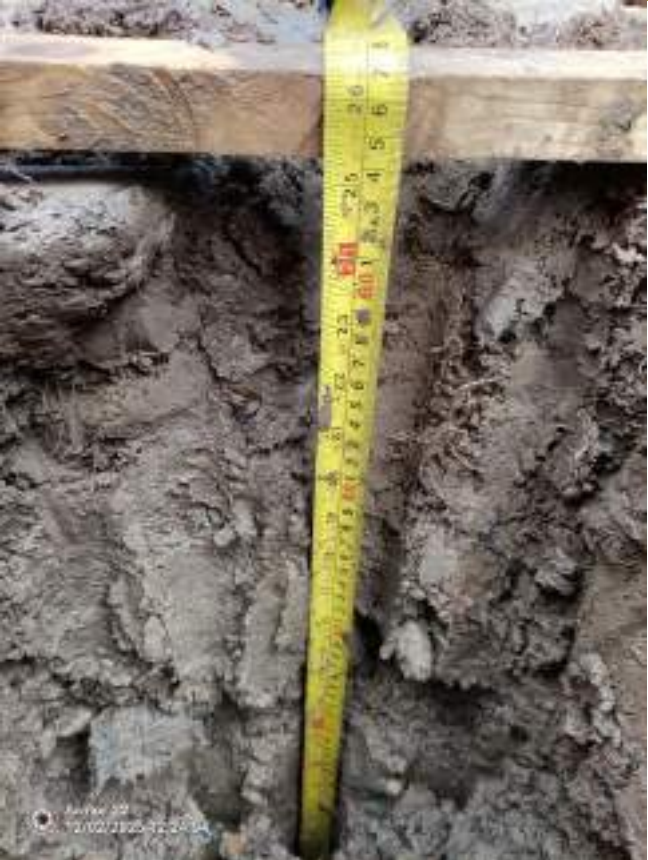
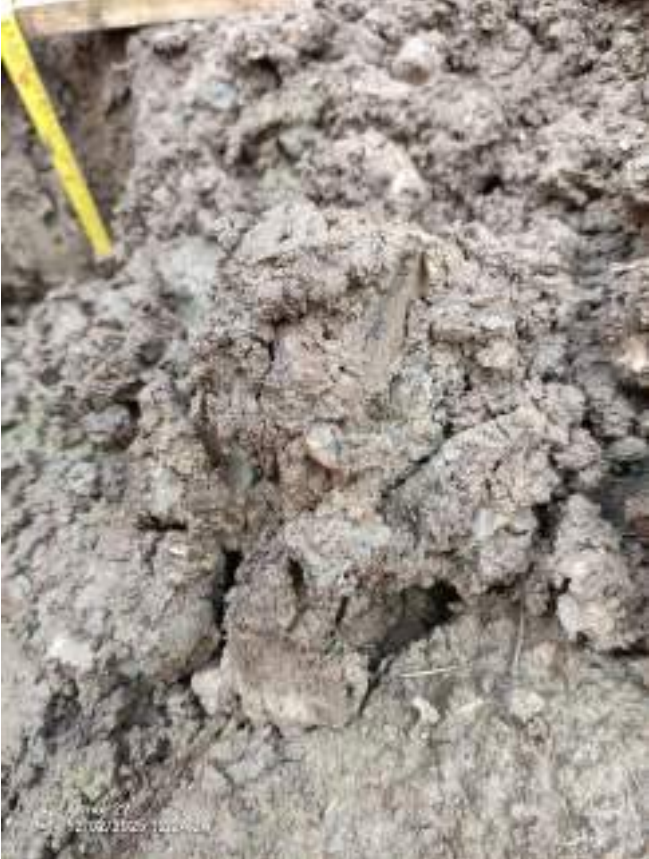
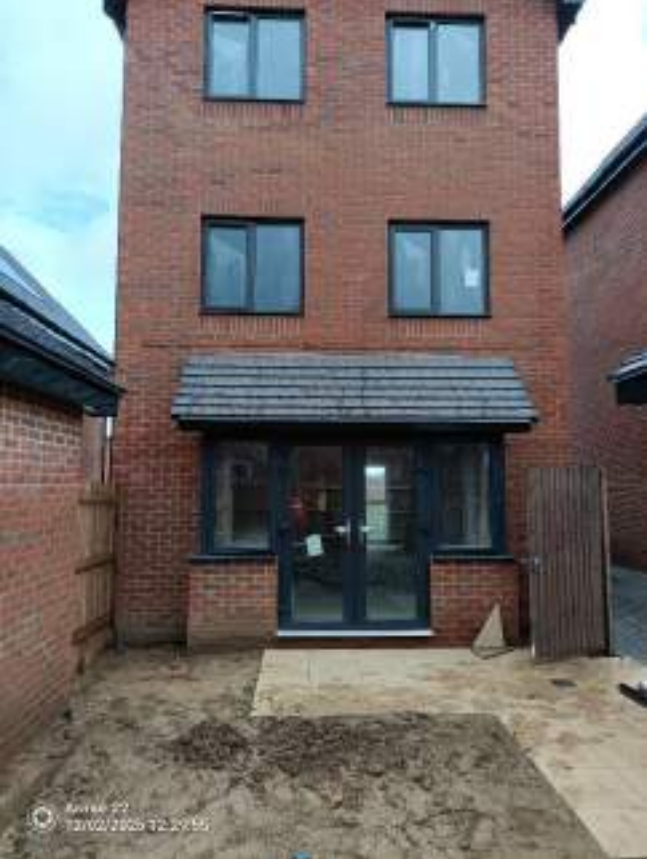
| Physical Suitability | No undesirable or injurious objects were observed within any of the materials inspected, such as sharps, metals, plastics or over-sized materials, except for a few cobble-sized fragments of brick and concrete within the subsoil. | | |
