## Verification Report

Plots 130-139

Barrington Road, Worthing

Site: Barrington Road, Worthing  
Document Title: Verification Report  
Document no.: STV5959-R22-Rev\_A  
Date: October 2025  
Client: Bellway Homes Ltd (South London)  
Issuing office: Soiltechnics Ltd  
Cedar Barn, White Lodge, Walgrave, Northampton. NN6 9PY  
Tel: 01604 781 877 E-mail: [mail@soiltechnics.net](mailto:mail@soiltechnics.net)

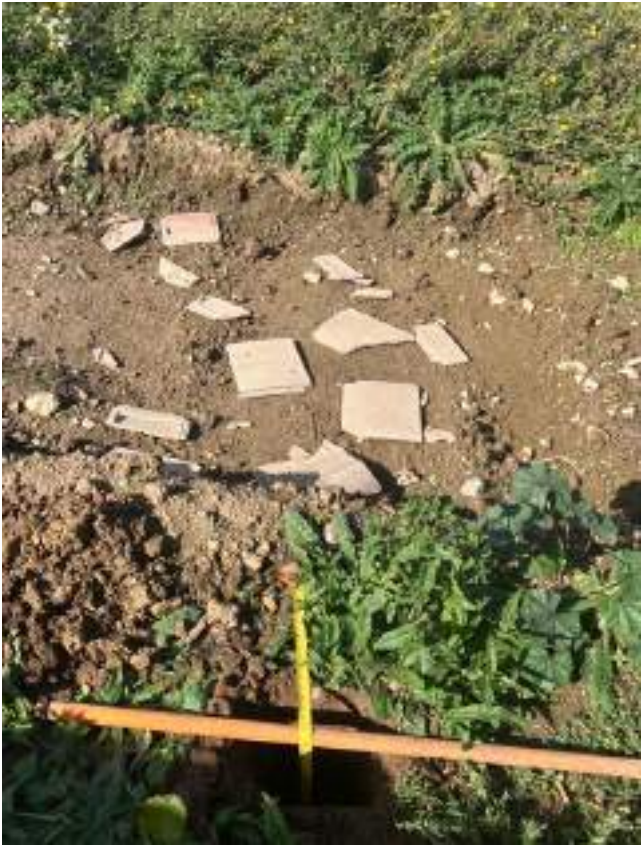
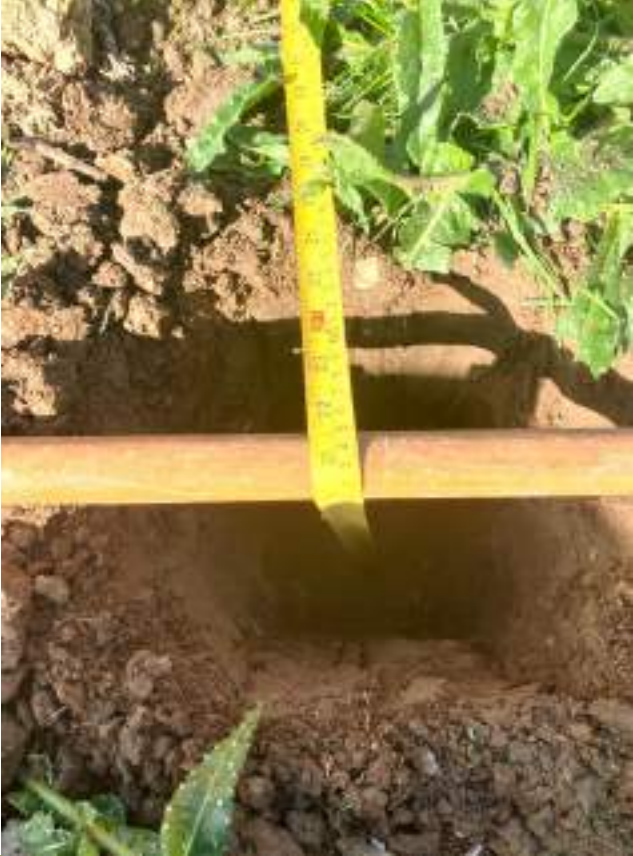
| Conclusion | Site clearance and topsoil finish not complete. At least 500mm of subsoil in place. |

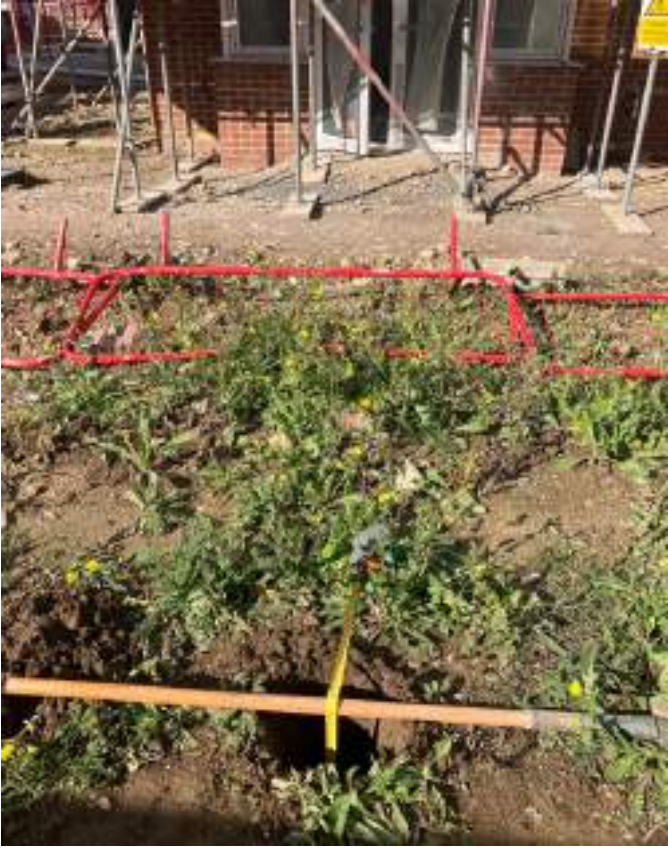
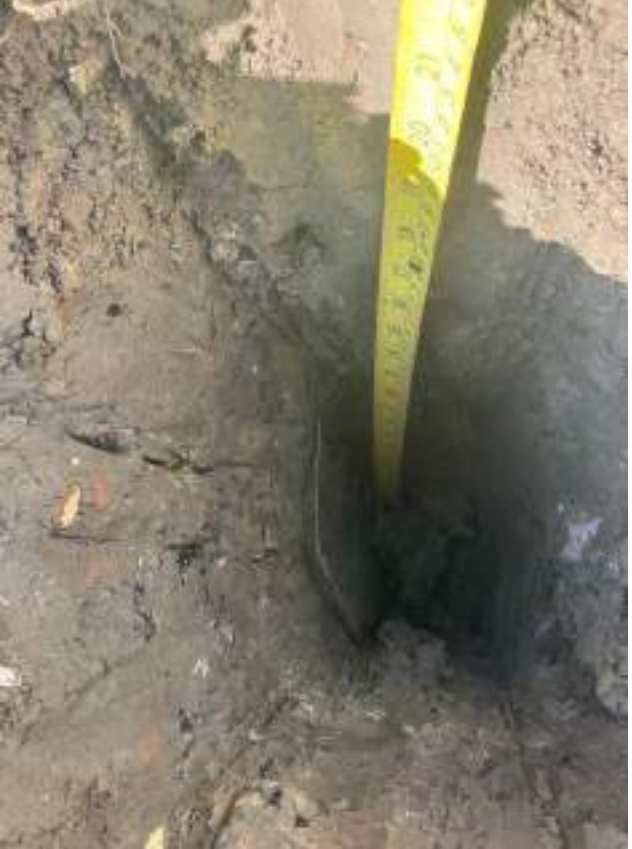
| Conclusion | Site clearance and landscaping unfinished; however, sufficient remedial cover is in place. |

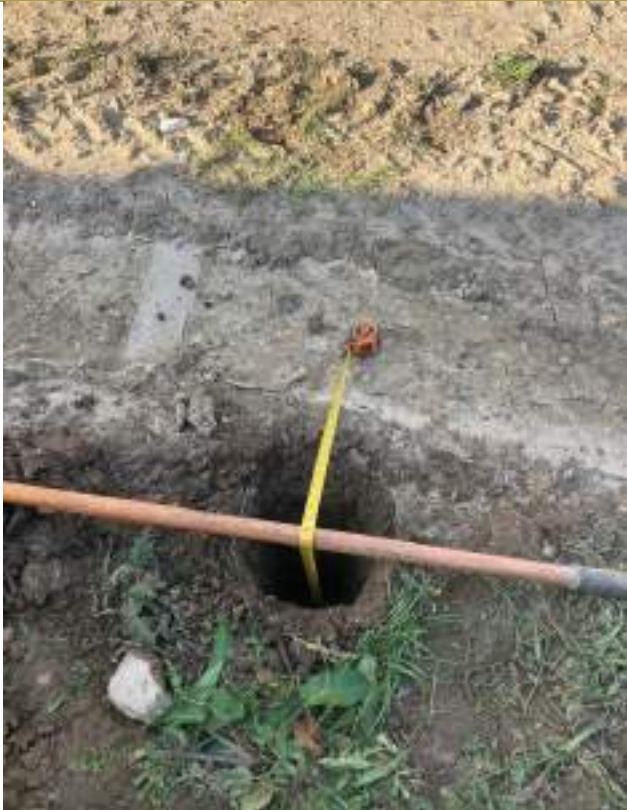
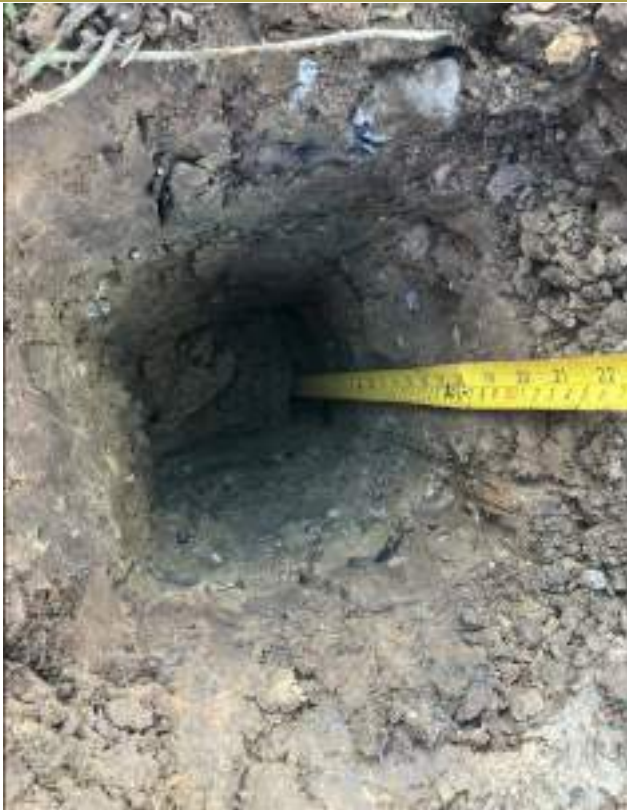
| Physical Suitability | No undesirable or injurious objects were observed within any of the materials inspected, such as sharps, metals, plastics or over-sized materials, except for occasional gravel sized fragments of brick and concrete within the subsoil, and cobble sized fragments at surface. | | |

| Conclusion | Site clearance and topsoil finish not complete. At least 500mm of subsoil in place. |
