**REPORT ON FIRE DAMAGED COTTAGE
AT
THATCHED COTTAGE, POND LANE,
WORTHING, BN13 2RH**

Name of Client: Manorwood

1. INTRODUCTION

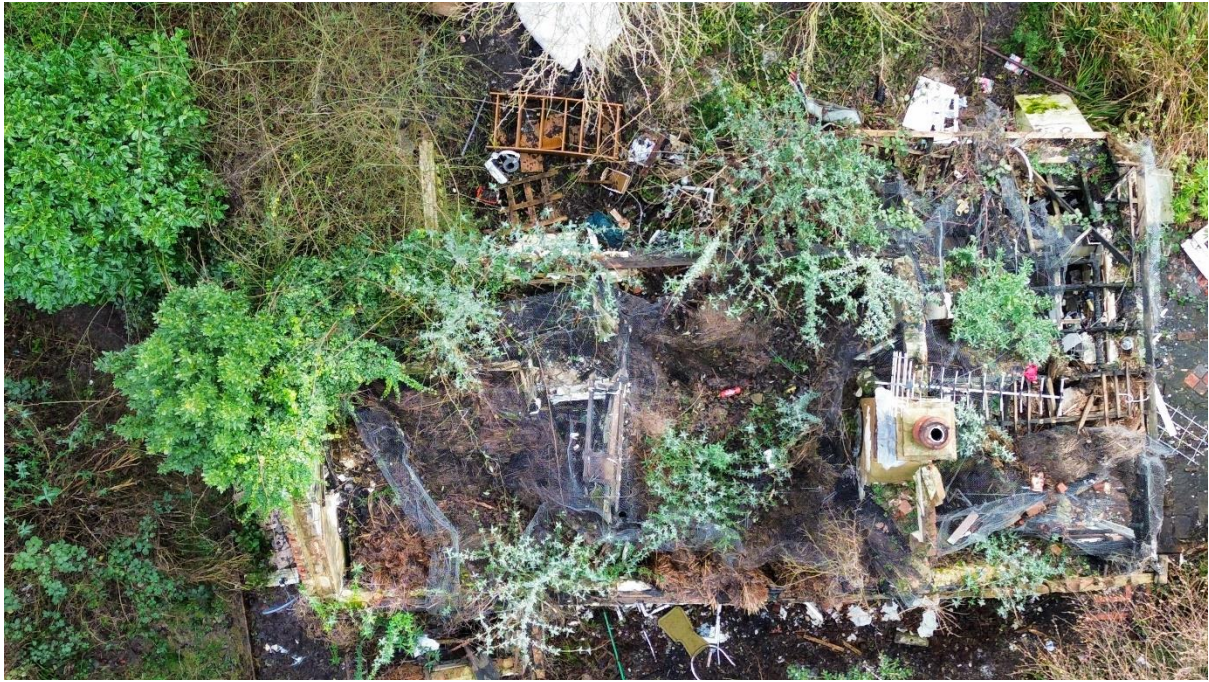
There is significant vegetation growth both within the fire damaged thatch and around the perimeter walls causing structural damage and spalling of the walls.

Photo 1 – Aerial showing vegetation

The first priority is to secure the site and strip all vegetation that is currently growing either in or on the property to prevent further damage to the structural fabric.

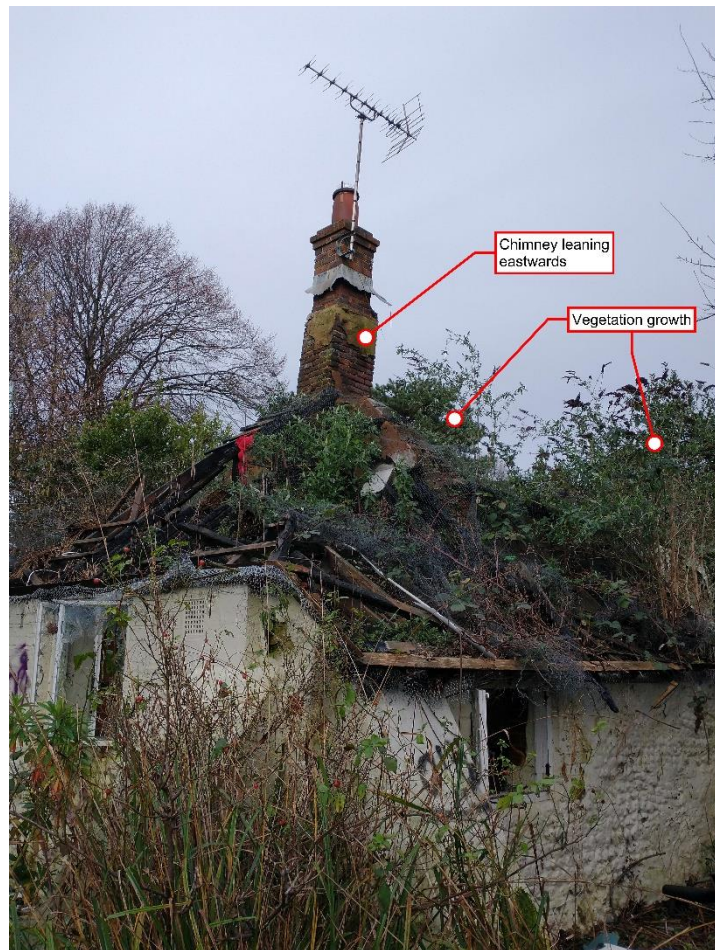
The chimney to the south gable is in very poor repair and is potentially unstable with a noticeable and significant lean to the east.

Photo 2 – Chimney 1

We would recommend that the chimney be carefully taken down to the top of the gable wall level and the brickwork set aside for reconstruction before any attempt at internal strip out is commenced or it be restrained in its current position with a structural scaffold. The latter appears to be excessive given it will need to be dismantled and rebuilt at some time as part of the works to the building.

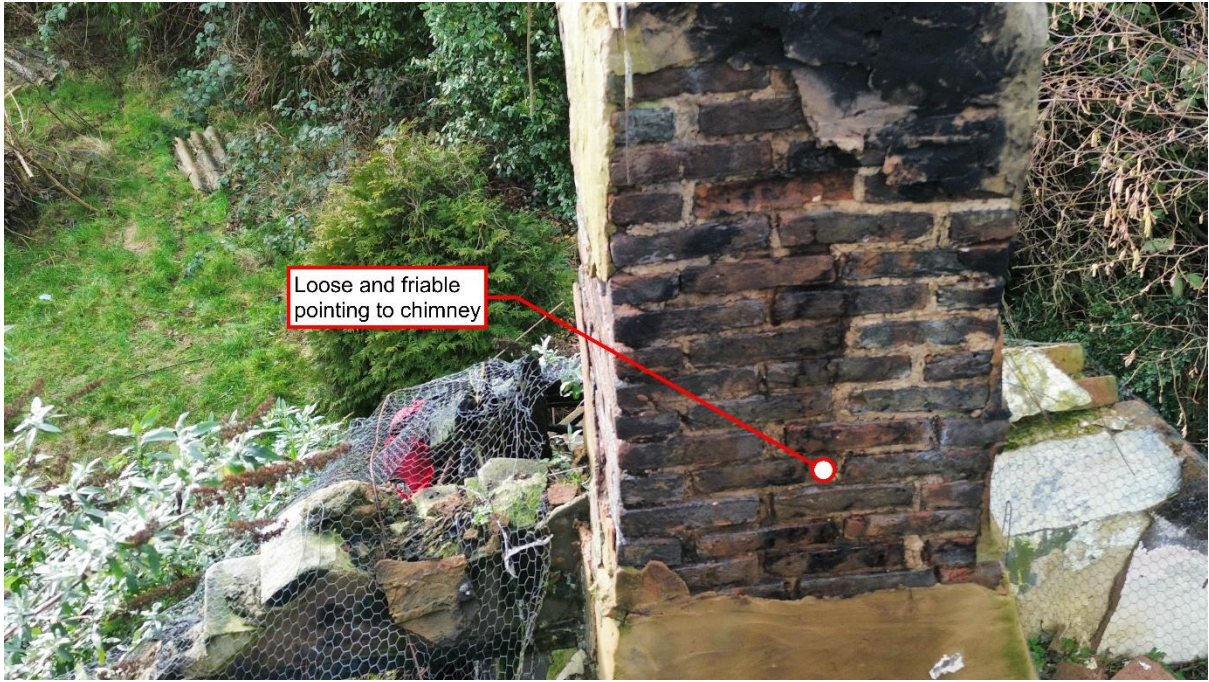
Loose and friable
pointing to chimney

Photo 3 – Chimney 2

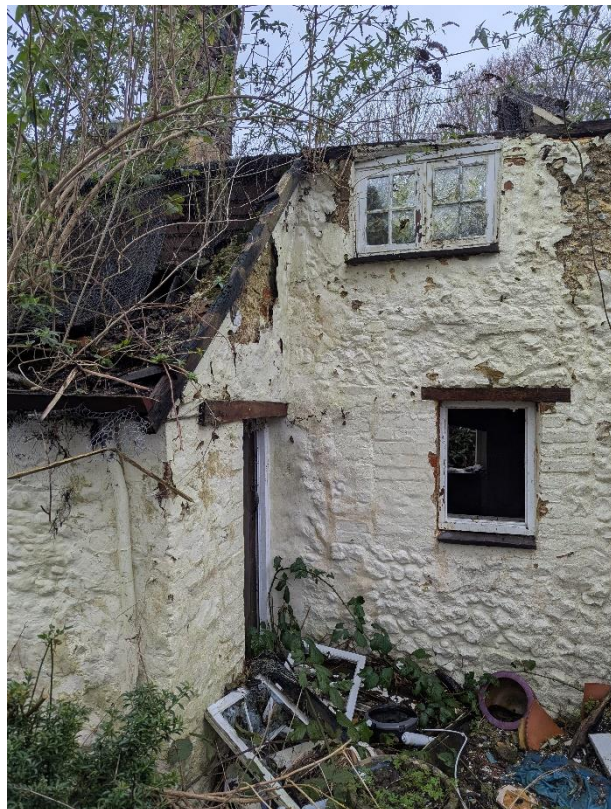
The external masonry fabric of the building would appear to be in a reusable condition and there does not appear to be any significant indication of thermal shock to the building on the exterior walls.

Photo 4 - External wall condition 1

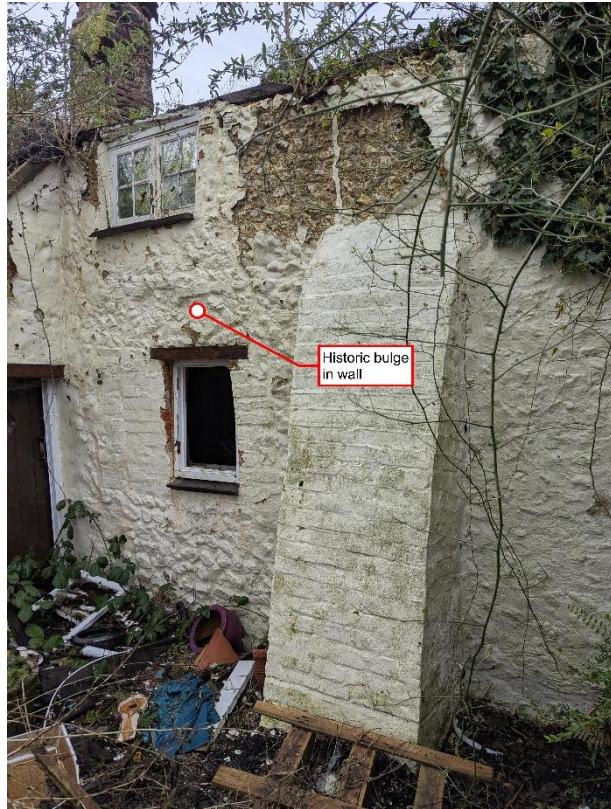
Photo 5 - External wall condition 2

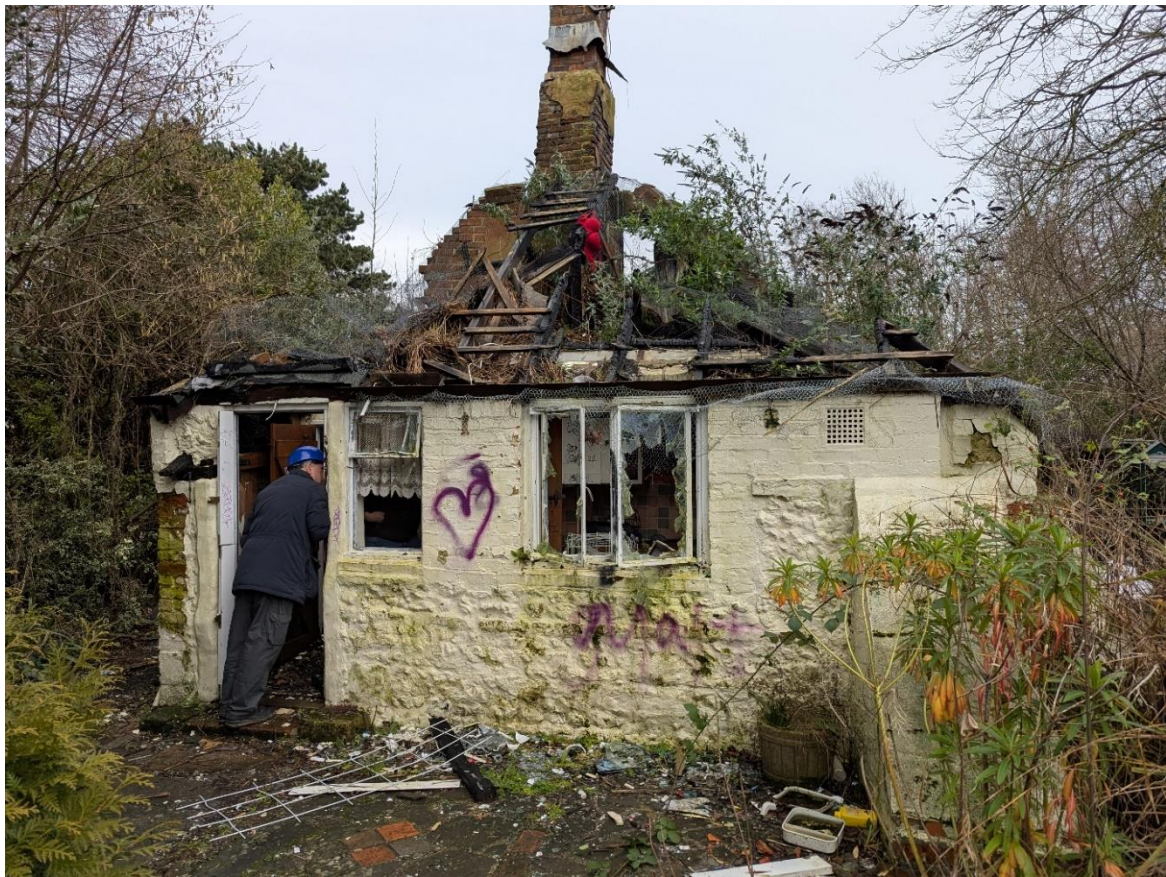
Photo 6 – External wall condition 3

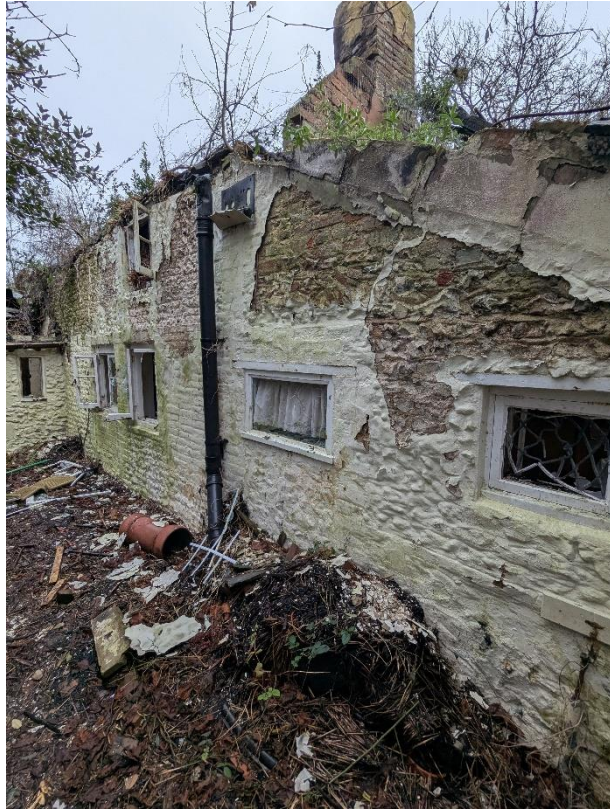
Photo 7 - External wall condition 4

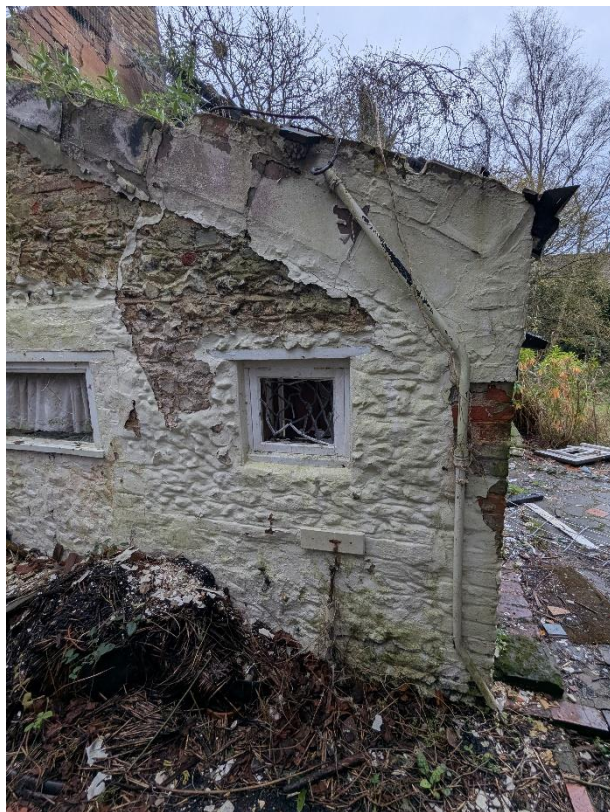
Photo 8 - External wall condition 5

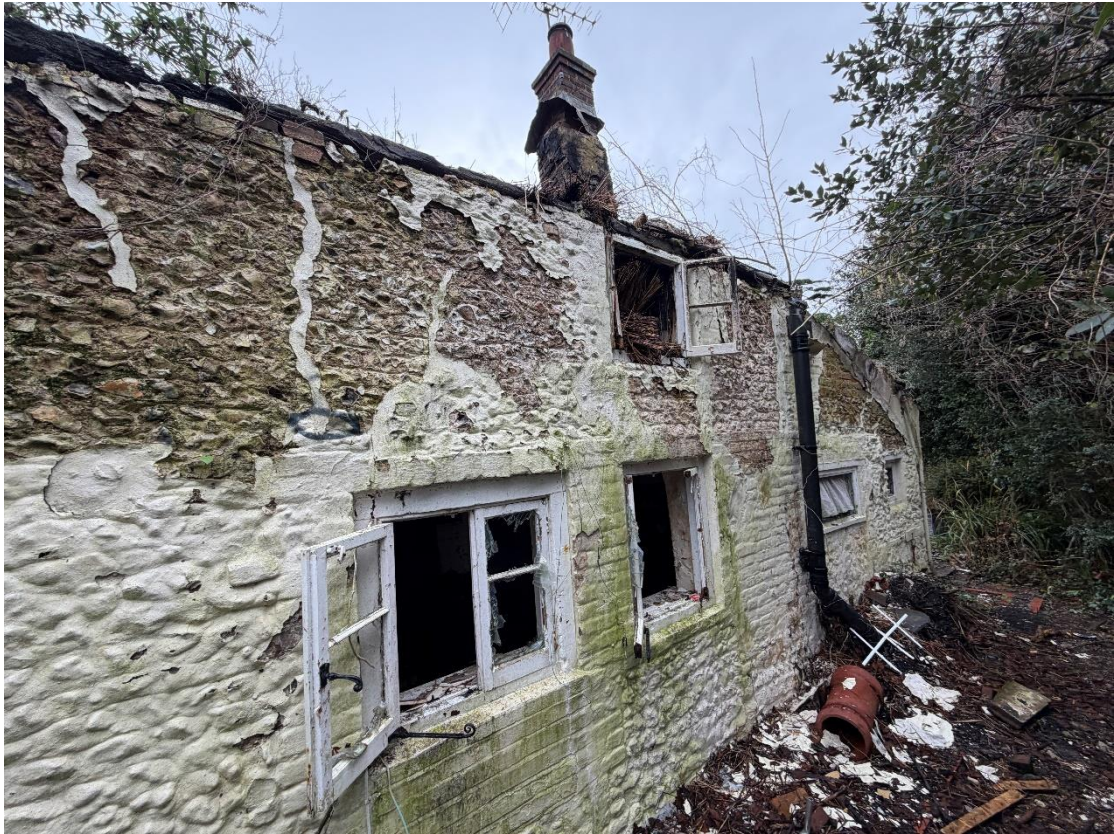
Photo 9 - External wall condition 6

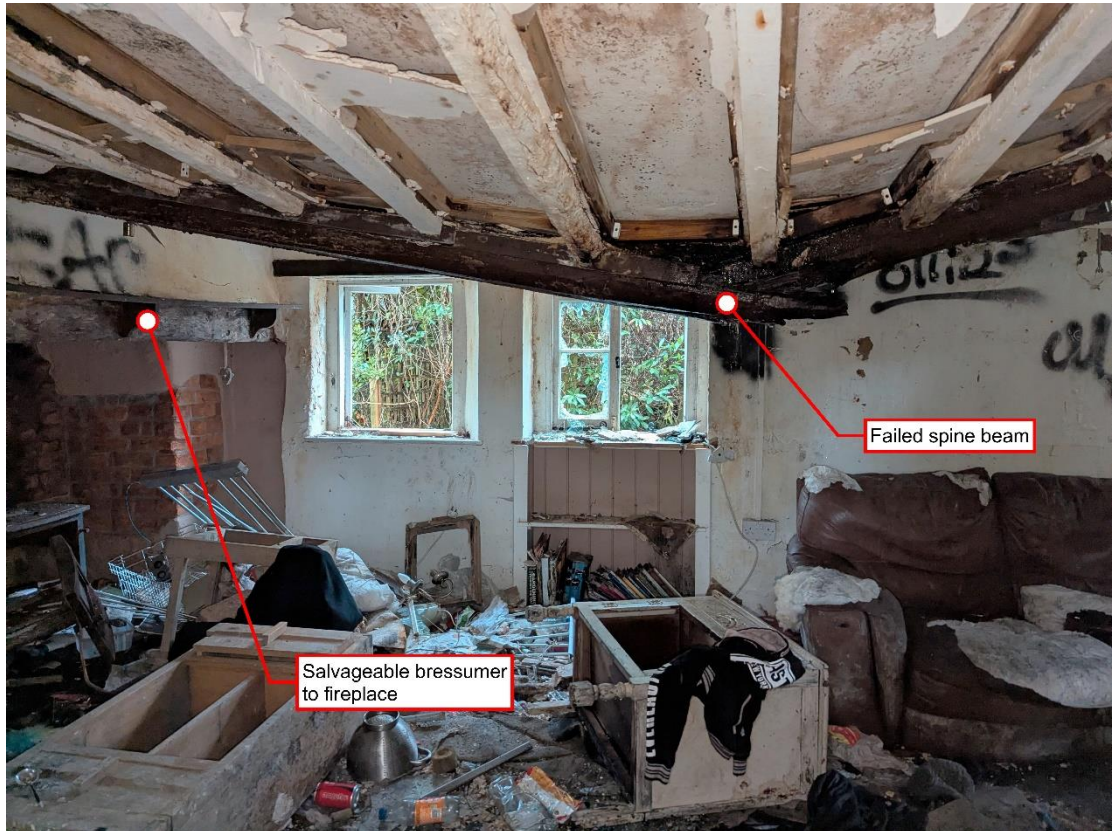
The main spine oak beam that supports the existing first floor joists has structurally failed under the weight of saturated thatch and is not salvageable, nor are many of the accompanying floor joists, and these would need to be removed as part of the soft internal strip out.

Photo 10 – Failed spine beam

The remnants of rafters, the first floor structure and the remaining saturated thatch needs to be removed and carted away, except for those areas of the first floor structure noted above that could potentially be set aside for reuse.

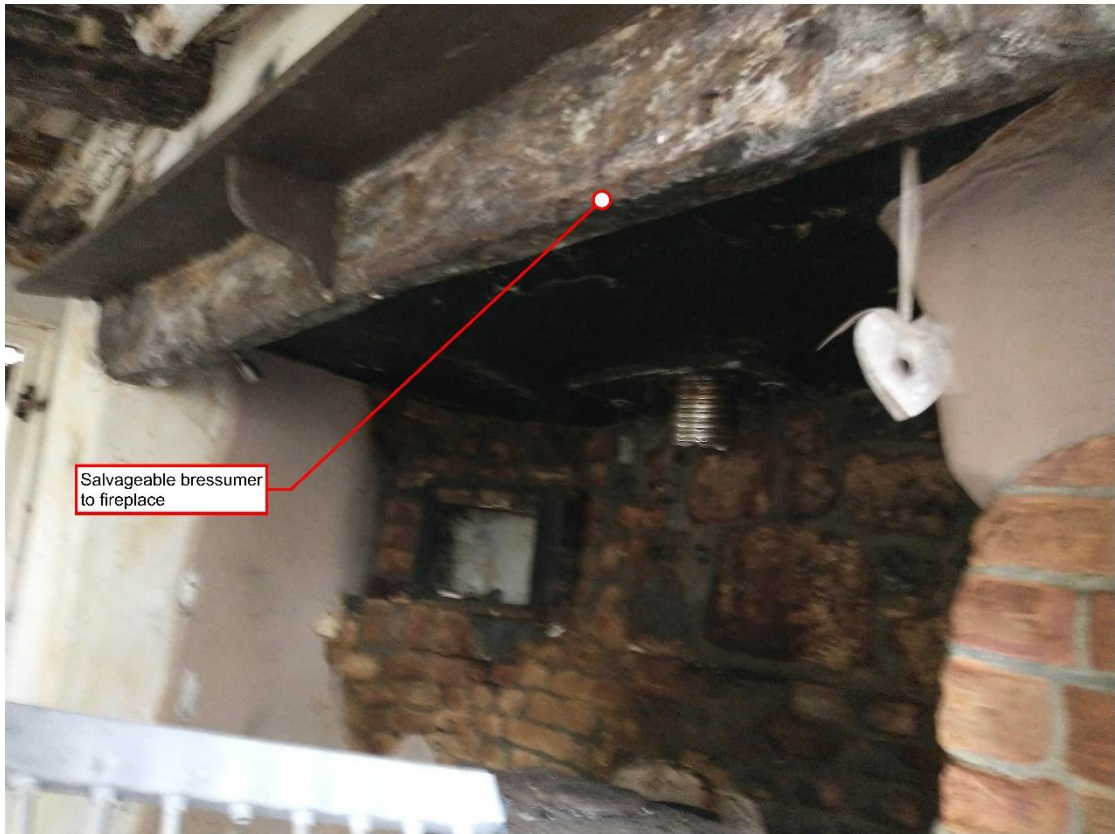
The oak bressummer over the fireplace/bread oven appears to be in reasonable condition and can remain in-situ. The masonry of the fireplace itself below first floor level also appears sound.

Salvageable bressumer
to fireplace

Photo 11 – Fireplace bressumer

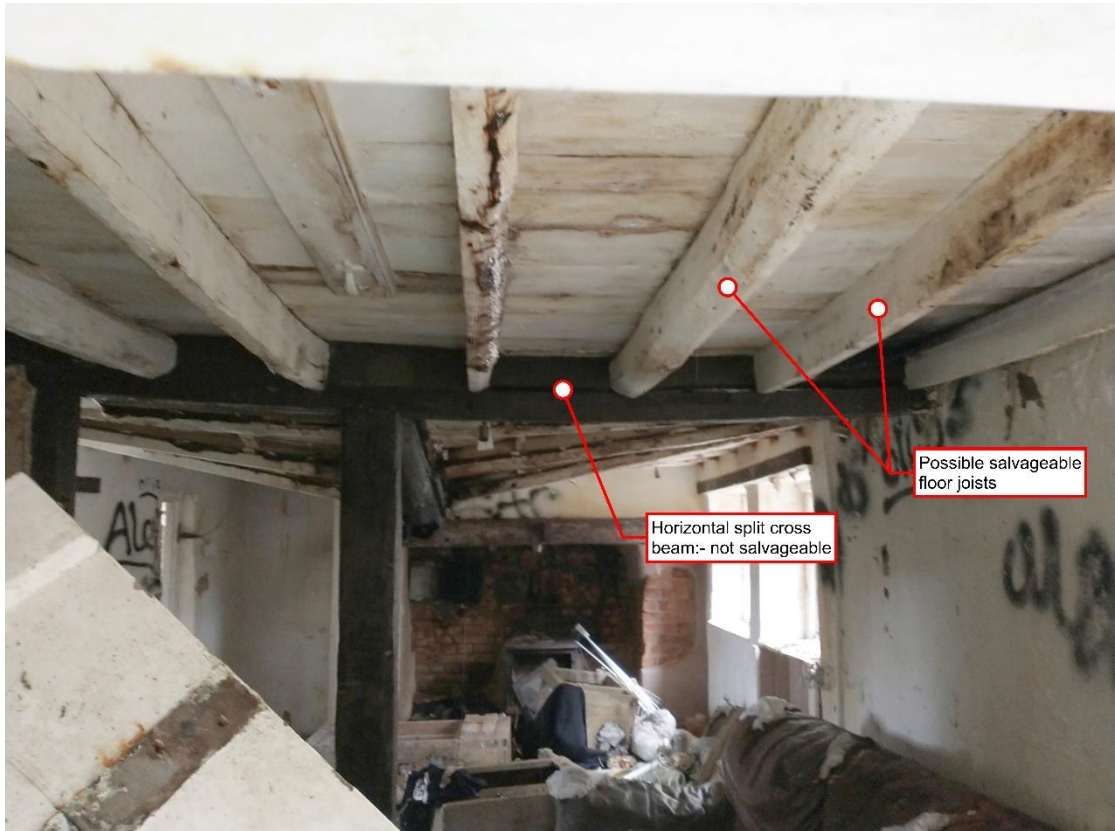
The Oak cross beam that spans onto the internal post has also split along its length and is not in a re-usable condition

The main support post that supports the failed spine beam and failed cross beam would also appear to be in reasonable condition and can be reused, and some of the first floor joists that span from the northern gable across the entrance lobby, could also potentially be salvaged and reused further to closer inspection and/or drying out.

Horizontal split cross
beam:- not salvageable

Possible salvageable
floor joists

Photo 12 – Internal view 1

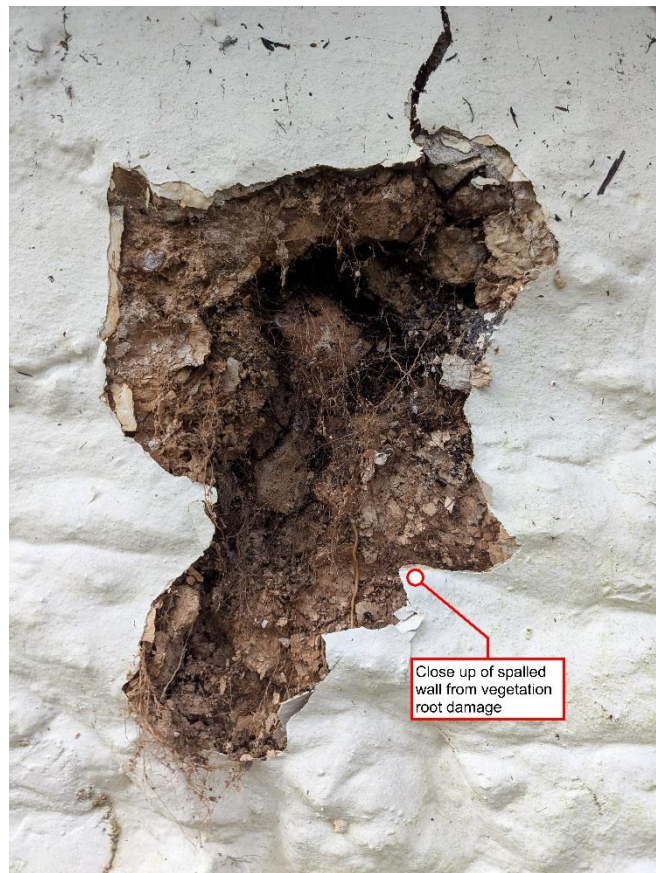
Photo 14 – Vegetation damage close-up

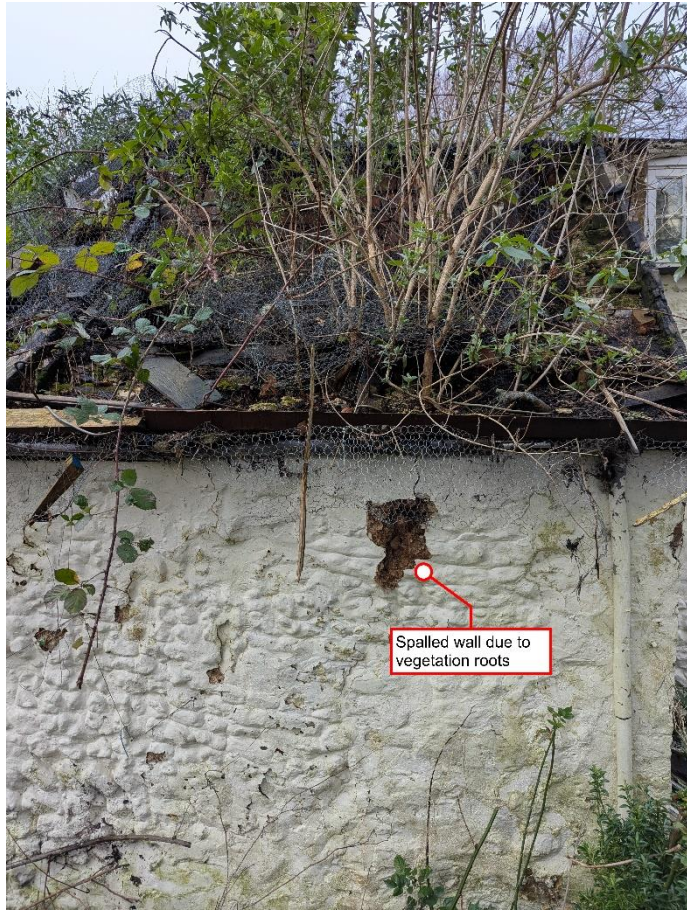
Photo 15 – Vegetation damage
