## **Natwest Group – Capital Investment Programme (CIP)**

**Natwest Worthing  
27 South Street  
Worthing  
BN11 3AR**

### **Photographic condition report**

Reference: 26-017-BS-R

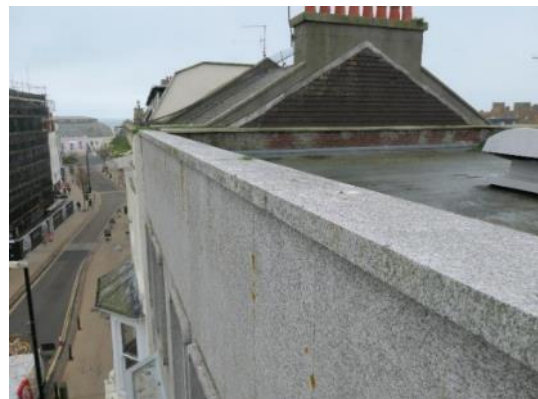
**Photograph A – Coping stones to main roof**

- 3.2 Concerns are raised regarding the condition of the granite coping stones surmounting the parapet walls on the front and side elevations – Photograph A. The former poses a risk of falling masonry on the public thoroughfare beneath, meaning it is imperative measures be taken to ensure the copings are adequately supported.

Re-bedding is recommended at the same time as any future refurbishment of the front elevation to ensure adequate protection is maintained in the long term.

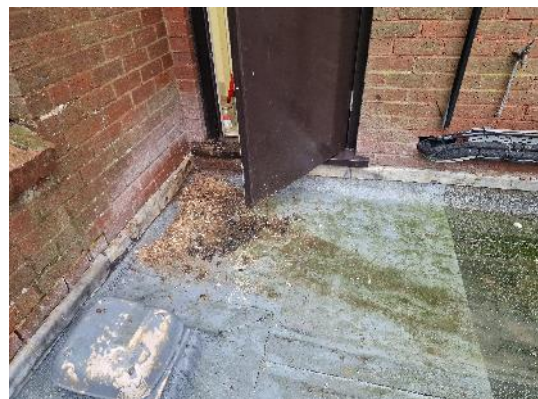
**Photograph B – Rear flat roof**

- 3.4 Both roofs were found to be exhibiting a number of defects, with evidence of reactive patch repairs have been undertaken previously and moisture ingress visible within the internal accommodation beneath – Photographs B, 14 15, 16, 17 & 18.

- 3.5 The level of degradation identified and the evidence of moisture ingress internally indicates that extensive failure is imminent – estimated to be within the next 12 months.

- 3.6 Based on the overall poor condition of the felt and the level of moisture ingress visible internally, it is recommended the roofs be refurbished in their entirety. Should a decision be made to proceed with full refurbishment, insulation will need to be introduced to improve thermal performance and ensure compliance with Part L of the Building Regulations.
- 3.7 In addition to the poor condition of the flat roof covering, concerns are also raised regarding the height of edge protection to the lower flat roof. The parapet wall extends approximately 840mm in height, posing a risk of falling. It is therefore recommended edge protection be installed to ensure compliance with Part K of the Building Regulations and the Work at Height Regulations 2005.

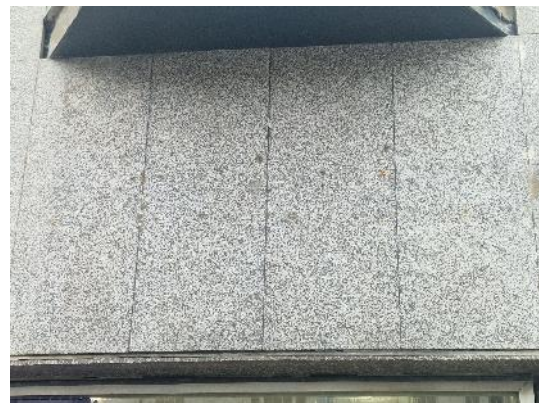
**Photograph C – Granite cladding to front elevation**

- 3.8 The building is concrete framed and finished with hewn granite cladding panels to the front elevation. Each panel is known to have a nominal dimension of approximately 550mm (w) x 1500mm (h) x 35mm (d). Concerns have been raised regarding evidence of displacement and the associated risk to posed to users of the public pavement beneath (photograph 1).
- 3.9 Photograph C shows the panels are principally butt jointed, albeit a white jointing material – possibly cementitious, has been used and found to be spalling excessively.

The fixing methodology of the cladding could not be ascertained at the time of the survey. Although it is understood investigations have been carried out previously by others, the exact fixing methodology is unknown, deemed likely to be combination of mechanical and chemical connections.

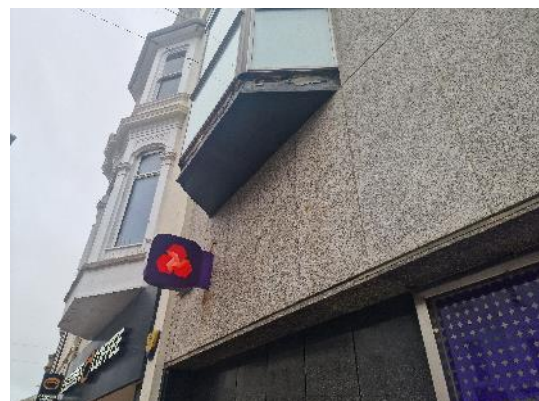
**Photograph D - Cladding**

- 3.10 Photographs D & 3 show slight evidence of distortion on the front elevation, with mis alignment indicating possible failure of fixings.

Previous investigations indicate phosphor-bronze tie wires are chemically bonded back to the concrete frame, with panels supported off shelf angles at each storey level. Movement in the tie wires and/ or angle connections would result in displacement, but would require further intrusive investigations to establish the exact condition.

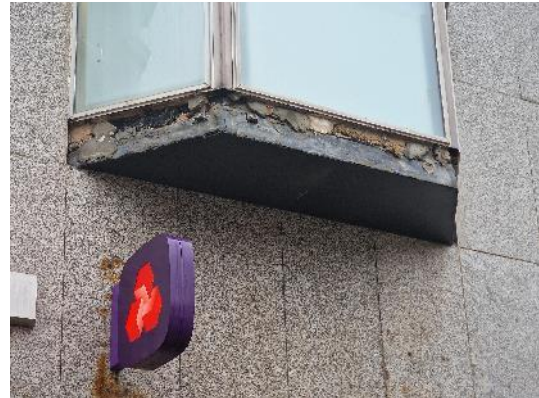
**Photograph E – Removed cladding to foot of bay window**

- 3.12 Photograph E illustrates sections of the cladding have been purposefully removed, envisaged to mitigate the risk of falling masonry (photograph 4).

Given the risk, it is recommended that all sections be either re-fixed, or replaced with an alternative construction detail to ensure adequate support is maintained in the long term.

Replacement options include; rendering, high pressure laminate (HPL), polyester powder coated cladding.

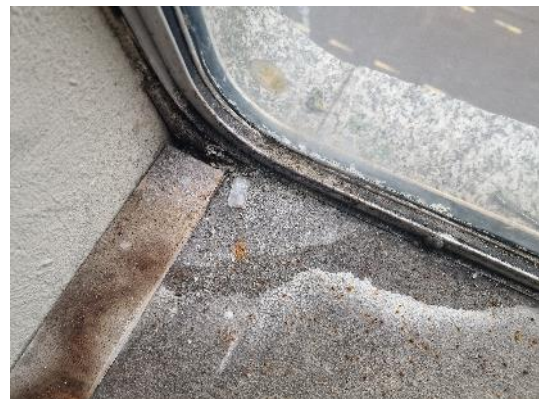
**Photograph F – Typical window to front elevation**

- 3.15 As described previously, mastic sealant applied to the perimeter of the window frames has failed, posing a risk of moisture ingress that was visible in areas – Photographs F & 9.

Openers were also found to be fixed shut and where operable, pose a risk of falling debris on the public thoroughfare beneath. Replacement of the bay windows is required at the same time as failed cladding, possibly introducing polyester powder coated panelling as described previously.

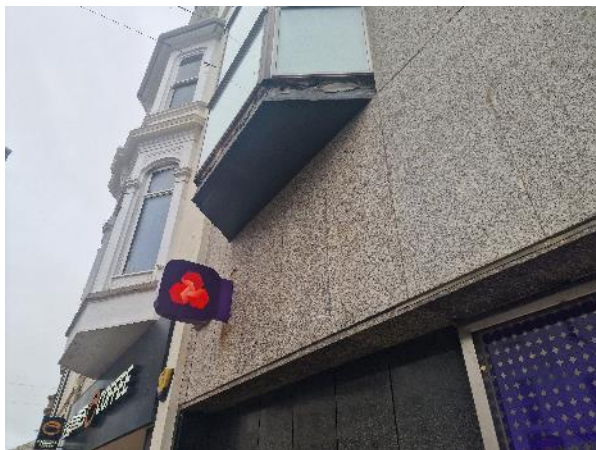
3. Granite cladding to front elevation

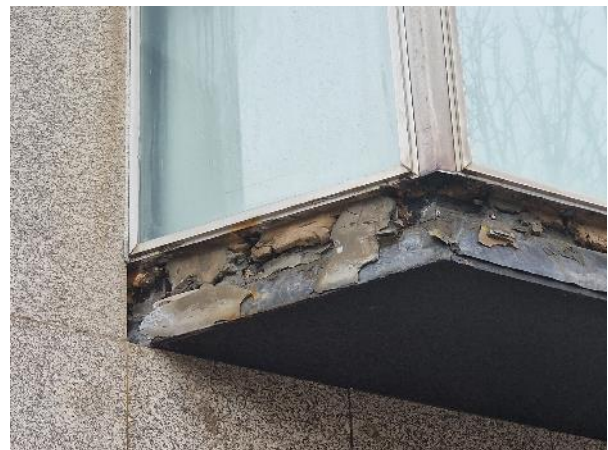
4. Defective cladding to bay windows

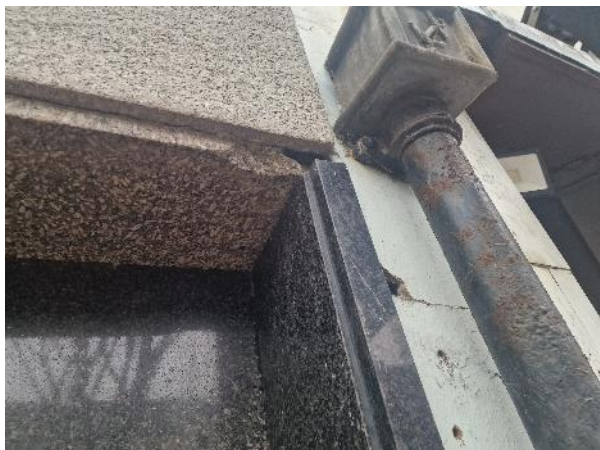
5. Damaged cladding at ground level

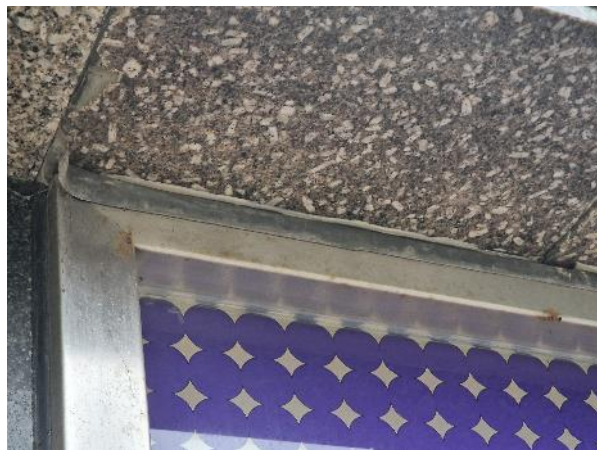
6. Degraded sealant to window frames

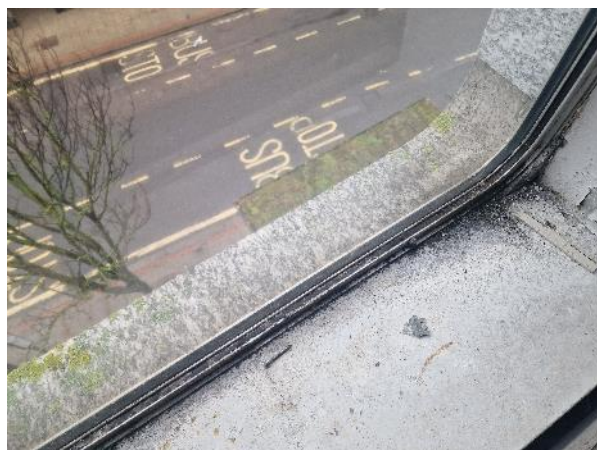
- 3.14 The windows to all elevations of the building are manufactured from extruded aluminium frames and were generally, found to be in poor condition. Windows of this type are thermally inefficient, suffering from cold bridging, that results in mould growth associated with condensation (photographs 8 & 13).

8. Degraded sealant to window frames

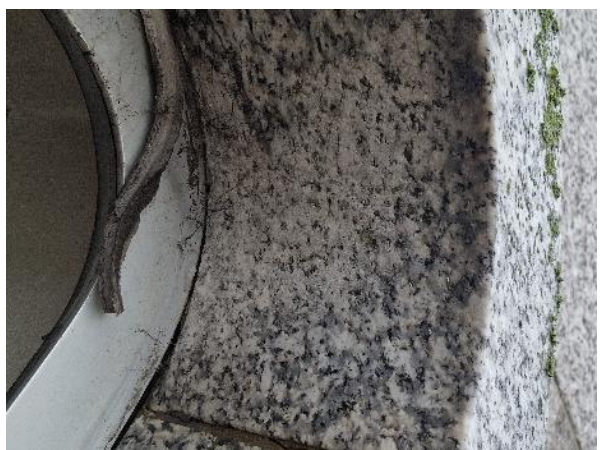
9. Degraded sealant to window frames

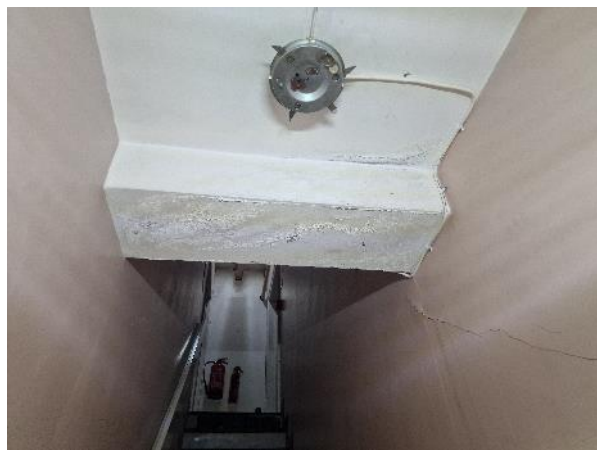
10. Evidence of moisture ingress internally

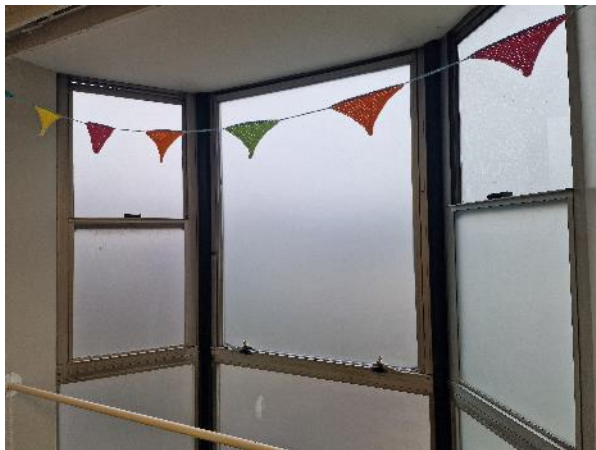
13. Bay window

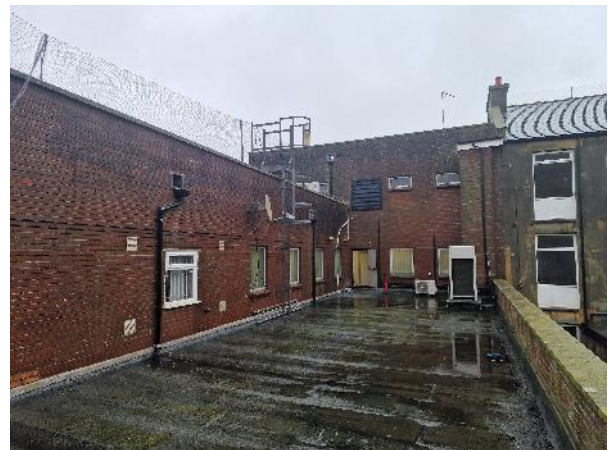
14. Lower flat roof to rear

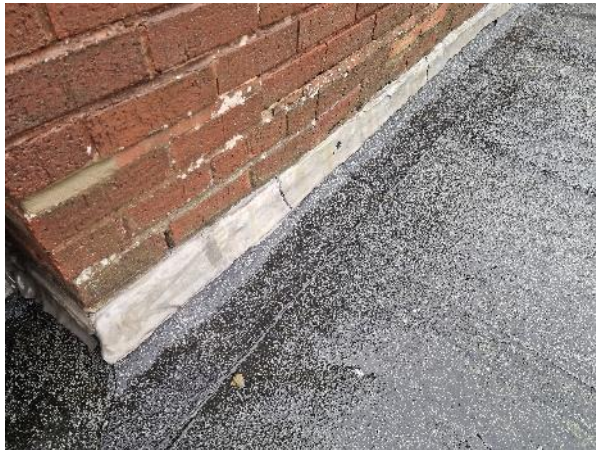
15. Poor flashing detail to lower flat roof

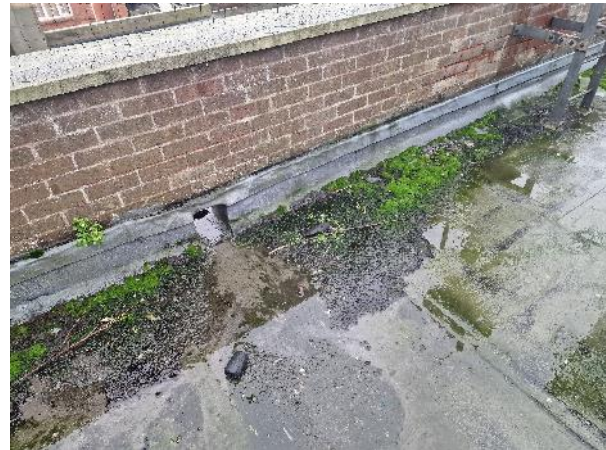
16. Upper flat roof – Roof 2

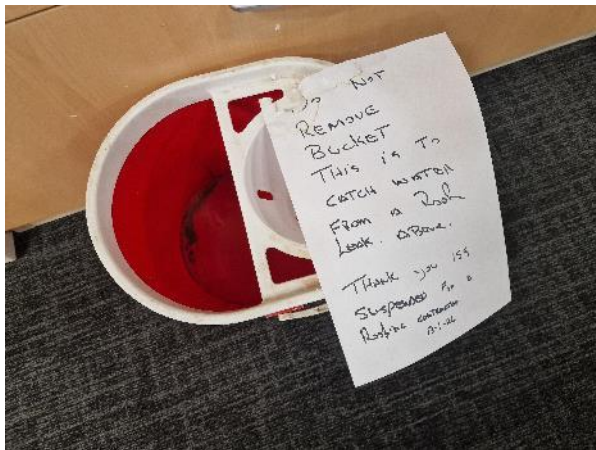
17. Evidence of water ingress internally

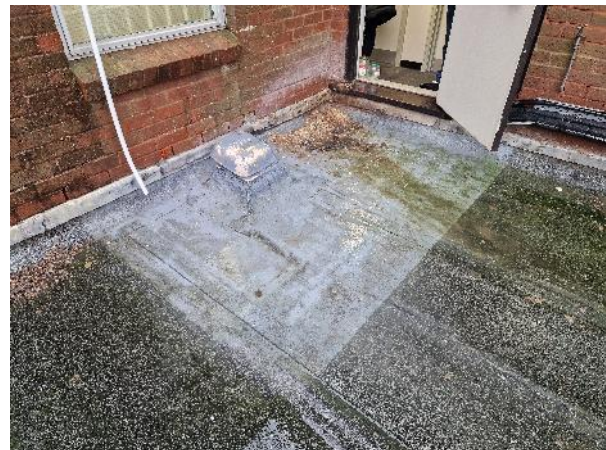
18. Poor patch repair to lower flat roof – Roof 3

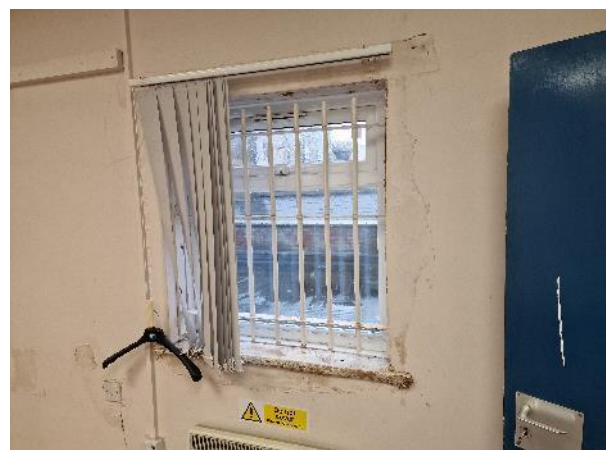
20. Water ingress to rear
