## Verification Report

Plots 24-28, 31, 32, 35, 36 Residential Development

Elizabeth Square, Durrington

December 2024

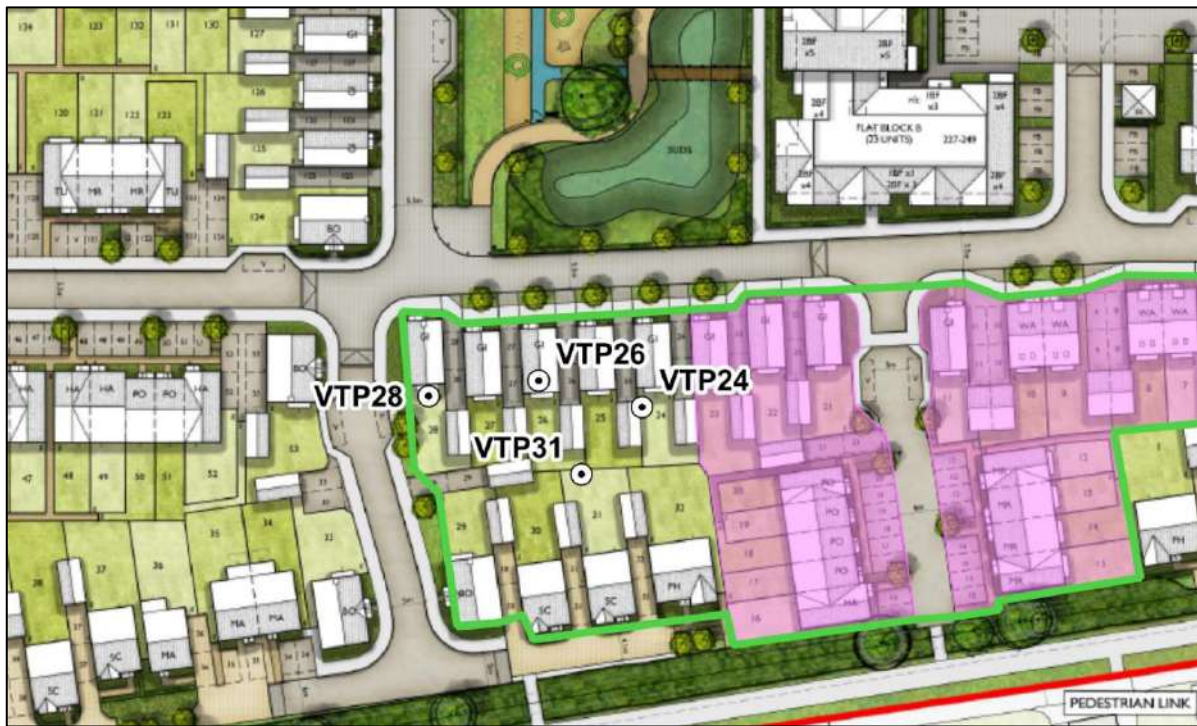
Figure 5-A: Pit Verification Plan

- 5.3.2 The pit inspection records are provided within Appendix E, and confirm the cover system to be of sufficient thickness and suitable composition.

- 5.3.4 The verification plan requires inspection pits to be completed in one of every five plots. This report includes four inspection pits complete across 9 plots, and is therefore considered sufficient. Given the observations on site, level of work observed, and evidence provided, Soiltechnics are confident that our observations made in the completed areas of the site can be applied to the other plots under consideration within this report.

5.4.1 No visual or olfactory evidence of contamination was noted within the clean cover soils, and no suspected ACMs were identified.

5.5.1 No undesirable or injurious artefacts were observed within the topsoil or subsoil, such as over-sized materials, sharps, or plastics.

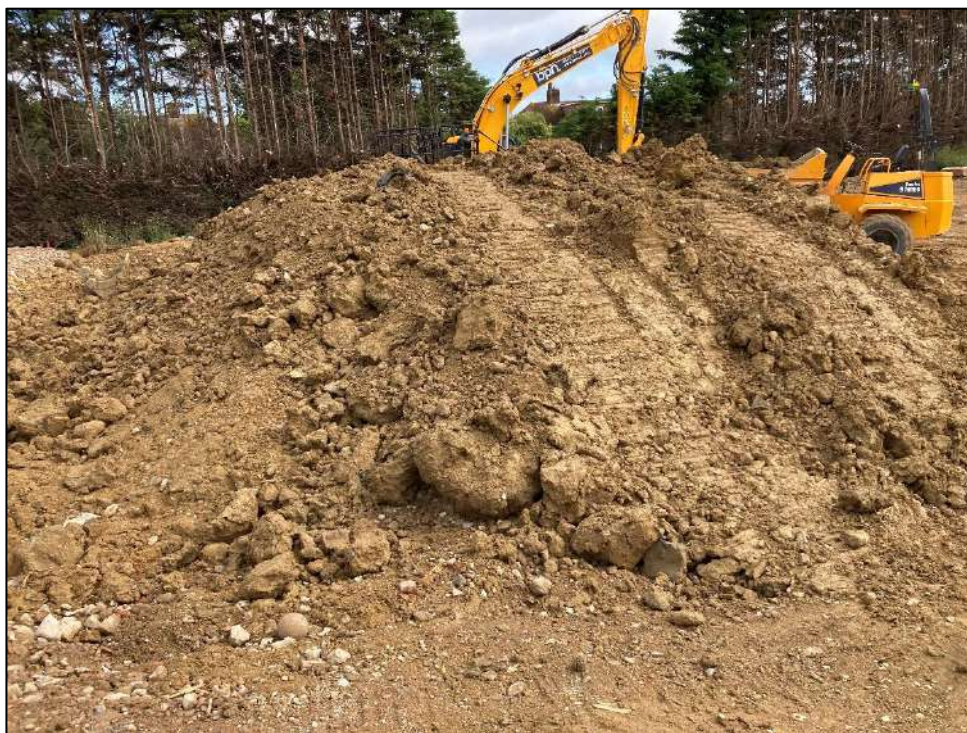
Figure 1: Billingshurst soil stockpile SL01

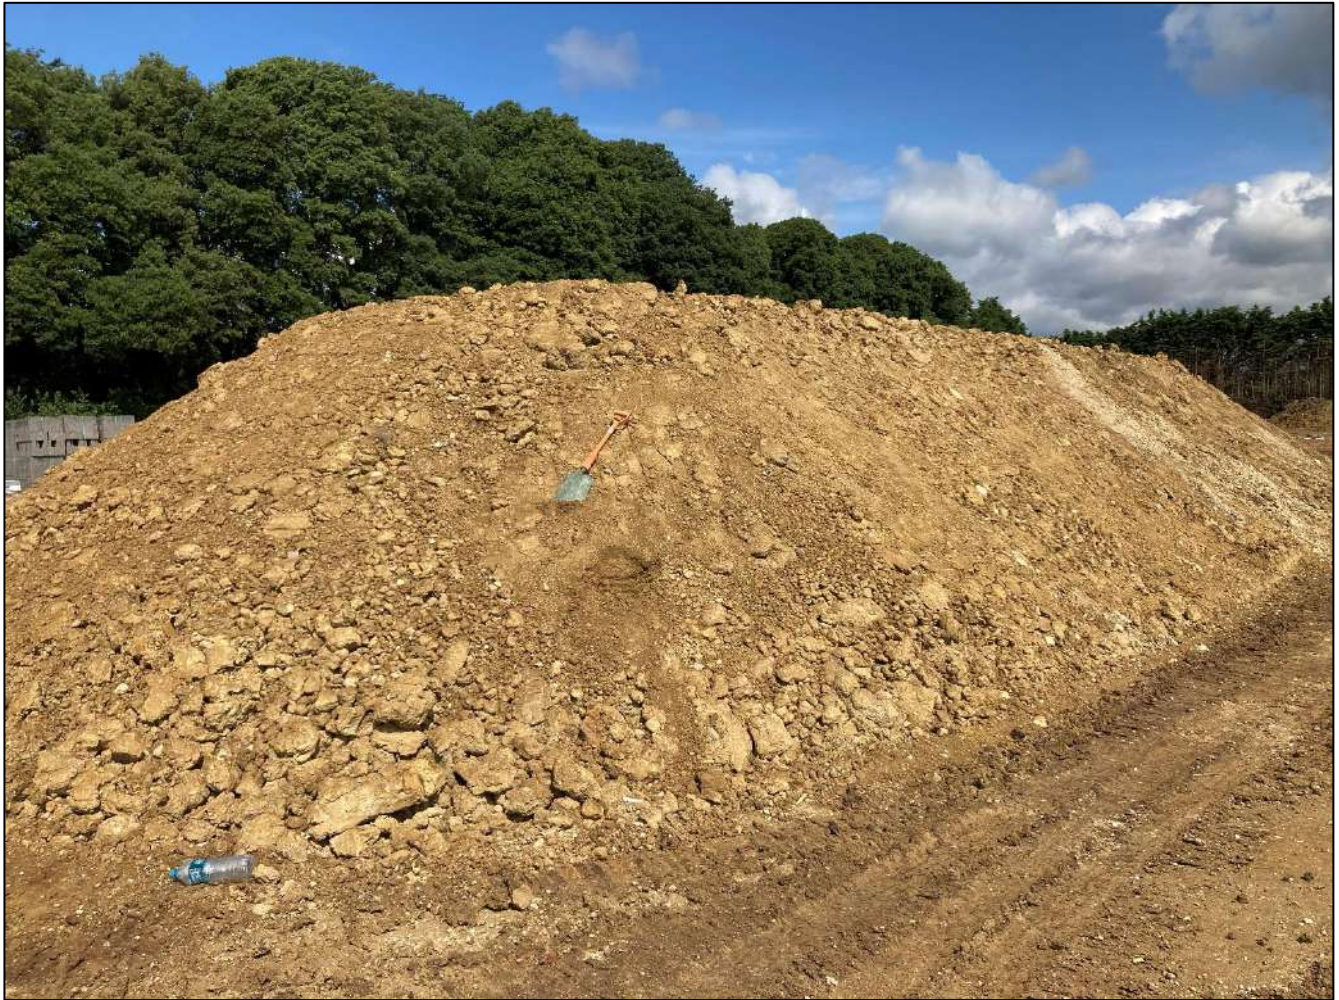
Figure 2: Billingshurst soil stockpile SL02

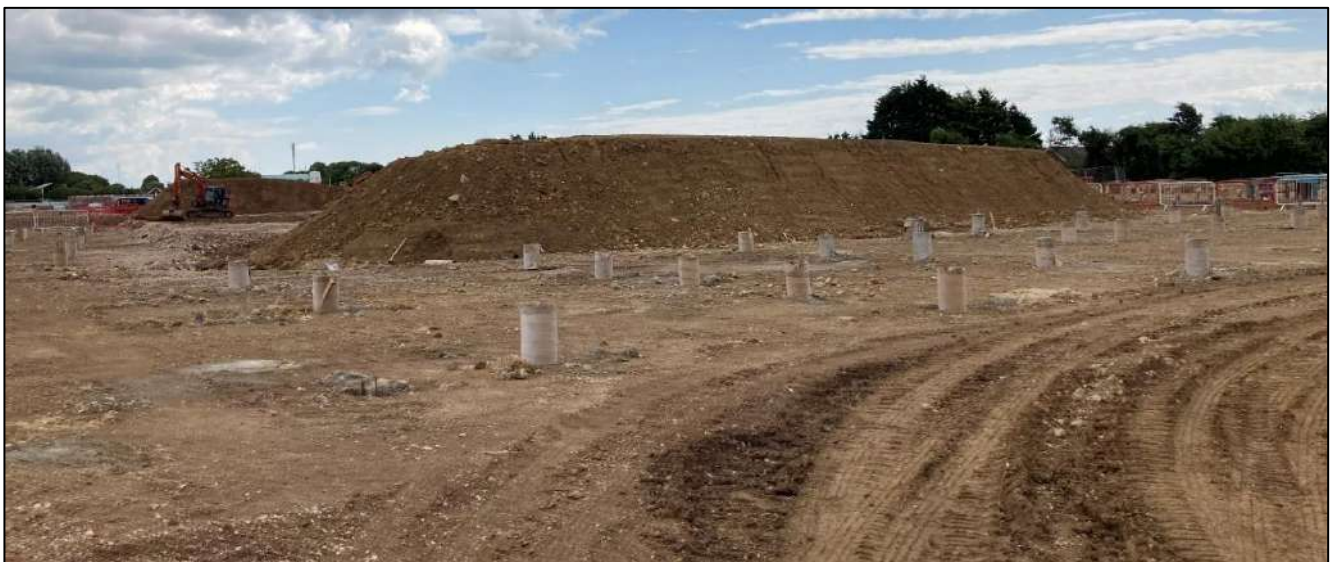
Figure 3: Billingshurst soil stockpile SL03

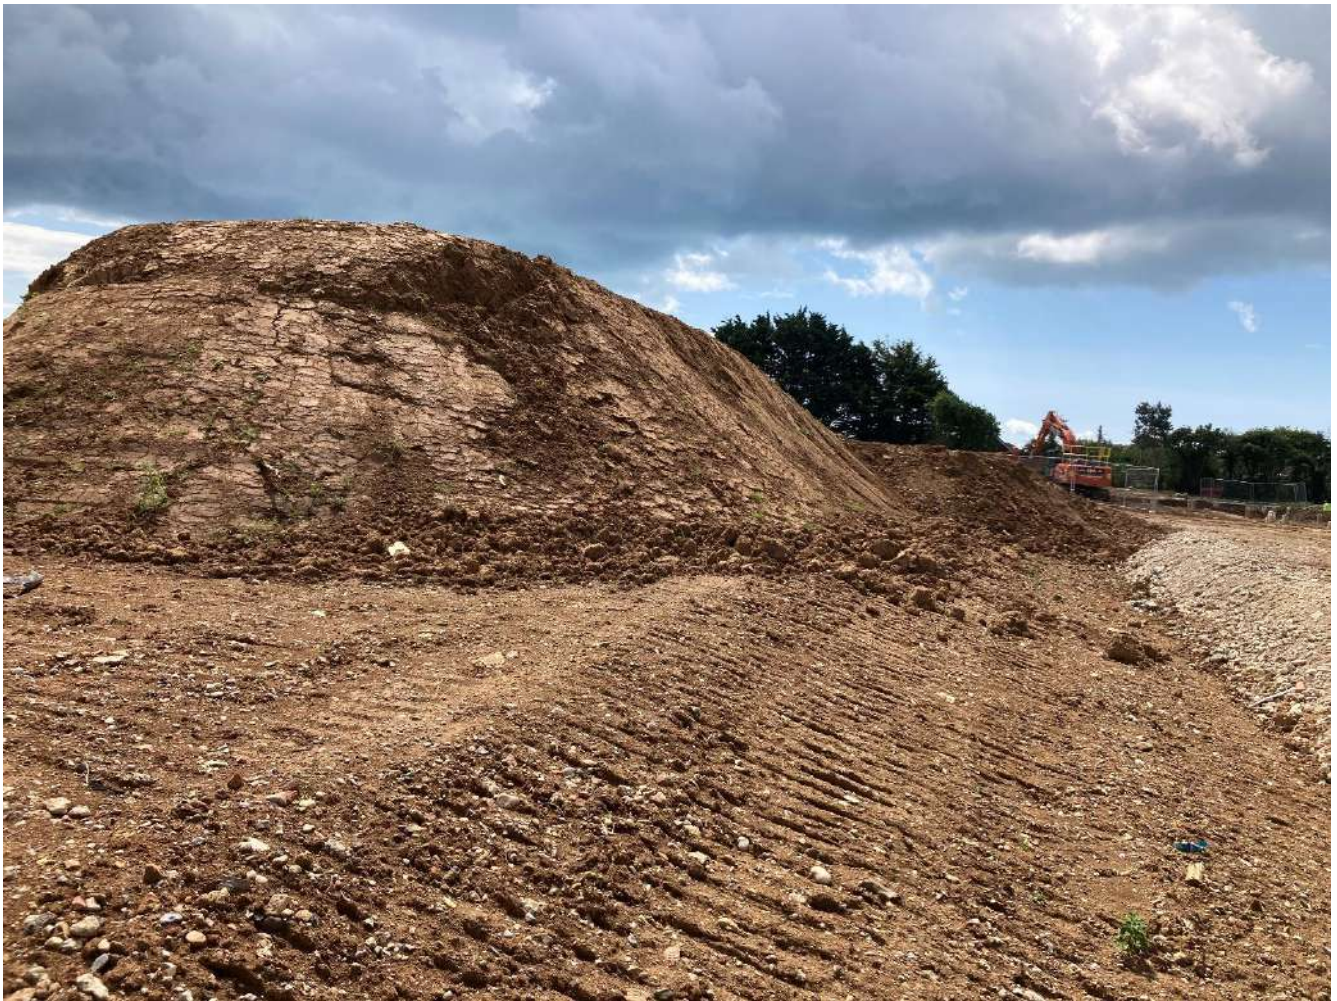
Figure 4: Billingshurst soil stockpile SL04/05
