# WORTHING HIGH SCHOOL, WEST SUSSEX

## SUSTAINABLE DRAINAGE STRATEGY

JULY 2026

Ref: 14943/08/HOP/RPT/01

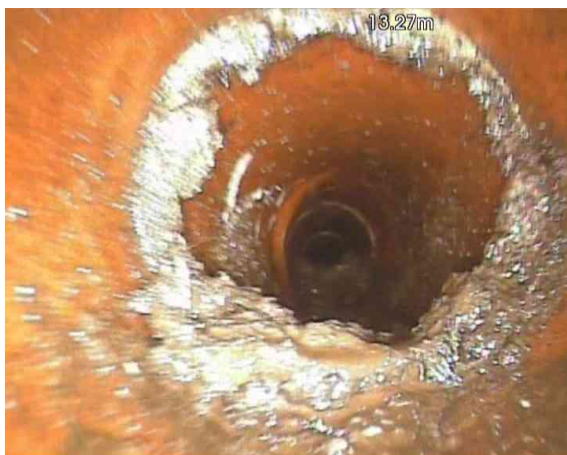
1, 00:01:03, 13.30 m

Attached deposits, encrustation at joint from 12 o'clock to 12 o'clock, 20% cross-sectional area loss

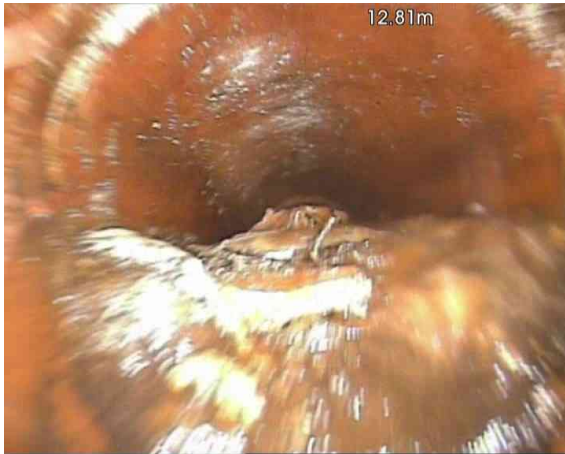
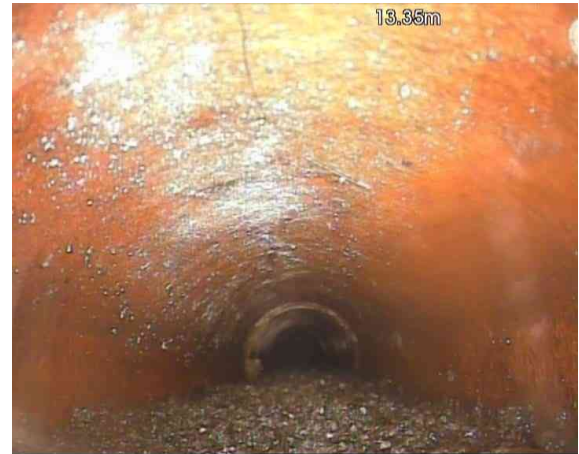
Settled deposits, fine, 50% cross-sectional area loss

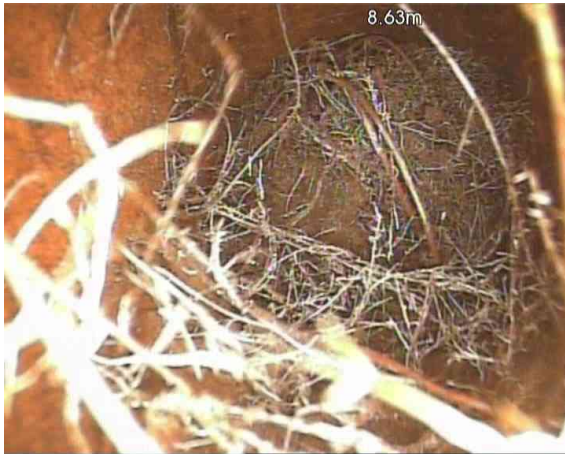
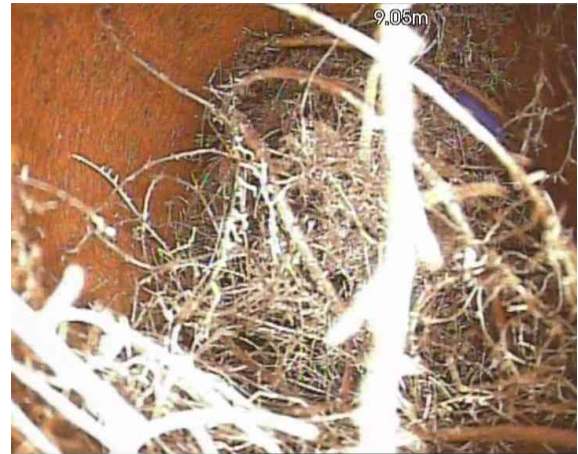
1, 00:00:32, 8.60 m  
Roots, mass, 75% cross-sectional area loss

2, 00:00:32, 8.60 m  
Roots, mass, 75% cross-sectional area loss

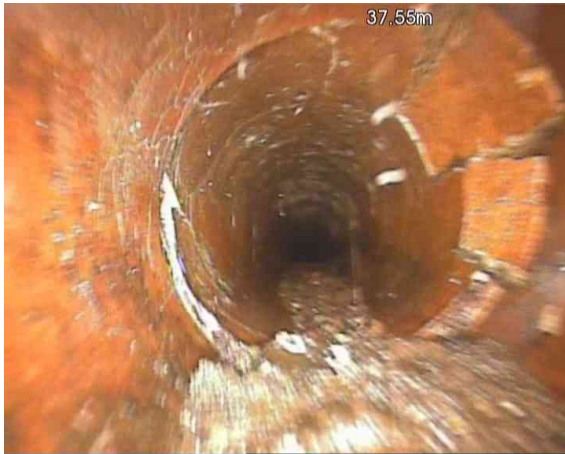
| Section | PLR | Grade | Description |
|---|---|---|---|
| 4 | SW01 XX | 4 | Broken pipe from 12 o'clock to 4 o'clock |

1, 00:01:34, 37.50 m  
Broken pipe from 12 o'clock to 4 o'clock

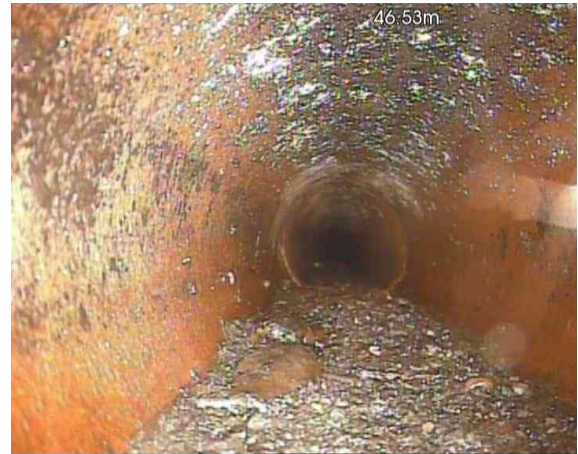
2, 00:02:39, 44.50 m  
Settled deposits, fine, 15% cross-sectional area loss

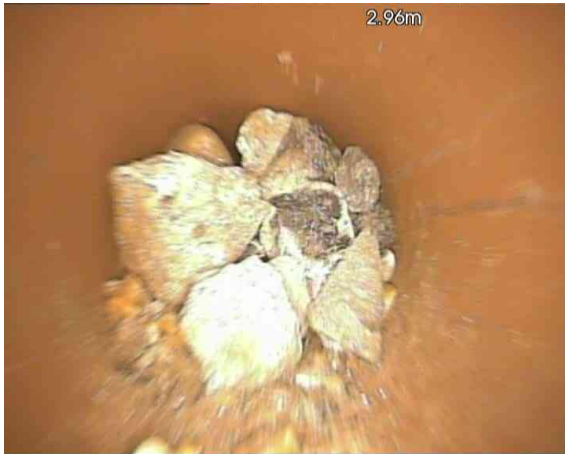
1, 00:00:14, 3.00 m

Settled deposits, hard or compacted, 75% cross-sectional area loss

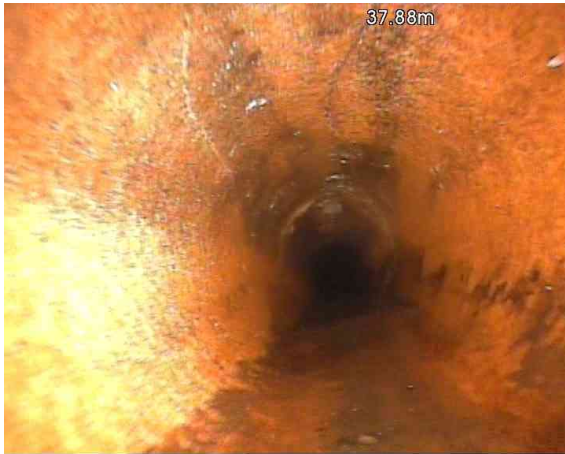
1, 00:02:31, 37.60 m  
Broken pipe from 12 o'clock to 5 o'clock

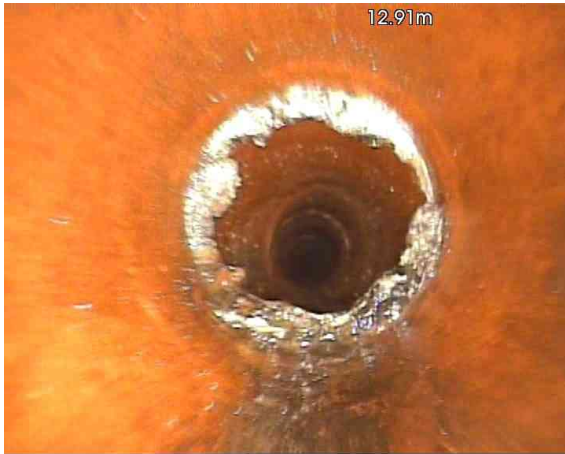
1, 00:00:53, 12.90 m

Attached deposits, encrustation at joint from 12 o'clock to 12 o'clock, 10% cross-sectional area loss

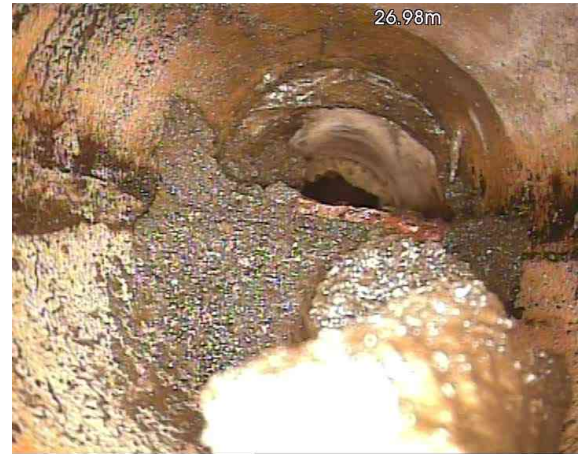
2, 00:01:44, 26.90 m

Settled deposits, hard or compacted, 35% cross-sectional area loss

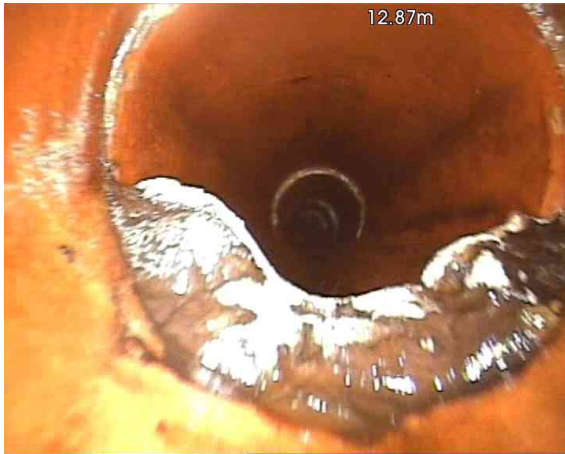
1, 00:00:47, 12.90 m

Attached deposits, encrustation at joint from 3 o'clock to 9 o'clock, 20% cross-sectional area loss

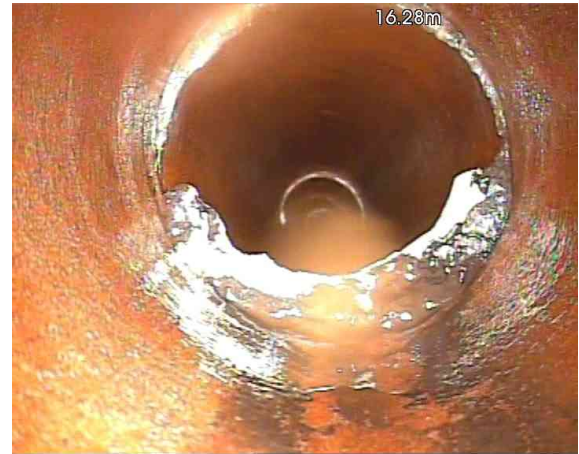
2, 00:01:12, 16.30 m

Attached deposits, encrustation at joint from 3 o'clock to 9 o'clock, 15% cross-sectional area loss

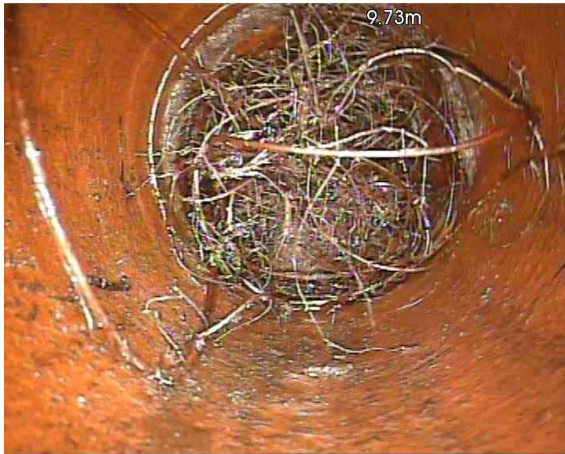
1, 00:00:39, 9.20 m  
Roots, mass, 80% cross-sectional area loss

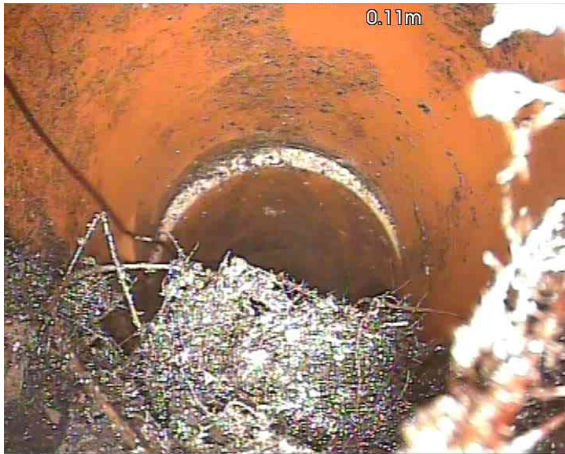
1, 00:00:11, 0.20 m  
Roots, mass, 15% cross-sectional area loss

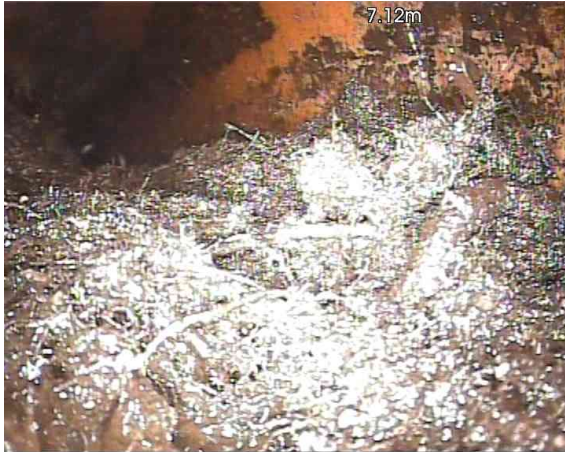
1, 00:00:46, 7.20 m

Roots, mass, 35% cross-sectional area loss
