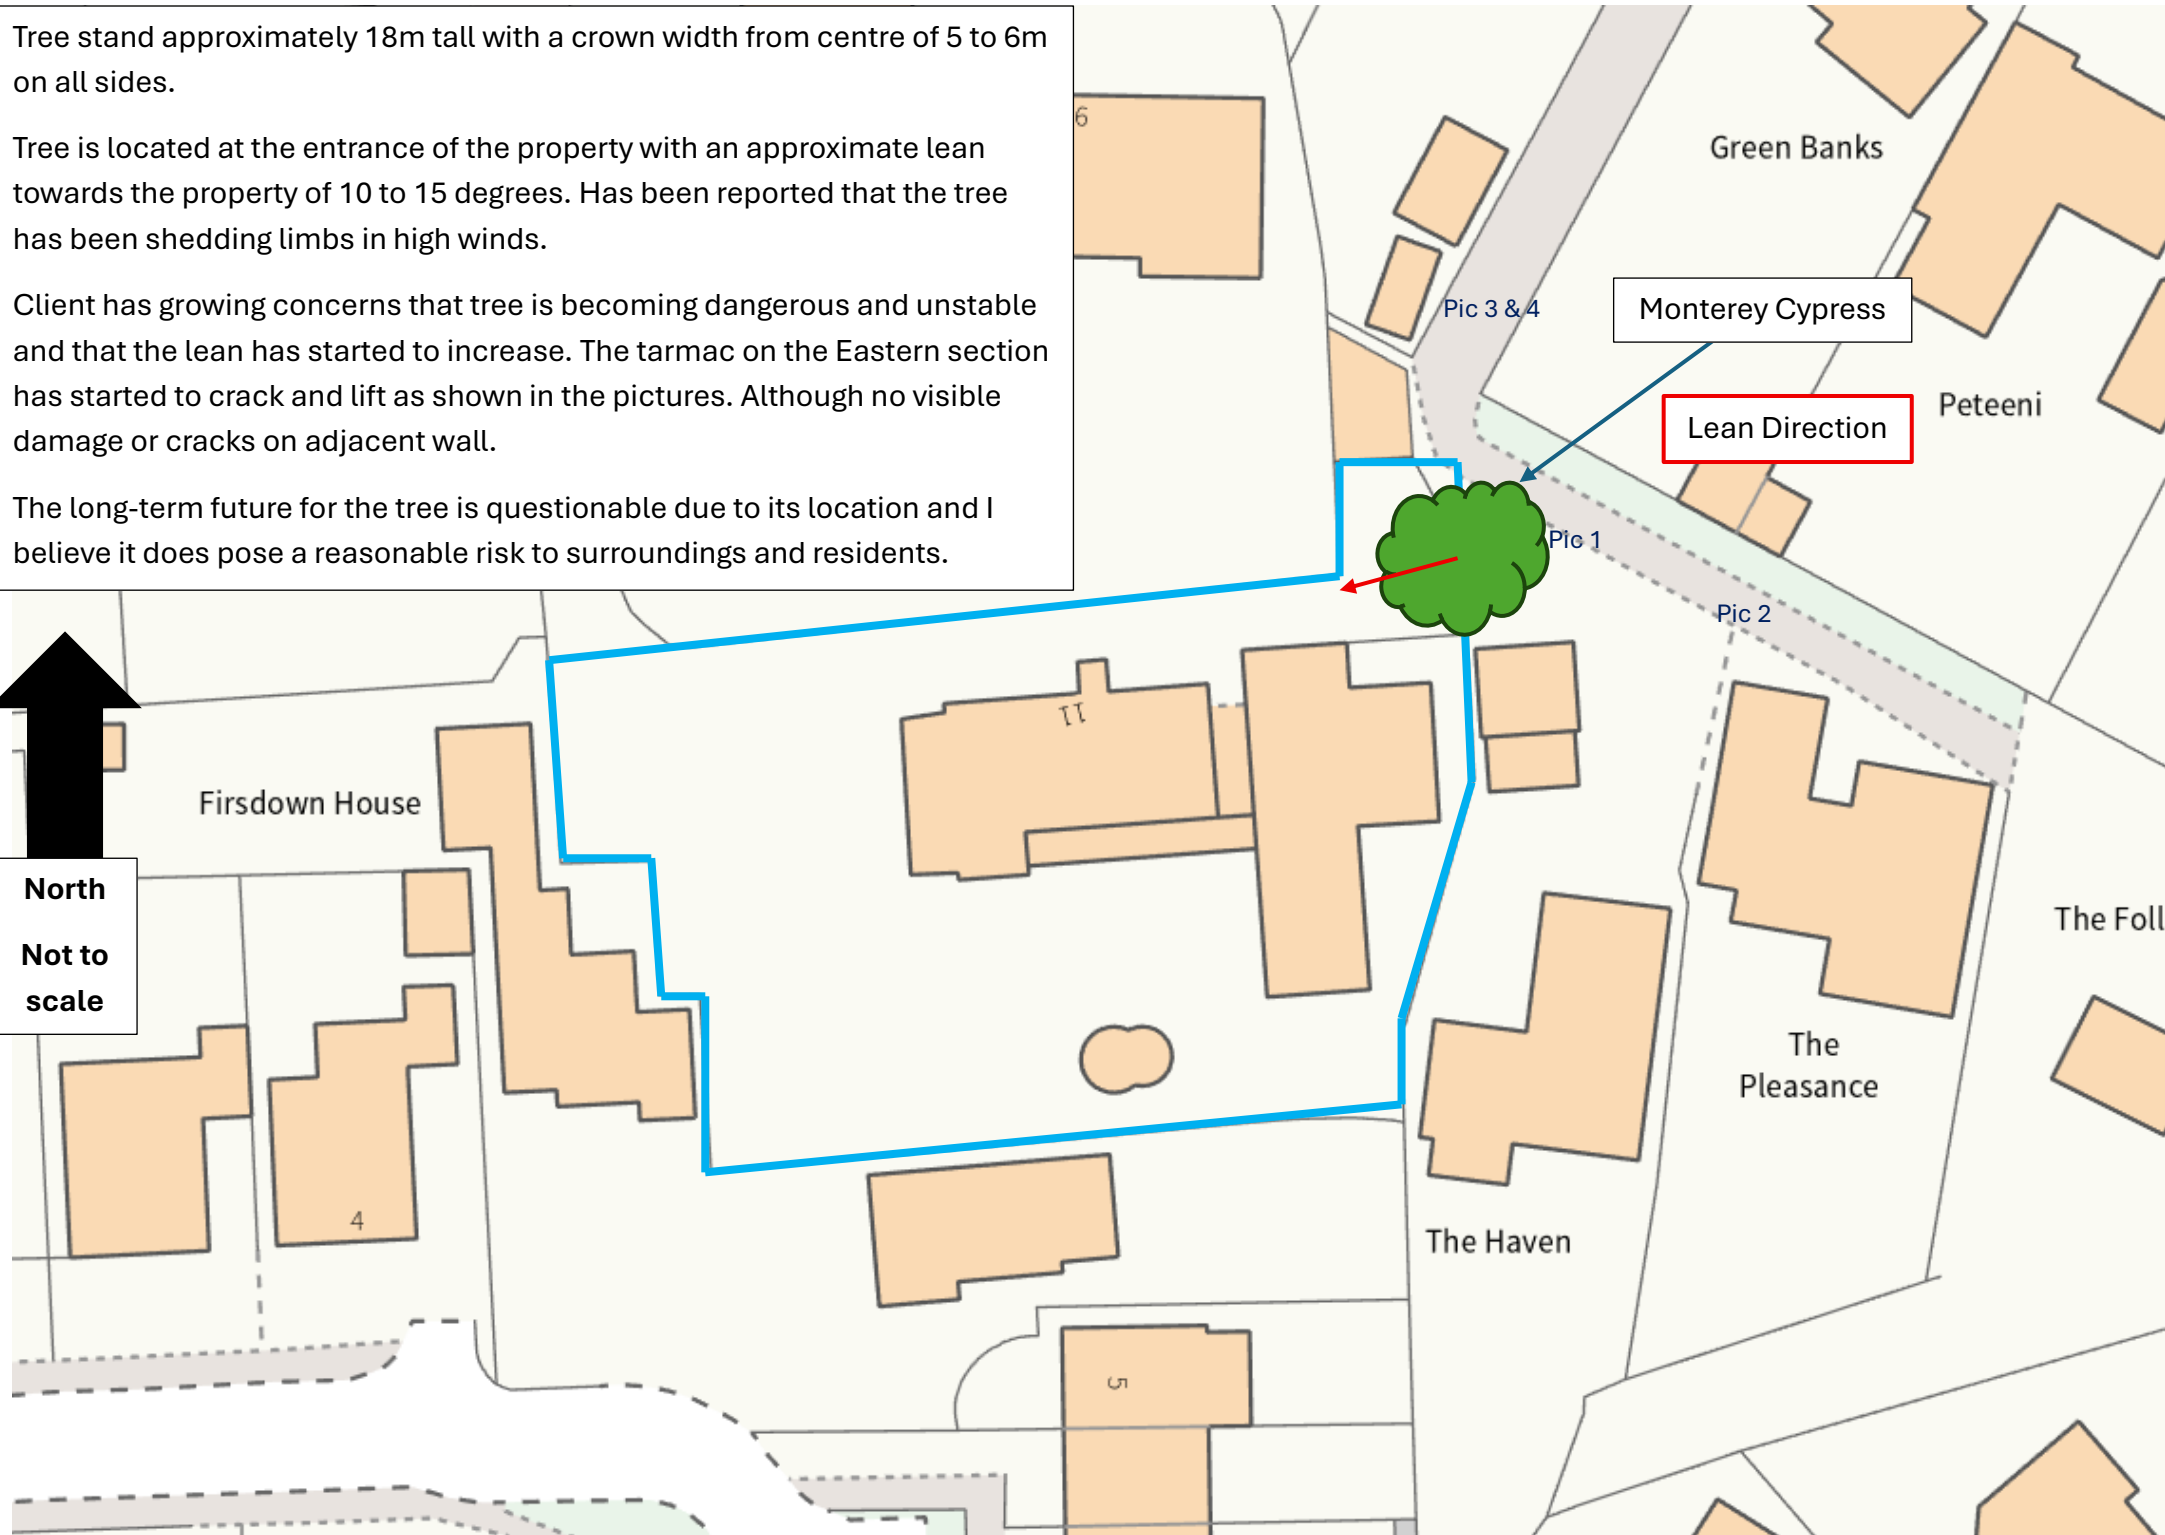
Tree is located at the entrance of the property with an approximate lean towards the property of 10 to 15 degrees. Has been reported that the tree has been shedding limbs in high winds.

Client has growing concerns that tree is becoming dangerous and unstable and that the lean has started to increase. The tarmac on the Eastern section has started to crack and lift as shown in the pictures. Although no visible damage or cracks on adjacent wall.

The long-term future for the tree is questionable due to its location and I believe it does pose a reasonable risk to surroundings and residents.
