**Berkeley Homes (Southern)  
Limited**

**17<sup>th</sup> April 2025**

# **FORMER GASWORKS, PARK ROAD, WORTHING VERIFICATION REPORT**

Drawing No. S929-RAM05-SW-XX-RP-O-110-1  
Project No. **1620016977**  
Issue No. **01**  
Date **17<sup>th</sup> April 2025**  
Made by **Ben Stride**  
Checked by **Lucy Cleverley**  
Approved by **Lucy Cleverley**

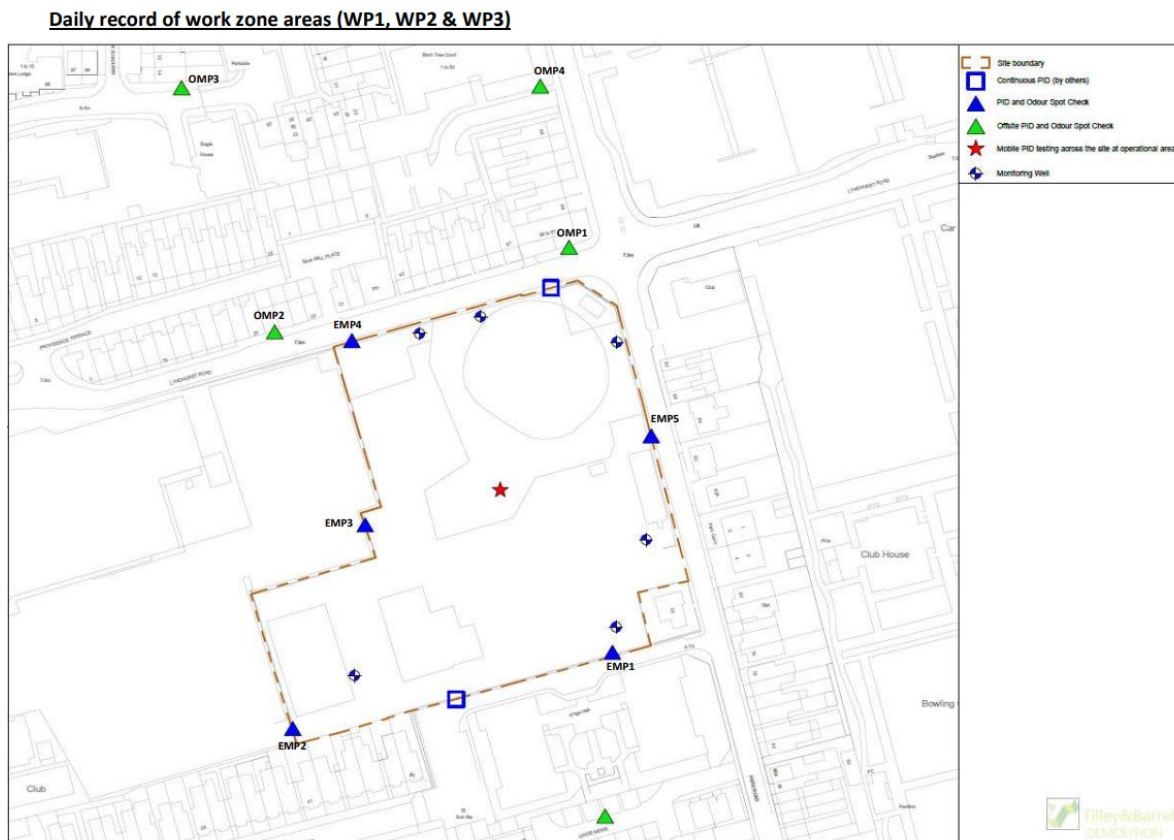
**Figure 7. Continuous VOC monitoring points**

No significant concentrations of VOCs were registered during the works. Results from the continuous VOC monitoring are provided in Appendix 4.
