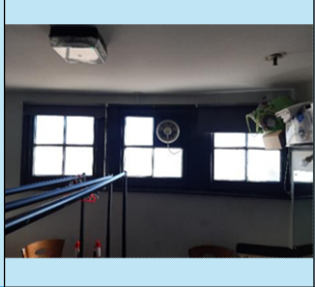
| REF | WIDTH<br>(APPROX.) | HEIGHT<br>(APPROX.) | FRAME TYPE | FIRE RATING<br>(PART B) | SAFETY GLASS<br>(PART K) | PRIVACY<br>(EXISTING) | EXTRACT<br>VENTILATION | LOCATION / ROOM | ELEVATION / ORIENTATION | OPENING TYPE | COMMENTS | SOLUTION | EXTERNAL PHOTO | INTERNAL PHOTO |
|---|---|---|---|---|---|---|---|---|---|---|---|---|---|---|
| G.W33 | 900 | 900 | Timber | | | Patterned glass | | Dressing Room 4 - BOH | E10 - East | Fixed (1 No) | | Secondary glazing - fixed | | |
