## Verification Report

Plots 54, 57-62 Residential Development

Barrington Road, Worthing

March 2025

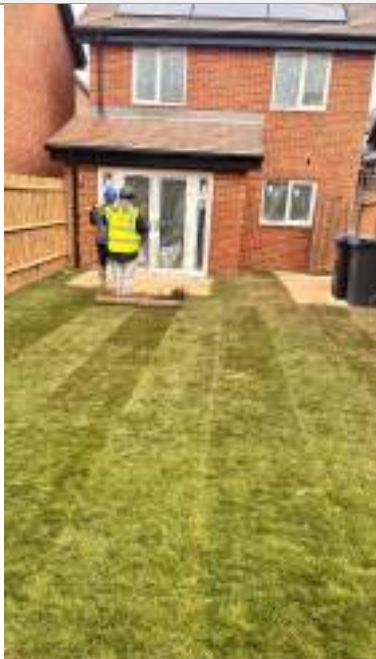
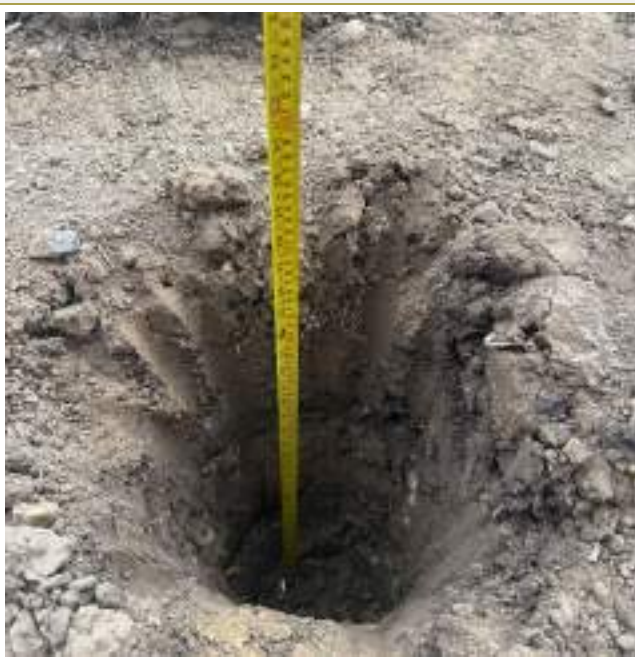
| Physical Suitability | No undesirable or injurious objects were observed within any of the materials inspected, such as sharps, metals, plastics or over-sized materials, except for a few cobble-sized fragments of brick and concrete within the subsoil. Plastic zip tie material found. | | |

| Remediation Requirement | | Observed Conditions (if applicable) | |
|---|---|---|---|
| Subsoil: | ≥300mm – 450mm loosened subsoil | Subsoil: | 500mm |

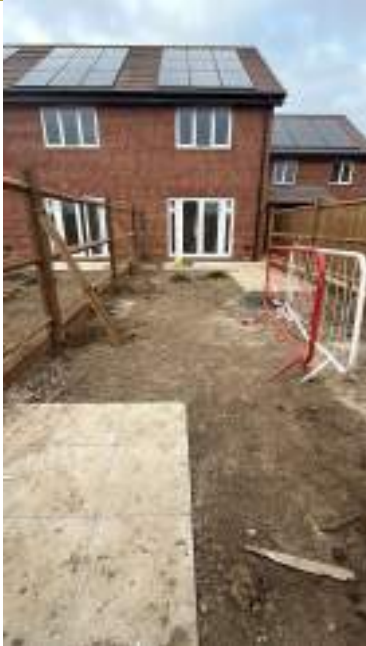
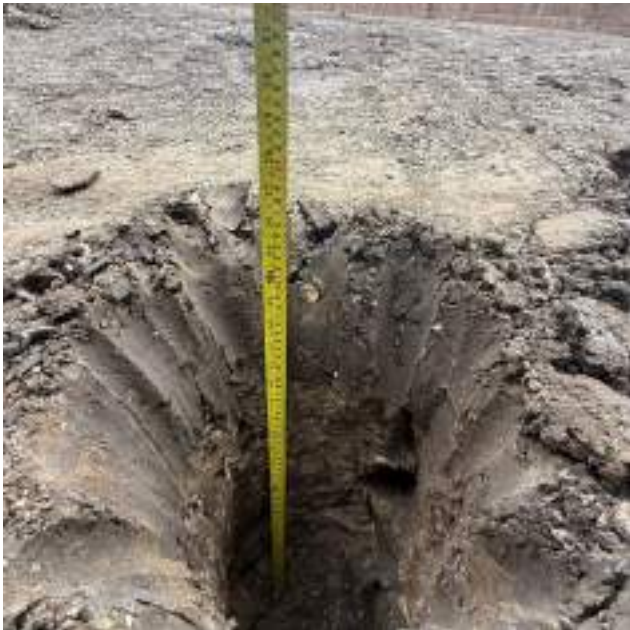
| Physical Suitability | No undesirable or injurious objects were observed within any of the materials inspected, such as sharps, metals, plastics or over-sized materials, except for a few cobble-sized fragments of brick and concrete within the subsoil. Rare geotextile material was found. | | |

| Remediation Requirement | | Observed Conditions (if applicable) | |
|---|---|---|---|
| Subsoil: | ≥300mm – 450mm loosened subsoil | Subsoil: | 500mm |

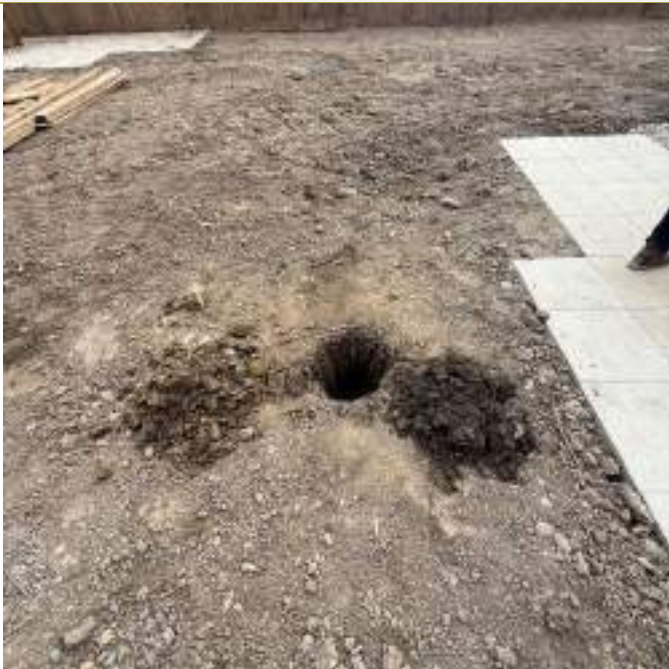
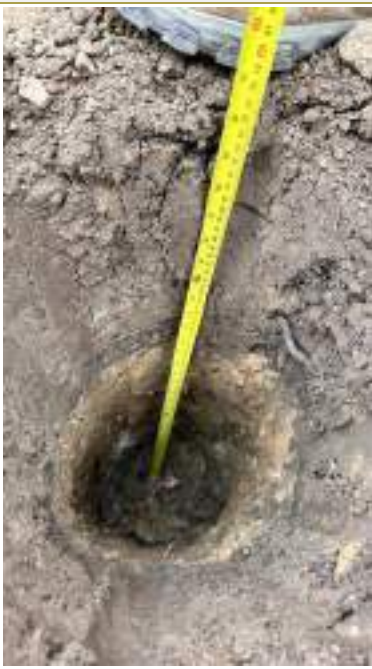
| Physical Suitability | No undesirable or injurious objects were observed within any of the materials inspected, such as sharps, metals, plastics or over-sized materials, except for a few cobble-sized fragments of brick and concrete within the subsoil. Rare geotextile material was found and metal sheeting (200mm x 100mm and 120mm x 50mm). | | |

| Remediation Requirement | | Observed Conditions (if applicable) | |
|---|---|---|---|
| Subsoil: | ≥300mm – 450mm loosened subsoil | Subsoil: | 500mm |

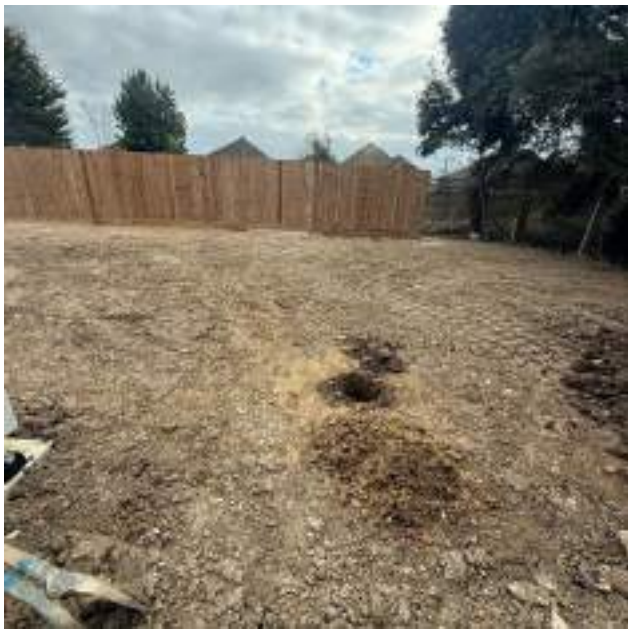
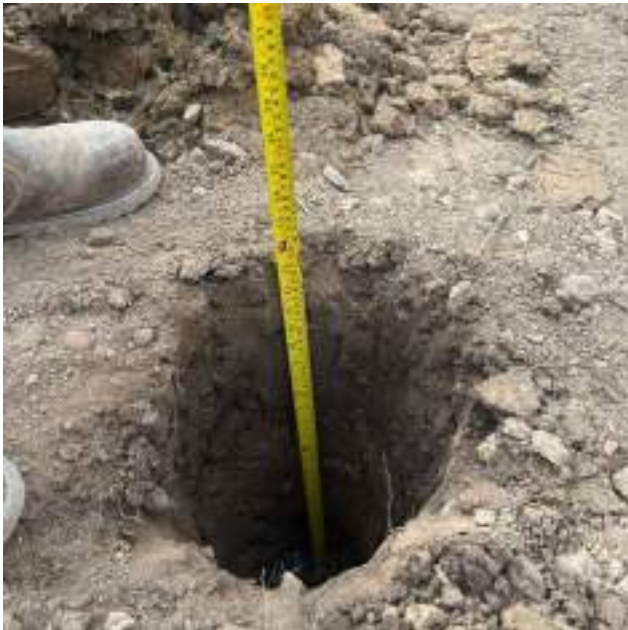
| Physical Suitability | No undesirable or injurious objects were observed within any of the materials inspected, such as sharps, metals, plastics or over-sized materials, except for a few cobble-sized fragments of brick and concrete within the subsoil. Coarse ceramic and black plastic sheeting found. | | |

| Remediation Requirement | | Observed Conditions (if applicable) | |
|---|---|---|---|
| Subsoil: | ≥300mm – 450mm loosened subsoil | Subsoil: | 400mm |

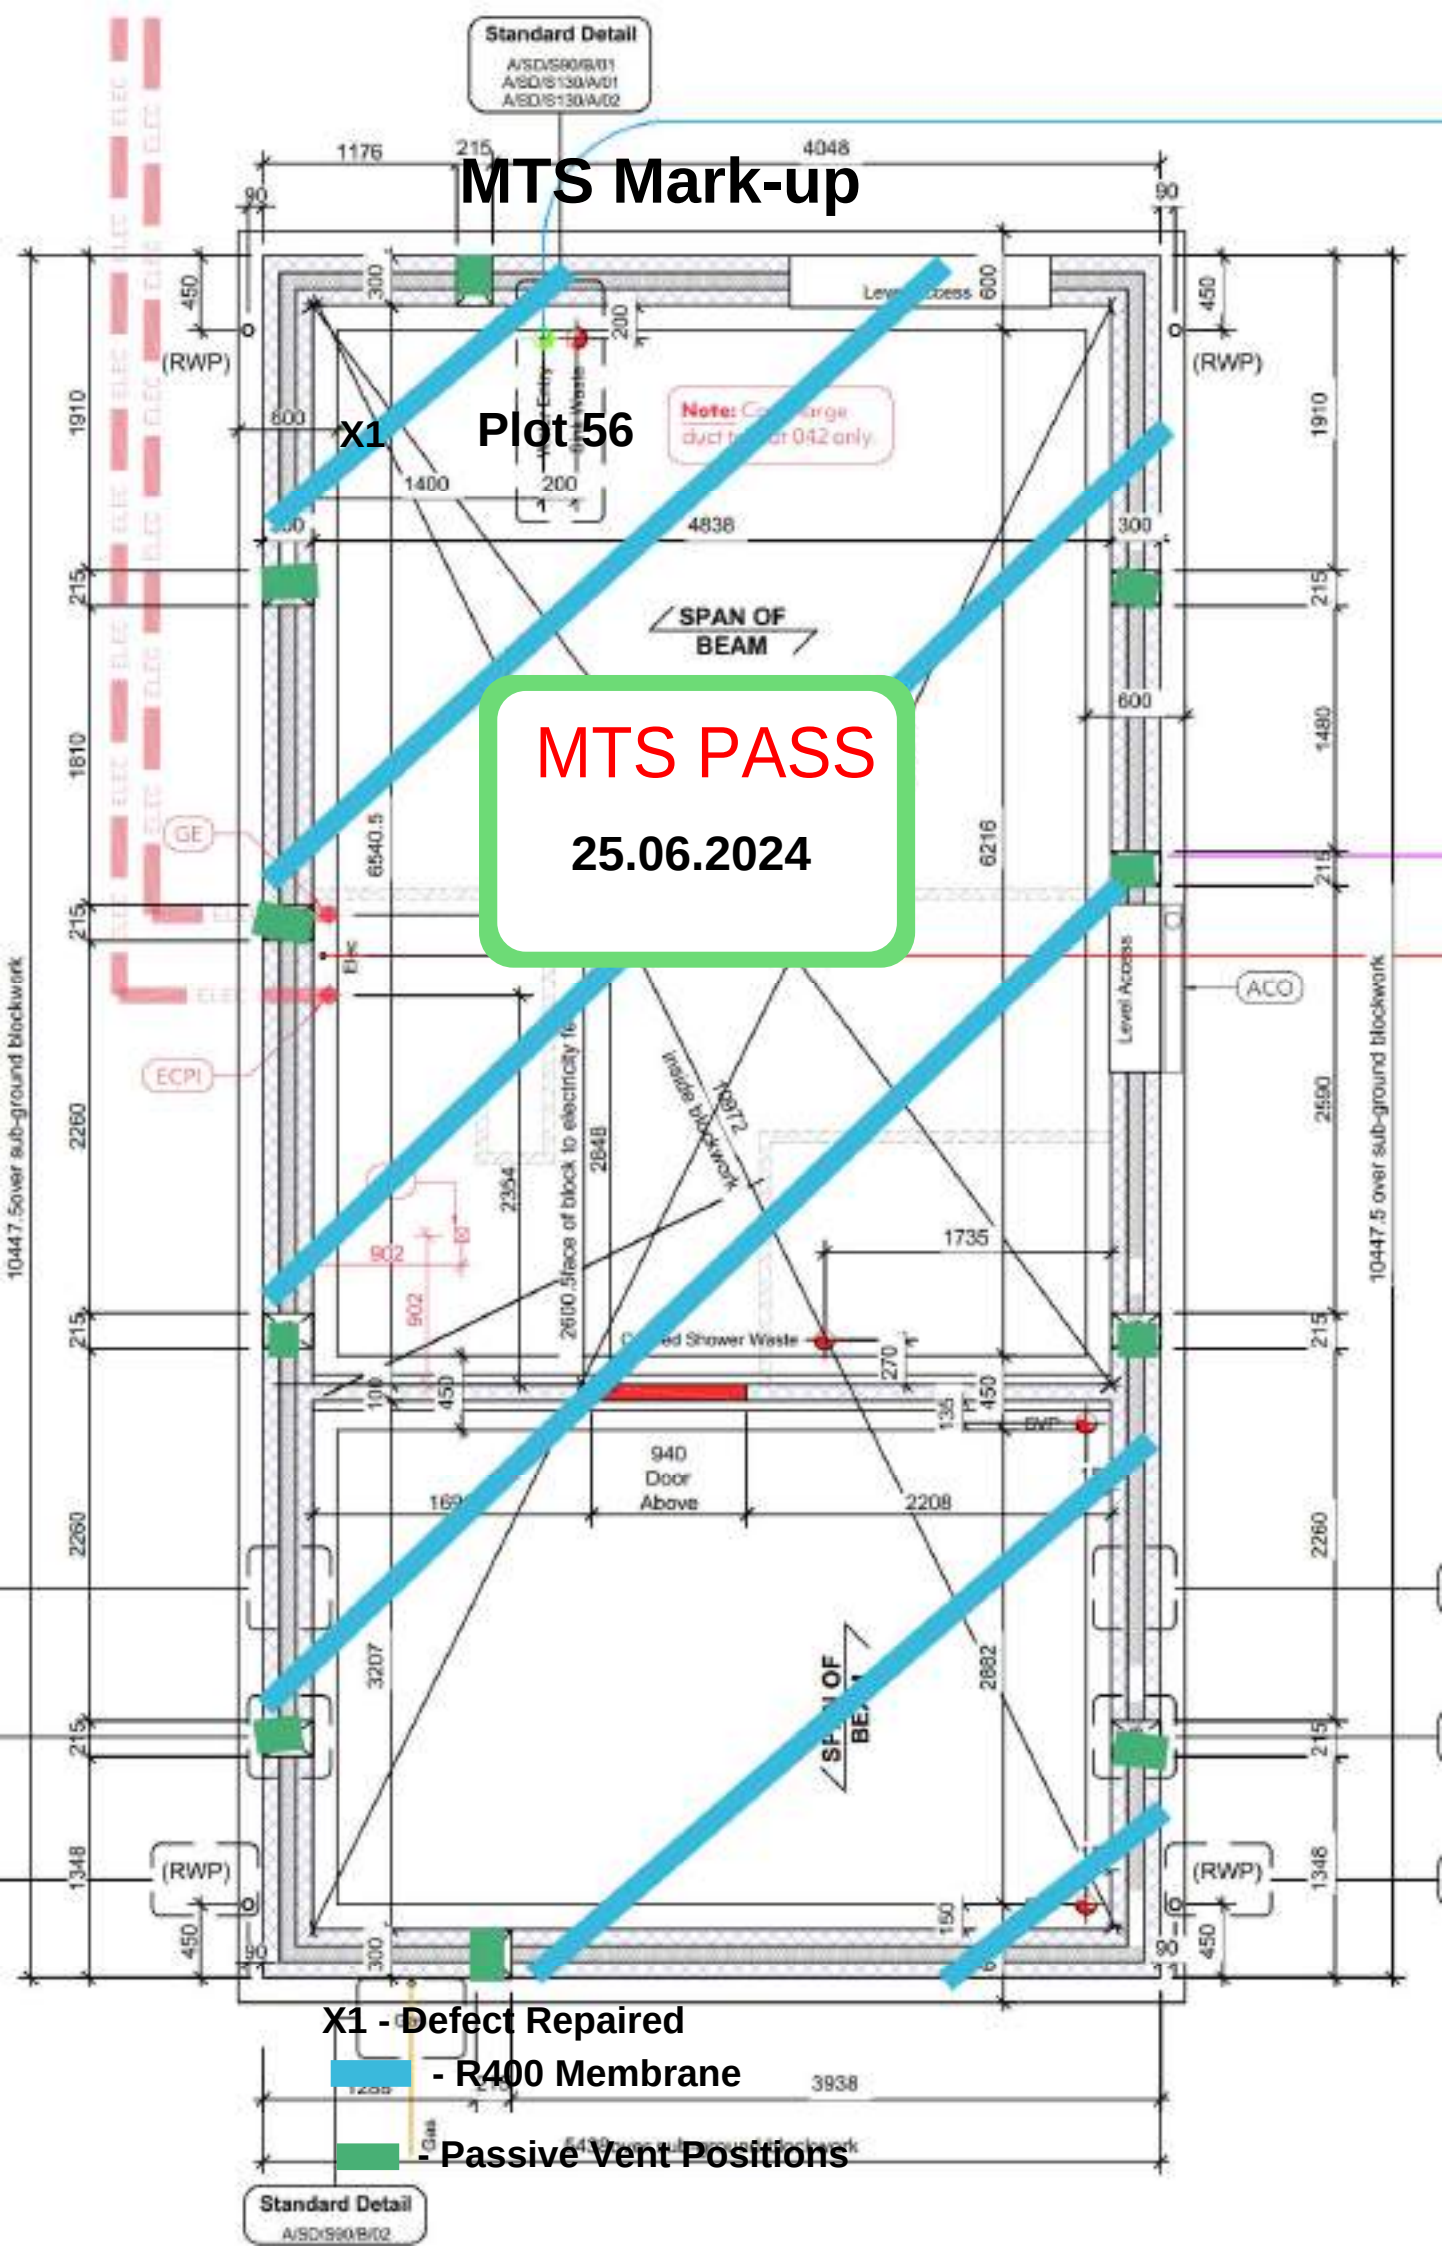
X1 - Defect Repaired

Checking adhesion and specification, then inspected all membrane for any defects or damage. All was installed well, however, one seam error was found. This was marked up and immediately repaired using extra GR lap tape by the installers. The repair was validated proving a pass. Photographic evidence was taken for report inclusion. All membrane was installed to design specification and validated in accordance with the Ciria C735 best practice document.
