## Verification Report

Plots 55 to 56 Residential Development

Barrington Road, Worthing

Site: Barrington Road, Worthing  
Document Title: Verification Report  
Document no.: STV5959-R15-Rev\_B  
Date: March 2025  
Client: Bellway Homes Ltd (South London)  
Issuing office: Soiltechnics Ltd  
Cedar Barn, White Lodge, Walgrave, Northampton. NN6 9PY  
Tel: 01604 781 877 E-mail: [mail@soiltechnics.net](mailto:mail@soiltechnics.net)

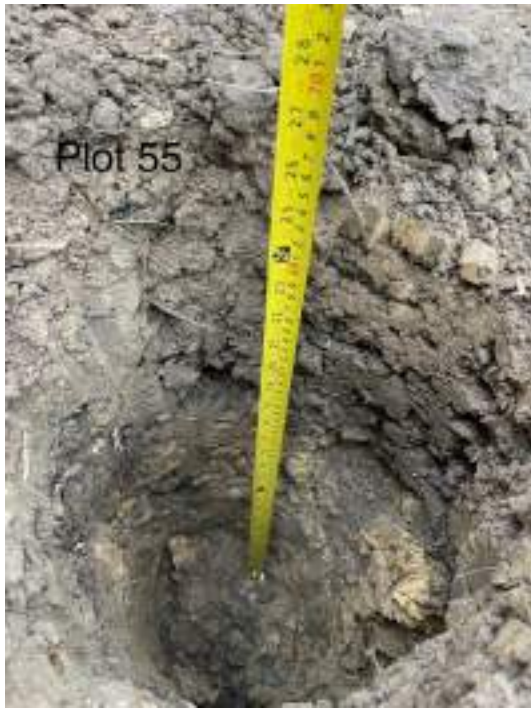
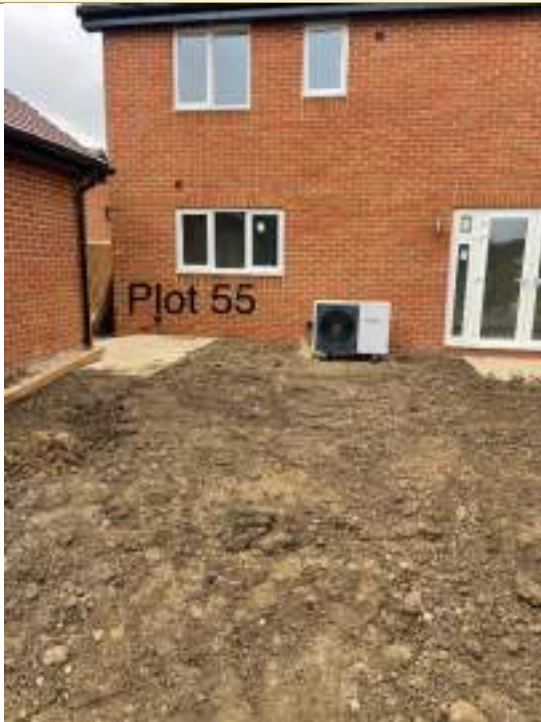
| Physical Suitability | No undesirable or injurious objects were observed within any of the materials inspected, such as sharps, metals, plastics or over-sized materials, except for a few cobble-sized fragments of brick and concrete within the subsoil. Plastic and metal material found. | | |

| Remediation Requirement | | Observed Conditions (if applicable) | |
|---|---|---|---|
| Subsoil: | ≥300mm – 450mm loosened subsoil | Subsoil: | >350mm |

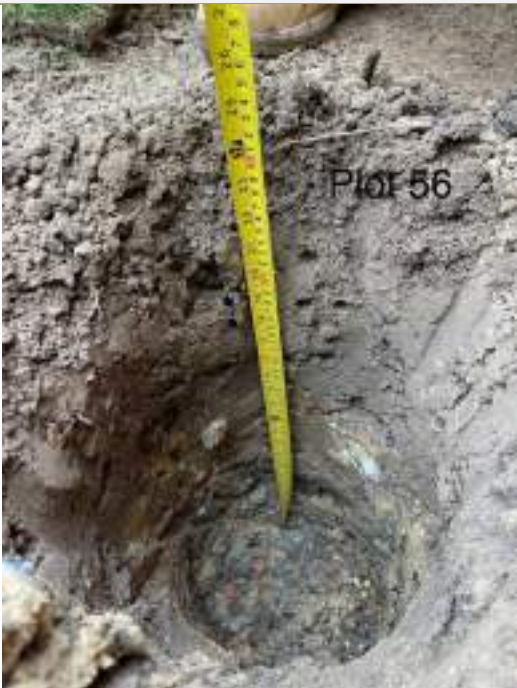
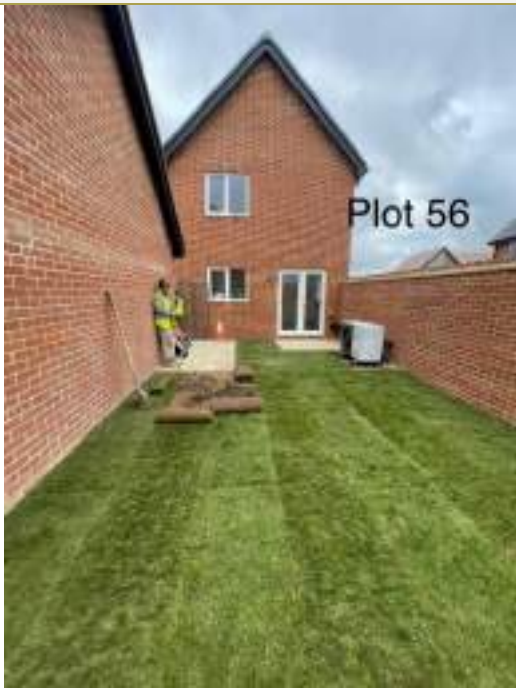
| General Comment | 04.02.25: Landscaping works ongoing. Excavated an inspection pit to sample and log the subsoil. 0.2m of crush material overlies the subsoil which will subsequently be replaced with topsoil.<br>13.03.25: Subsequent inspection by contractor on completion to verify depth of topsoil. Photos included below provided by the contractor. | | |
| Physical Suitability | No undesirable or injurious objects were observed within any of the materials inspected, such as sharps, metals, plastics or over-sized materials, except for a few cobble-sized fragments of brick and concrete within the subsoil. Plastic and metal material found. | | |

| Subsoil: | ≥300mm – 450mm loosened subsoil | Subsoil: | >350mm |

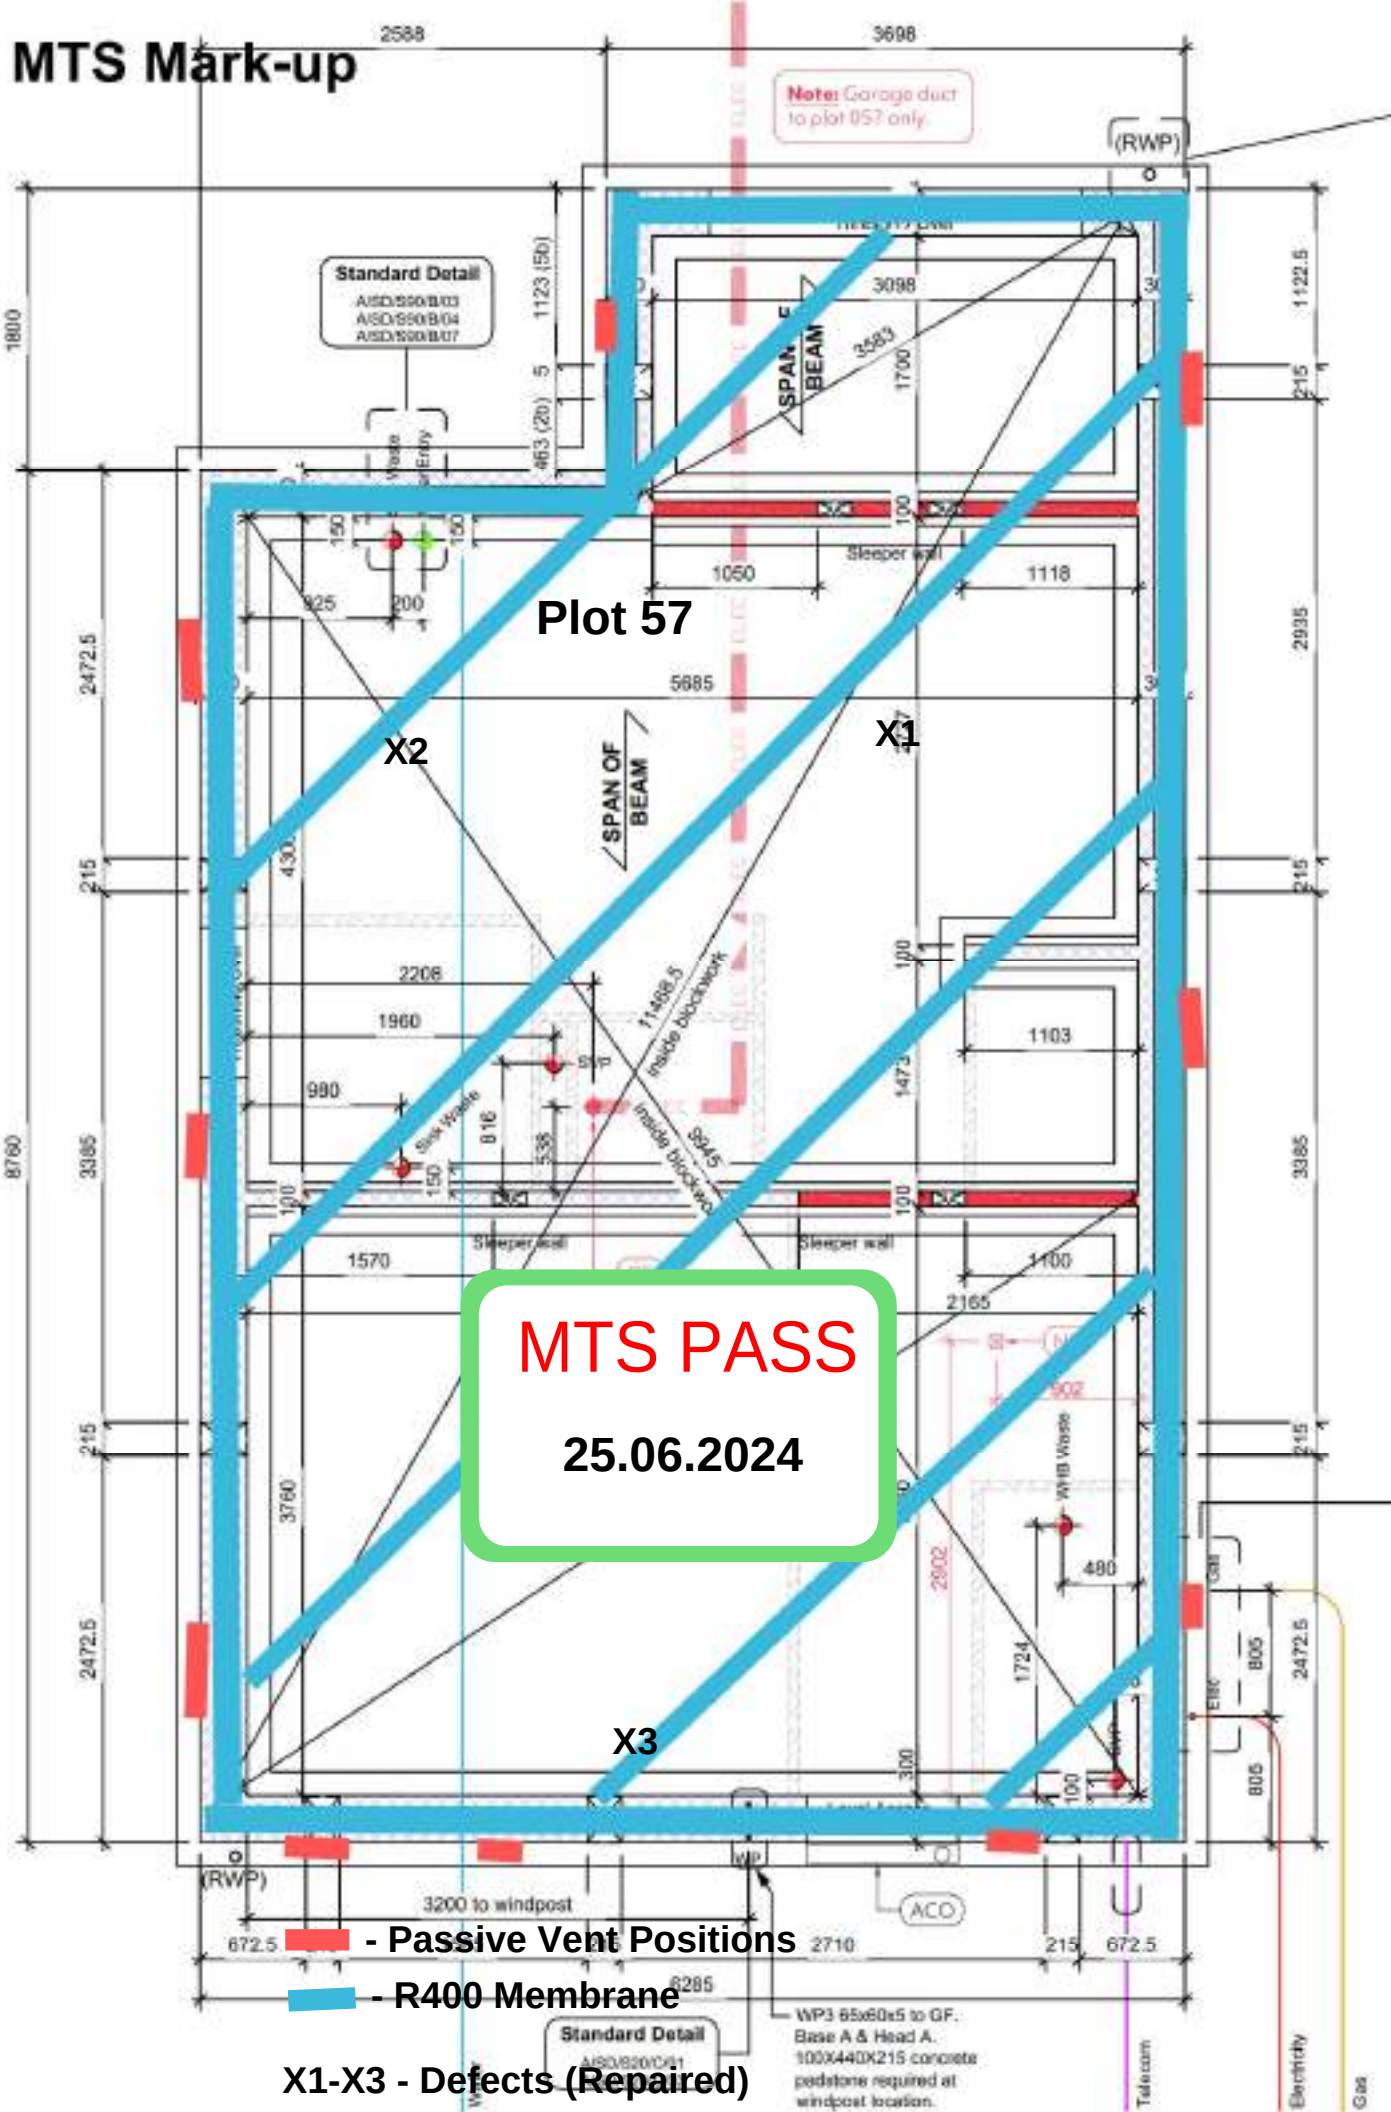
MTS Mark-up

installed well however, 3 defects were found. These were marked up and immediately repaired using extra GR lap tape by the installers. The repair was validated proving a pass. Photographic evidence was taken for report inclusion. All membrane was installed to design specification and validated in accordance with the Ciria C735 best practice document.

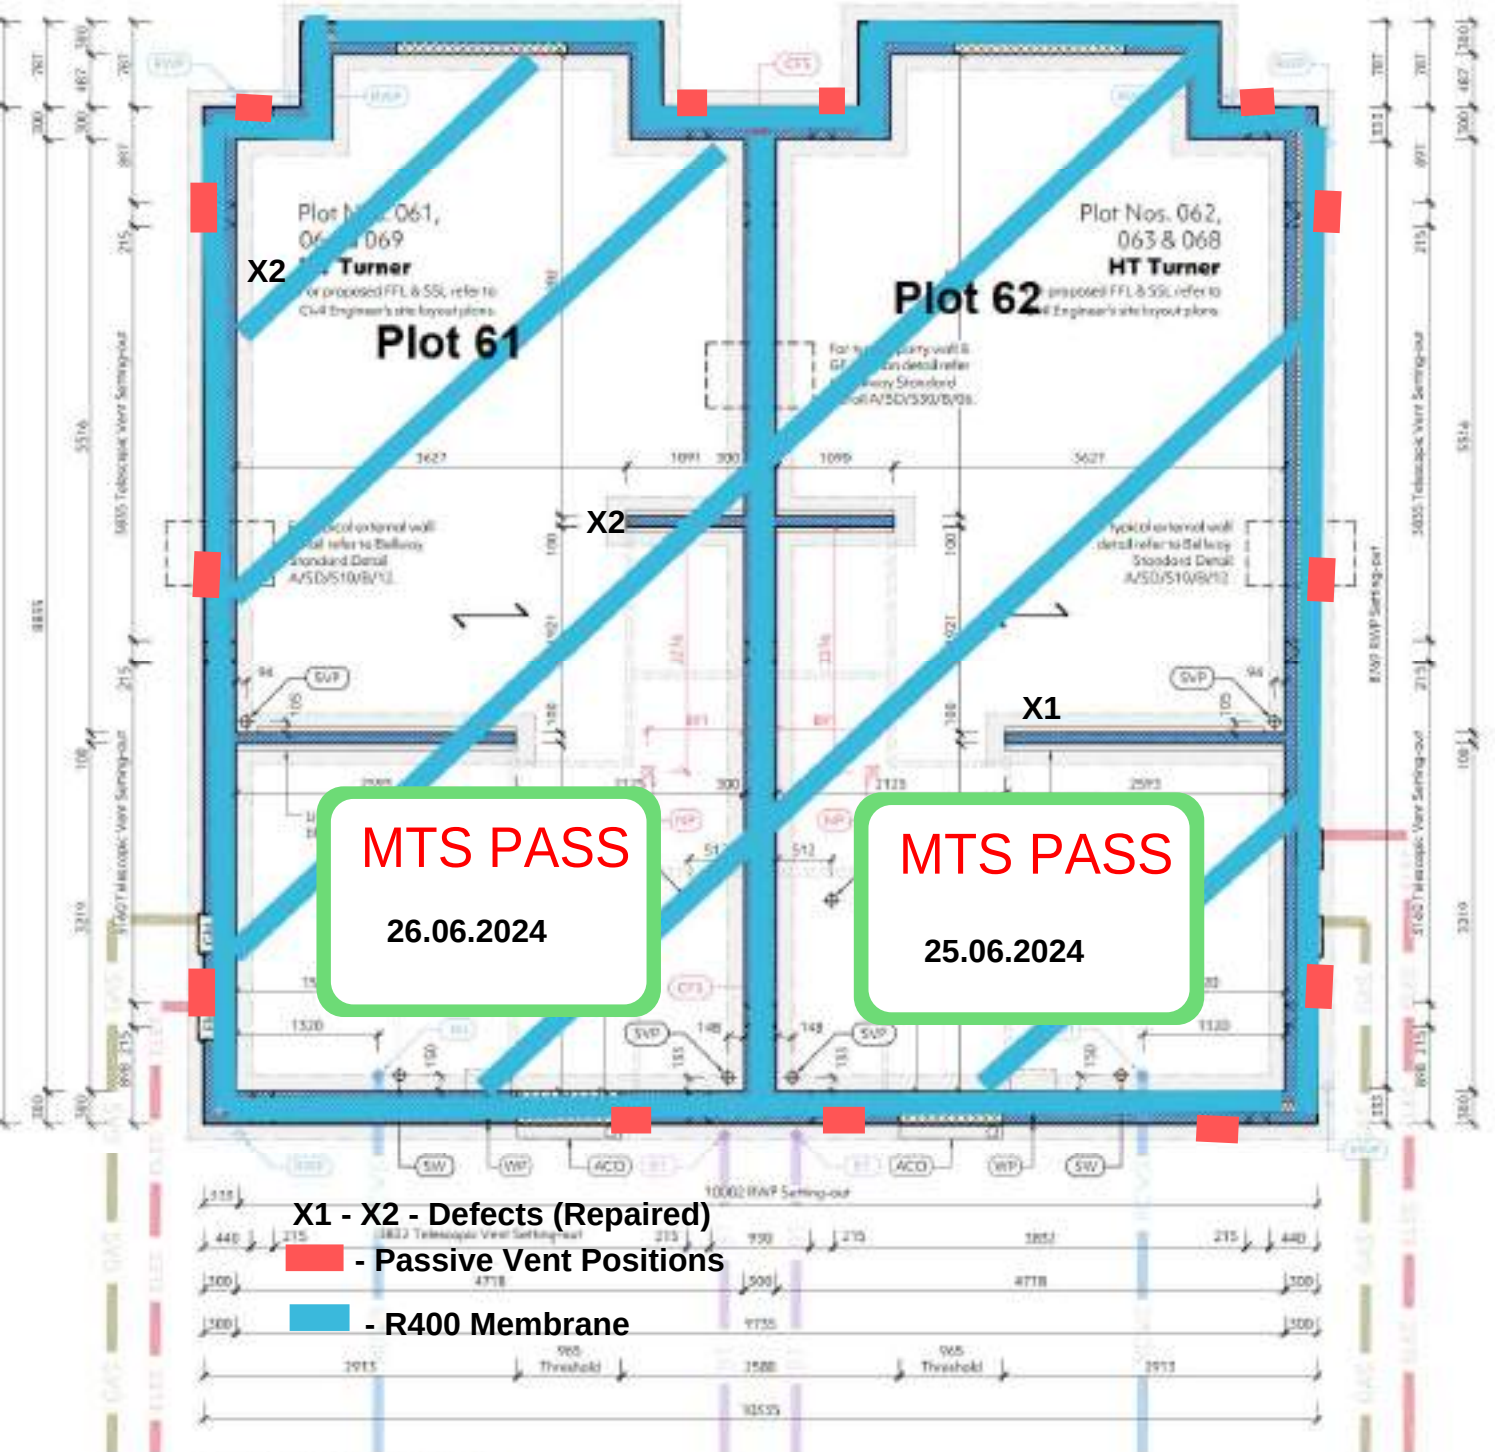
## MTS Mark-up

X1 - X2 - Defects (Repaired)

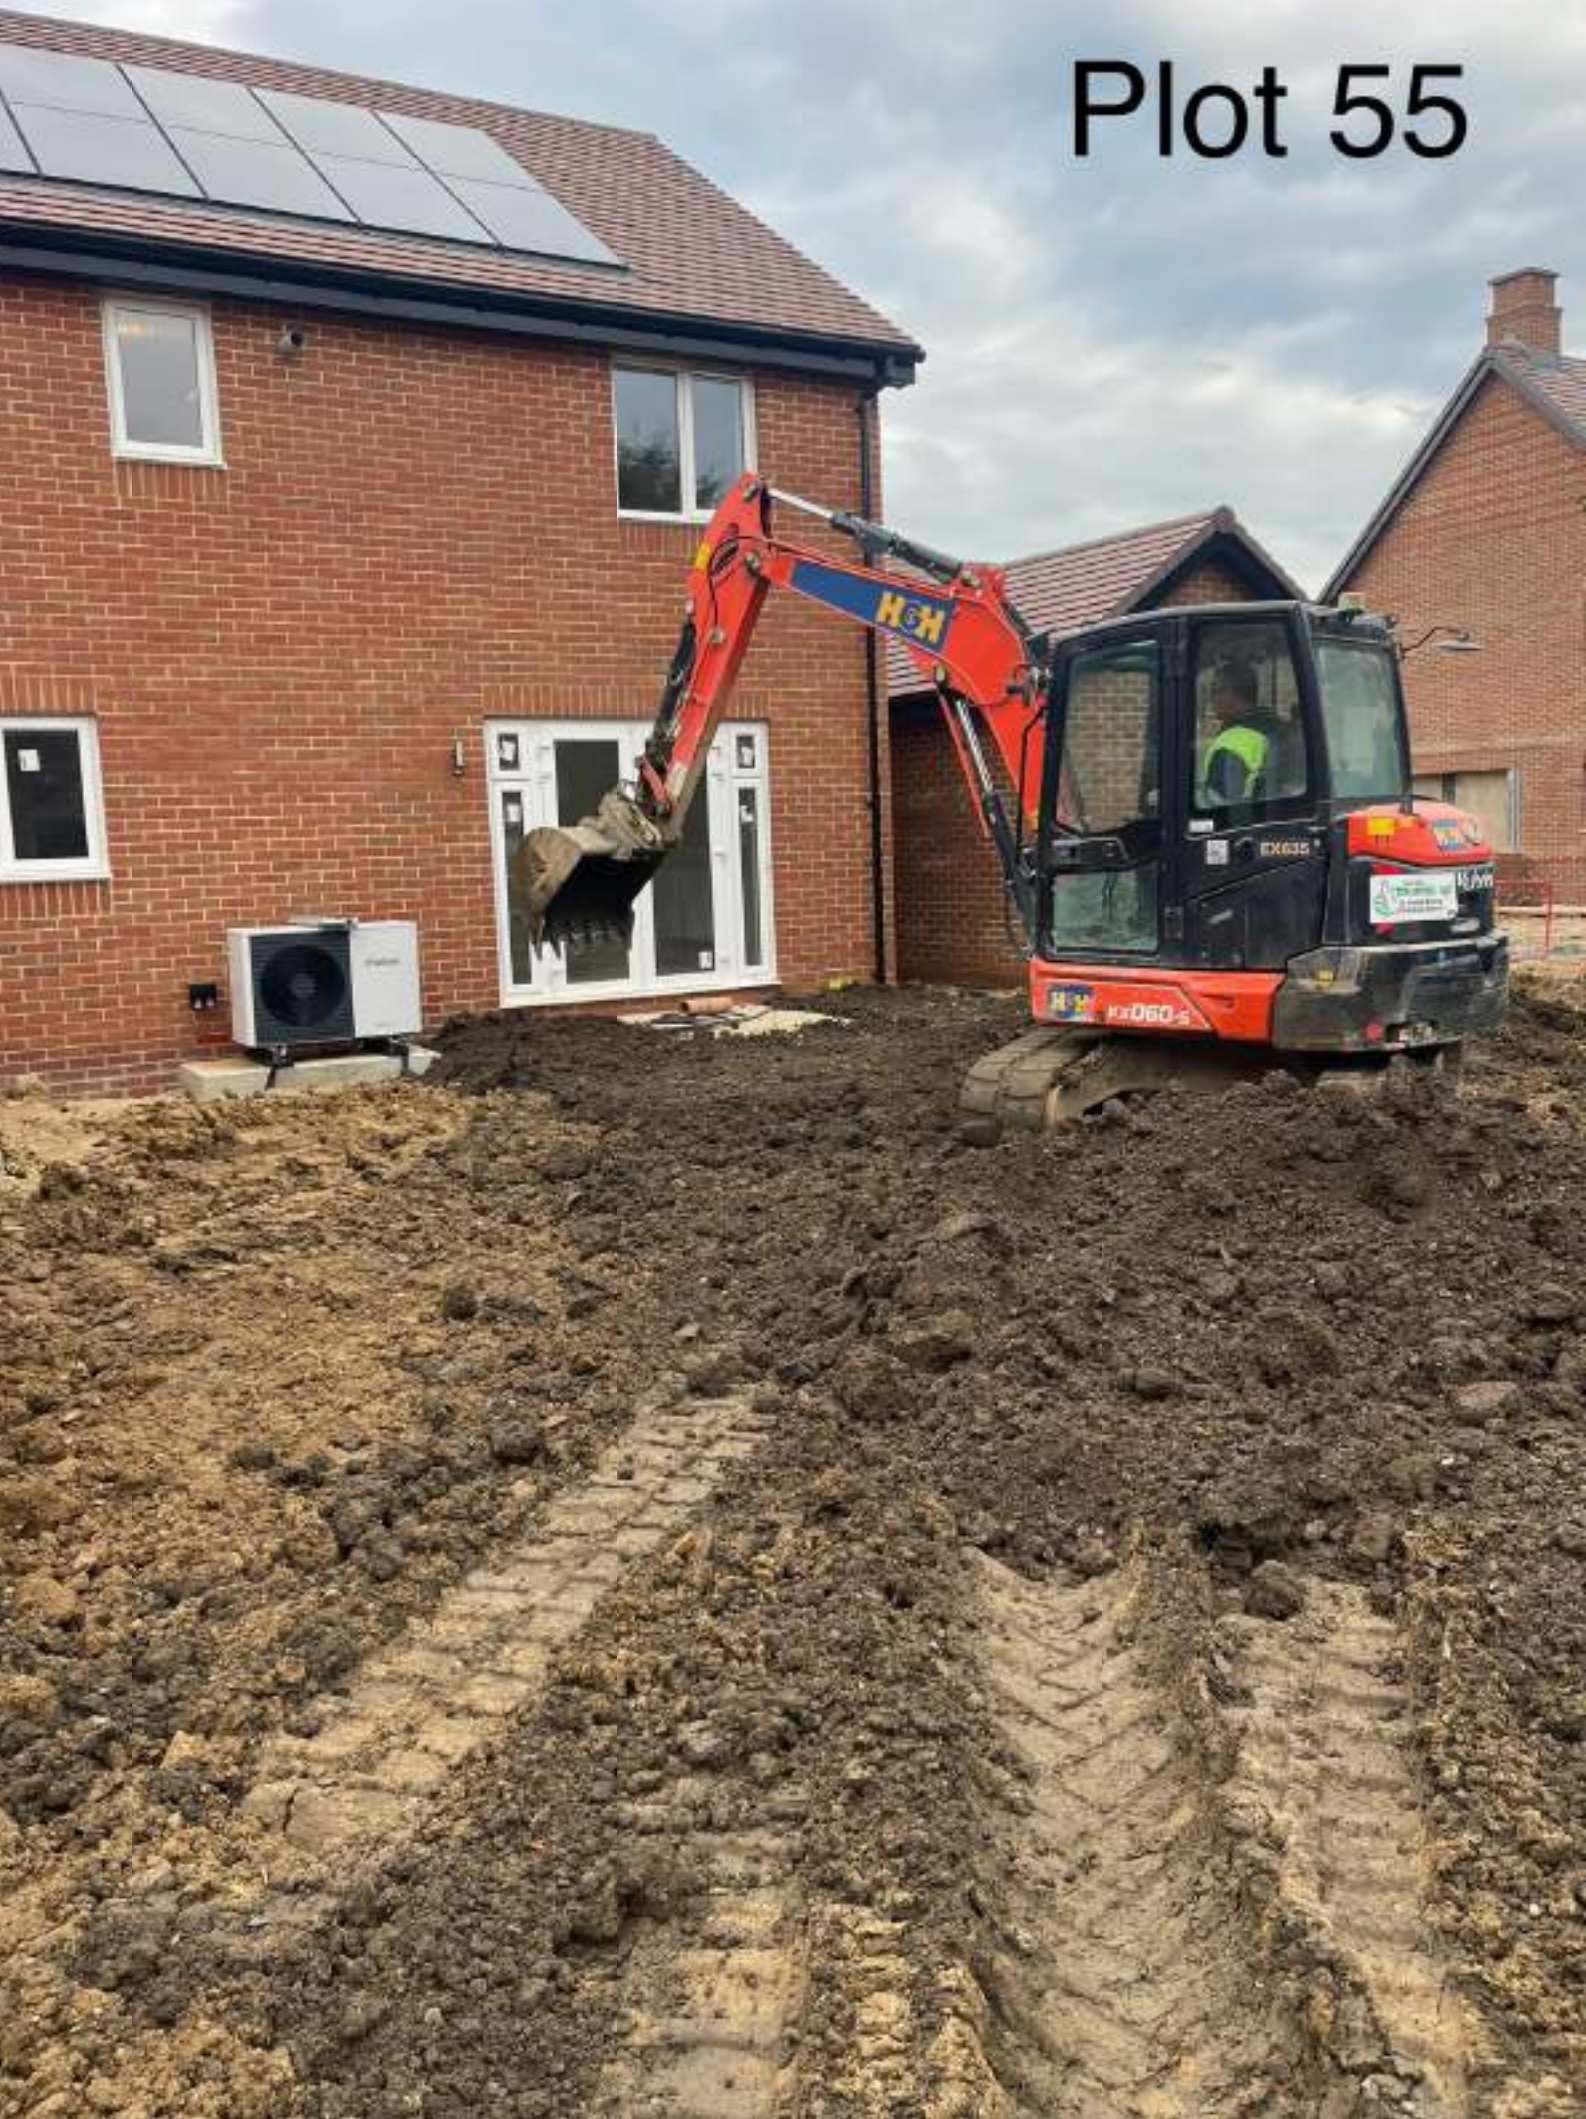
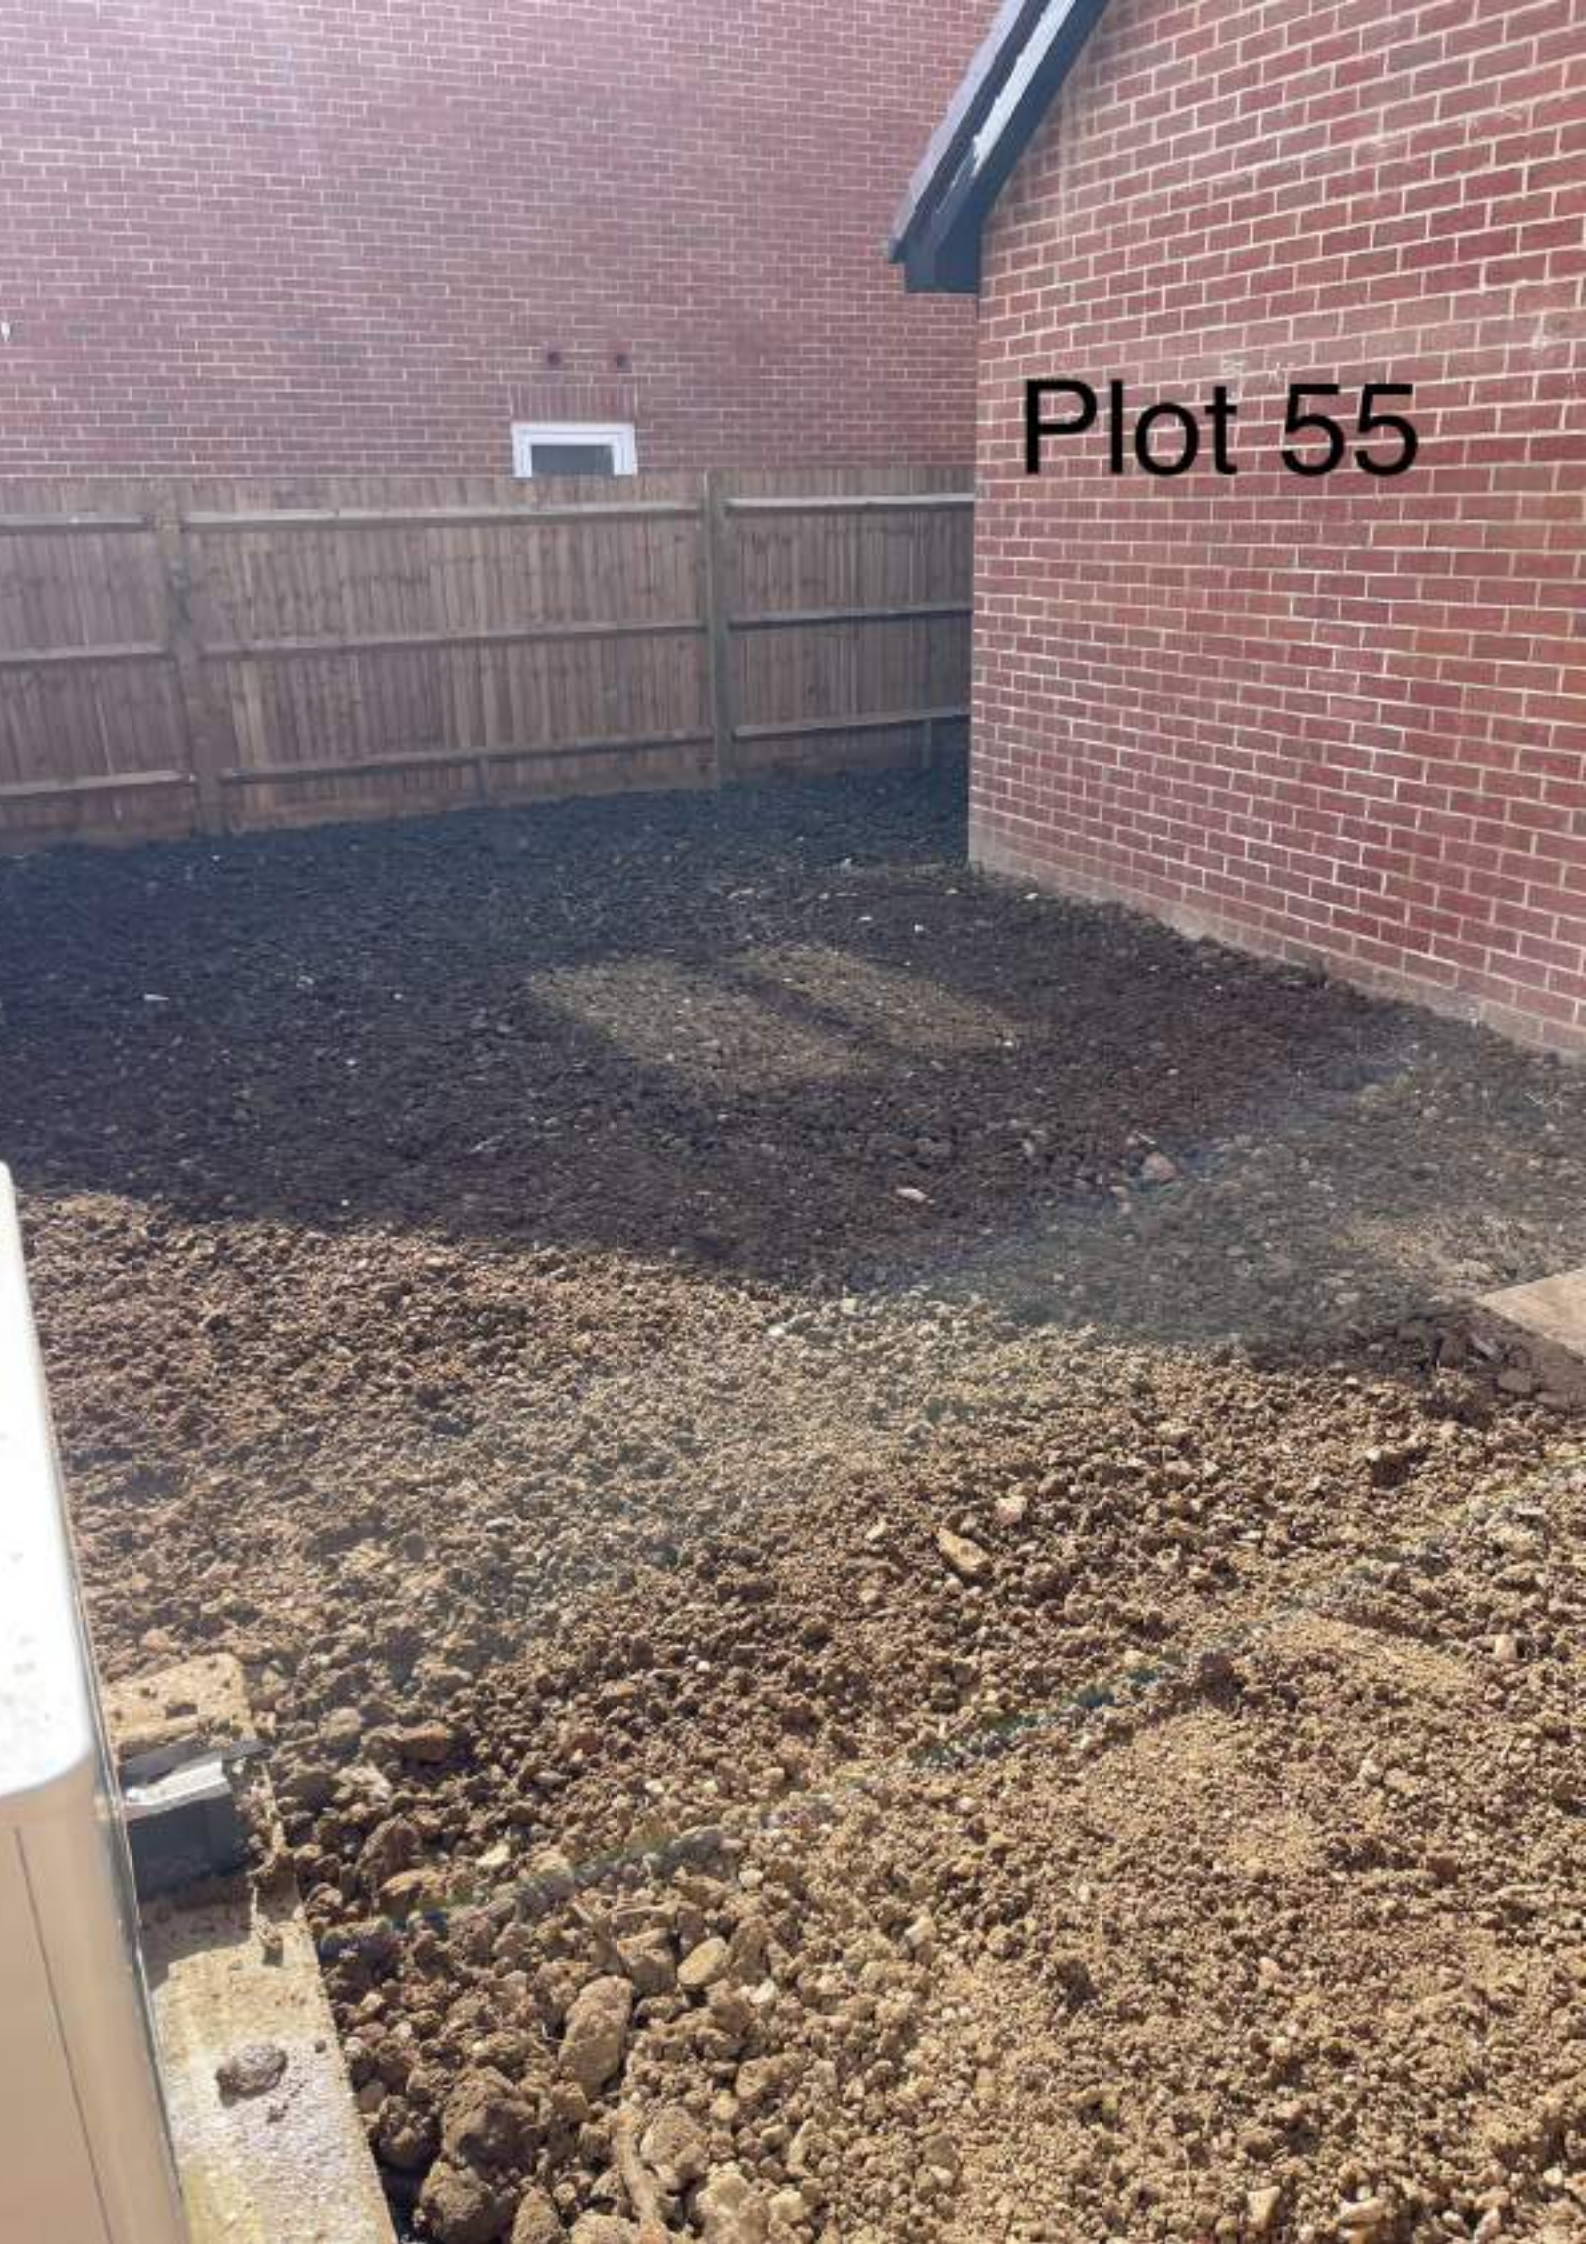
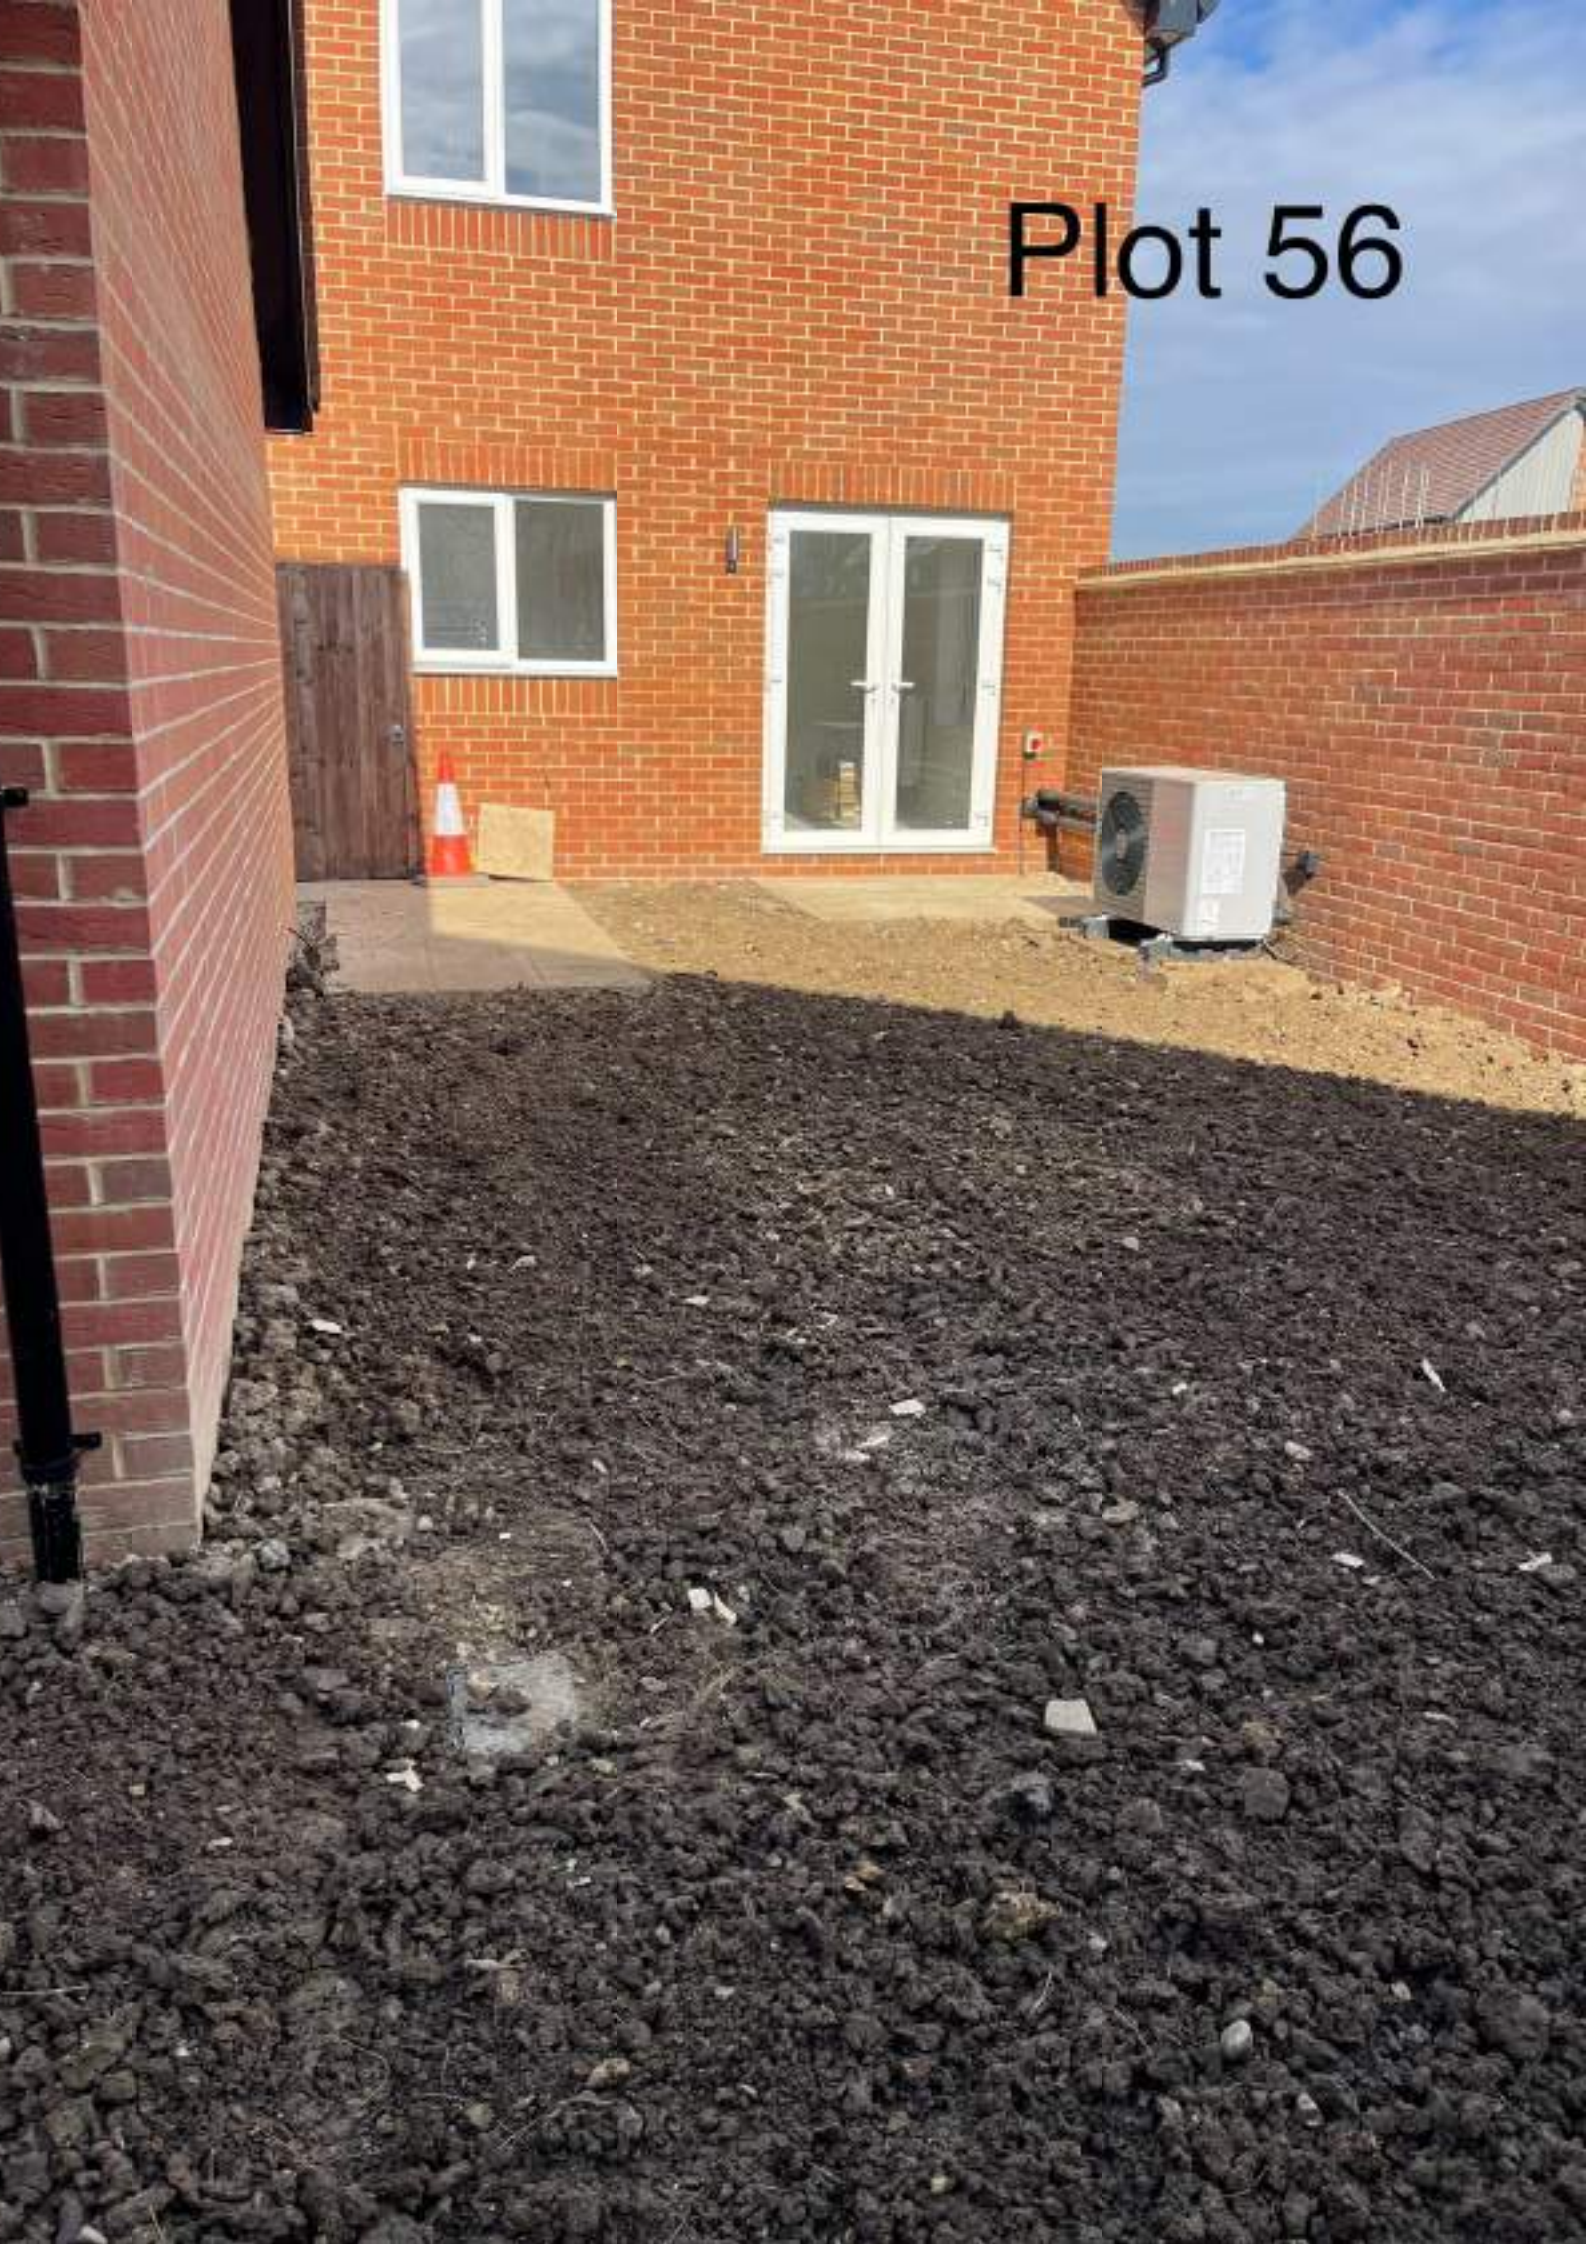
Plot 55

- 5.3.5 Since completion of plots where topsoil had not been placed during the site visit, the contractor has provided a photographic depth profile of the completed garden areas for Plots 55 and 56. These photos are included in the watching brief records in Appendix E.
- 5.3.6 General photos of plots provided by the contractor are included within Appendix I.
- 5.3.7 Given the observations on site, level of work observed, and photographic evidence provided, Soiltechnics are confident that our observations made in the previously inspected and tested areas of the site can be applied to the plots under consideration within this report.
