## Verification Report

Plots 74-77, 80-82, 91-93 Residential Development

Barrington Road, Worthing

Site: Barrington Road, Worthing  
Document Title: Verification Report  
Document no.: STV5959-R27-Rev\_A  
Date: April 2026  
Client: Bellway Homes Ltd (South London)  
Issuing office: Soiltechnics Ltd  
Cedar Barn, White Lodge, Walgrave, Northampton. NN6 9PY  
Tel: 01604 781 877 E-mail: [mail@soiltechnics.net](mailto:mail@soiltechnics.net)

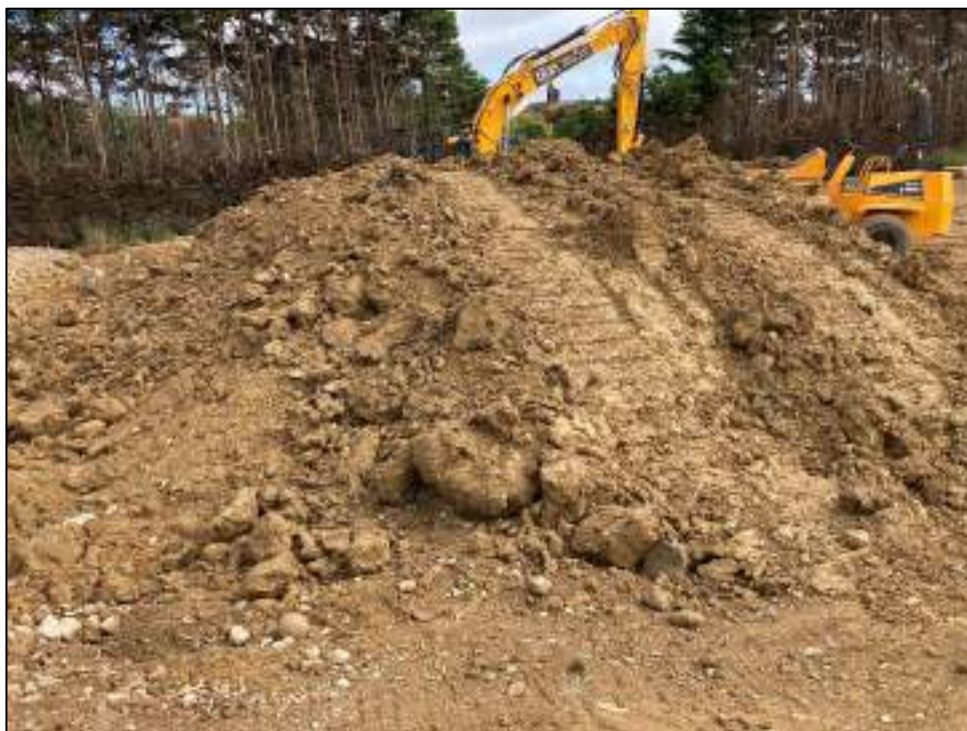
Figure 1: Billingshurst soil stockpile SL01

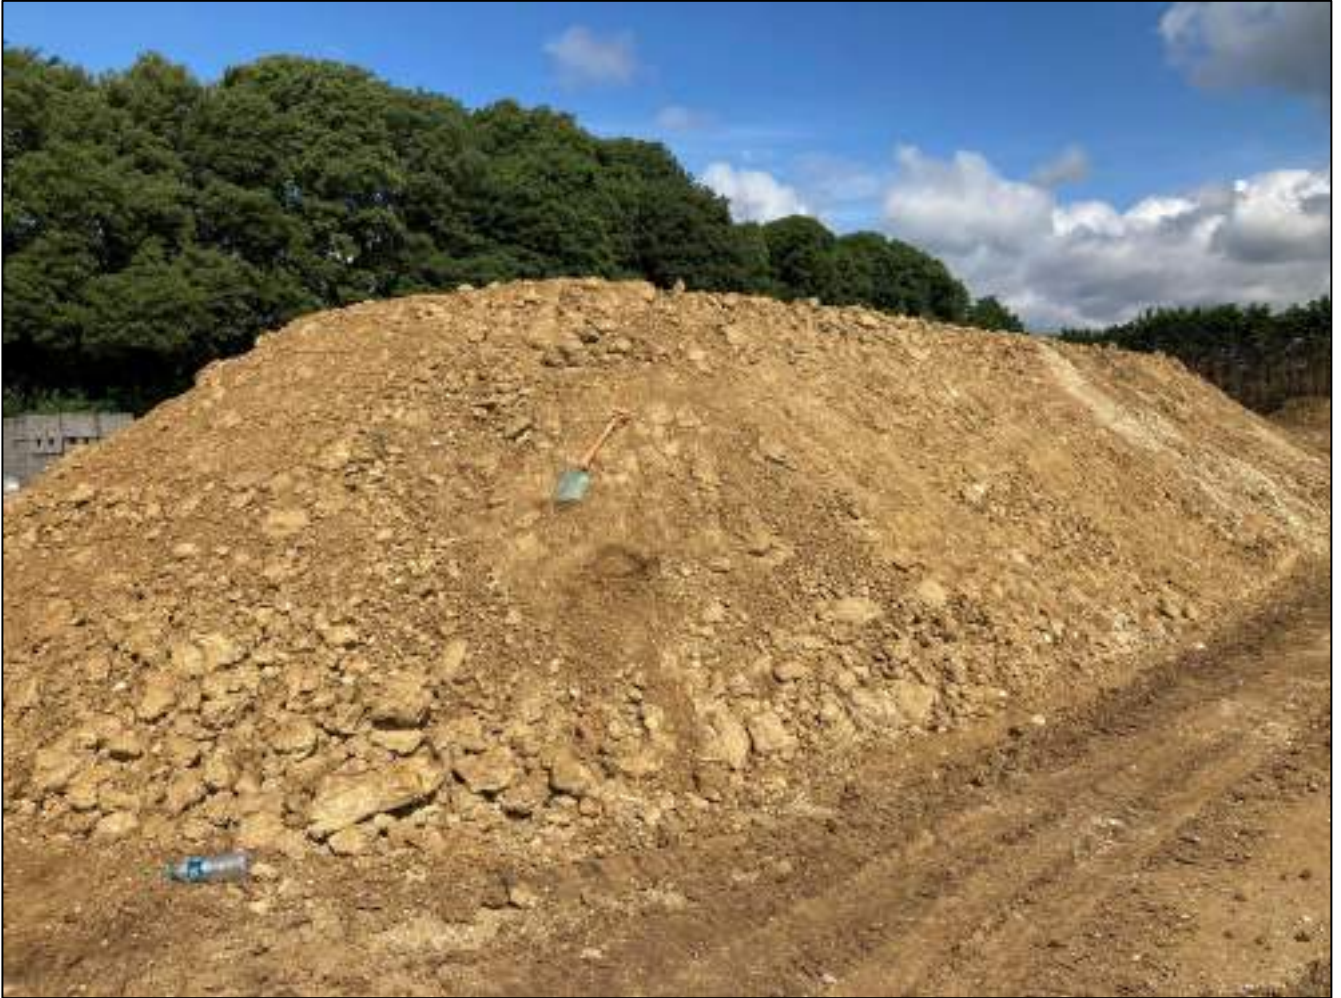
*Figure 2: Billingshurst soil stockpile SL02*

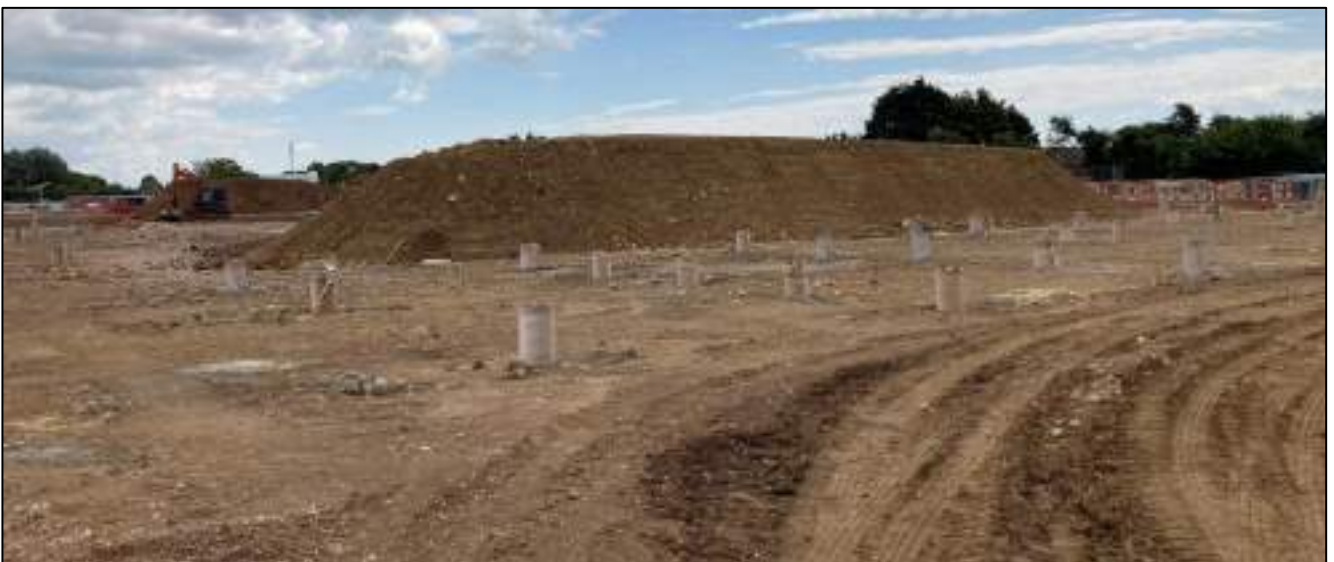
*Figure 3: Billingshurst soil stockpile SL03*

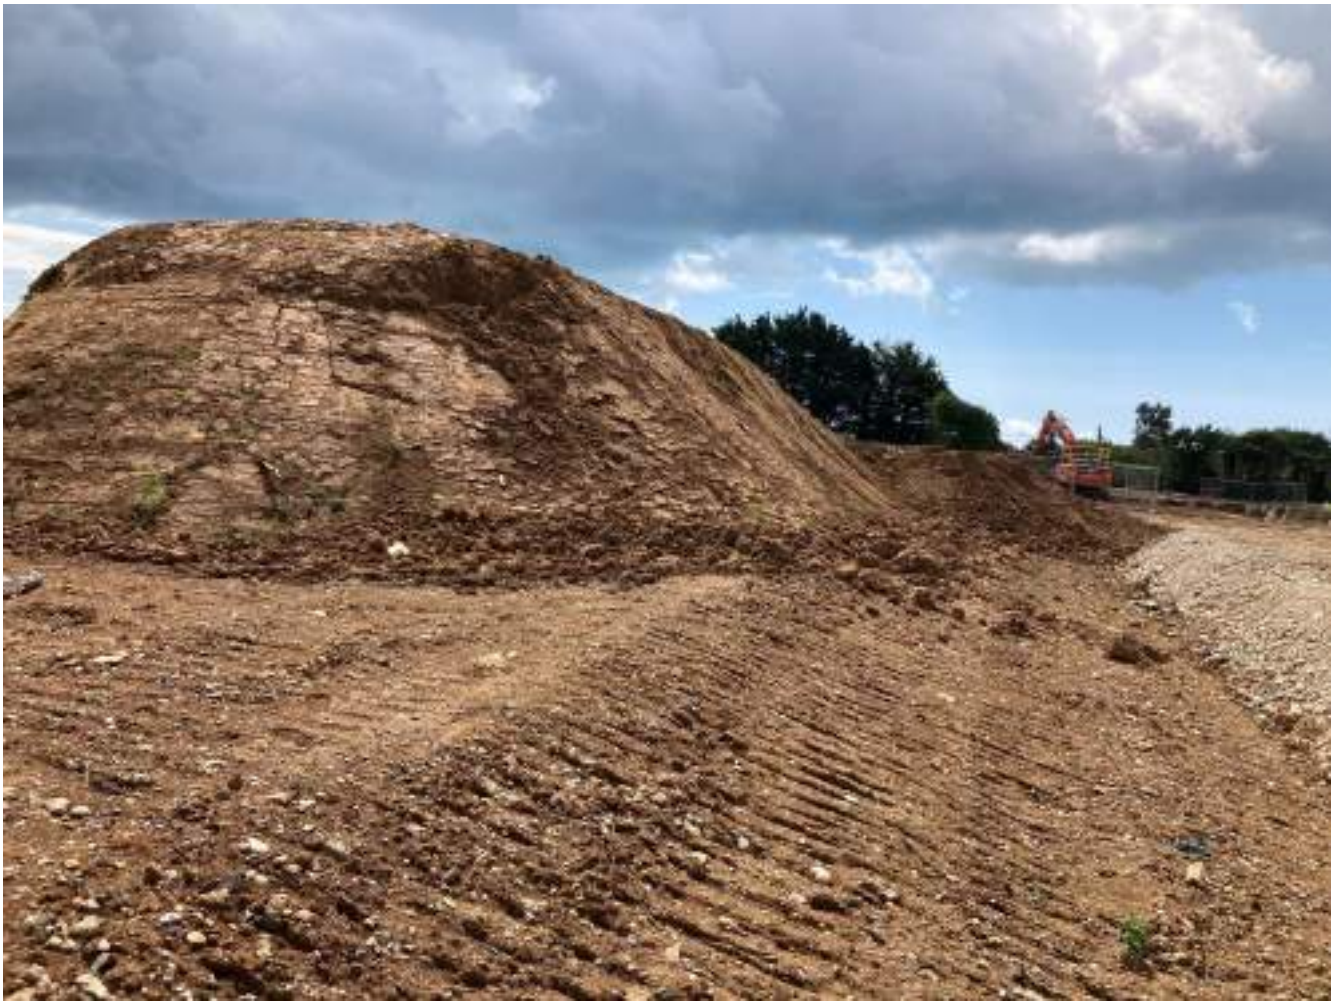
Figure 4: Billingshurst soil stockpile SL04/05

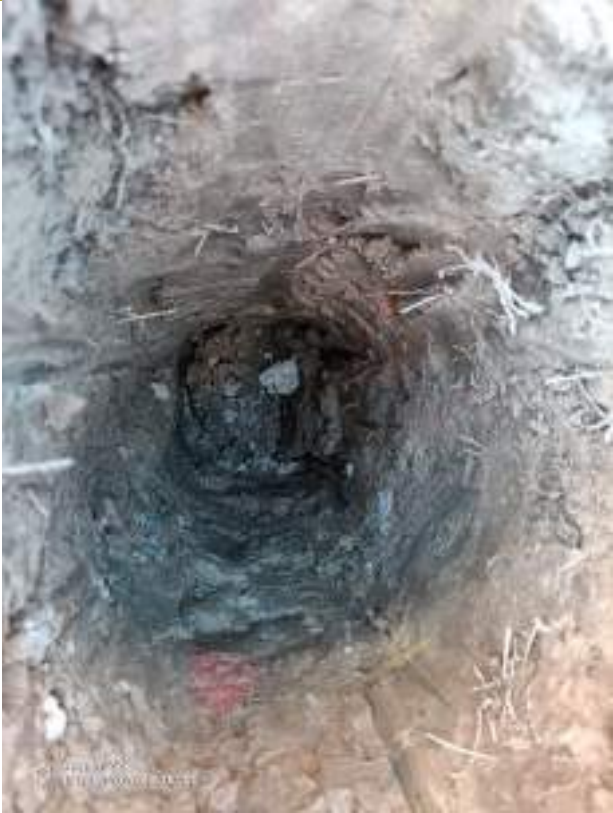
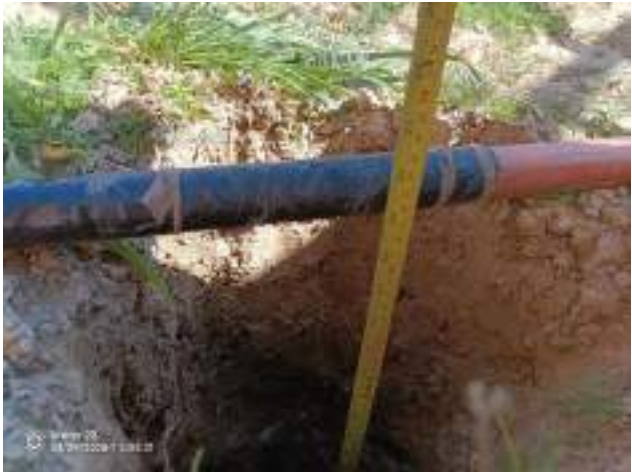
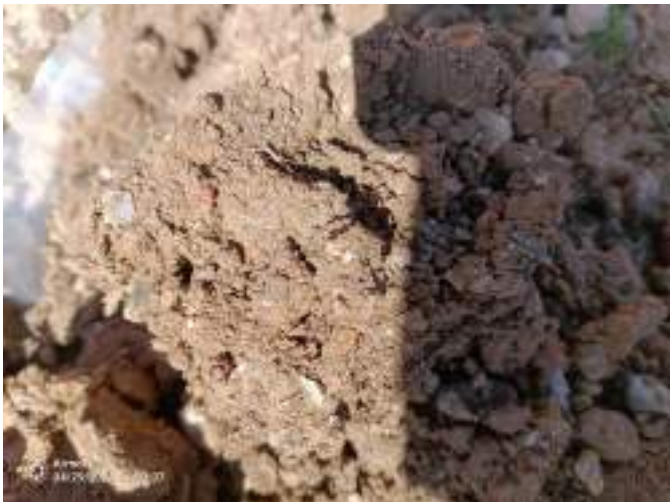
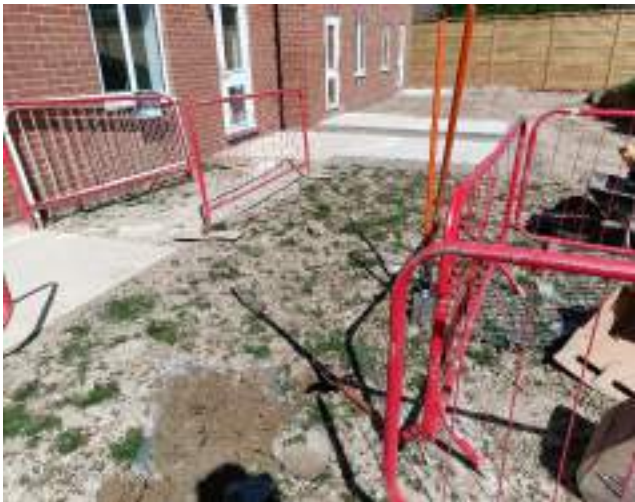
| Physical Suitability | Topsoil encountered as compact clay. No undesirable or injurious objects were observed within any of the materials inspected, such as sharps, metals, or over-sized materials, except for cobble-sized fragments of brick and concrete within the subsoil. Whilst undesirable this does not present a risk of harm to the end users. | | |

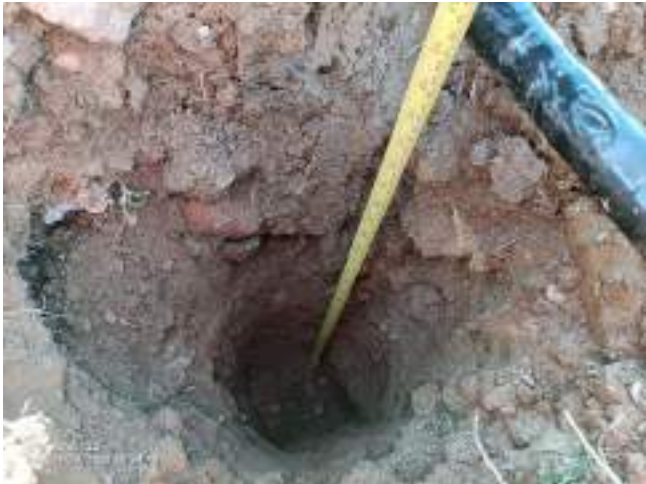
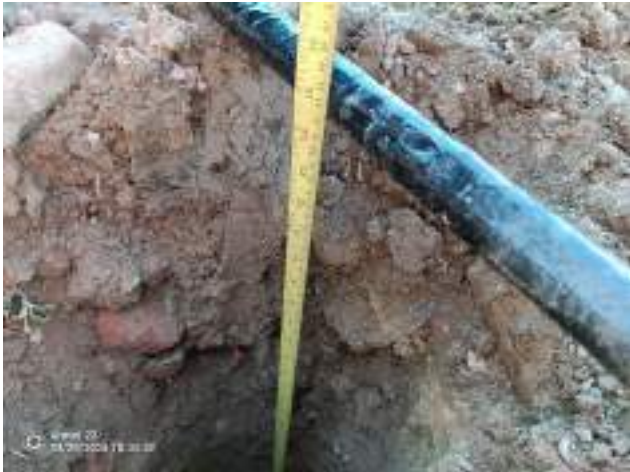
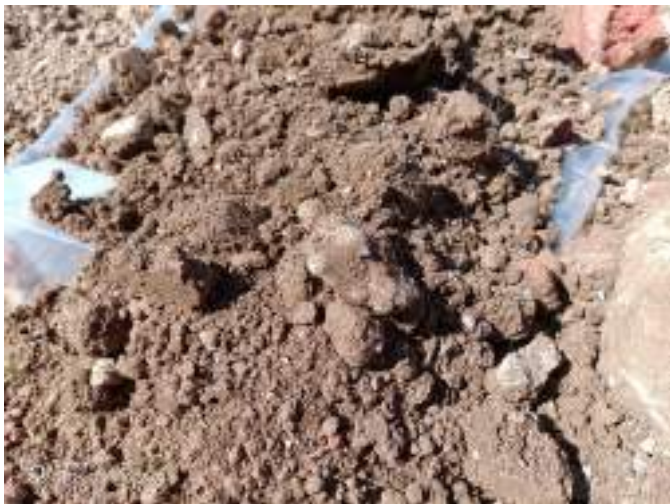
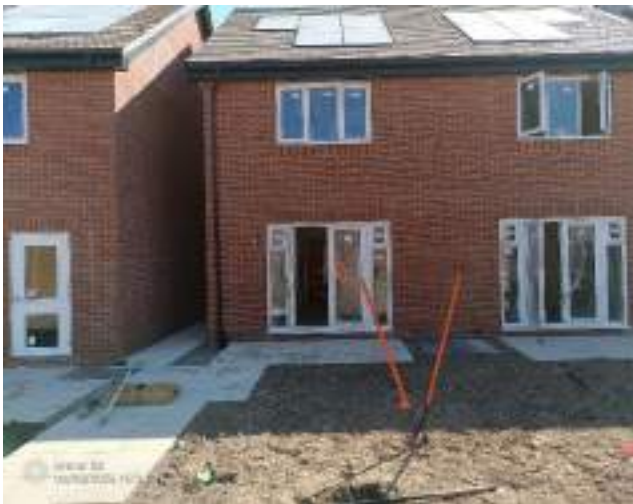
| Physical Suitability | Topsoil encountered as compact clay. No undesirable or injurious objects were observed within any of the materials inspected, such as sharps, metals, or over-sized materials, except for cobble-sized fragments of brick and concrete within the subsoil. Whilst undesirable this does not present a risk of harm to the end users. | | |

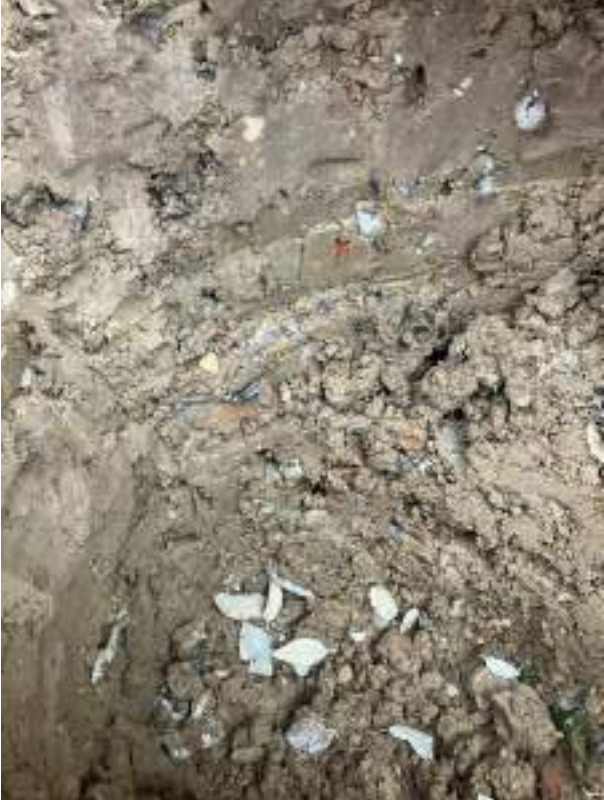
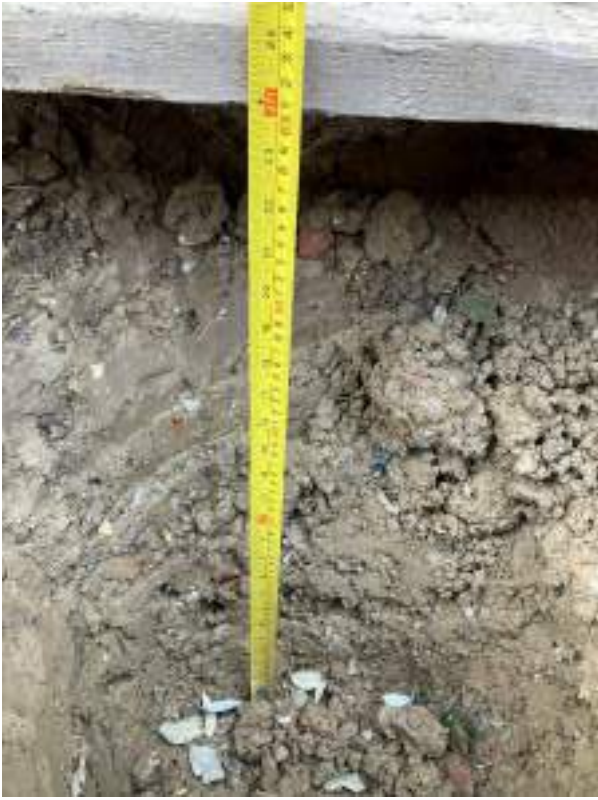
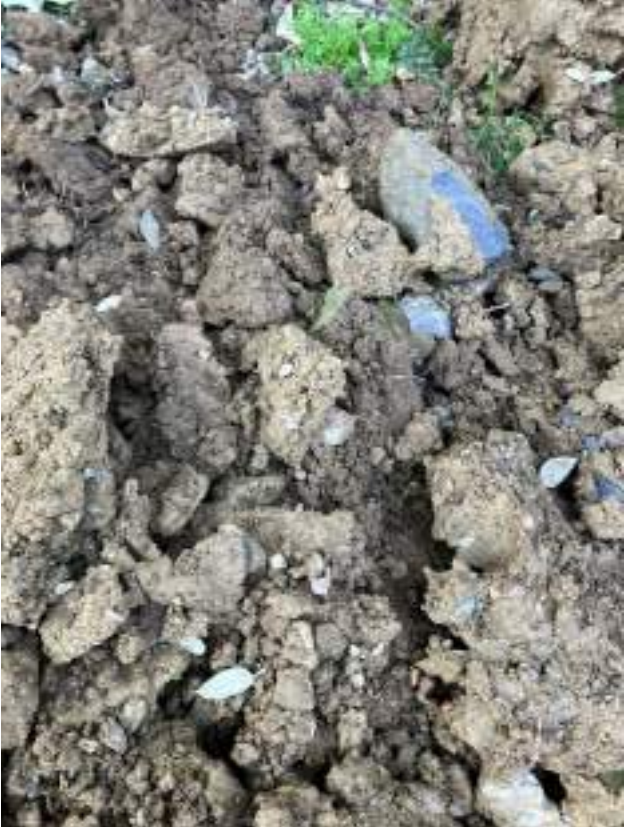
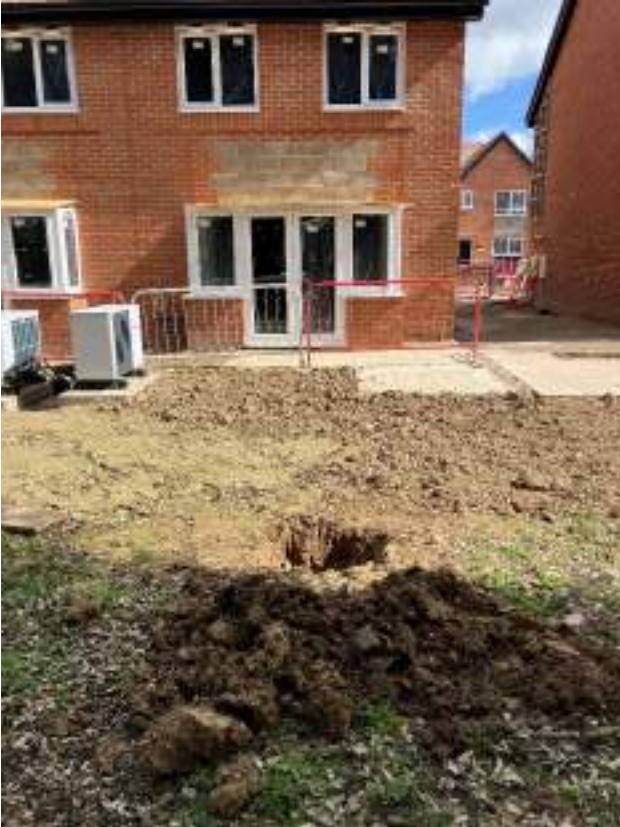
| Physical Suitability | Topsoil encountered as compact clay. No undesirable or injurious objects were observed within any of the materials inspected, such as sharps, metals, or over-sized materials, except for cobble-sized fragments of brick and concrete within the subsoil. | | |

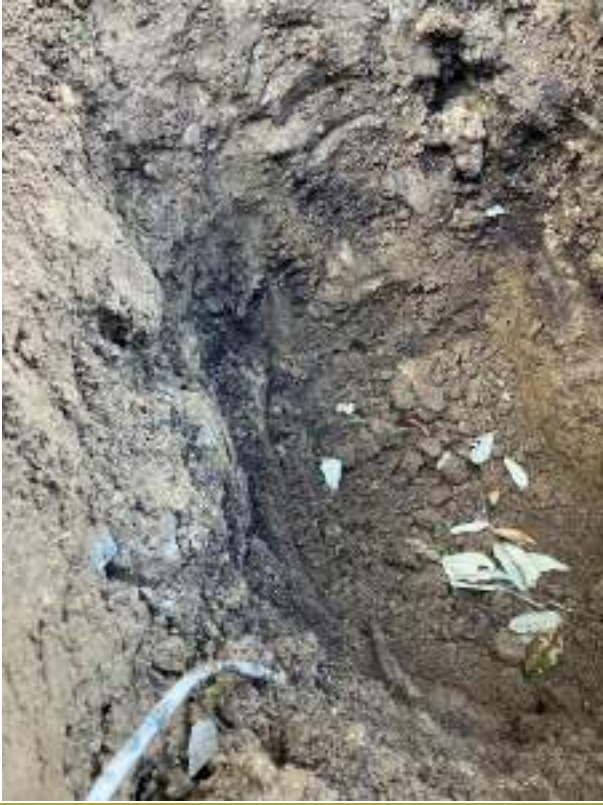
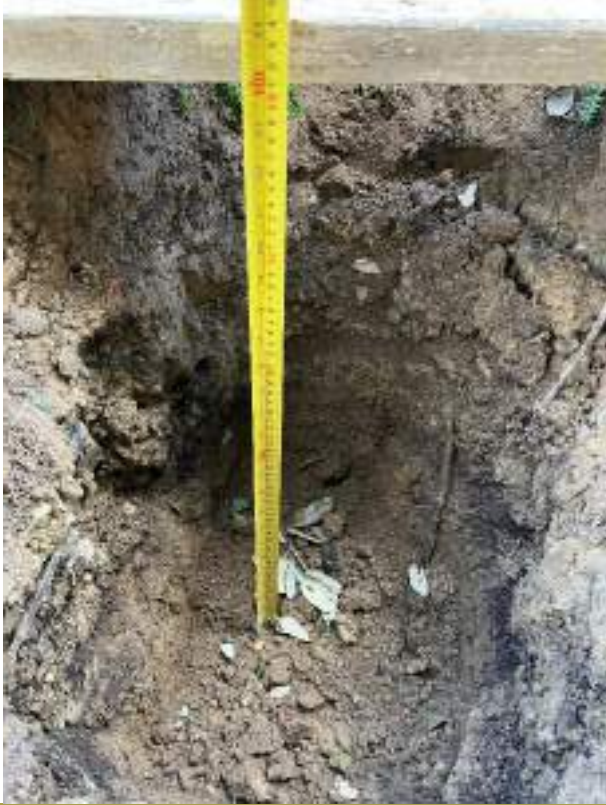
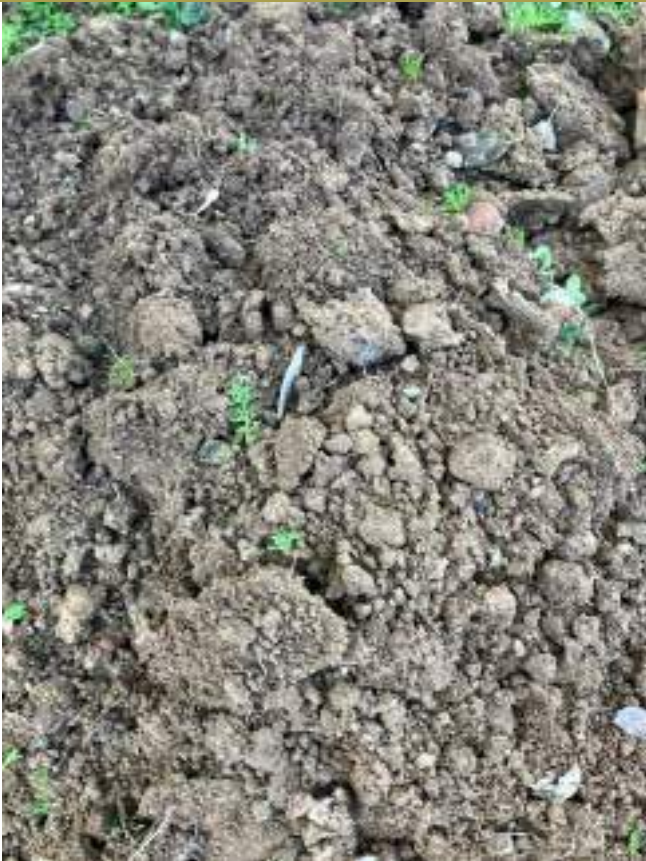
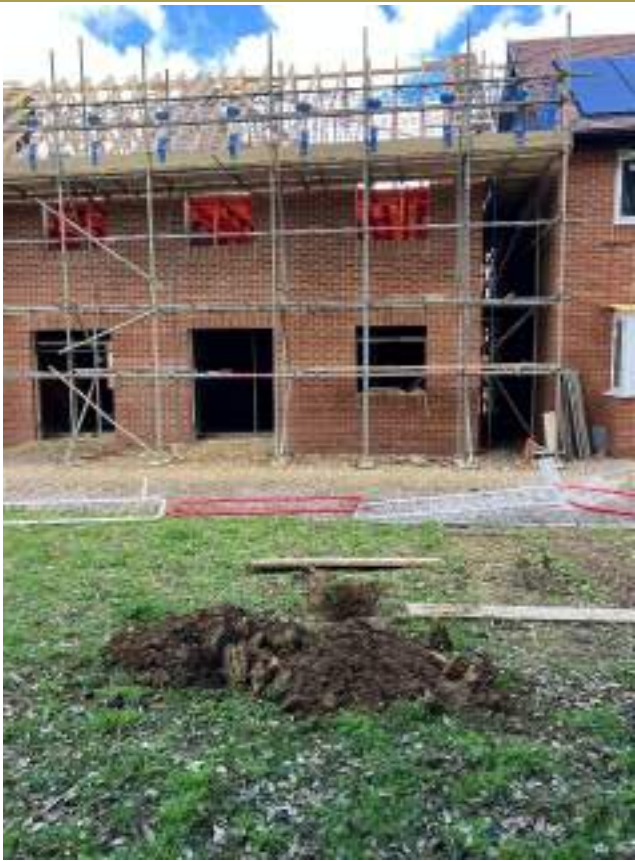
| Physical Suitability | Topsoil encountered as compact clay. No undesirable or injurious objects were observed within any of the materials inspected, such as sharps, metals, or over-sized materials, except for cobble-sized fragments of brick and concrete within the subsoil. | | |

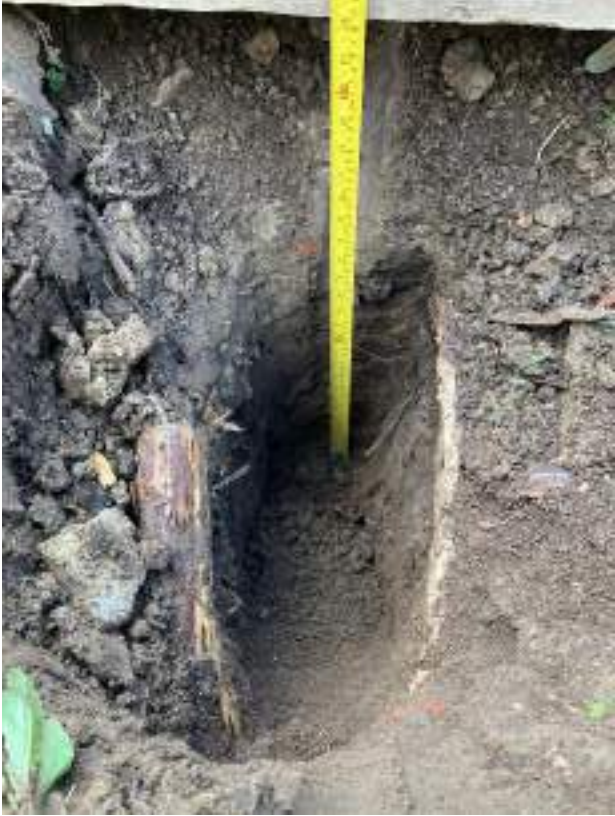
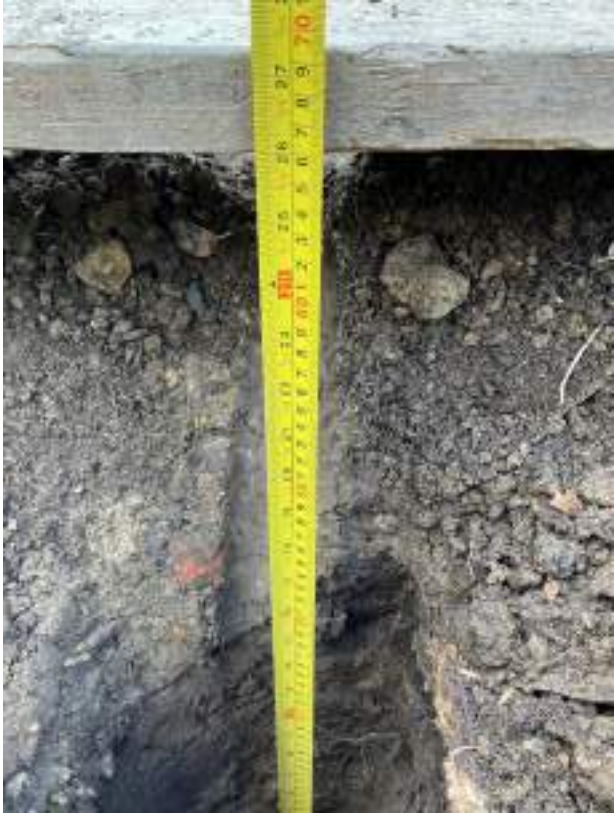
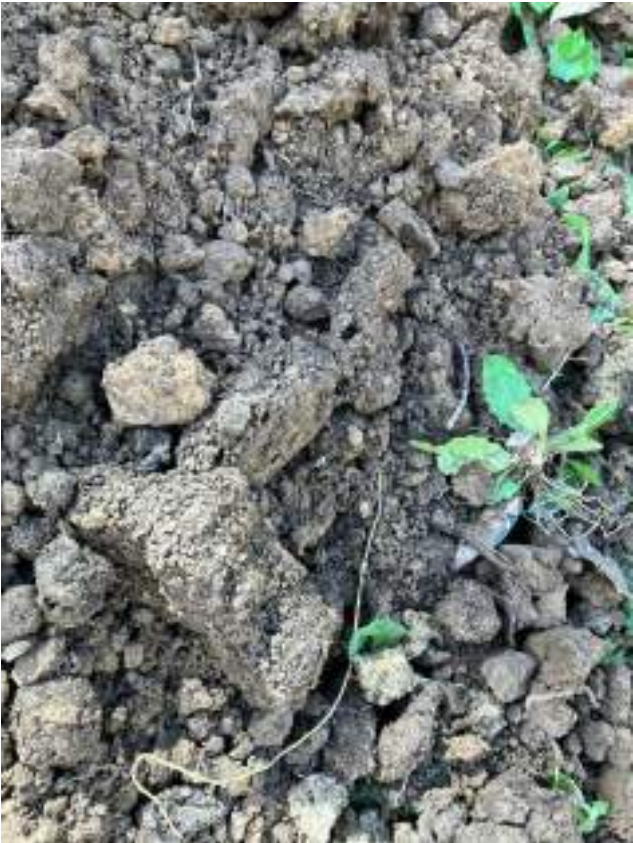
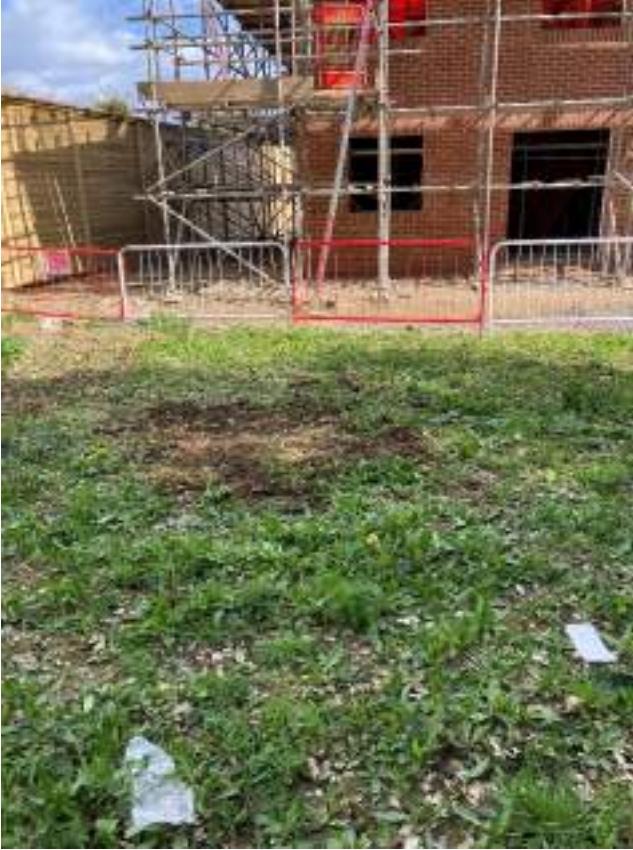
| Physical Suitability | Topsoil encountered as sandy clay. No undesirable or injurious objects were observed within any of the materials inspected, such as sharps, metals, or over-sized materials, except for cobble-sized fragments of brick, concrete and wood within the subsoil. Whilst undesirable, this does not pose a risk to end users. | | |
