## Verification Report

Plots 78, 79, 94-101 Residential Development

Barrington Road, Worthing

Site: Barrington Road, Worthing  
Document Title: Verification Report  
Document no.: STV5959-R28-Rev\_A  
Date: May 2026  
Client: Bellway Homes Ltd (South London)  
Issuing office: Soiltechnics Ltd  
Cedar Barn, White Lodge, Walgrave, Northampton. NN6 9PY  
Tel: 01604 781 877 E-mail: [mail@soiltechnics.net](mailto:mail@soiltechnics.net)

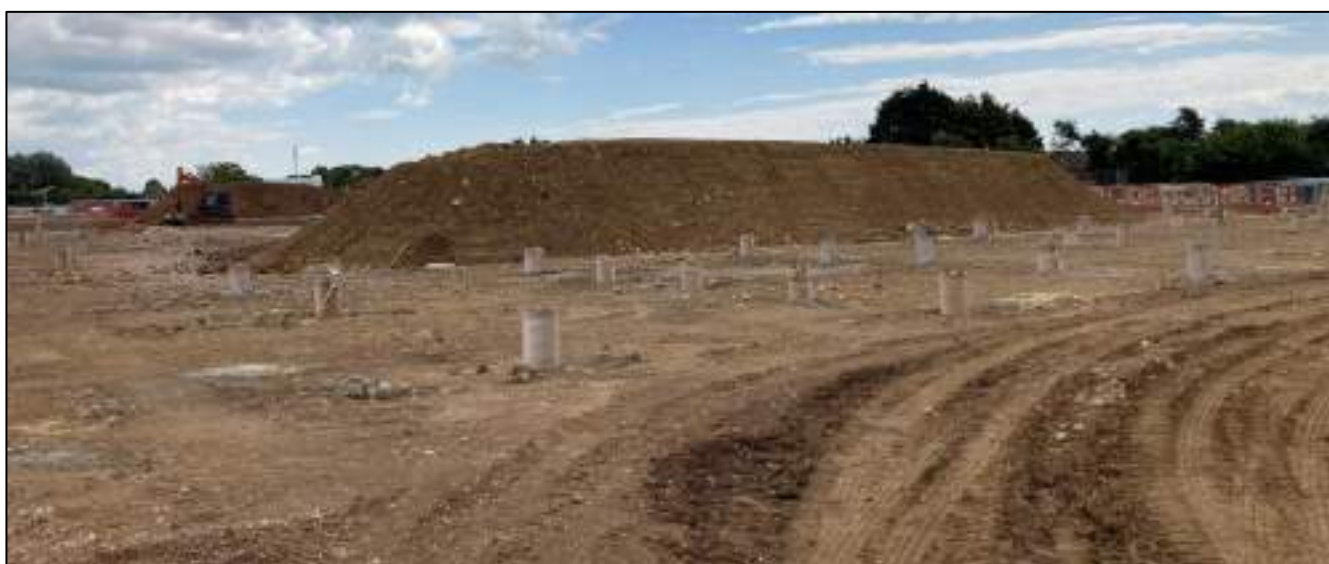
*Figure 3: Billingshurst soil stockpile SL03*

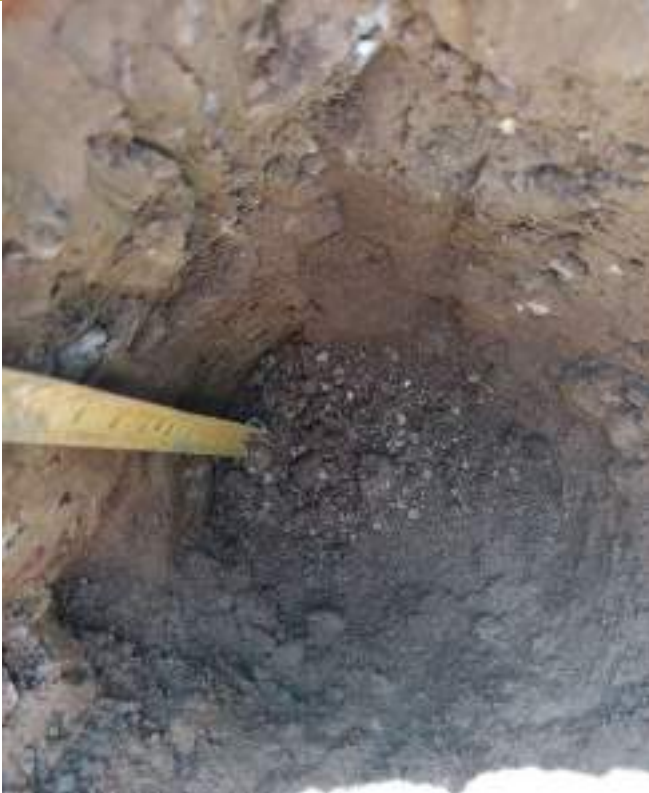
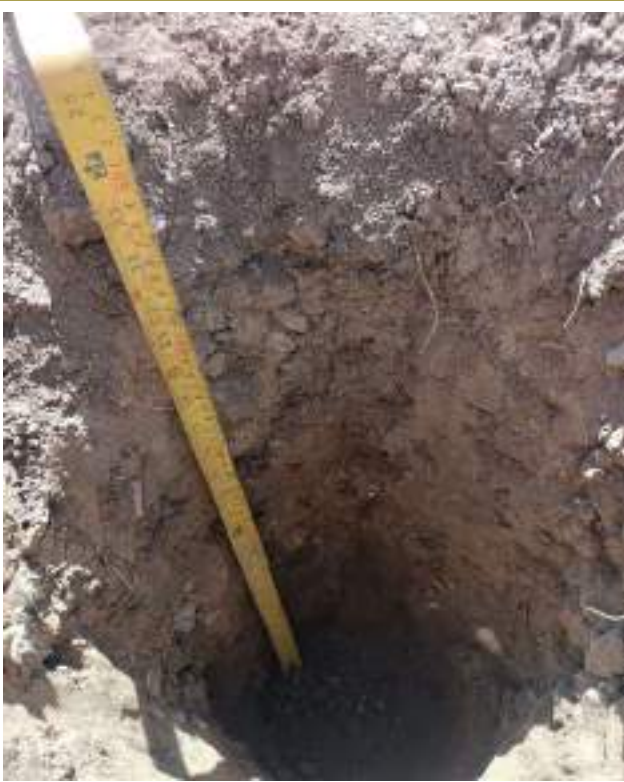
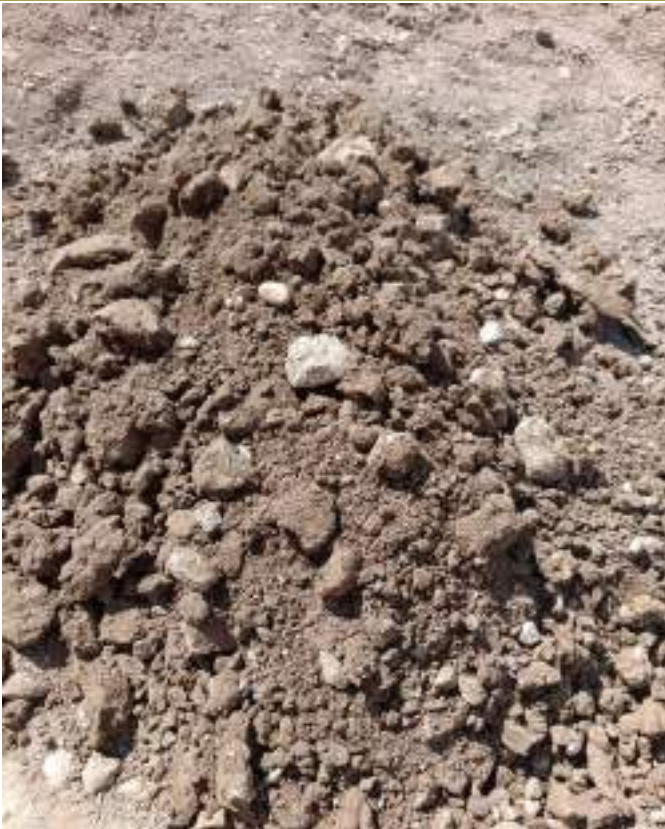
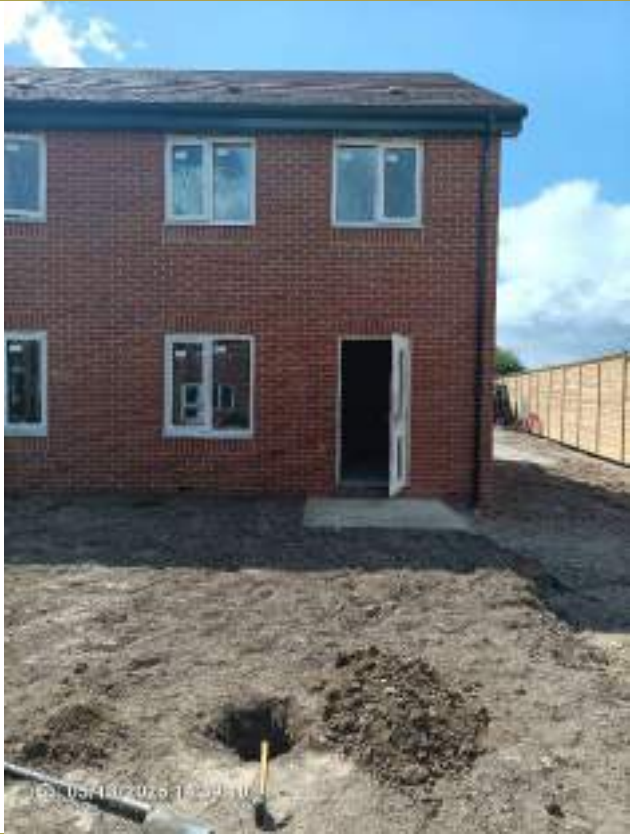
| Physical Suitability | No undesirable or injurious objects were observed within any of the materials inspected, such as sharps, metals, plastics or over-sized materials, except for a few cobble-sized fragments of brick and concrete within the subsoil. | | |

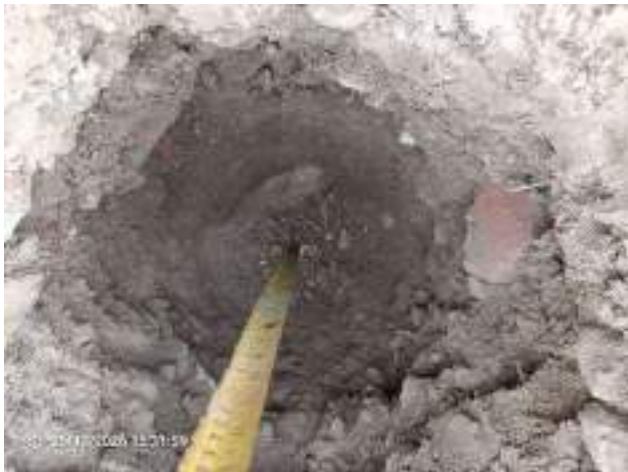
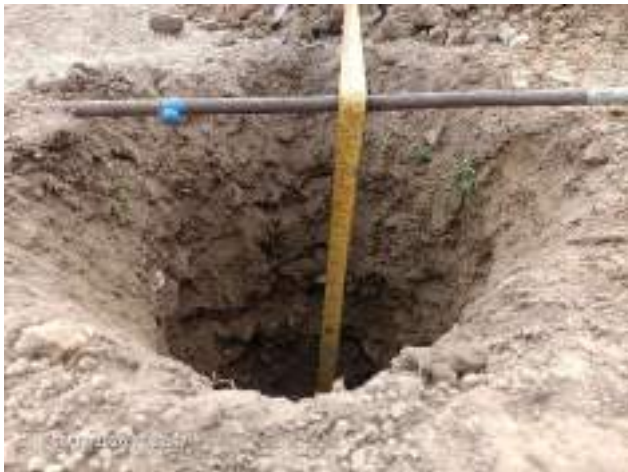
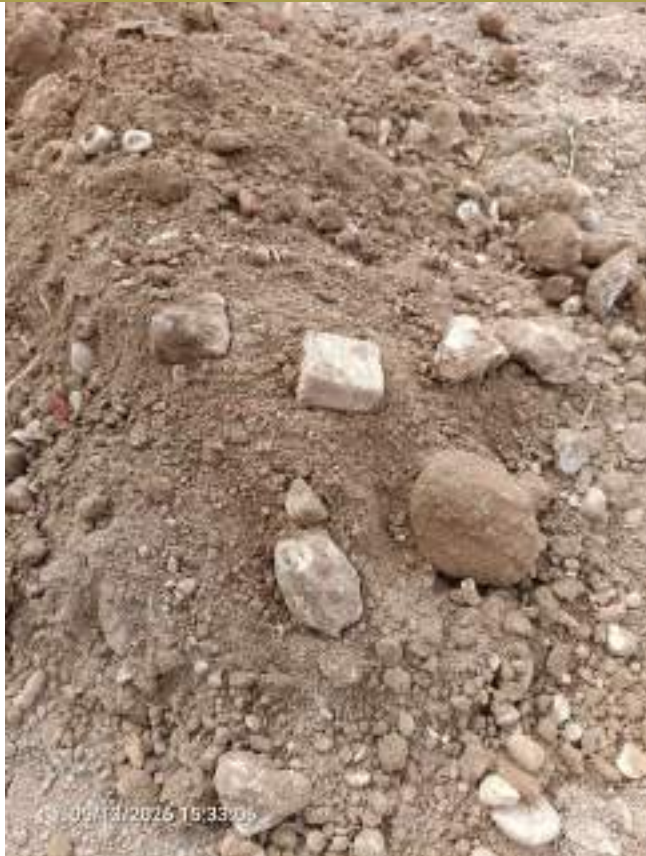
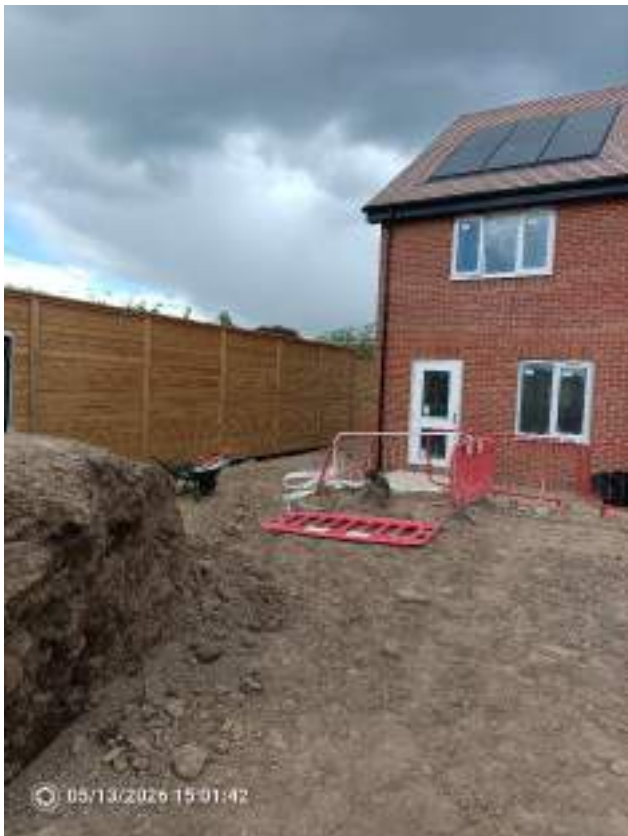
| Physical Suitability | No undesirable or injurious objects were observed within any of the materials inspected, such as sharps, metals, plastics or over-sized materials, except for a few cobble-sized fragments of brick and concrete within the subsoil. | | |

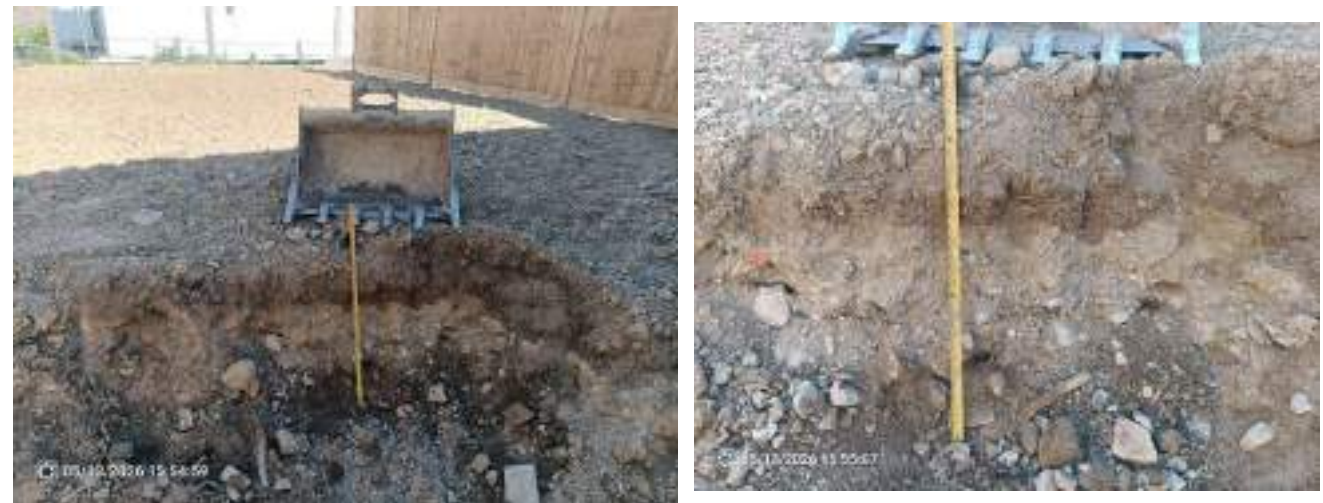
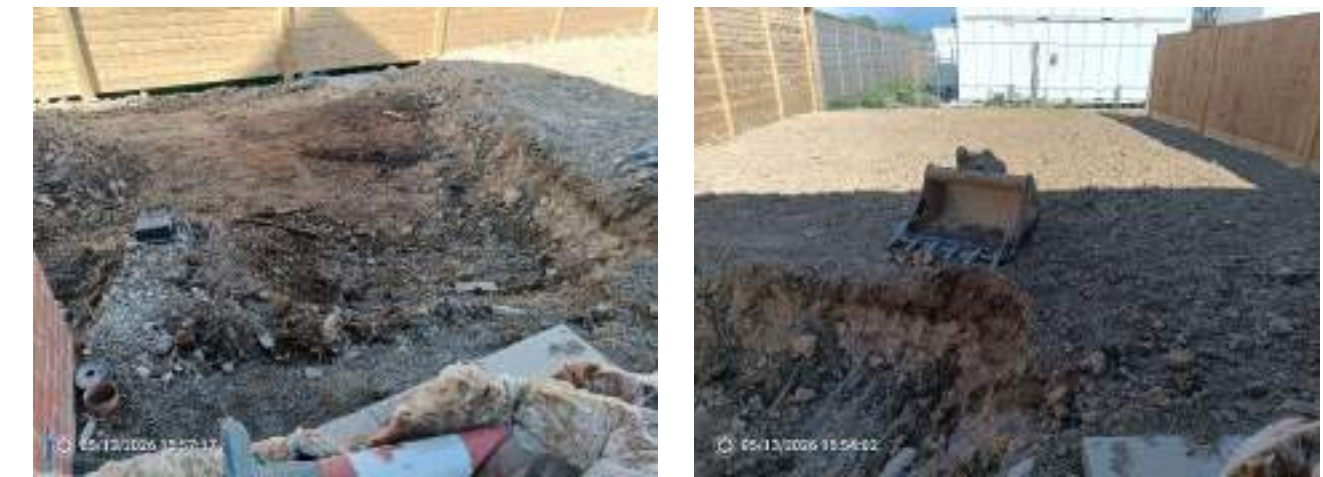
| Physical Suitability | No undesirable or injurious objects were observed within any of the materials inspected, such as sharps, metals, plastics or over-sized materials, except for a few cobble-sized fragments of brick and concrete within the subsoil. | | |

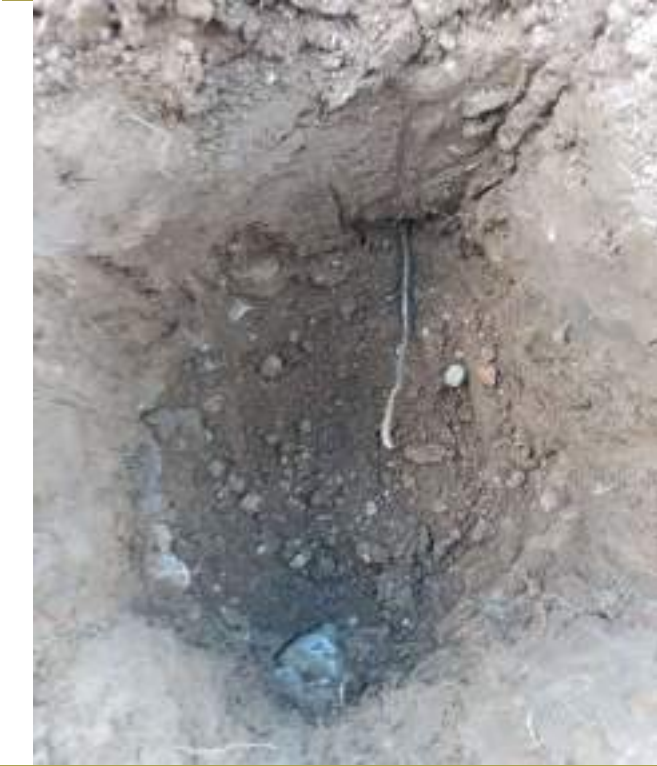
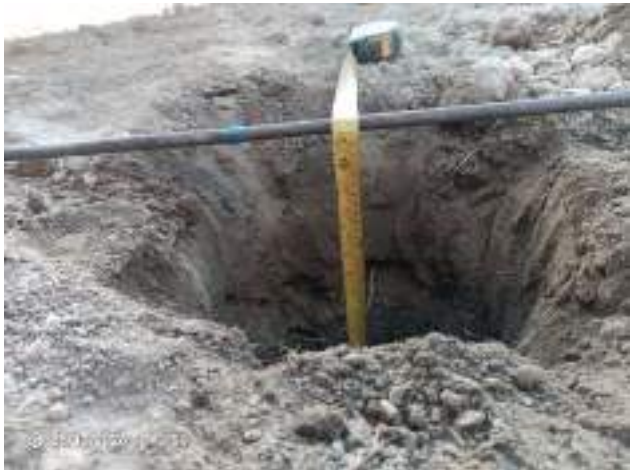
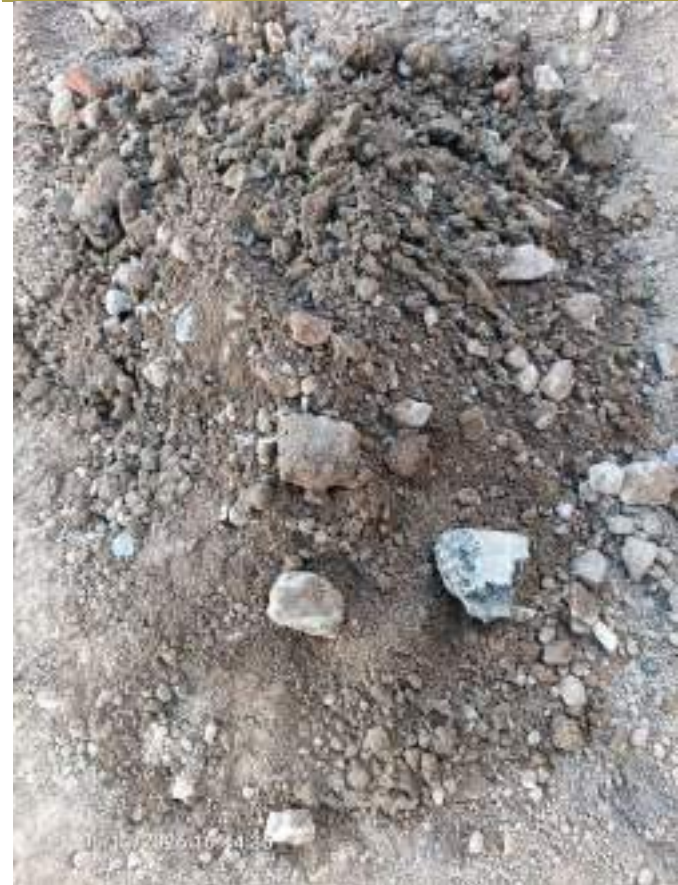
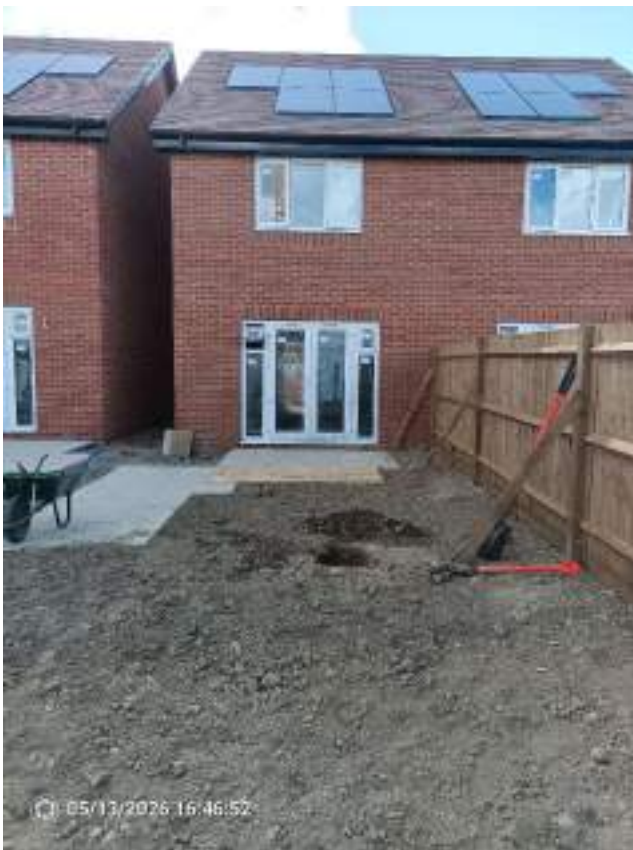
| Physical Suitability | No undesirable or injurious objects were observed within any of the materials inspected, such as sharps, metals, plastics or over-sized materials, except for a few cobble-sized fragments of brick and concrete within the subsoil. | | |

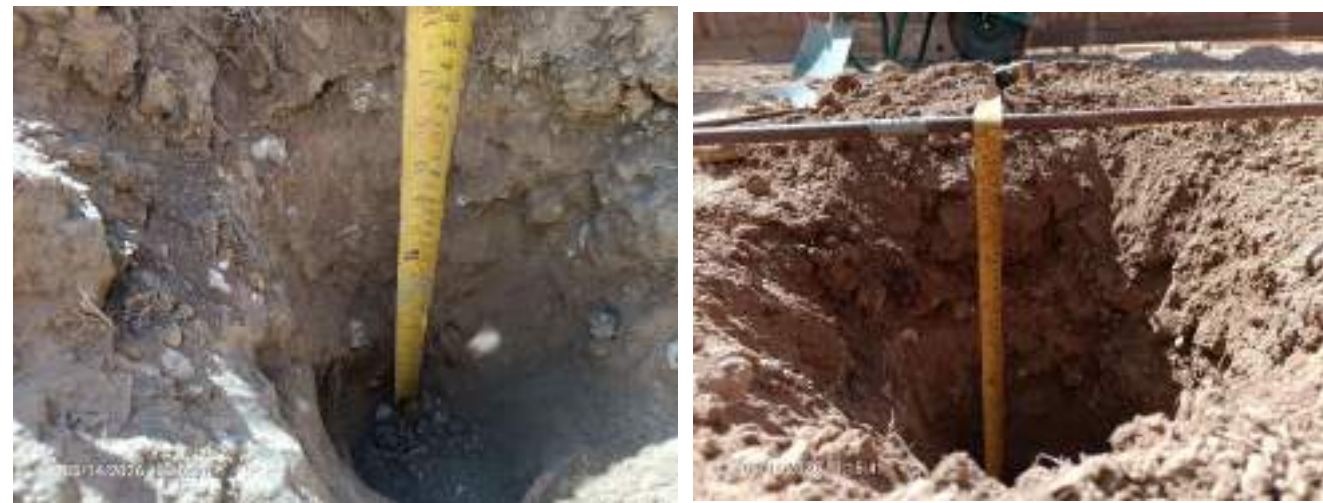
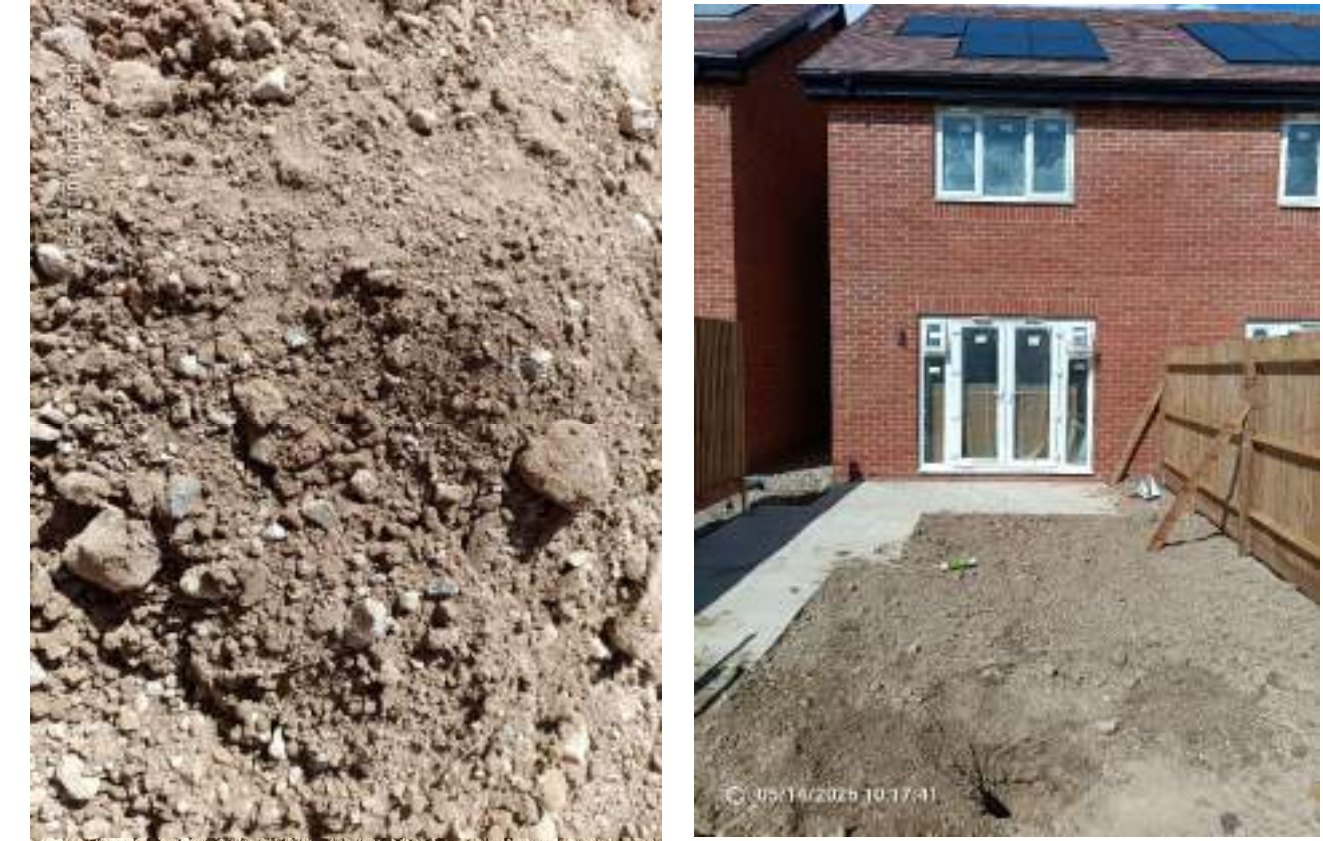
| Physical Suitability | No undesirable or injurious objects were observed within any of the materials inspected, such as sharps, metals, plastics or over-sized materials, except for a few cobble-sized fragments of brick and concrete within the subsoil. | | |

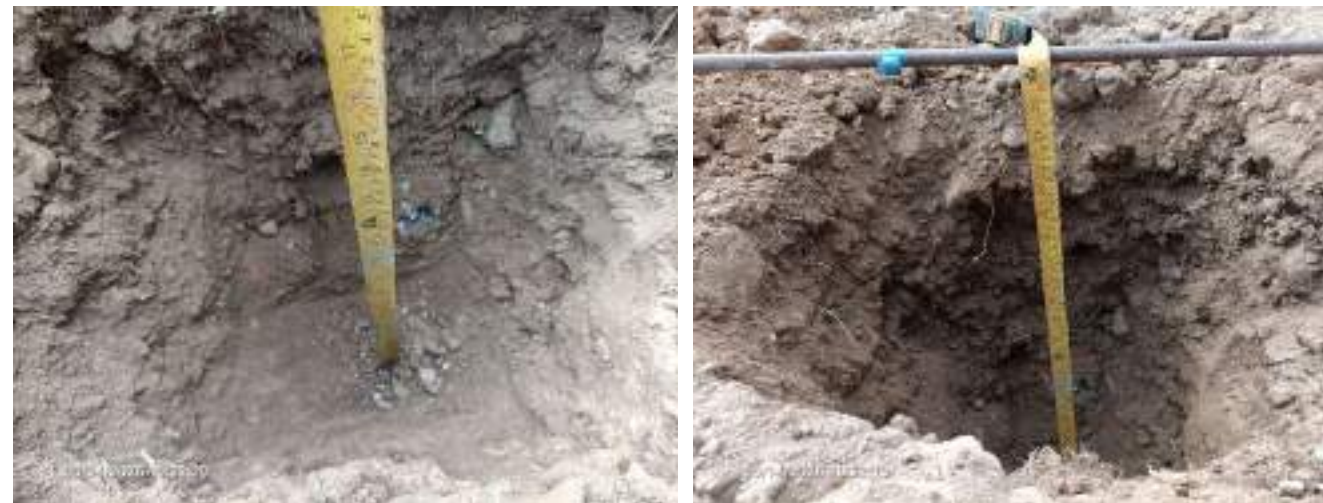
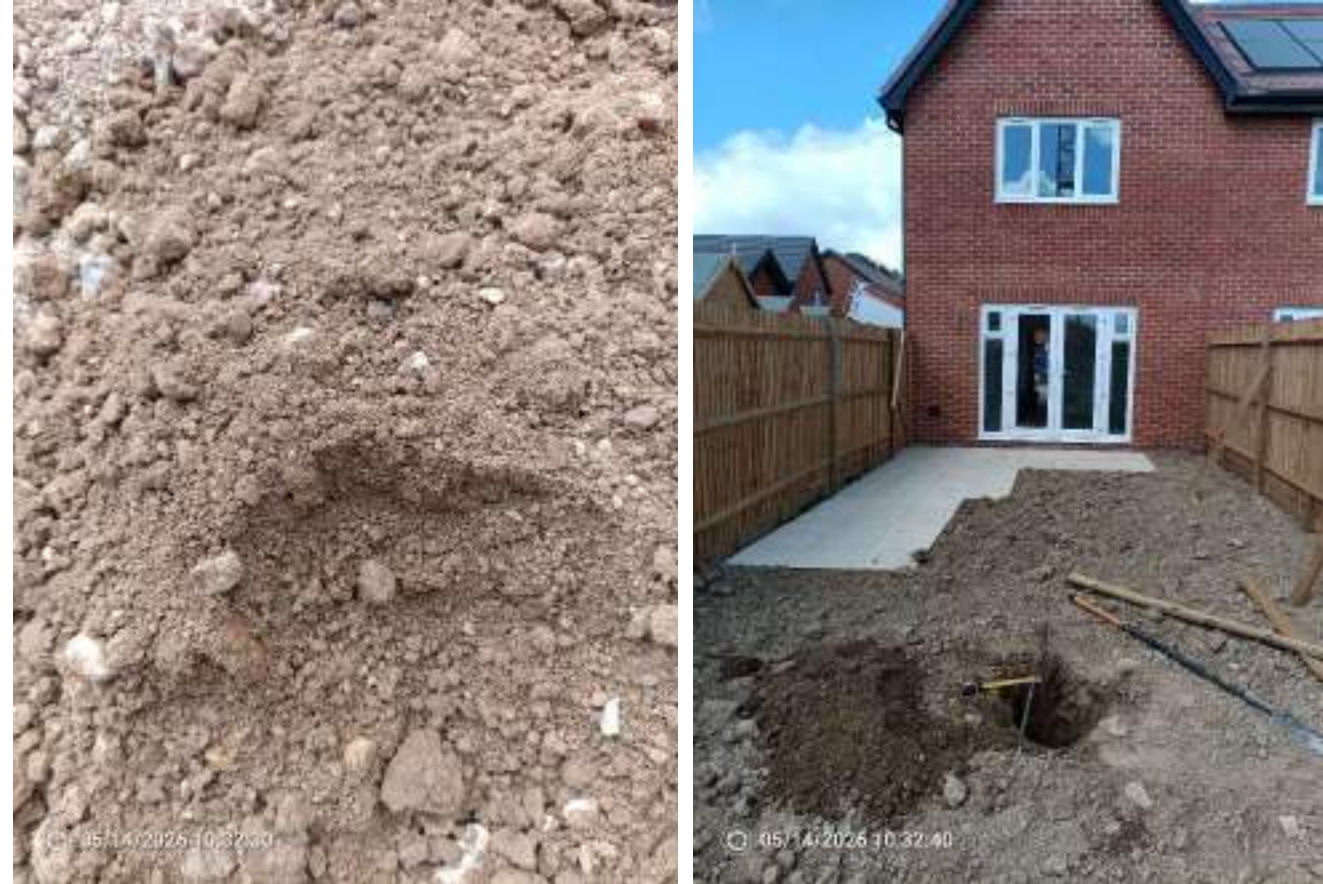
| Physical Suitability | No undesirable or injurious objects were observed within any of the materials inspected, such as sharps, metals, plastics or over-sized materials, except for a few cobble-sized fragments of brick and concrete within the subsoil. | | |
