**Lloyds Bank**

**41-43 South St, Worthing BN11 3AU**  
**Wind & Watertight**

# Scope of Works

27<sup>TH</sup> NOVEMBER 2025

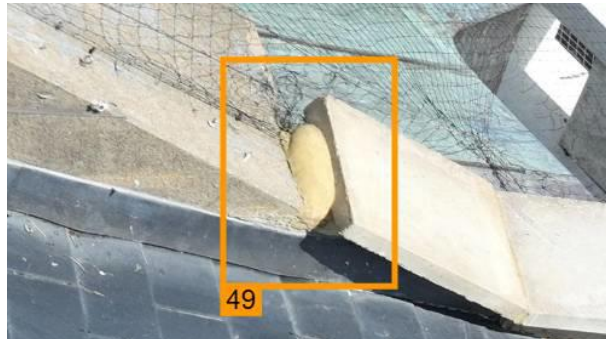
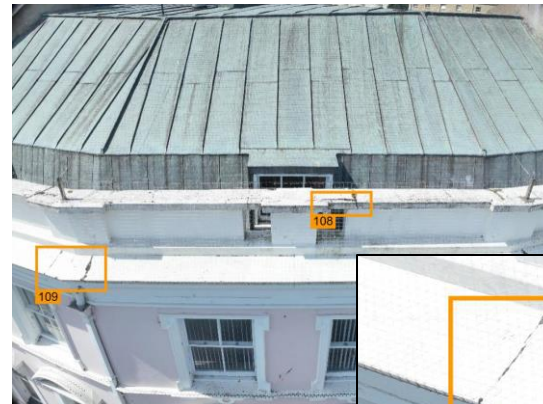
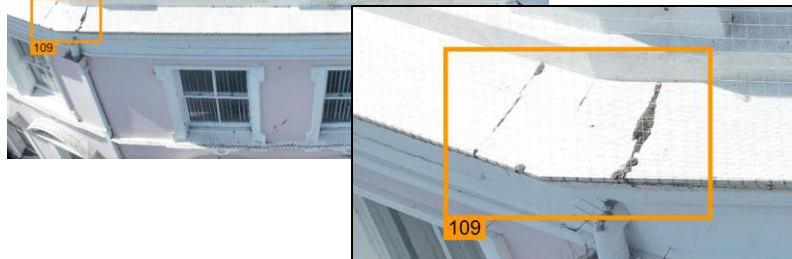
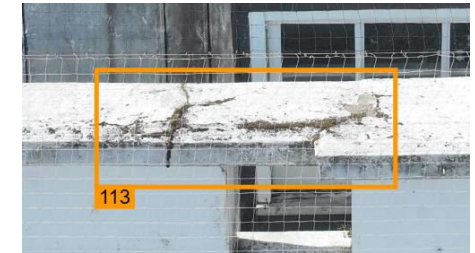
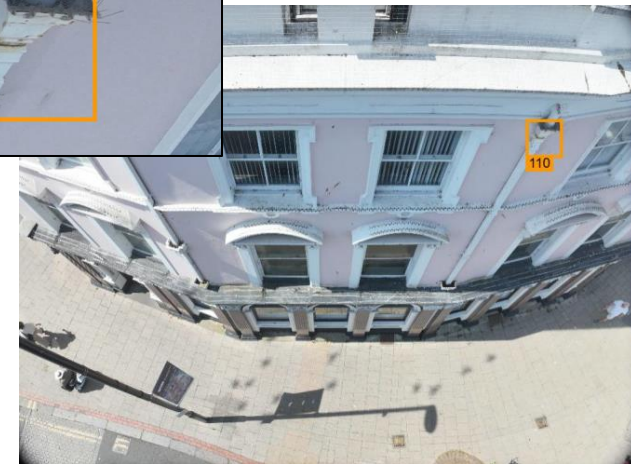
# Roof 1

Party wall –  
parapet wall.

Flat roof area at ridge level.

- Repair / refix dislodged, missing or damaged roof slate to match existing.
- Survey condition of copper / asphalt flat sections & flashings at ridge level.
  - Repair existing copper if required.
  - Repair / install new flashings to roof plant exhaust sections.
- Party wall. Review
  - Cracked render finish to determine requirements.
  - Assess parapet coping stone to confirm details / requirement to make W&WT.
- Remove vegetation & accumulated debris from front elevation box gutter / surround area.
- Paint finish has failed to upper section of parapet stone to front elevation.
  - Prepare & decorate.
- Remove moss & vegetation from parapet etc. repoint and make good as necessary.
- Replace leaf guards in box gutter outlets.
- Clear gutters and downpipes.

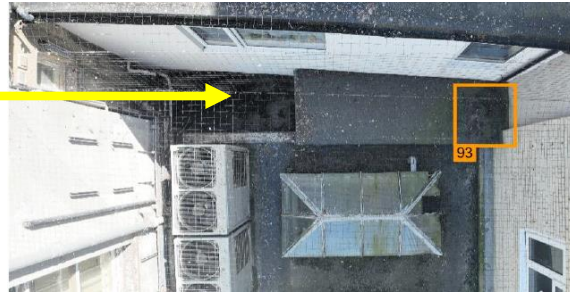
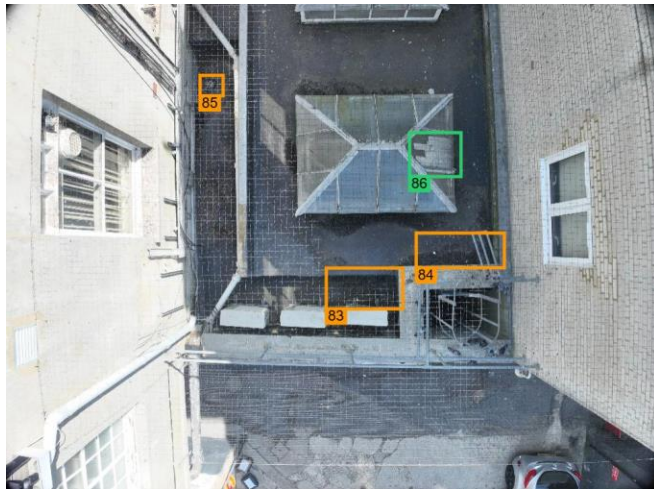
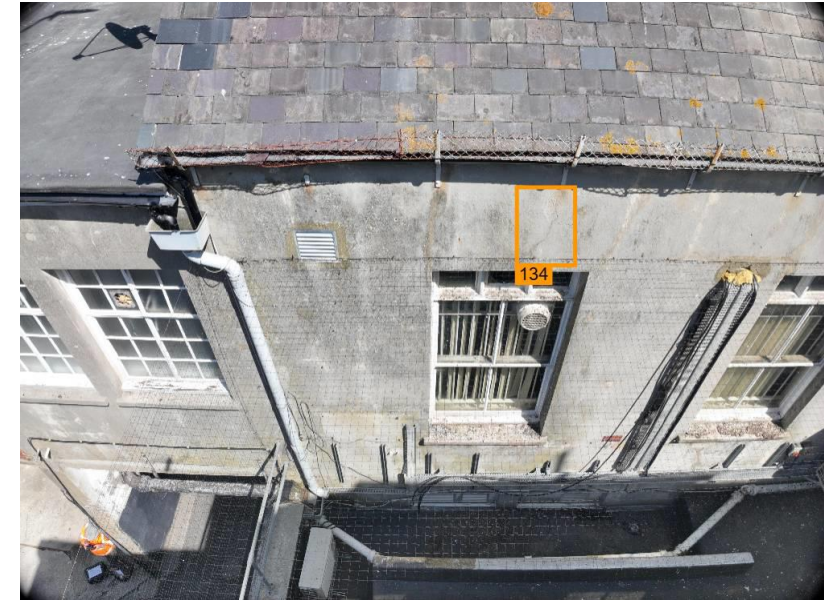
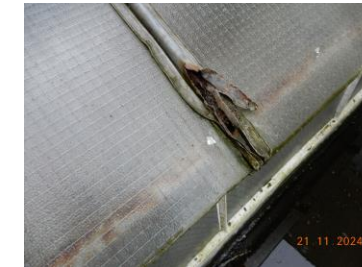
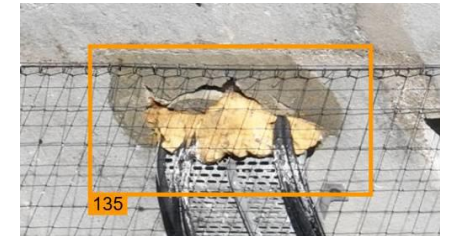
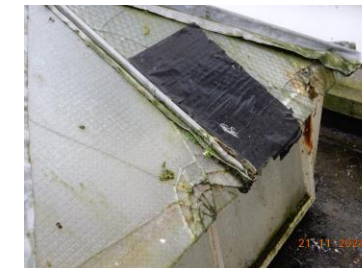
# Roof area 5.

Recessed roof extending into a void beneath residential property.

- Patch repair roof surface including flashings to walls
- Remove 3No. Corroded and damaged lantern lights complete.
  - Install new box construction over existing openings, suitably flashed to existing roof surface.
- Remove vegetation and debris from roof surface.
- Refix single ACU which has been dislodged from support base.
- Wall face beneath Roof 5. Remove, repair and replace defective render where cracking is evident.
- Remove foam and install suitable, recognised wall infill detail surround to incoming cable trays.
- Clear bird guano from window sills.
- Ensure existing bird mesh is complete and inaccessible by birds. Mitie

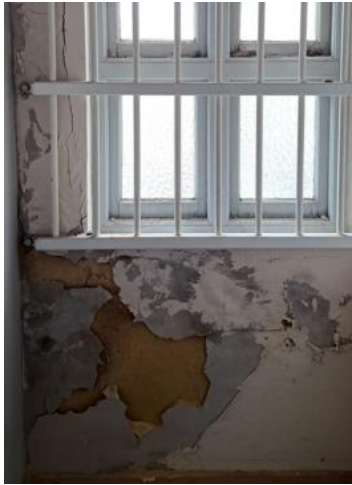
- Walls are in poor condition throughout.
- Structural engineer to provide report on cause of cracks.
- Roof survey required as previous.

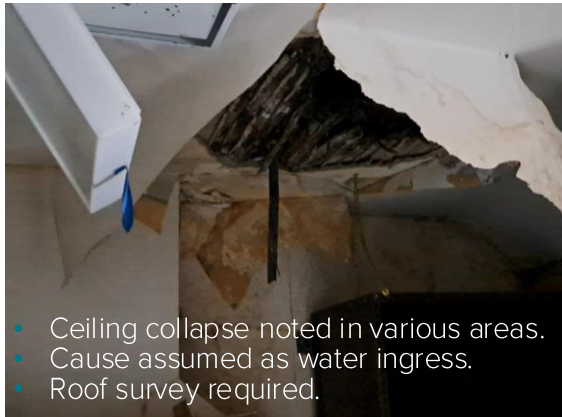
- Ceiling collapse noted in various areas.
- Cause assumed as water ingress.
- Roof survey required.

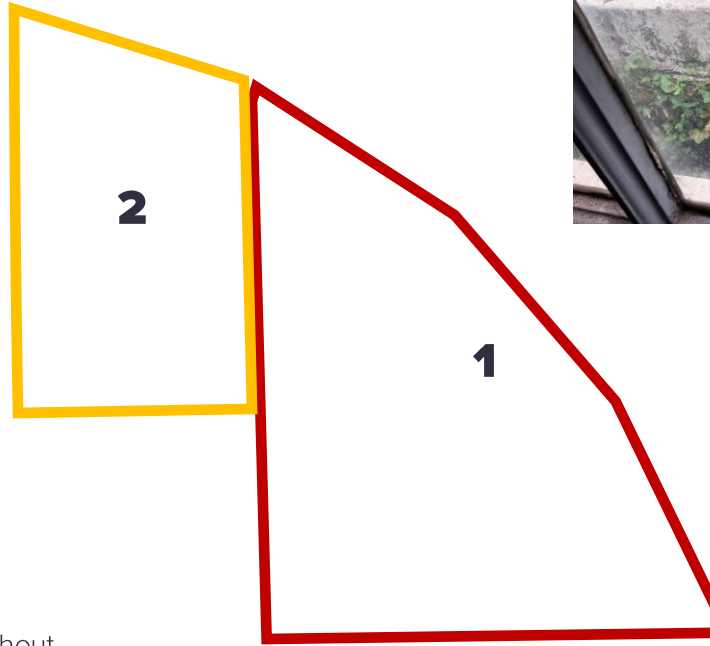
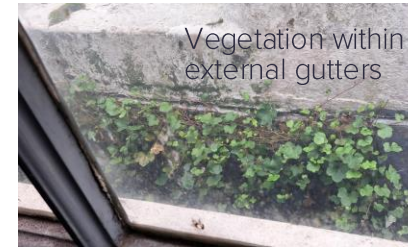
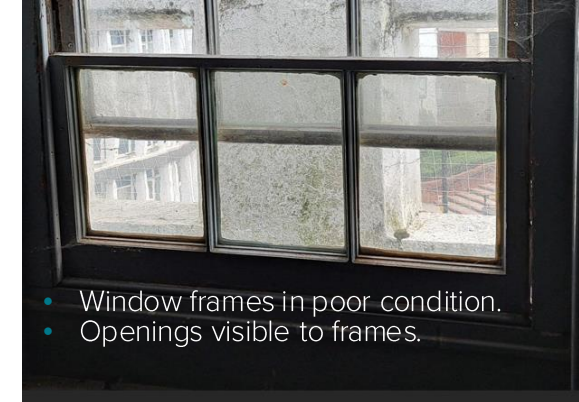
- Window frames in poor condition.
- Openings visible to frames.

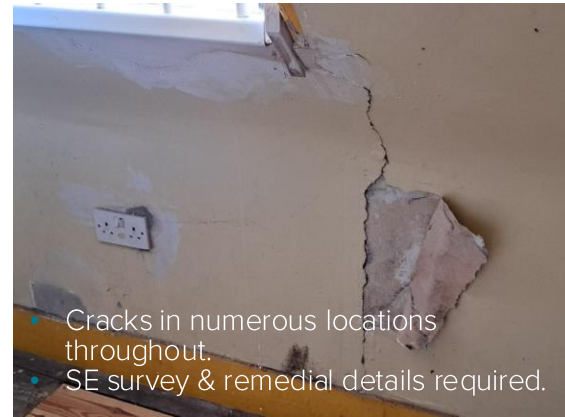
- Cracks in numerous locations throughout.
- SE survey & remedial details required.

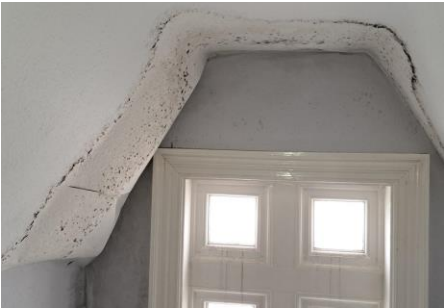
Condensation noted in plant room and adjacent rooms. Damp occurrence in finishes including carpet which transfers to surroundings.

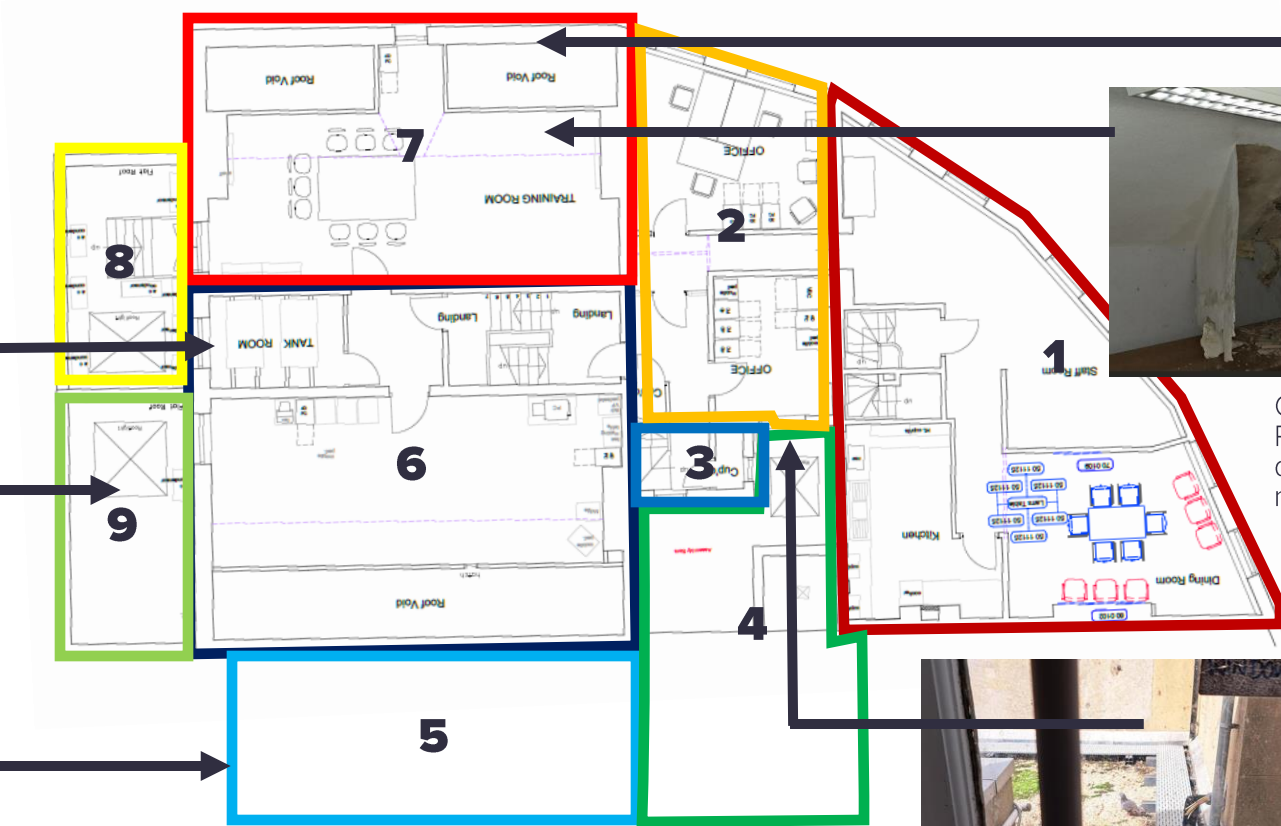
Roof leaks noted at first floor beneath roof voids.

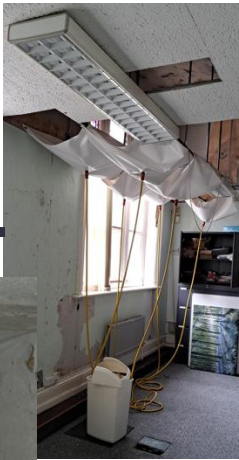
Ceiling collapse noted. Roof survey required to determine extents of remedial works.

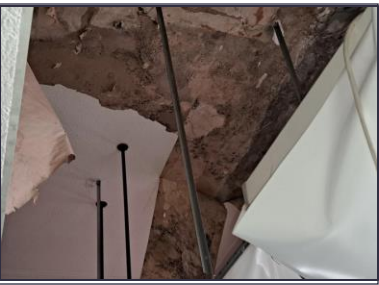
Water ingress appears to have been remedied. Leak occurs beneath Thord floor level roof voids. Roof survey required to determine remedials.

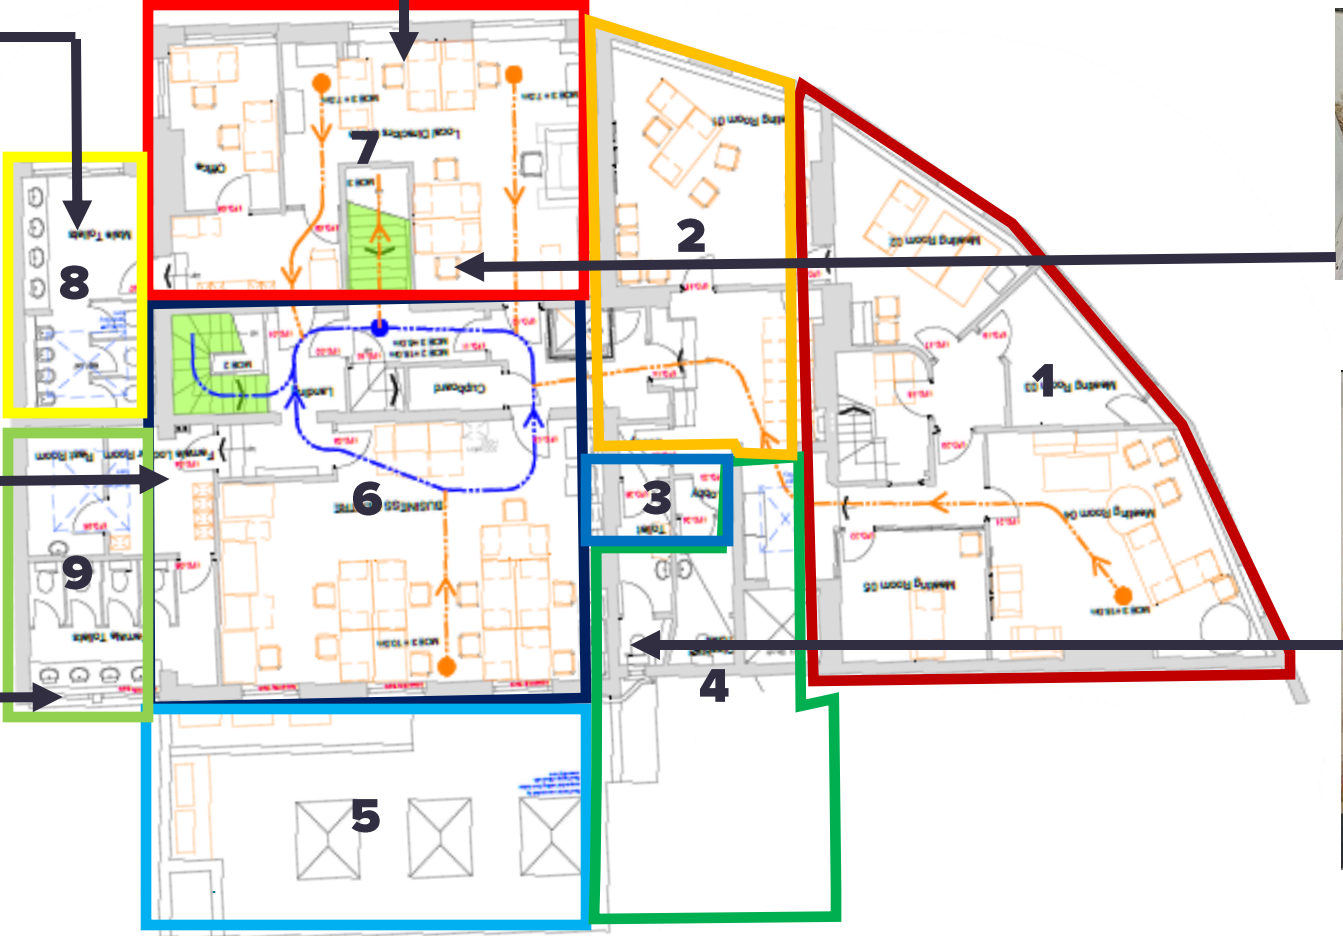
Female WC.  
FM to address window opening mechanism. Ease to allow closure.  
FM to replace damaged extract fan.

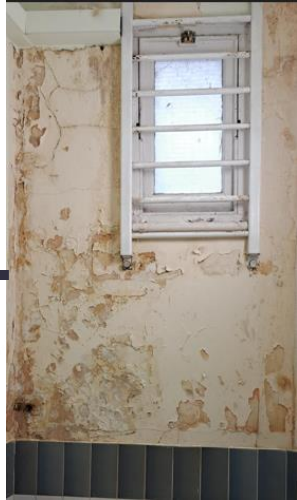
Damp ingress due to M&E noted and is currently being remedied by FM.

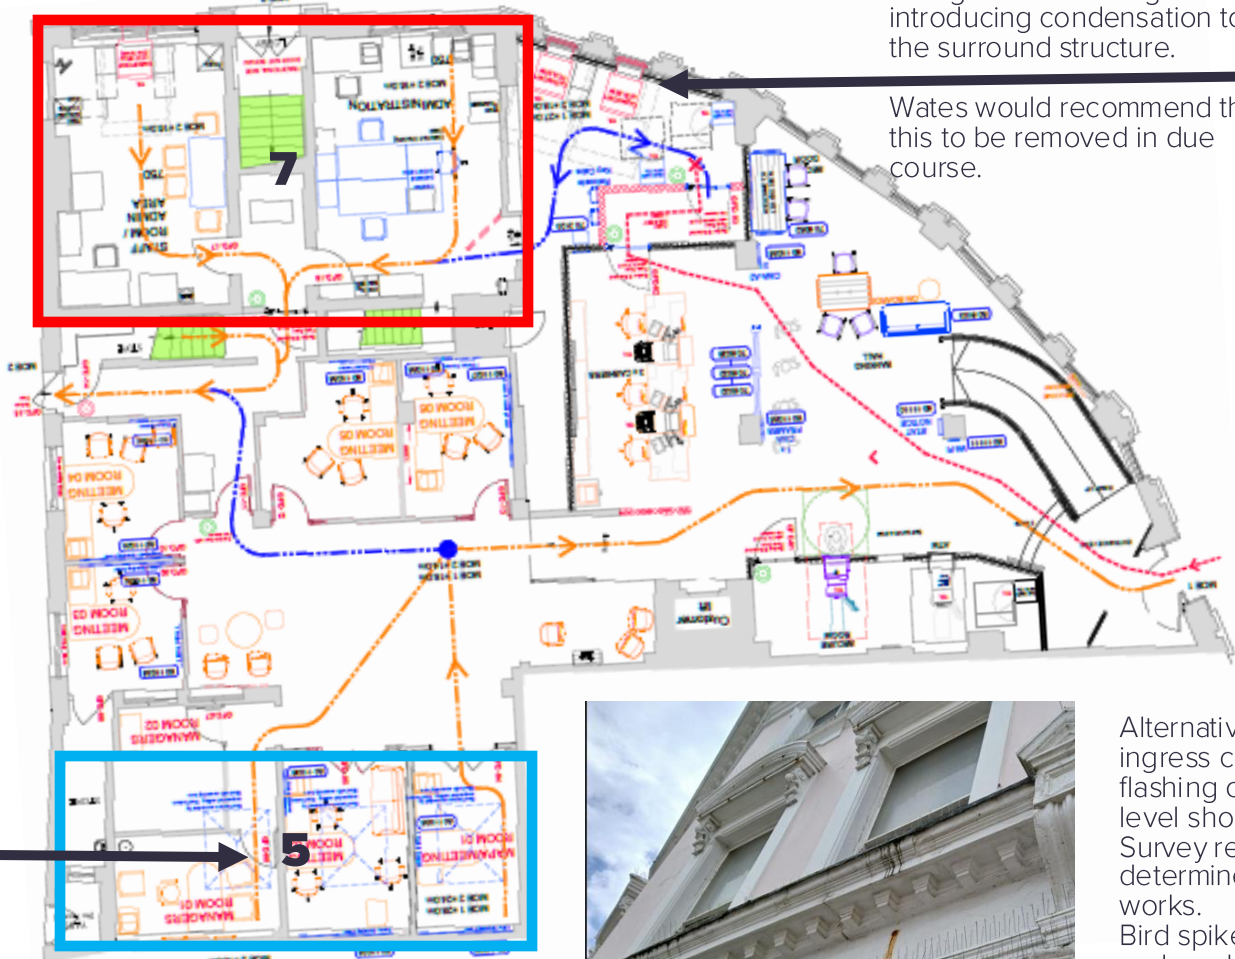
Roof lights above Interview rooms.

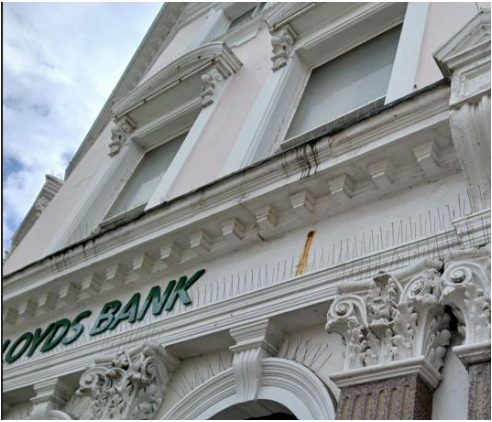
Admin room. Existing night safe is no longer used and redundant.  
The understanding is that it is acting as a cold bridge and introducing condensation to the surround structure.

Alternative source of ingress could be the flashing over the ground level shopfront.  
Survey required to determine remedial works.  
Bird spikes to be replaced alongside this work.

Wates would recommend that this to be removed in due course.
