Site Location : 207 Brighton Road, Worthing, BN11 2HA

Project Name : Internal Alterations & Repair Works

Drawing Name : Existing and Proposed Replacement Balcony Roof Covering Details

Drawing No: FB26-0207 DT02 Scale : 1 : 20 @ A3

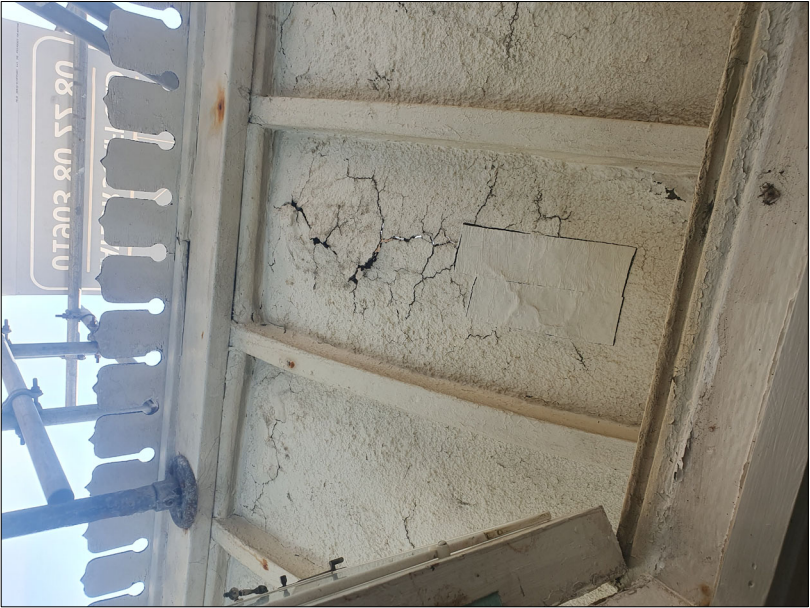
Photo showing existing decayed self-supporting felt laid directly across timber ribs with no intermediate support. It will not be possible to lay lead, which is soft, across these gaps without the introduction of pre-curved plywood sheeting between the ribs to provide a supportive laying surface for the lead.
