## Damp and Timber Report

Date of Survey: 18/12/2025

Site address: The Old Scantling's, 26 Church Street, Shoreham by Sea, BN43 5DQ

Surveyor: Matilda Jacobs-Milburn

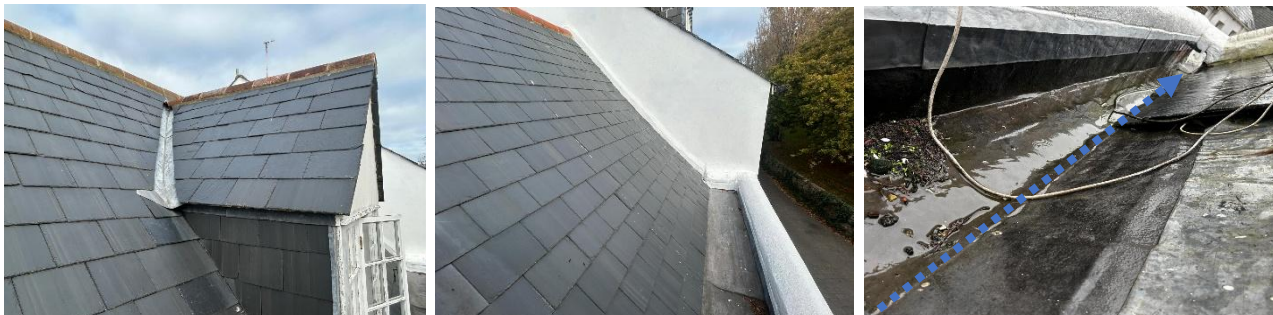
Inspection of the main roof covering was carried out from the front of the property by accessing the rainwater valley via the window. From this vantage point, the roof appeared to be in good overall condition. No cracked, spalled, or displaced slate tiles were observed, and all valley junctions appear to be well constructed and free from visible weaknesses. The slate tiles themselves are in excellent condition. A re-roofing may have been undertaken within the past five years, as the slates appear relatively new; if older, they are performing exceptionally well.

Observations of the roof undertaken during periods of heavy rainfall were consistent with those recorded during dry weather conditions. The rainwater valley is formed with adequate falls, allowing rainwater to disperse efficiently from the roof without evidence of ponding or backflow.

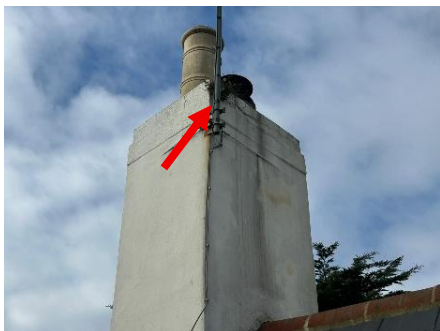
One defect was noted on the chimney stack at roof level. A significant crack was observed within the render or flaunching at the top of the stack, with vegetation growth emerging from the opening. As plants require a consistent moisture source to survive, this indicates that water is penetrating the cracked flaunching. While this may not yet result in internal leakage, it does suggest that moisture is entering the chimney structure and could raise humidity levels within the stack. Trapped moisture of this nature can contribute to long-term deterioration of masonry, mortar, or embedded metal fixings if not addressed.

It should also be noted that the chimney stack has been thoroughly coated in cement render. Cementitious coatings tend to reduce breathability and can cause the upper section of the flue and chimney stack to become significantly colder than the lower sections of the chimney. This effect is increased as the stack projects above roof level and is fully exposed to external weather conditions.

Where chimneys are not in regular use, humidity can accumulate within the flue. As warm, moisture-laden air rises, it can reach the colder zone of the chimney above roof level, where condensation may form internally within the chimney breast or stack. Over time, this can contribute to elevated moisture levels, increased risk of masonry deterioration, and may exacerbate defects such as cracking to flaunching or render if moisture is unable to dissipate effectively.

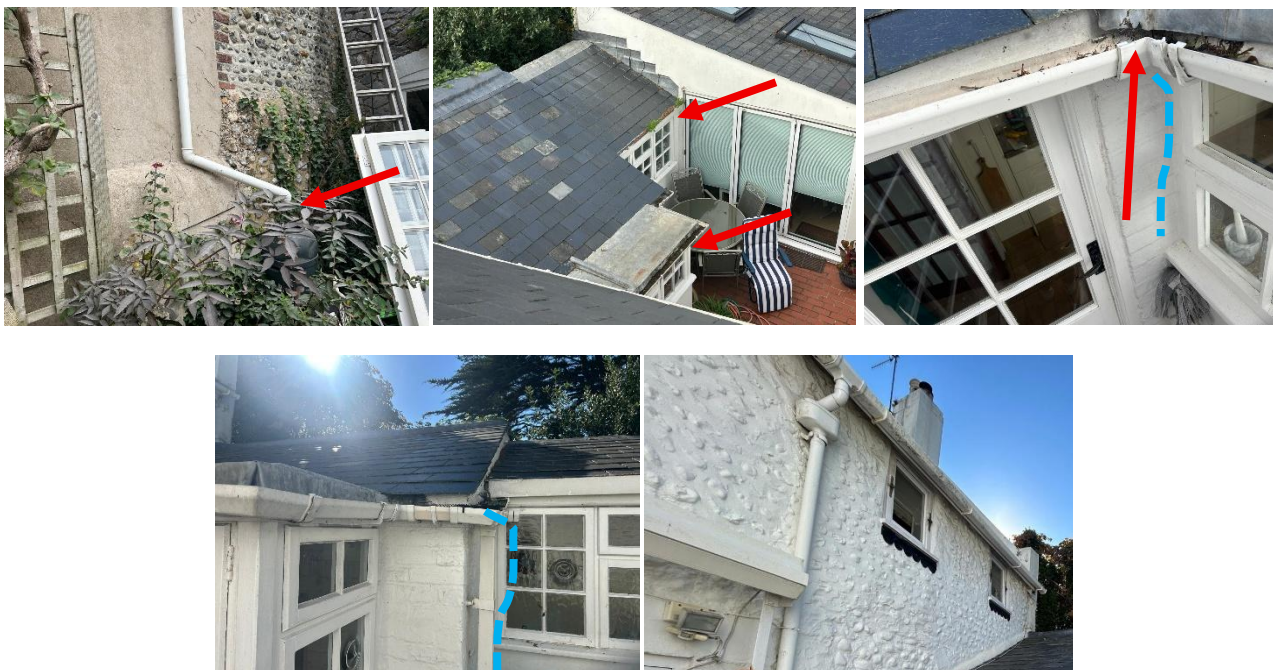
All rainwater goods around the property are slightly compromised and require maintenance. The gutters are heavily obstructed with debris, which reduces their effective capacity and increases the likelihood of overflow during heavy rainfall. The accumulated debris is also likely to travel into the downpipes, potentially blocking drainage channels below ground.

There is clear evidence of overspilling water, indicated by dark staining on the undersides of the guttering. Several sections are misaligned and do not fall correctly toward their respective downpipes. In some areas, this has resulted in water discharging over the outer edge of the gutter and onto the patio, while in others, the gutters are tilted toward the property, allowing water to escape over the back edge and run down the external walls.

Where guttering undulates, water collects in the low points rather than flowing freely. This standing water accelerates wear on the rubber seals at the joints, leading to persistent dripping from the underside of connections. Gutters are designed to channel water efficiently to downpipes, not to retain large volumes as they are currently doing.

One downpipe within the neighbouring garden discharges above a water butt, although observation suggests that in heavy rainfall, much of the flow overshoots the butt entirely, allowing water to soak into the adjacent ground. This may increase moisture content around the building's foundations and, during periods of heavy rain, could also result in splashback against the rendered wall of the property.

Ensuring all rainwater goods are clear, correctly aligned, and fully functional is essential to prevent continued saturation of masonry and ground adjacent to the walls. Properly maintained gutters and downpipes are critical to directing roof water safely away from the building, reducing the risk of damp penetration and localised foundation moisture.

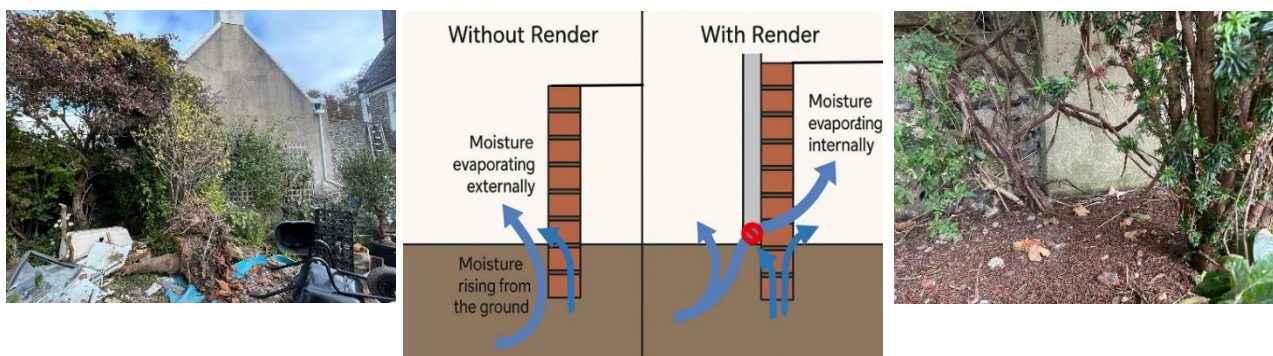
The left-hand external wall, located within the neighbouring garden, has been fully rendered in cement from top to bottom, with the render extending below external ground level. This is particularly problematic because moisture that naturally rises through the ground has no opportunity to evaporate once it reaches the surface. Under normal conditions, any ground moisture entering the base of a traditional lime wall would evaporate harmlessly as soon as it rose above ground level. However, with cement render continuing below the soil line, that evaporation path is blocked. As a result, the trapped moisture is forced to evaporate internally rather than externally, where conditions are warmer, and evaporation is easier.

The wall, therefore, remains permanently damp and much colder than intended. Cold, moisture-laden masonry is prone to condensation on the internal face and to salt crystallisation and frost damage within the wall core. Over time, this trapped moisture can cause the stone or flint faces to spall and the render itself to delaminate.

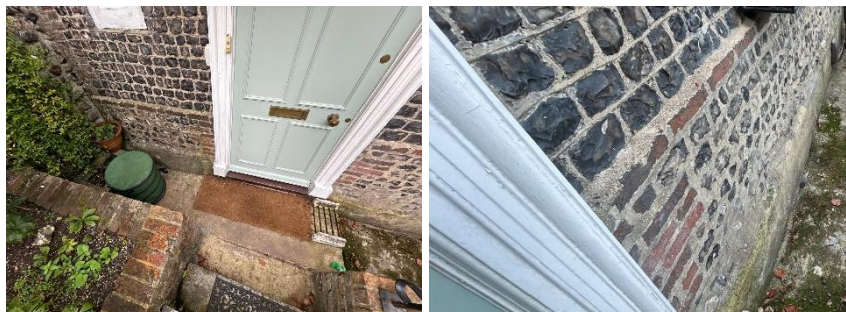
All visible pointing around the property appears to have been replaced with hard cement mortar, including low-level cement fillets at the front elevation. Cement pointing does not flex or breathe in the same way as lime. As the building expands and contracts naturally with temperature and humidity, the rigid cement develops fine cracks. These cracks allow small quantities of moisture to penetrate the wall, but then prevent it from escaping.

In a flint wall, this problem is particularly acute, as flint itself is non-porous and cannot release moisture through its surface. The wall relies entirely on the permeability of its lime pointing to regulate internal moisture. With lime replaced by cement, this mechanism is lost, creating a wall with no practical means of evaporation, much like the fully rendered wall described above.

The result is a cold, damp structure that cannot regulate its moisture content effectively. While this may not result in visible water ingress, it significantly lowers the wall temperature and creates internal conditions that encourage condensation and mould growth.

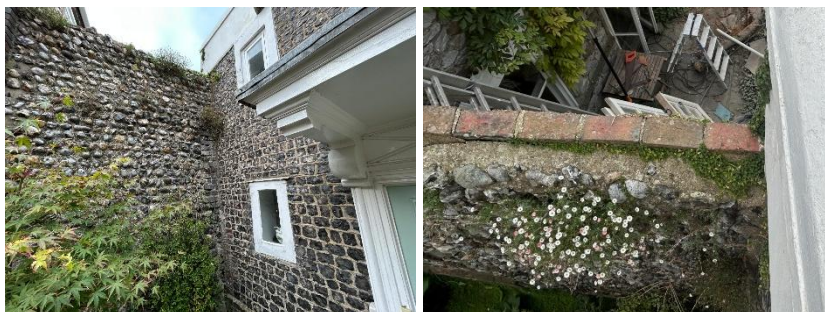
The partition garden wall abutting both The Old Scantlings and the neighbouring property has also been heavily repaired with cement. Numerous cracks are present, and vegetation growth is visible from the joints, indicating moisture ingress. At the top of this wall, evidence of trapped water can be seen, saturating the masonry and providing a constant source of moisture. This damp, cold wall lies directly against the property and has the potential to transfer moisture laterally into the stonework of the building, contributing to persistent dampness along the adjoining elevation.

- Dress the top of the wall with lead sheeting to create a continuous, waterproof capping.
- The lead should be chased securely into both The Old Scantlings and the neighbouring property's wall, forming a smooth and watertight junction along the entire length of the wall top.
- The lead should overhang approximately 0.5 to 1 metre on each side to direct rainwater clear of the wall faces.
- The finished edge of the lead should be slightly flicked outwards, ensuring that rainwater is propelled away from the wall rather than running down its surface.

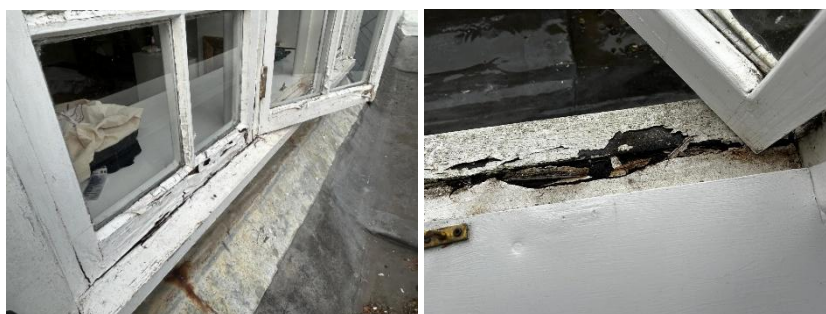
Most external joinery elements, primarily windows, have been finished with a plastic-based vinyl paint. This type of coating is non-breathable and traps moisture within the timber, which accelerates decay. The problem becomes more severe as the paint ages and begins to crack or flake. When this happens, water can penetrate through the damaged areas, but the surrounding impermeable coating prevents the trapped moisture from evaporating. This dramatically increases the rate of deterioration.

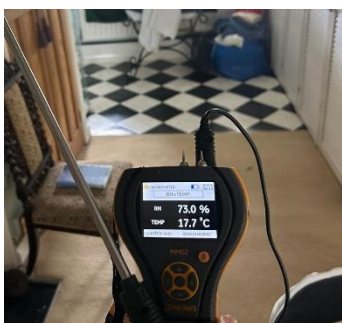
During our inspection, we recorded humidity levels of 73% at 17.7°C. This humidity level is too high; the ideal range for indoor humidity is 40% to 60%.

It should be noted that this was only a snapshot reading taken on a dry and sunny day. Humidity levels within the property are likely to be higher at night or in the winter months, varying between 75% and 85% depending on temperature changes and everyday activities such as cooking and cleaning.

We can confirm that when we returned during heavy rainfall, humidity levels were between 78-81% RH.

The property's higher humidity is largely a result of changes to its original construction and environmental balance. Modern materials such as cement render, cement pointing, and impermeable wall finishes have been used throughout, preventing the building from regulating internal moisture vapour as it was designed to do. Originally, moisture generated inside the house would have travelled through the breathable lime-based walls and escaped to the outside. This process has been restricted, allowing moisture to build up internally. In addition, the open fire has been replaced with a log burner, which removes far less humidity from the internal air. Combined with the external issues noted earlier, such as poor surface water drainage, high ground levels, and trapped moisture in the walls, these factors have increased the overall moisture burden within the property, contributing to raised internal humidity levels.

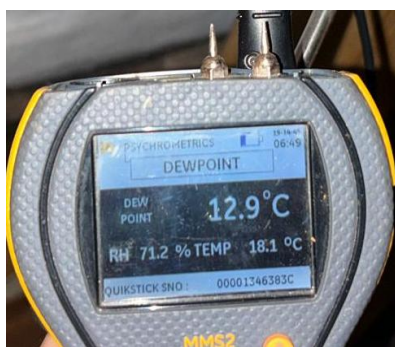
All eaves spaces within the second floor were inspected. Relative humidity readings of 70 to 71% were recorded at a temperature of 17.8°C. These levels indicate that the eaves space lacks adequate ventilation, as no provision for air movement was observed.

Using a Protimeter, the dew point was calculated at 12.9°C. This means that if any surface within the eaves voids cools to 12.9°C while the humidity remains at 71%, condensation will begin to form on that surface. Without ventilation, moisture-laden air becomes trapped, allowing condensation to accumulate on cooler materials such as rafters, insulation, and wall plates.

The roof timbers readily absorb prolonged high humidity and condensation. Evidence of historical woodworm activity was observed, with flight holes consistent with both Common Furniture Beetle (*Anobium punctatum*) and Deathwatch Beetle (*Xestobium rufovillosum*), the latter typically associated with oak. Moisture content readings taken from a range of timbers averaged 12.9%, which is too dry to sustain active infestation, suggesting that most of the activity is historic. However, localised areas returned higher moisture content readings of 17.4%, just above the 16% threshold at which wood-boring insects can begin to feed. If these elevated levels persist, the conditions could once again support active woodworm.

No evidence of live beetles or larvae was observed during the inspection, though this may be due to timing, as the insects are not active during this season. Monitoring is advised from April to May, when adult beetles typically emerge.

Improving ventilation within the eaves space is strongly recommended. Increasing airflow will lower humidity levels, prevent condensation, and create an environment that discourages insect activity. Chemical spray treatments are not advised, as they address the symptom rather than the cause. Woodworm thrives in damp conditions; by drying the environment, the timbers become too hard and dry for them to feed. The insects are simply indicators of a moisture problem, and once the environment is stable, they will move on naturally.

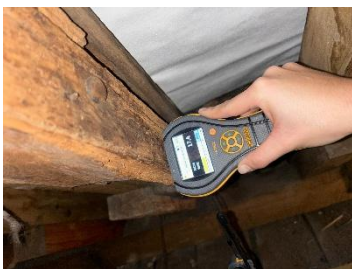
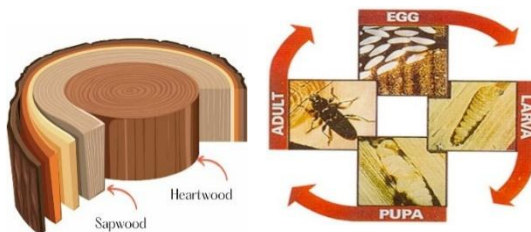
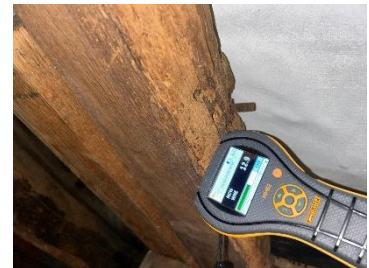
As a note of reassurance, the majority of the main roof structure is formed of hardwood. During the life of a tree, it sends all of its natural toxins to the heartwood, which is where its strength comes from. This process creates a natural insecticide that protects the tree's structural core and allows it to remain standing and resistant to insect attack. When the tree is felled and used in construction, that natural insecticide remains within the heartwood. As a result, woodworm rarely infest this dense inner section, preferring instead the softer, nutrient-rich sapwood just beneath the bark. Since the structural strength of a beam lies in its heartwood, limited surface-level woodworm damage within the sapwood generally does not compromise overall integrity, provided it is monitored, and the surrounding environment remains dry and stable.

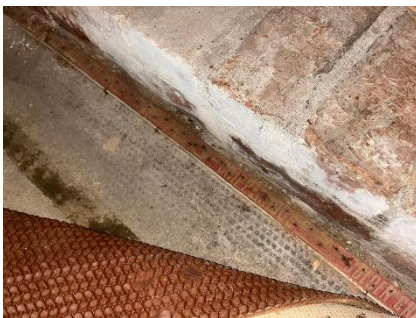
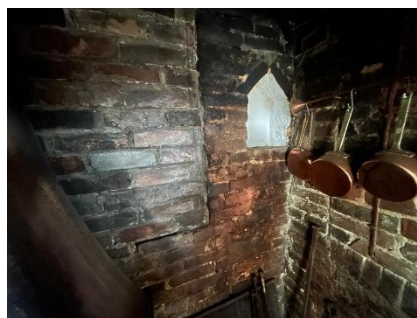
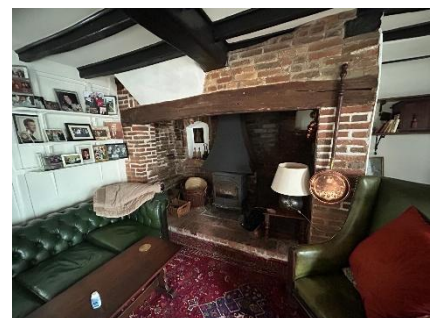
The fireplace at The Old Scantlings is a traditional inglenook, originally designed as the main source of both heating and ventilation for the property. In a house of this age, the open fire would have been lit almost every day, providing not only warmth but also a constant movement of air through the chimney. The natural draw of the fire created a steady upward airflow that helped remove internal humidity and kept the surrounding masonry dry and warm.

In its current state, the fireplace has been adapted to accommodate a log burner. While efficient at retaining heat within the room, a log burner does not generate the same level of radiant heat as an open fire, nor does it provide the same degree of air exchange through the chimney. All heat and air movement are now contained within the metal flue liner, meaning that the chimney breast itself receives little to no warmth or airflow. This change has fundamentally altered how the masonry surrounding the fireplace manages moisture.

During inspection, the brick hearth was found to have cement-based pointing, which prevents moisture from evaporating through the joints. As a result, any moisture that accumulates in the masonry is forced to escape laterally into the adjoining solid floor. Evidence of this was visible where the gripper rods had decayed and where the outline of the carpet could be seen on the floor surface. The area beneath the carpet felt damp to the touch, suggesting that the floor is absorbing excess moisture that the hearth and chimney structure can no longer release naturally.

The interior surfaces of the inglenook show signs of long-term moisture retention. Historically, soot and tar from open fires would have been deposited throughout the chimney flue. These deposits contain hygroscopic salts, which readily absorb atmospheric moisture. Under normal circumstances, the warmth and airflow from a daily fire would have kept the chimney dry. However, because the log burner now directs all heat and movement through its sealed flue, the interior of the chimney remains cool and still. This provides the perfect conditions for the hygroscopic salts to draw in moisture from the air and release it into the surrounding brickwork.

The cement render on the reverse side of the chimney wall further restricts breathability. Moisture that once evaporated through the masonry is now trapped within it, gradually being drawn inward rather than outward. This has resulted in visible dampness, salt migration, and a general sense that the fireplace is struggling to regulate moisture in the way it originally did.

Encouraging regular use of the fire, together with the use of breathable materials around the hearth and fireplace, will help restore some of the chimney's natural moisture regulation. Allowing gentle warmth and airflow through the structure will reduce condensation, discourage salt activity, and enable trapped moisture to dissipate gradually.

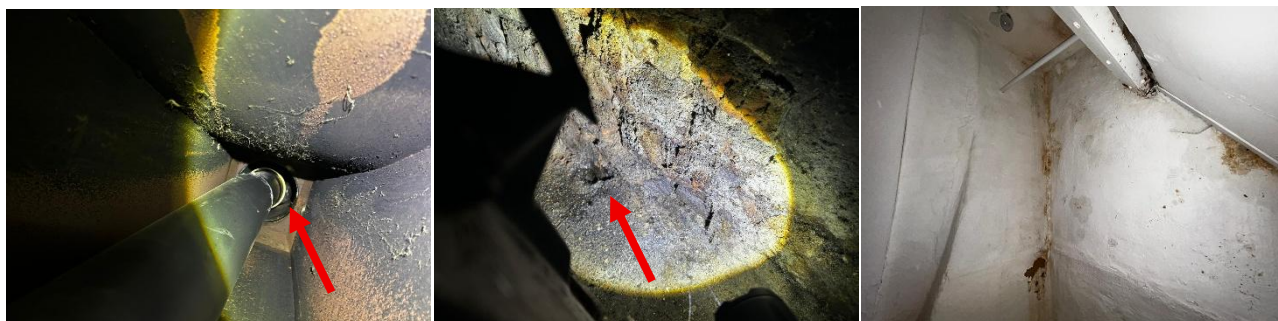
During this later inspection, active moisture was observed within the chimney breast. Water was noted dripping onto the hearth area behind the log burner, and significant wetting was recorded within the eaves cupboard at the second floor level. In this location, the rear elevation wall, which corresponds with the externally cement-rendered wall, together with the chimney breast itself, was found to be heavily saturated.

While the presence of free water may suggest rainwater ingress, the pattern, extent, and distribution of moisture remain consistent with severe condensation occurring within a cold, poorly ventilated chimney structure. The chimney breast, flue, and adjacent masonry are formed of dense materials, further affected by cement render and modern finishes, which significantly restrict breathability. In the absence of meaningful heat and airflow through the chimney, these cold surfaces provide ideal conditions for condensation to occur, even to the extent that liquid water can be produced and discharged internally.

It is acknowledged that a minor rainwater ingress at high level, particularly at the cracked render or flaunching noted on the chimney stack, could be contributing additional moisture to the system. However, due to the inability to safely access and fully inspect the chimney stack from roof level, owing to the fragility of the slate covering, this could not be conclusively confirmed at the time of inspection. A more detailed inspection of the chimney stack by a suitably qualified roofing contractor or chimney specialist is therefore recommended to rule out contributory defects.

Notwithstanding this, it is considered likely that the majority of the moisture observed internally is the result of condensation driven by cold masonry, restricted ventilation, and the use of impermeable materials. This conclusion is further supported by the presence of modern pink gypsum plaster on the chimney breast and the internally affected external wall. Gypsum plaster is not well-suited to cold or high-humidity environments and will readily exhibit signs of moisture distress when applied to solid walls or chimney structures of this nature.

In summary, while a minor defect at the chimney stack may be adding to the overall moisture burden, the primary mechanism is considered to be condensation associated with altered fireplace use, reduced heat transfer to the chimney mass, limited ventilation, and inappropriate material selection.

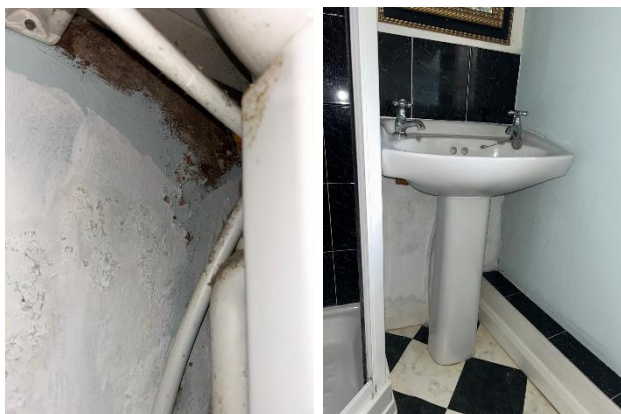
Areas of the property have been repaired or replastered using modern, non-breathable materials such as cement mortars and gypsum plaster. These materials are trapping moisture within the building fabric, creating cold wall surfaces that are highly susceptible to condensation. Thermal imaging confirmed significant temperature differences across the walls, particularly around upper corners, beams, and behind fixtures, with readings as low as 14.3°C.

A clear example is behind the sink basin in the main bedroom, where condensation and salt activity are breaking down the modern plaster. The embedded timber within the wall is softening, and crystalline salts are erupting through the plaster surface. This wall was recorded as one of the coldest in the property, and with the adjacent shower generating high humidity, moisture repeatedly condenses on its surface.

Gypsum plaster and dense finishes cannot cope with this moisture or the salts drawn inward by evaporation. As salts crystallise, they expand, causing plaster failure and surface flaking. The surrounding beams also show mould growth and salt deposits, further evidence of condensation forming on cold, impermeable surfaces.

These issues are not necessarily caused by water ingress but by trapped vapour unable to escape through modern materials. Reinstating breathable lime-based finishes and improving ventilation in high-humidity areas will allow the walls to dry naturally, stabilise humidity levels, and prevent further condensation and salt-related decay.

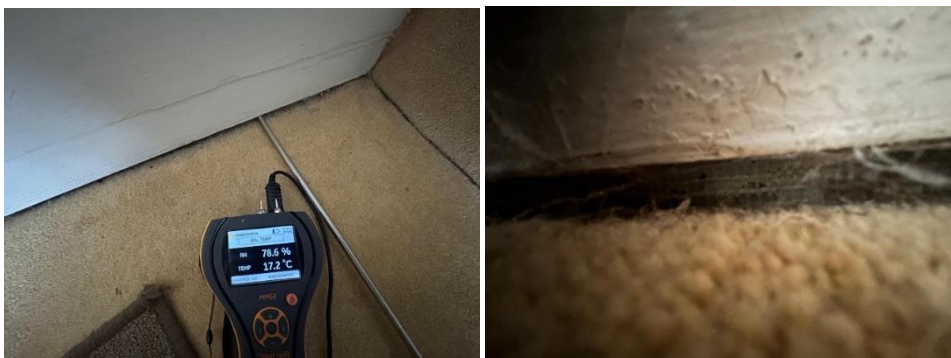
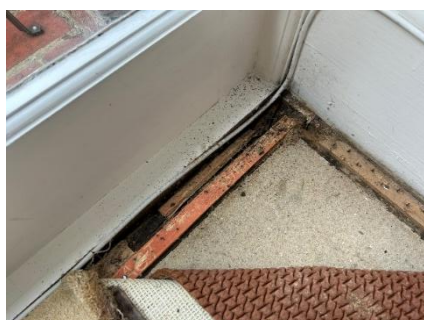
The solid floor within the property is taking on moisture due to raised external ground levels and the lack of effective surface drainage. When the carpet was raised near the back door, the surrounding timber was found to be completely decayed. This deterioration has occurred because the solid floor is finished with an impervious underlay and carpet, which traps moisture within the floor structure and prevents natural evaporation.

Because the floor surface is sealed, any moisture that builds up within the slab cannot evaporate evenly. It becomes trapped beneath the floor covering and can only escape at the perimeter where the carpet meets the wall. This small gap acts as a localised evaporation zone, releasing cold, damp air at low level. The surrounding skirting boards and adjacent plaster then absorb this moisture, becoming cold and damp and more susceptible to condensation. Over time, this has caused visible timber decay and deterioration of low-level finishes.

It is also possible that salts from the ground are being drawn upward with the retained moisture, further contributing to damage in the lower walls. The lack of adequate external drainage and the raised ground levels mean that groundwater pressure beneath the slab remains consistently high, keeping the floor base in a damp condition.

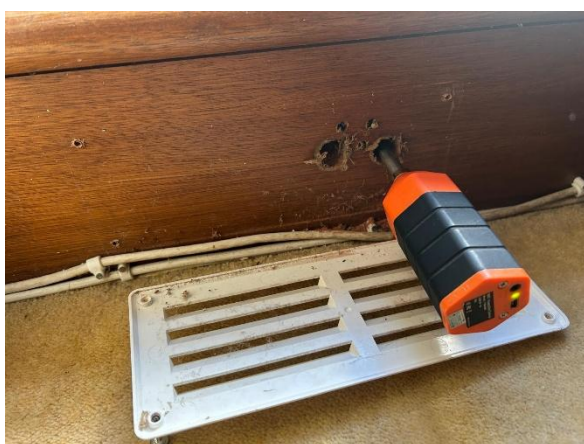
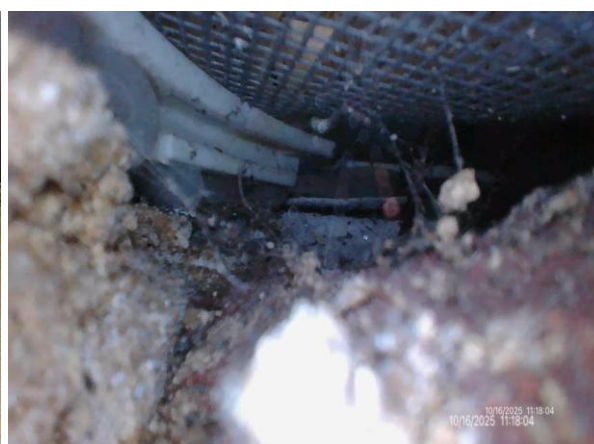
The photographs illustrate that the area is sealed, with accumulated material likely holding residual moisture. This combination of damp debris, trapped air, and timber enclosure can lead to localised humidity build-up and eventual fungal decay if not ventilated properly.
