**30<sup>th</sup> June 2026**

**BAT ROOST POTENTIAL MEMO REPORT: FOREST BARN, FOREST LANE, CASTLE GORING,  
WORTHING, BN13 3FD, NGR: TQ 10729 05321.**

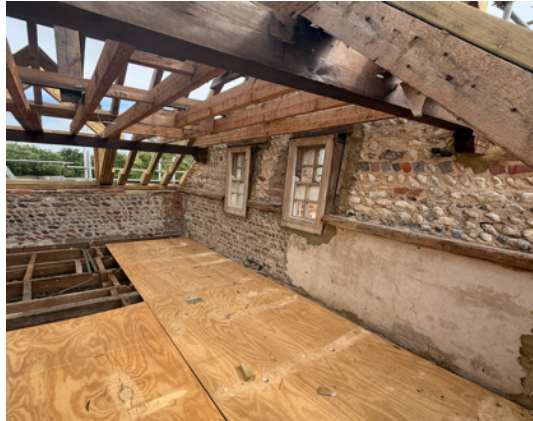
***Plate 5: Eastern Roof Void***

- 1.14 No residual roost features are evident. The photographic record shows no remaining original roof structure, no undisturbed voids, and no accumulation of droppings or other roost indicators in accessible areas.

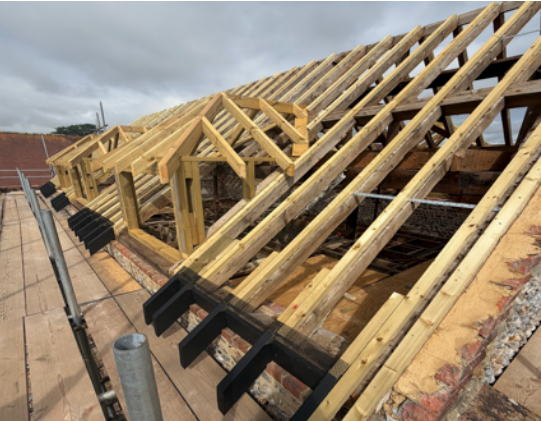
- 1.11 Despite the building's age and construction type — the current state of the structure renders its roosting potential as ***negligible***.
- 1.12 The roof has been entirely stripped. All tiles, any underfelt, and the original roof structure have been removed. Any roosting features that may have existed — voids beneath tiles, gaps at ridge and verge, spaces in decayed rafters — have been destroyed in the process.

***Plate 6: Stripped Northern Roof***

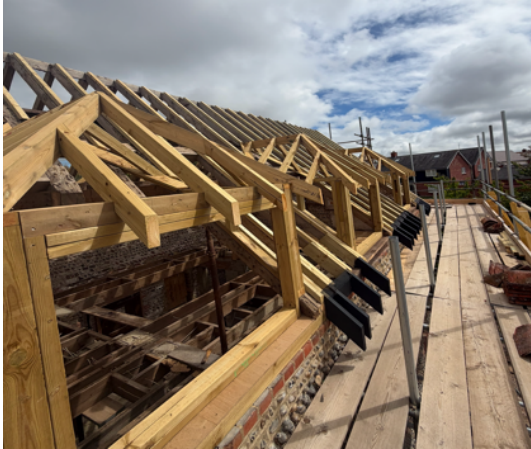
***Plate 7: Stripped Southern Roof***
