**Natwest Worthing  
27 South Street  
Worthing  
BN11 3AR**

## **Design & Access Statement**

May 2026

Our Reference: 26-017-BS-DAS

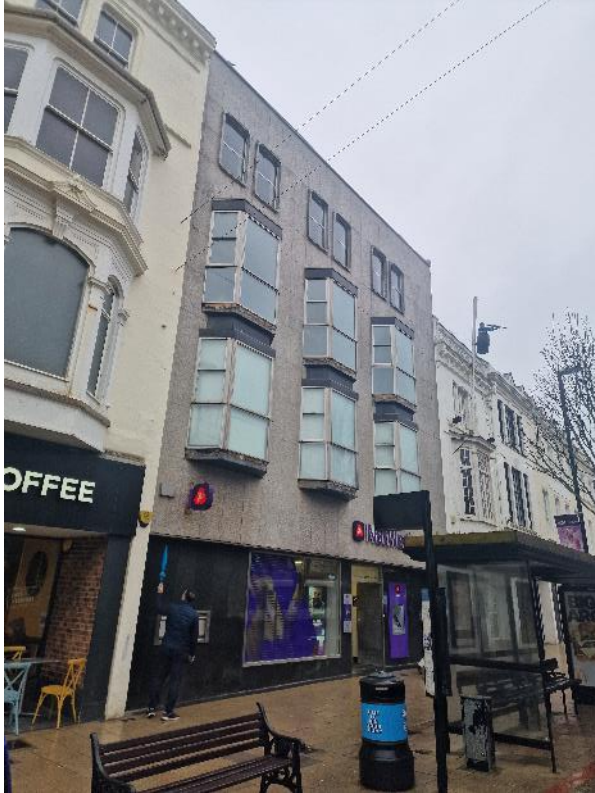
1. Front elevation

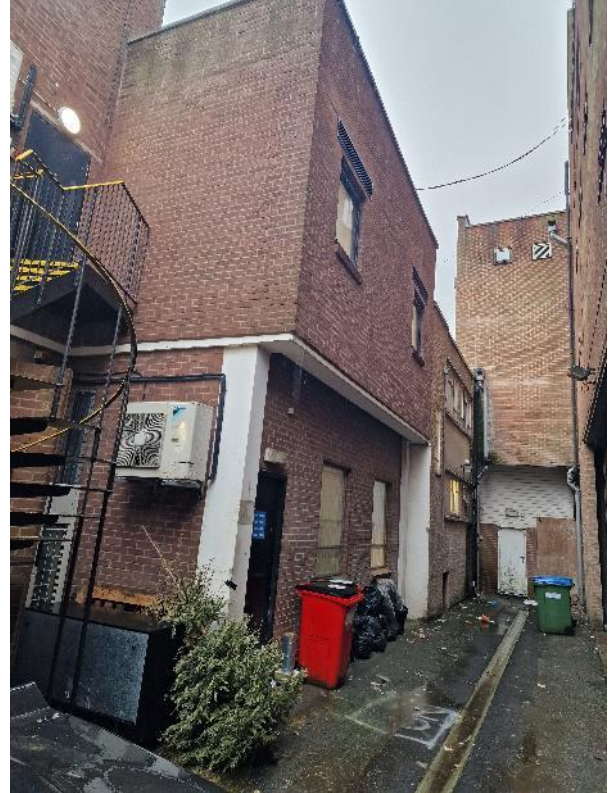
2. Rear elevation of extended portion

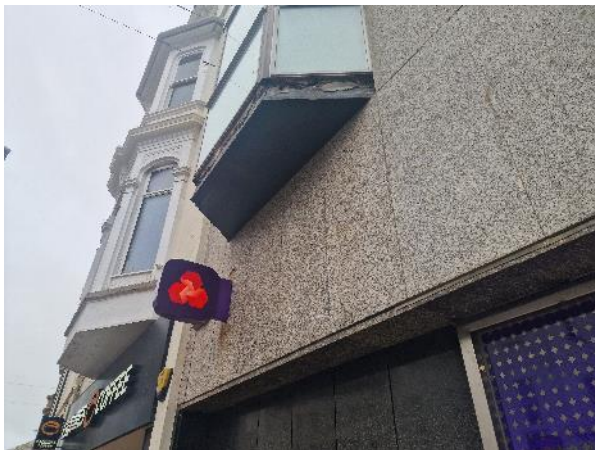
3. Granite cladding to front elevation

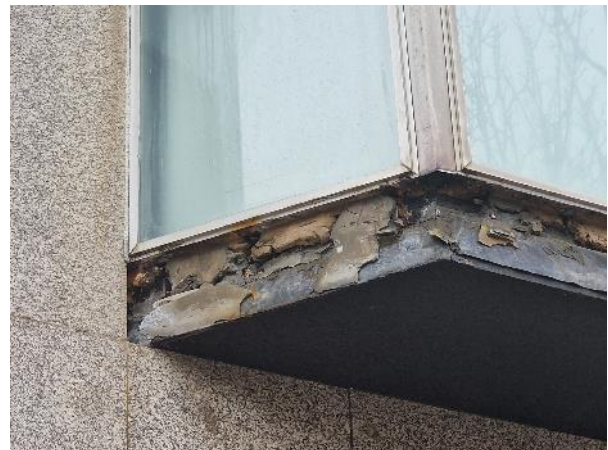
Movement has been identified in the granite cladding to the front elevation, with visible displacement and failure of fixings noted to the bay windows. Further intrusive investigations are recommended, with an allowance for localised repairs and re-pointing complete.

4. Defective cladding to bay windows

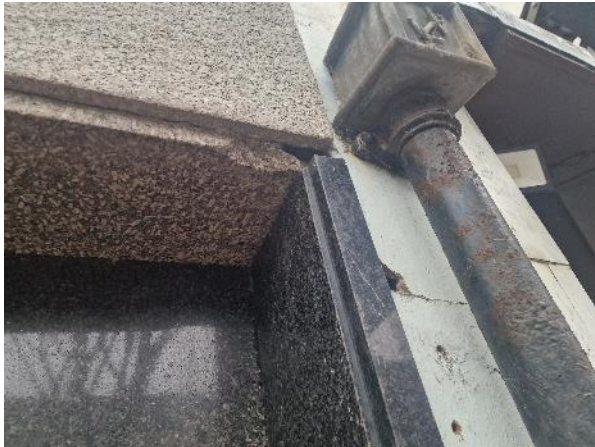
5. Damaged cladding at ground level

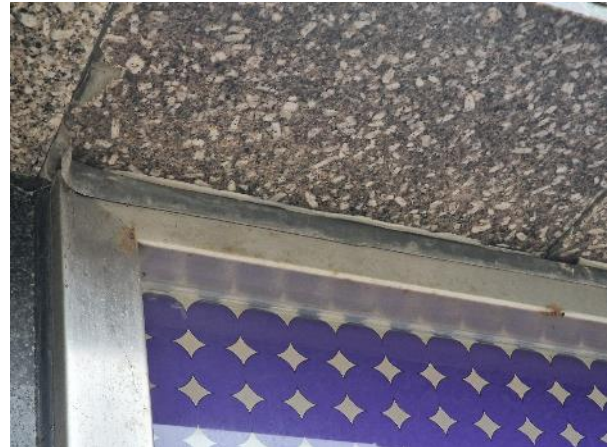
6. Degraded sealant to window frames

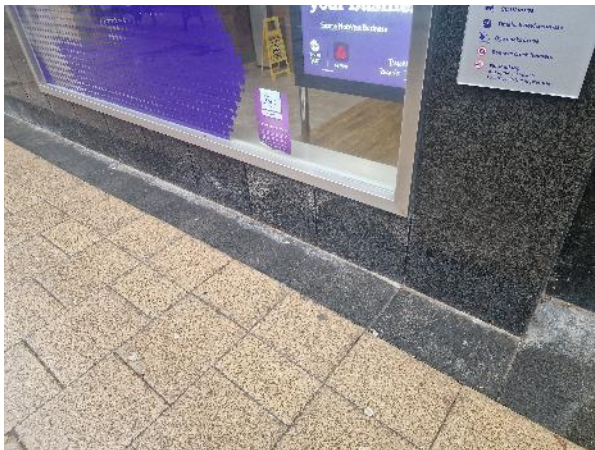
7. Granite to shop front

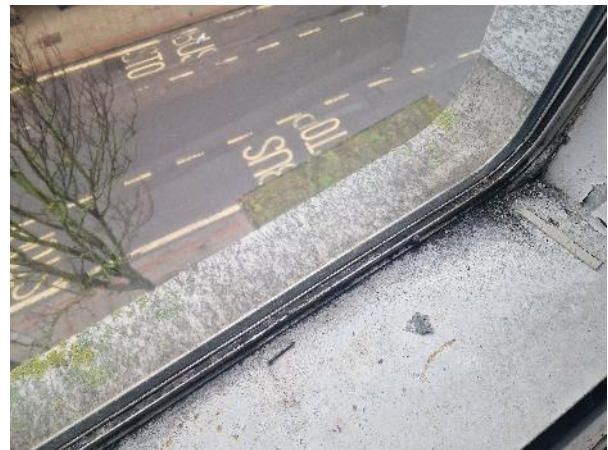
8. Degraded sealant to window frames

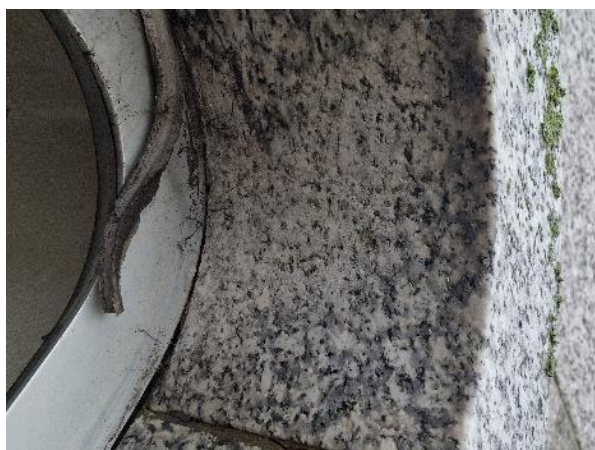
9. Degraded sealant to window frames

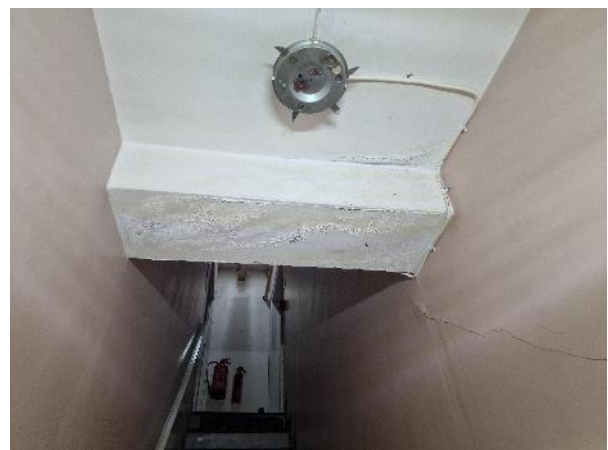
10. Evidence of moisture ingress internally

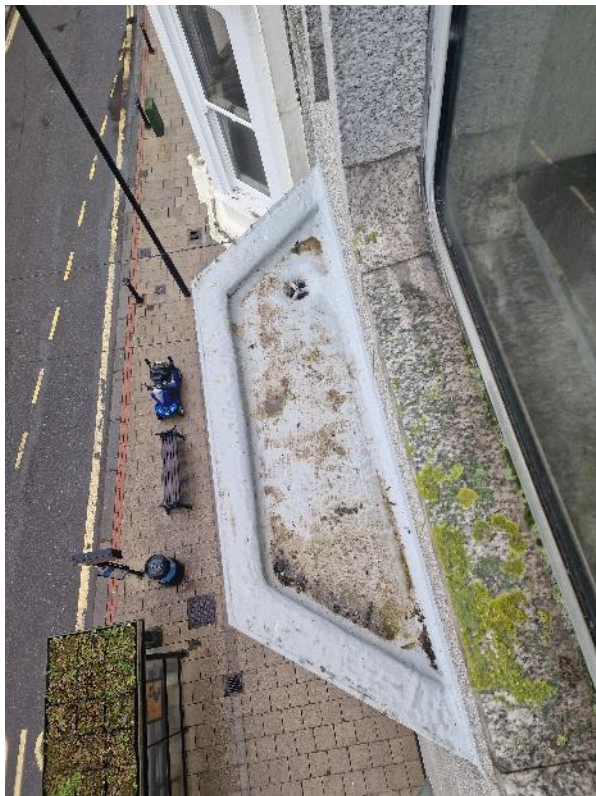
11. Roof to bay window

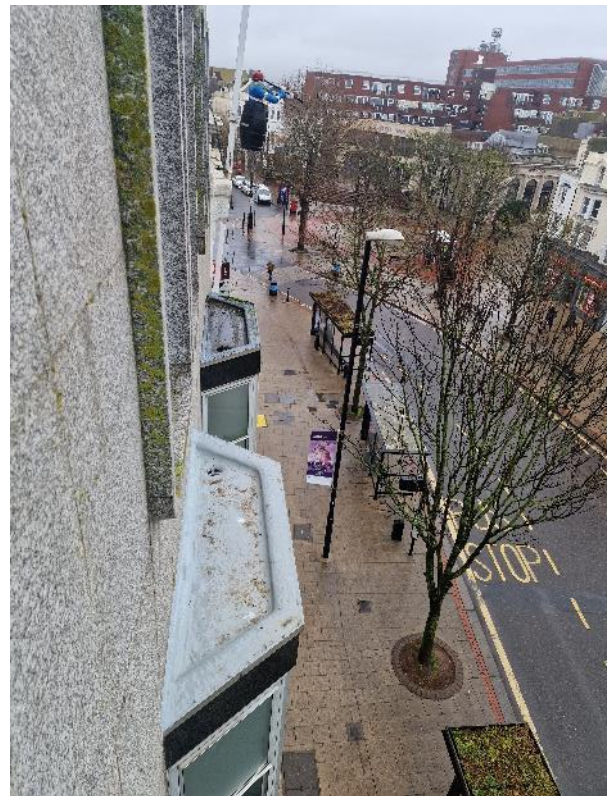
12. Roofs to bay windows

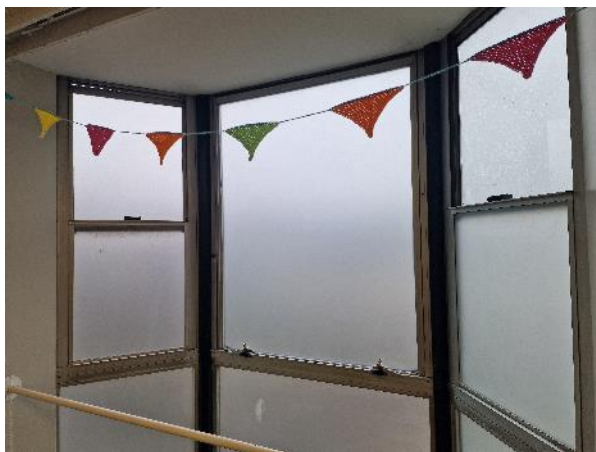
13. Bay window

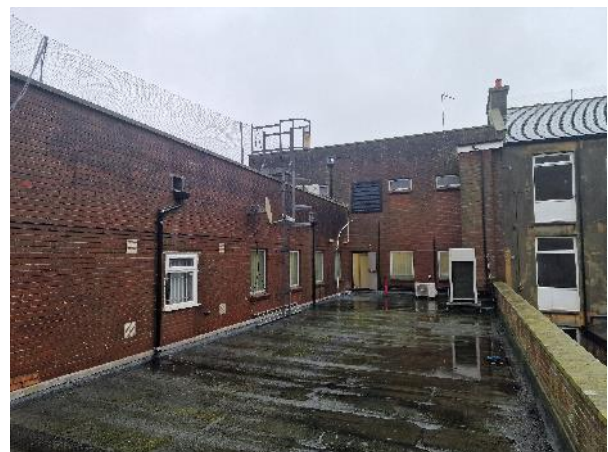
The flat roof portions to the rear projections are in poor condition, with evidence of water ingress visible internally. Full refurbishment, including the introduction of insulation, is recommended. Consideration should also be given to refurbishing the main roof, as evidence of historic water ingress was also identified.

14. Lower flat roof to rear

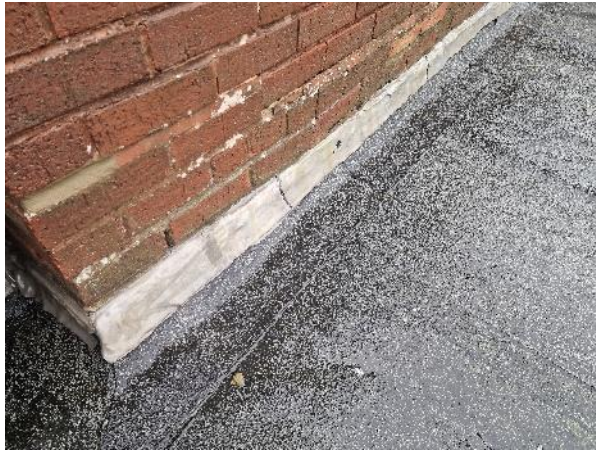
15. Poor flashing detail to lower flat roof

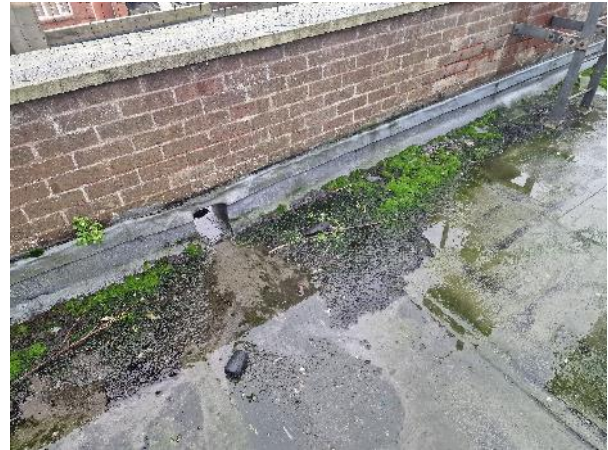
16. Upper flat roof – Roof 2

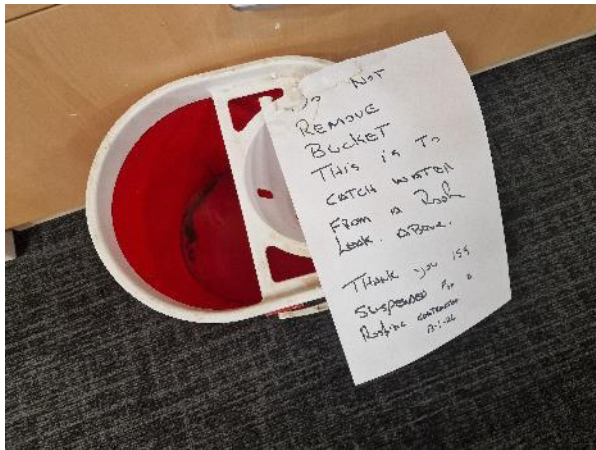
17. Evidence of water ingress internally

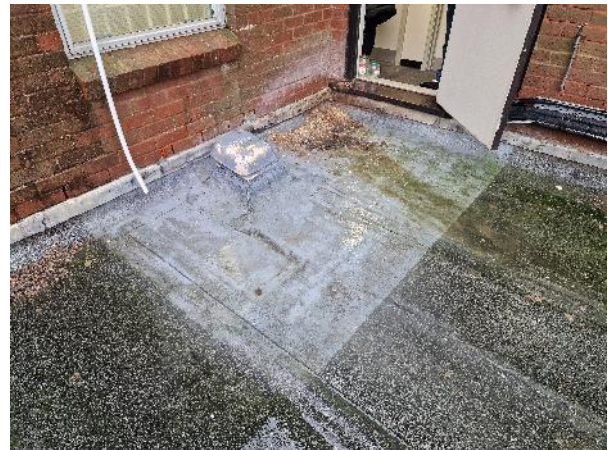
18. Poor patch repair to lower flat roof – Roof 3

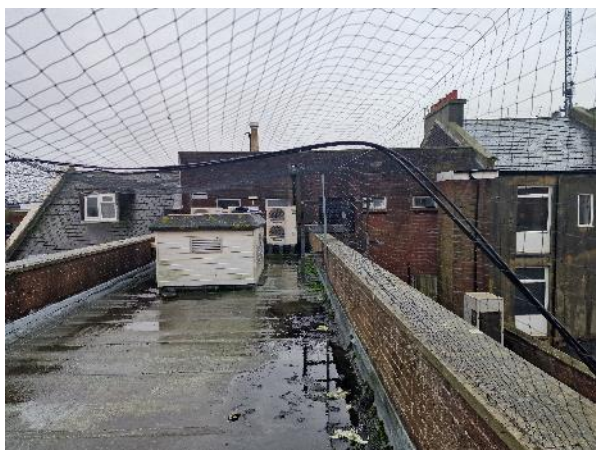
19. Upper flat roof – Roof 2

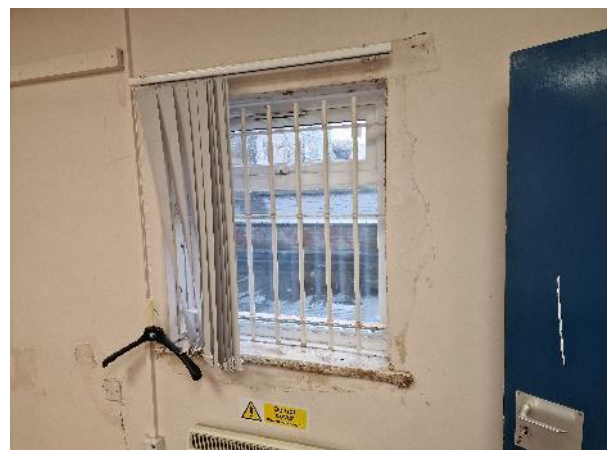
20. Water ingress to rear

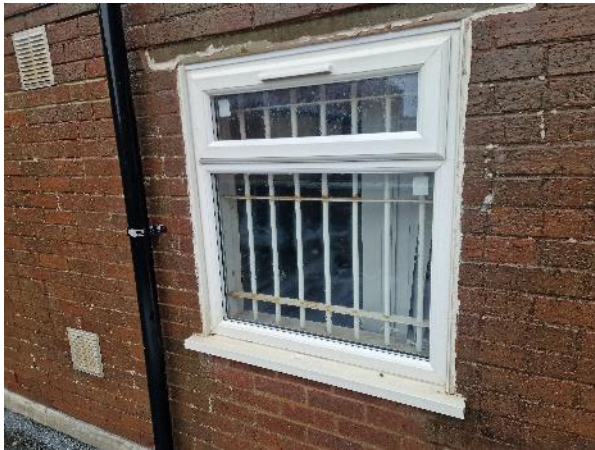
21. Replacement PVCu framed window to rear

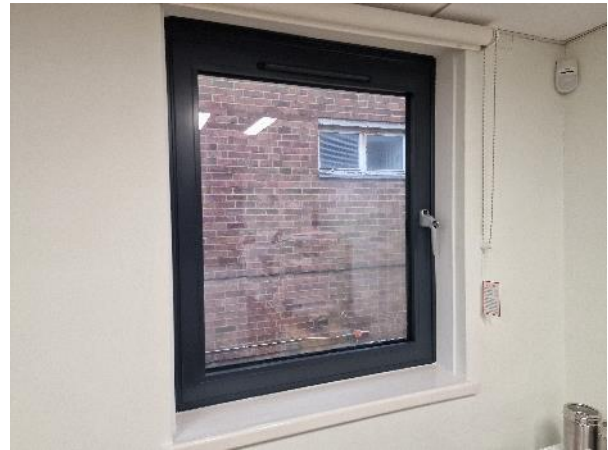
22. Replacement aluminium framed window to rear
