**HERITAGE STATEMENT - LISTED BUILDING CONSENT APPLICATION**

**REPAIR OF BAY STRUCTURE AND ADDITIONAL INVESTIGATION TO  
13 PARK CRESCENT, WORTHING, BN11 4AH**

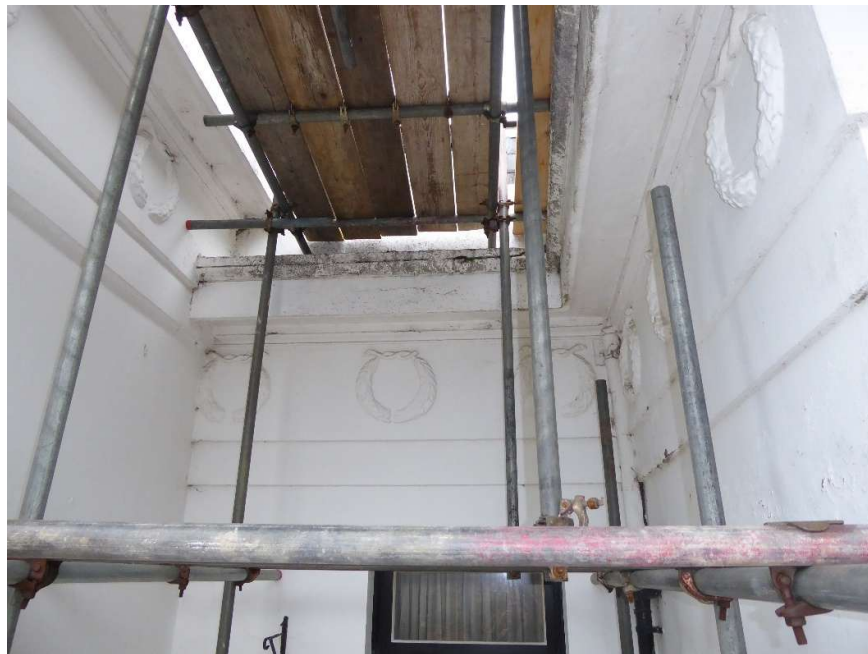
*Fig 2. Front elevation showing the existing rainwater goods below second floor.*

- 3.5 Supply and install new hopper and downpipe, routed to existing gulley at second floor, to service new outlet in parapet wall. Downpipe and gulley to be provided as cast iron and painted white to match the existing.

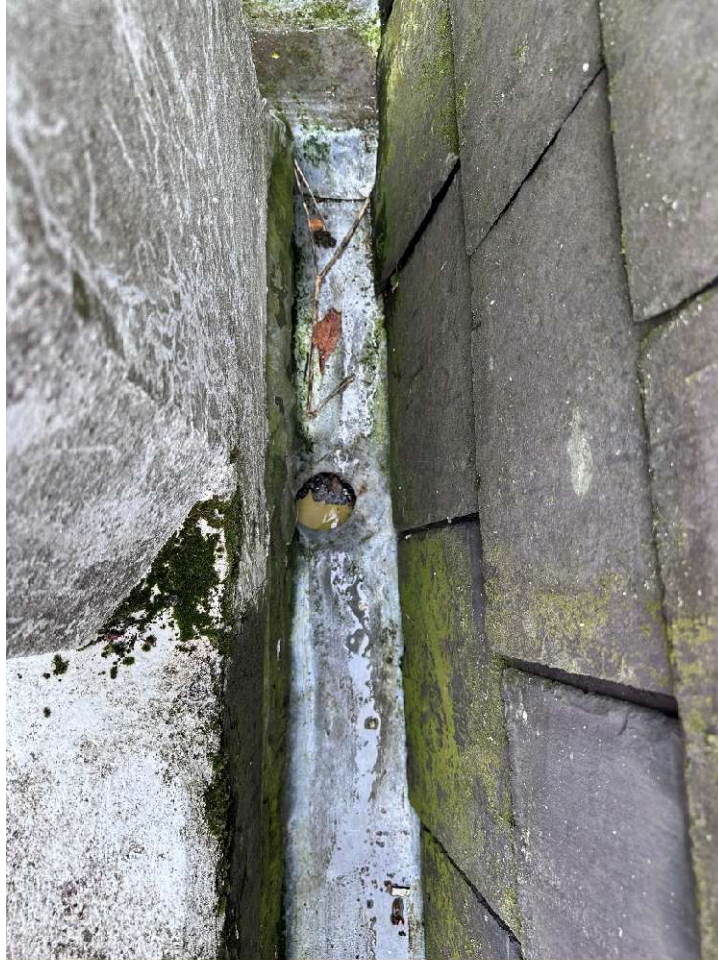
The alterations are focused on moving the existing gulley within the gutter to allow for access for cleaning from within the second floor flat, through the mansard window. The new location of the gulley will require the installation of a new rainwater hopper and downpipe which will be installed and provided in a sympathetic manner to the original building using traditional materials and finishes.

*Fig 3. Existing blocked gully. Inaccessible without scaffolding to front elevation.*

- 3.4 Allow to drill through existing parapet wall to similar diameter as existing penetration and to exit below moulding, to allow for installation of newly routed downpipe and gulley as per item 3.5 below. Contractor to provide suitable lead lining, lapped under leadwork to gutter, through penetration.

- 3.9 Provisional sum for replacement slate tiles. Allow for 1m<sup>2</sup> of new slate tiles (to be remeasured).
- 3.10 Infill hole to existing gulley. Infill to be provided with 15N bricks laid in suitable lime mortar to match existing. Infill to be toothed and bonded to existing bricks.
- 3.11 Undertake render repair using lime based render to match existing. Allow for 3m<sup>2</sup> of repair (to be remeasured).
- 3.12 Parapet wall to be repainted using white paint to match existing. Allow to use Earthborn silicate paint installed to manufacturer's instructions.
