**Document:** Supporting Photographs and Window Locations

**Property:** Flat 5, Ace House, 1 Bridge Road, Worthing, West Sussex, BN14 7BU

**Proposal:** Like-for-like replacement of 2 timber sliding sash windows (Grade II listed building)

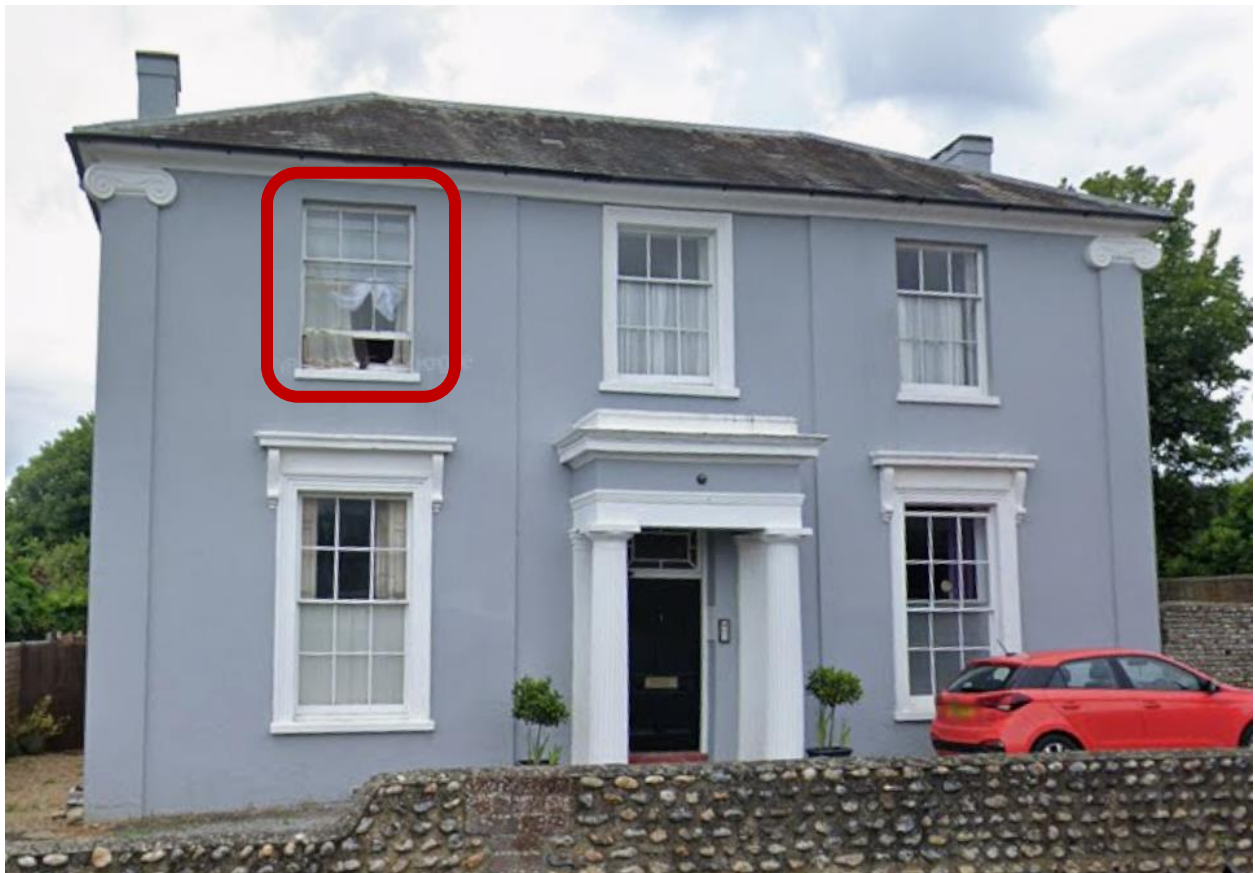
**Photo 1a - Front elevation (lounge window highlighted)**

External view of the front elevation showing **Window 1** serving Flat 5, proposed for like-for-like replacement.

The proposed works will not alter the external appearance.

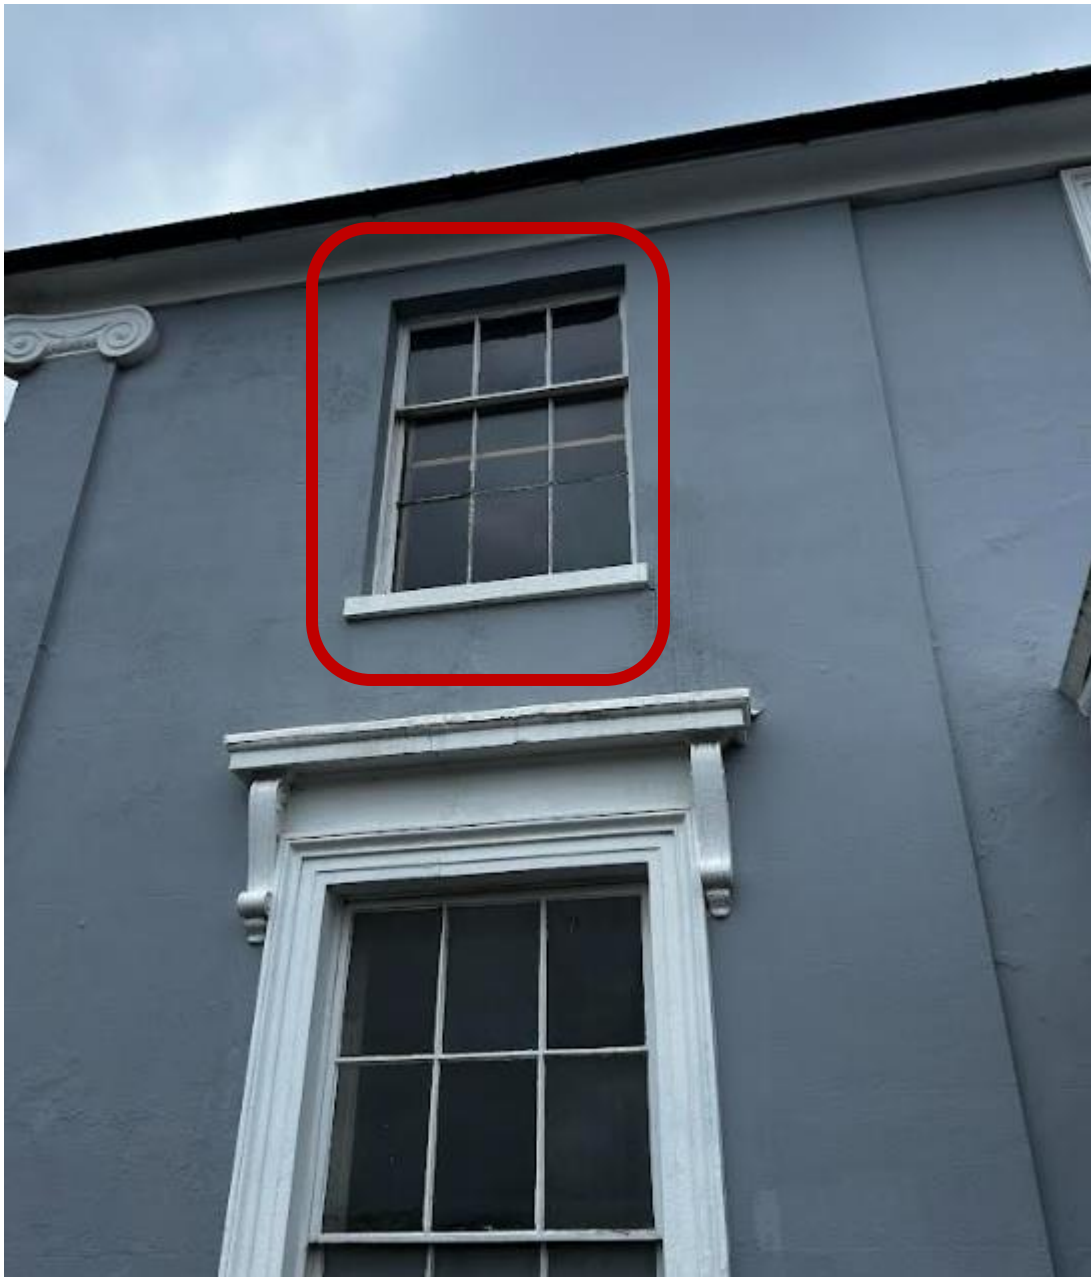
**Photo 1b - Front elevation (lounge window highlighted)**

External view of the front elevation showing **Window 1** serving Flat 5, proposed for like-for-like replacement.

The proposed works will not alter the external appearance.

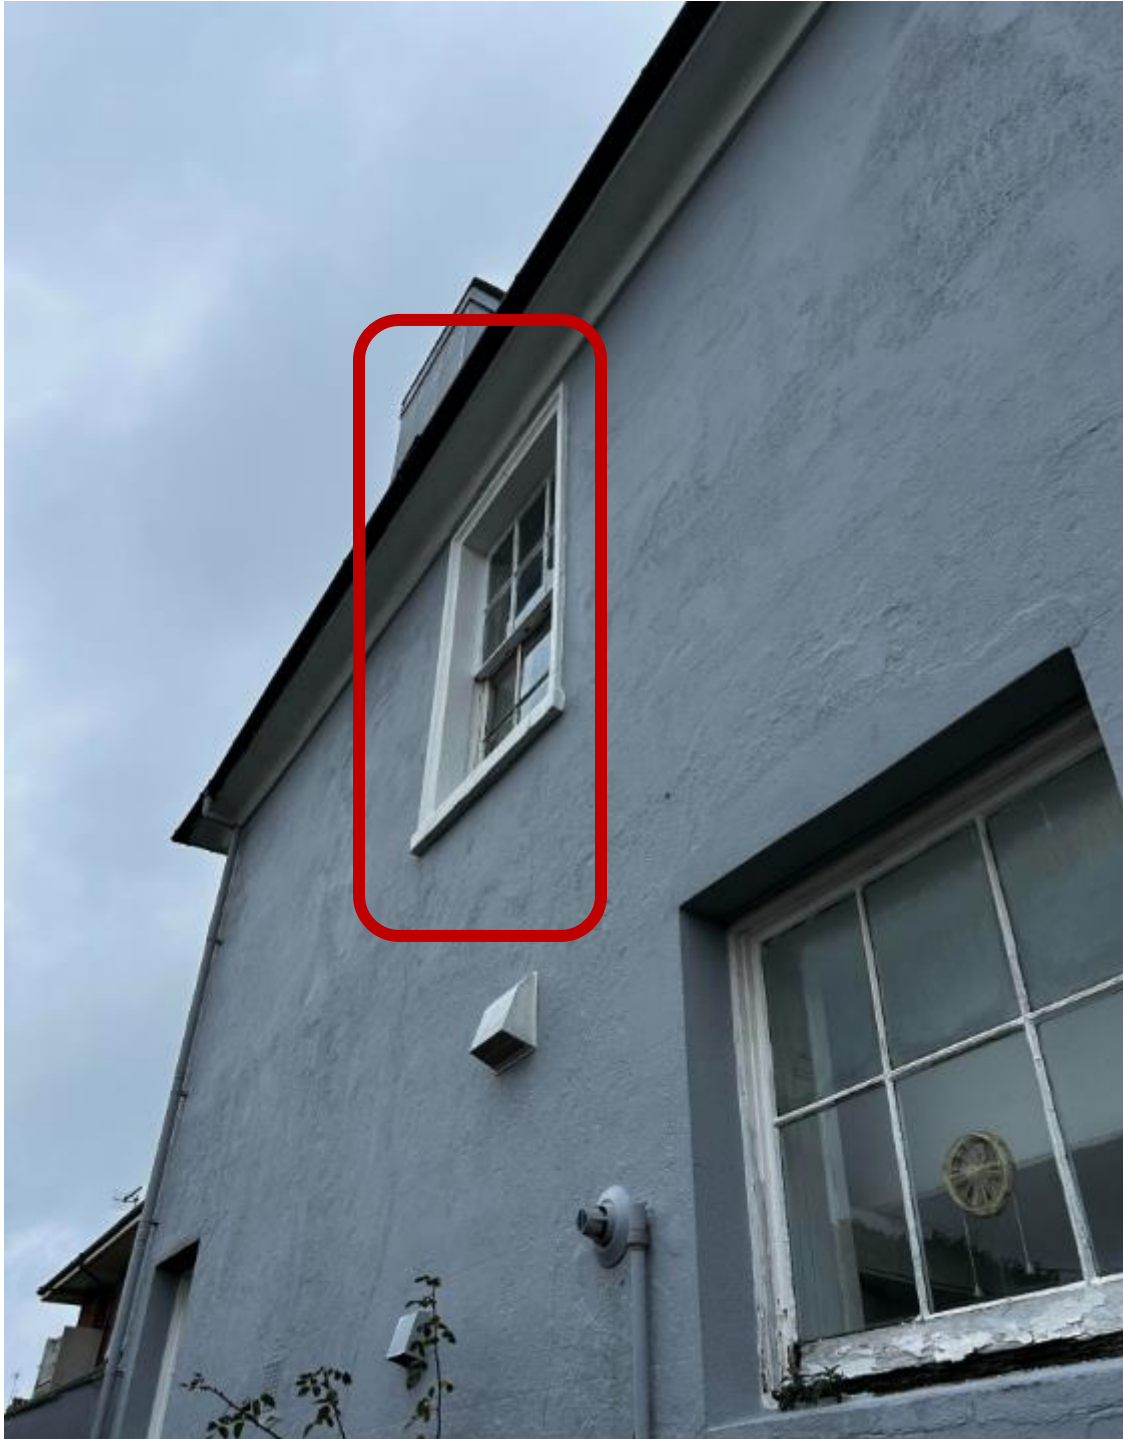
**Photo 2a - Side elevation (bedroom window highlighted)**

External view of the side elevation showing **Window 2** serving Flat 5, proposed for like-for-like replacement.

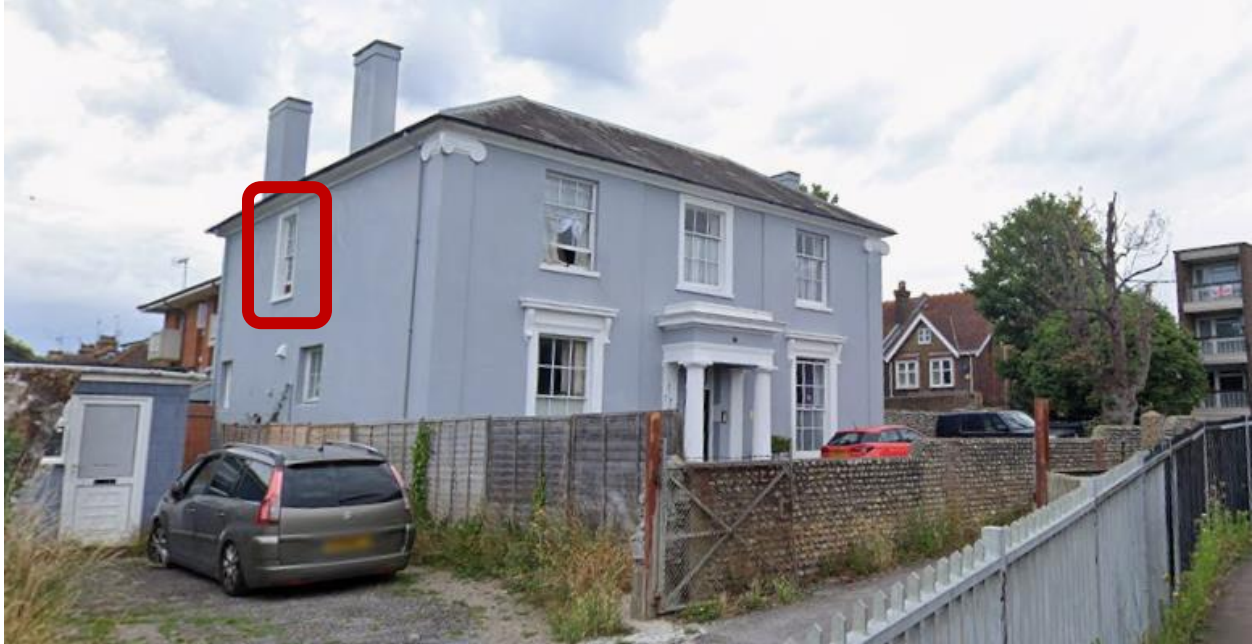
**Photo 2b - Side elevation (bedroom window highlighted)**

External view of the side elevation showing **Window 2** serving Flat 5, proposed for like-for-like replacement.

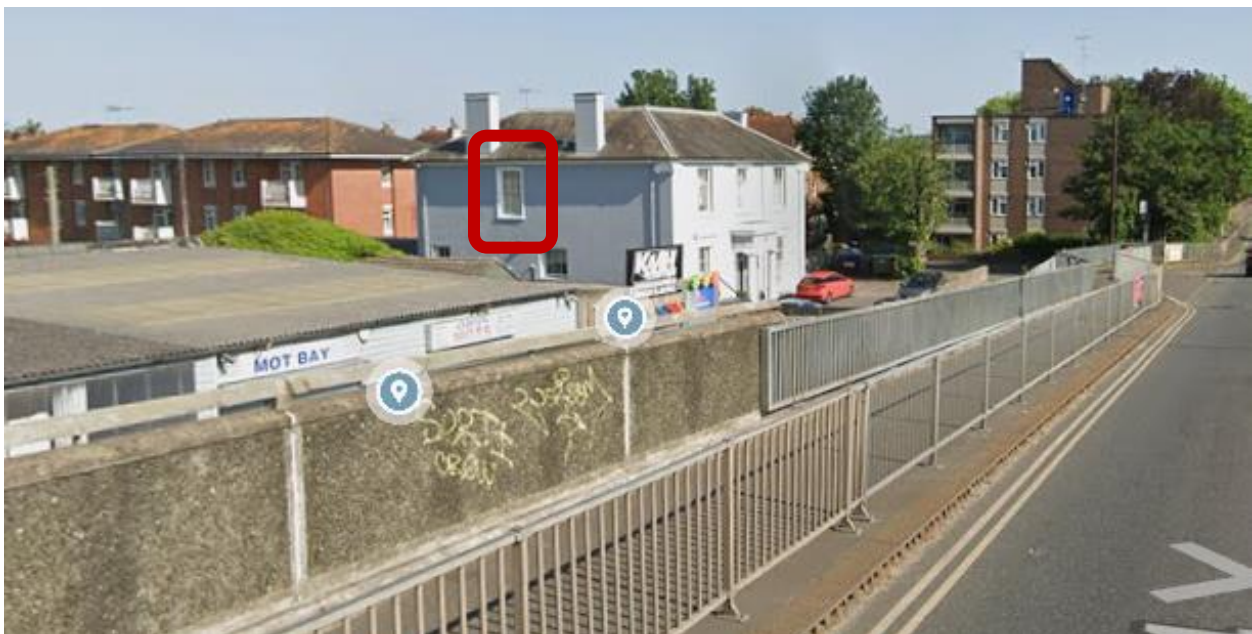
**Photo 2c - Side elevation (bedroom window highlighted)**

External view of the side elevation showing **Window 2** serving Flat 5, proposed for like-for-like replacement.

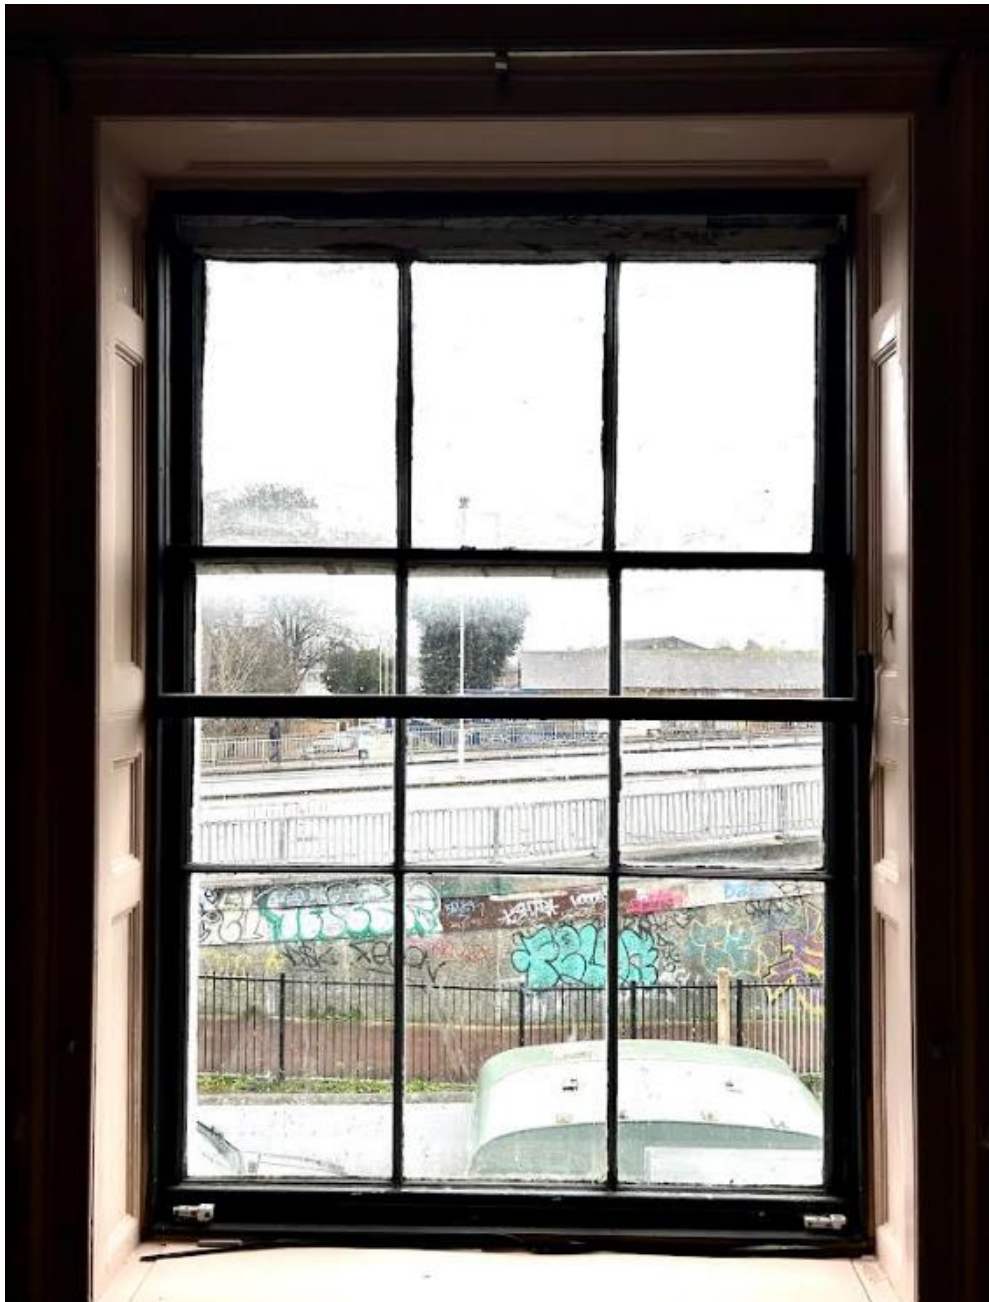
**Photo 3 - Window 1 (Front, lounge window) - Internal view**

Internal view of **Window 1**, showing existing sash arrangement and glazing pattern to be replicated in the replacement.

*\*The window frame and glazing bars have been painted black as a result of previous occupation. The proposed replacement will be painted white/off-white to reinstate a finish consistent with the existing windows elsewhere on the listed building.*

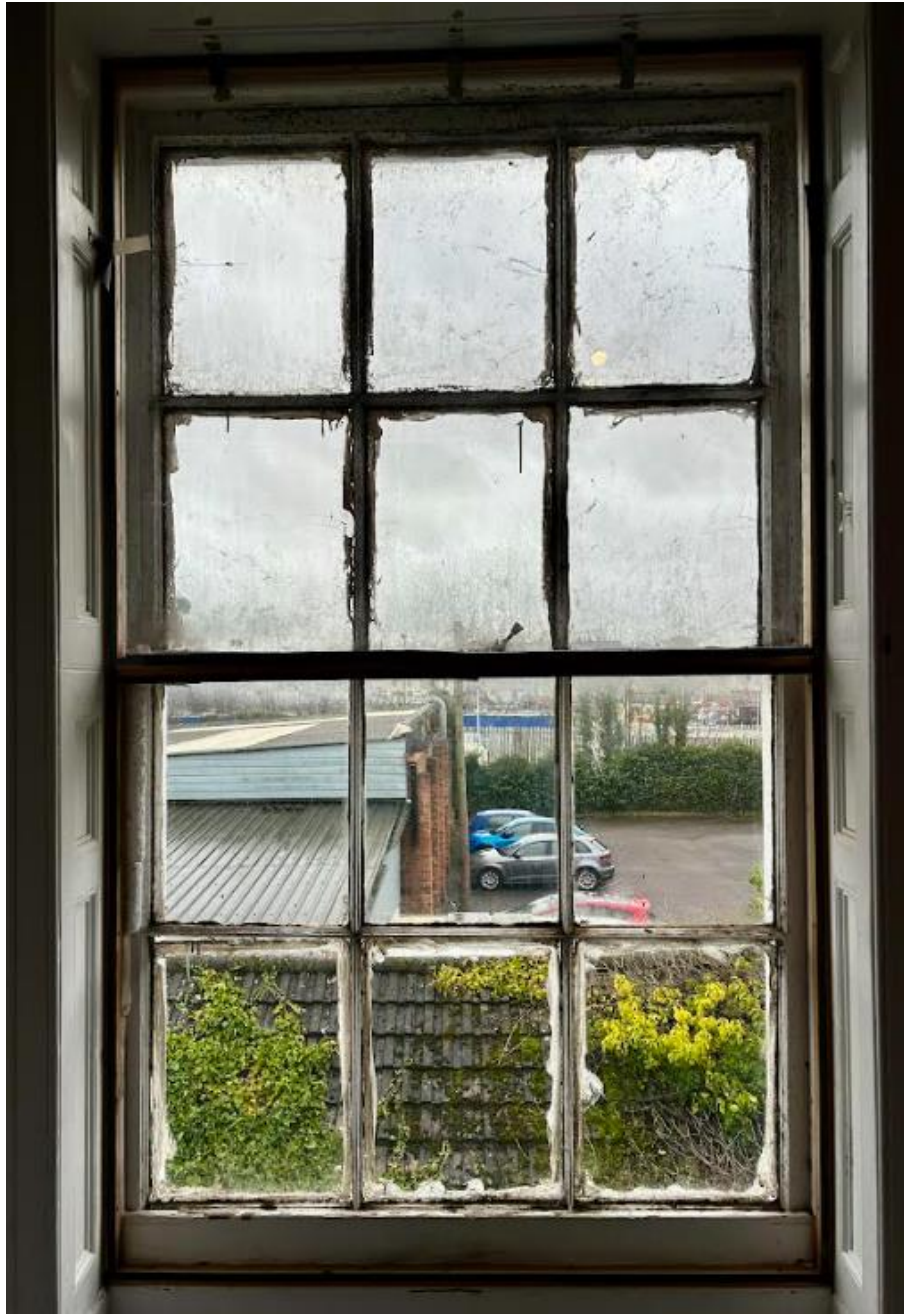
**Photo 4 - Window 2 (Side, bedroom window) - Internal view**

Internal view of **Window 2**, showing glazing bar arrangement and proportions to be matched like-for-like.

*\*The glazing bars have been painted as a result of previous occupation. The proposed replacement will be painted neatly in white/off-white to reinstate a finish consistent with the existing windows elsewhere on the listed building.*

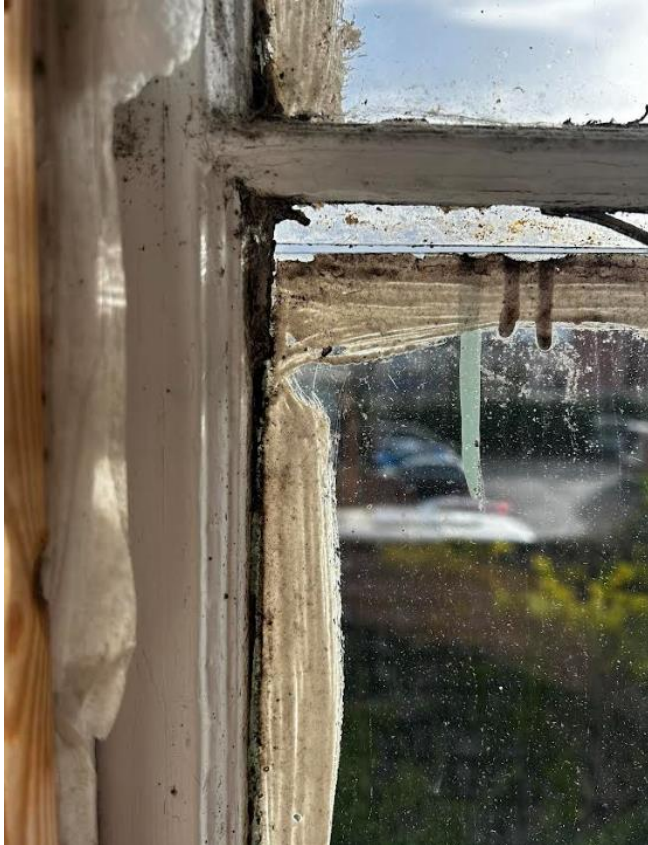
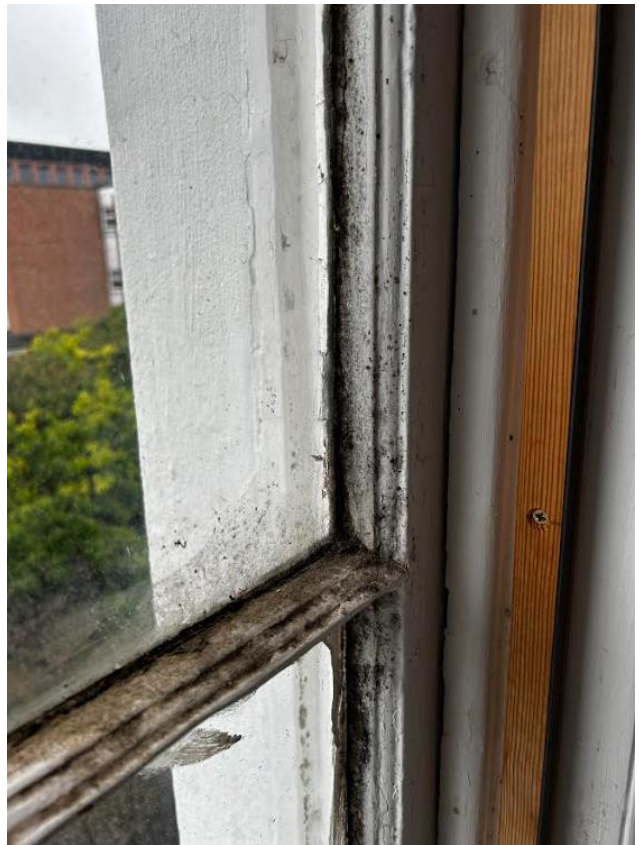
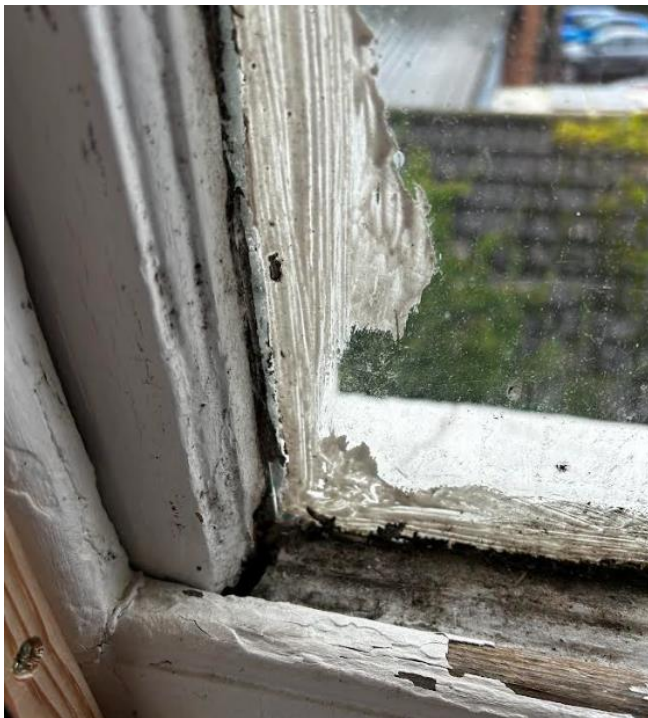
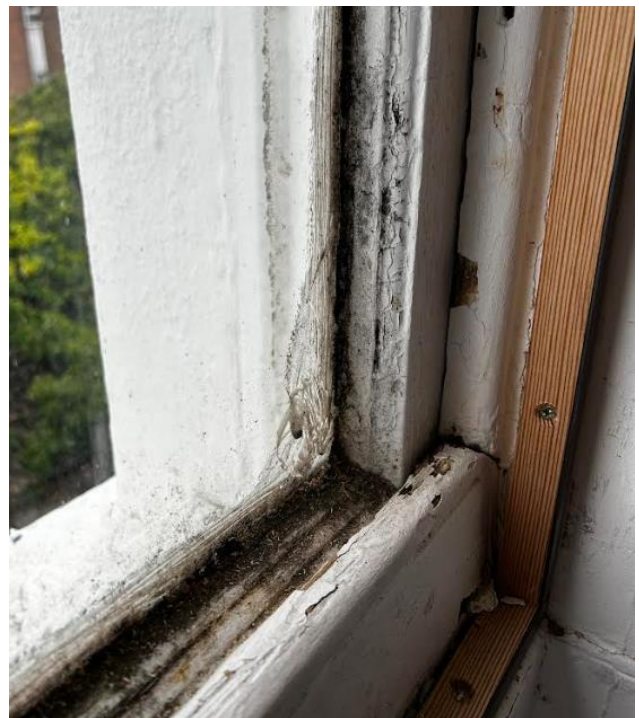
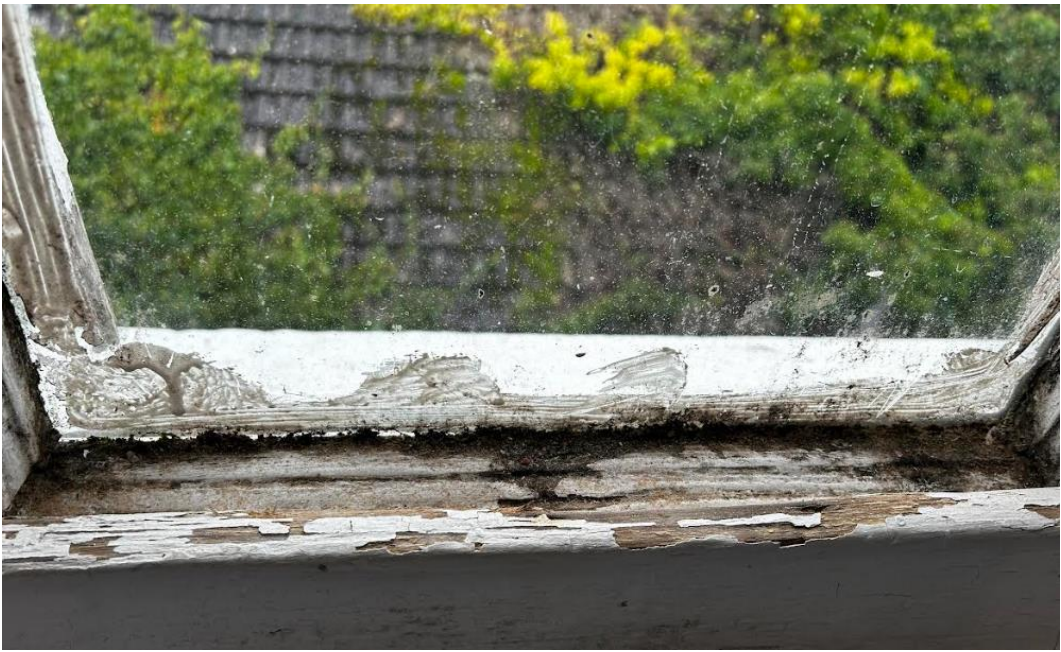
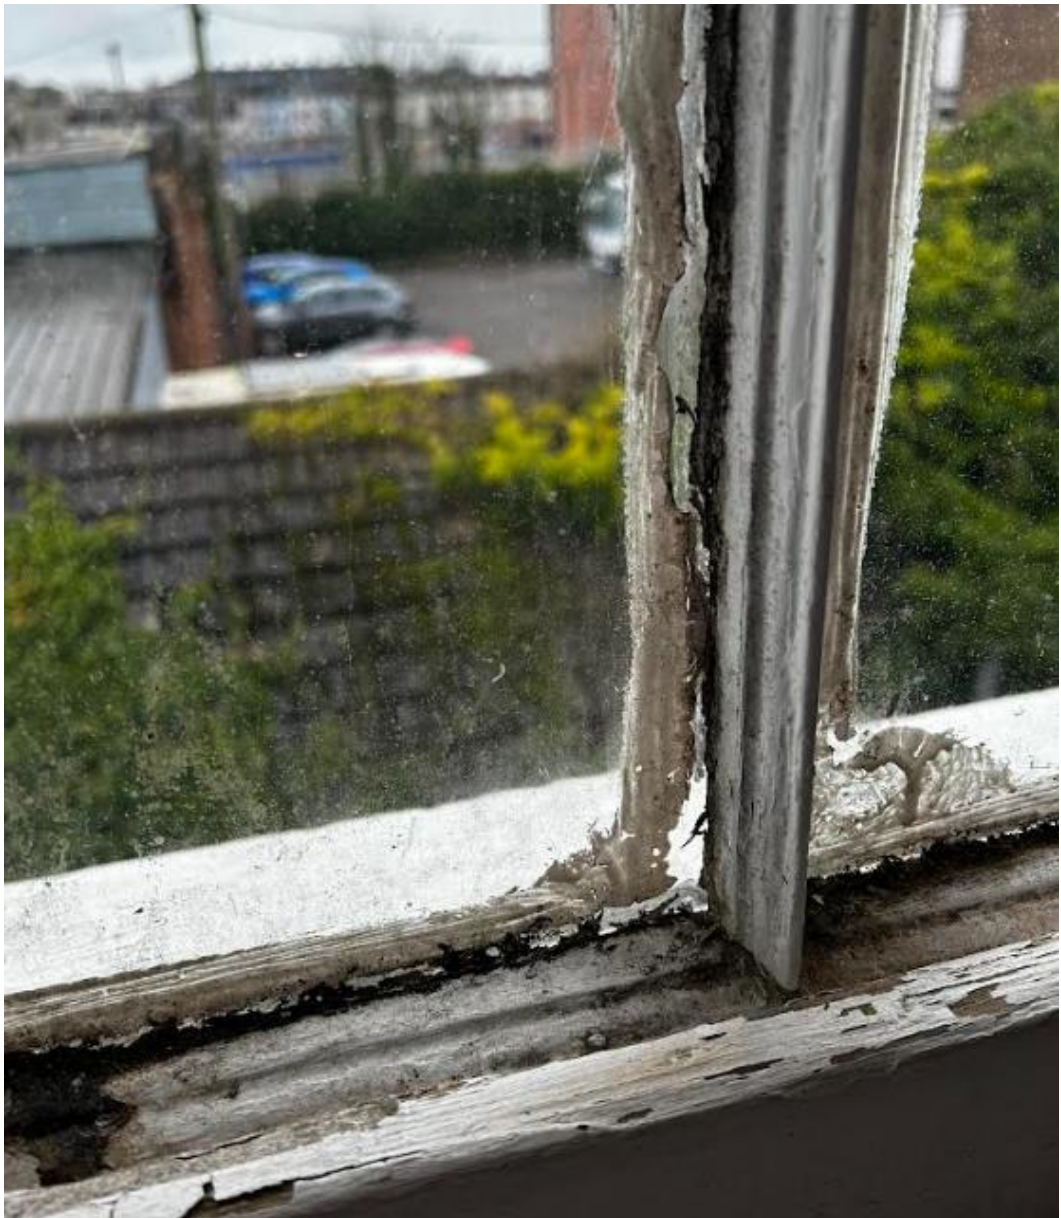
**Photo 5 (Collection of 6 photos) - Window condition detail**

6 Photographs showing representative defects (e.g. timber decay, open joints, failed paint finish).
