Preliminary Ecological Appraisal and Roost Assessment

6 Hayling Rise, Worthing, West Sussex BN13 3AL

This report is prepared to inform a planning application with Worthing Borough Council. The proposal is described as "Removal of existing side extension, erection of front extension and detached 2 bedroom bungalow"

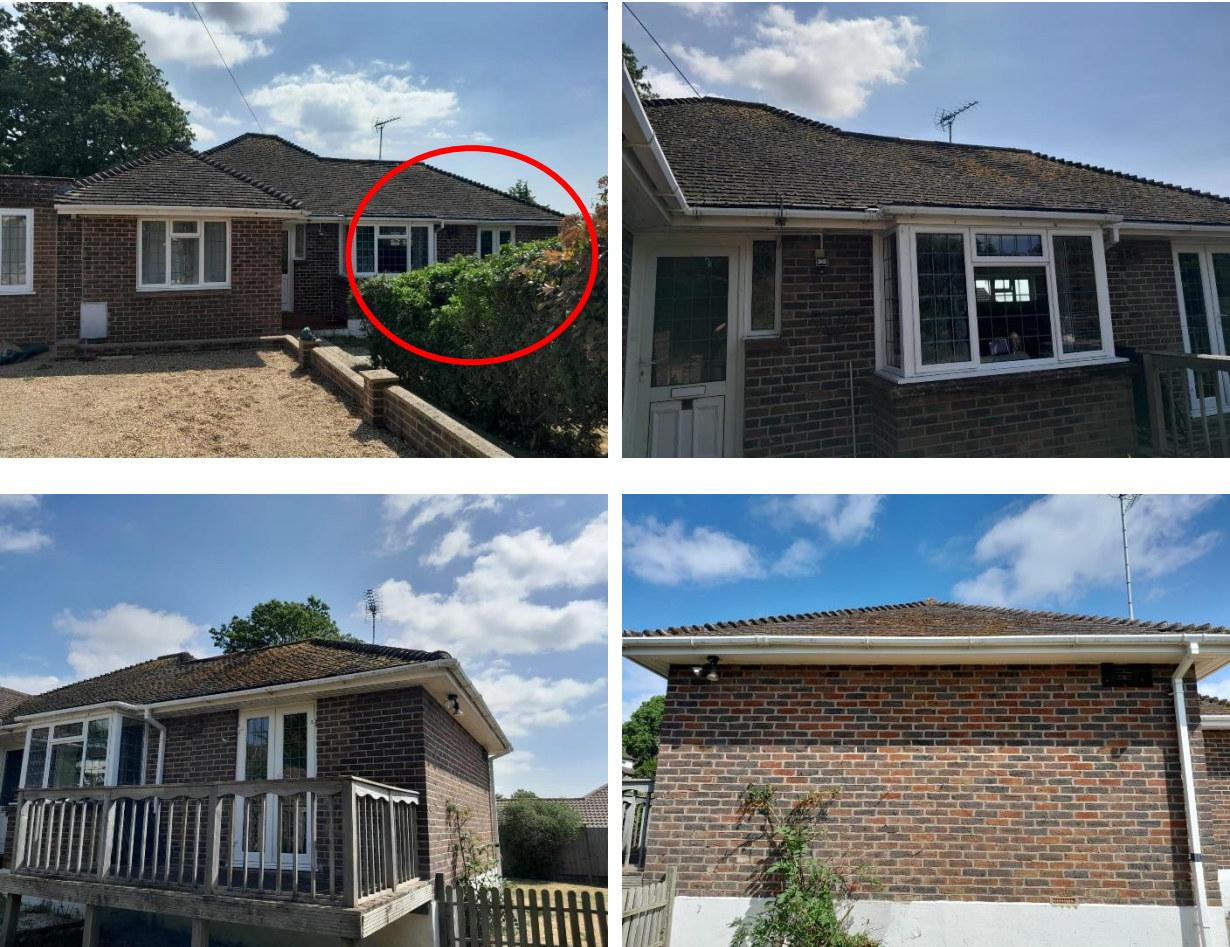
Description	Photographs
Preliminary Roost Assessment	
<p>Overview of building exterior</p> <p>Red circle shows the extension proposed to be removed</p>

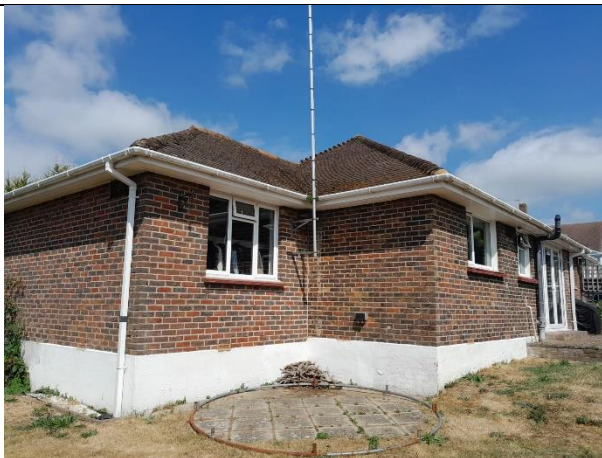
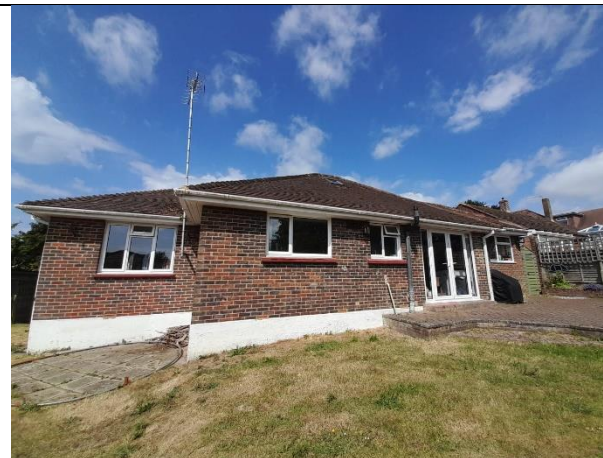
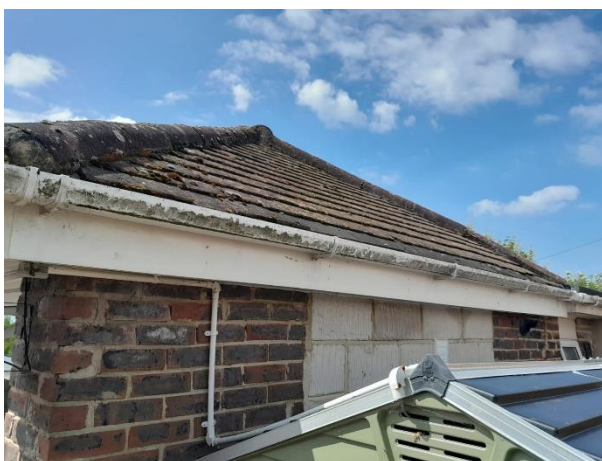
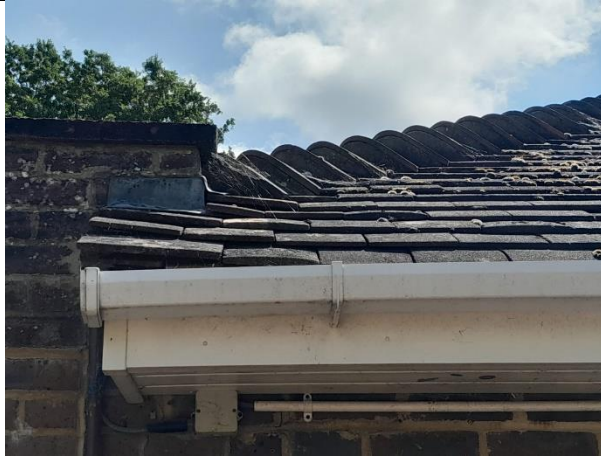
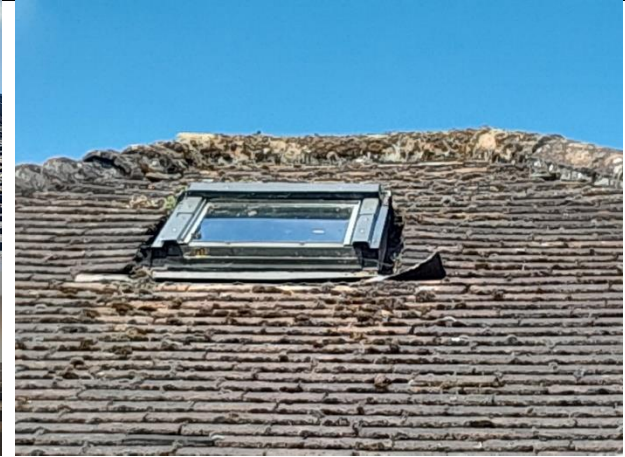
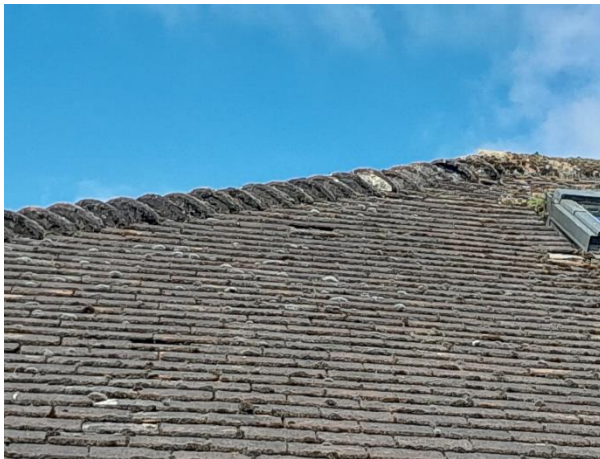
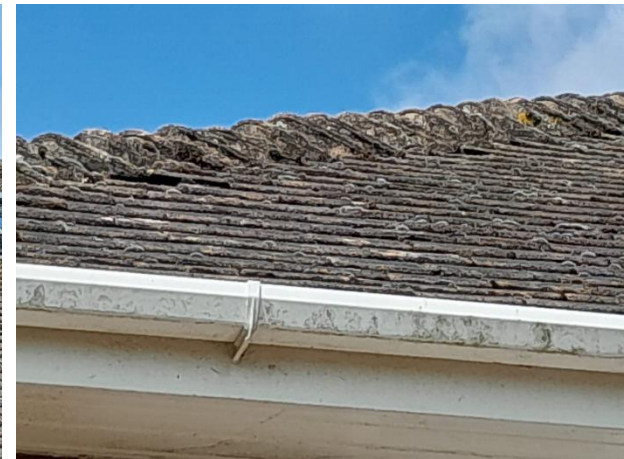
Invertebrates	
<i>Summary of Survey Findings</i>	The vegetated garden within the site provides suitable habitat for common invertebrates. The site contains no habitat to support notable assemblages of invertebrates.
<i>Foreseen Impacts</i>	No impacts anticipated.
<i>Recommendations</i>	No further surveys.
Bats	
<i>Summary of Survey Findings</i>	<p>EPSLs</p> <p>A search of the magic.gov.uk database for granted EPSLs within a 2km radius of the site has been completed. There are no granted EPSLs for bats within a 2km radius of site.</p> <p>Roosting habitat</p> <p><u>Building</u></p> <p>The building is a one-storey, brick-built bungalow with a multi-hip roof clad with concrete roof tiles. The front of the building (west elevation) presents an 'L' shaped elevation with a double hip roof and a uPVC door and windows, with a flat roof on the very west section with one window. The south elevation presents a hipped roof with no windows or doors, the east elevation presents a cross hip roof with a uPVC door and several windows. There is a shed present against the north elevation, located between the north building wall and site boundary brick wall. This elevation presents a cross hip roof, with the flat roof present on the western side. The windows, doors, soffits and fascia are all well sealed with no gaps observed. There are numerous gaps underneath lifted roof tiles and a gap under lifted lead flashing by the velux window, which provide suitable roosting features for crevice-dwelling bats.</p>

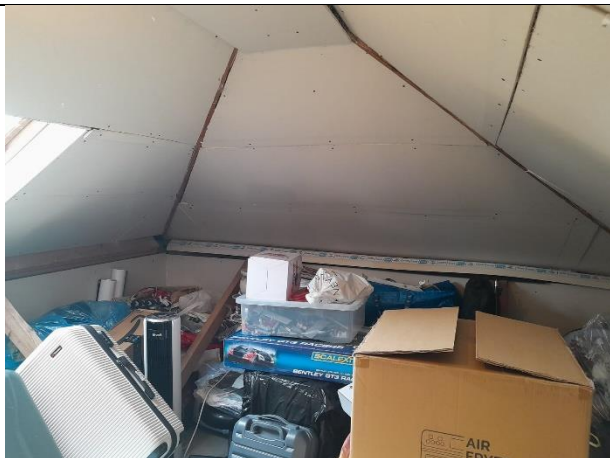
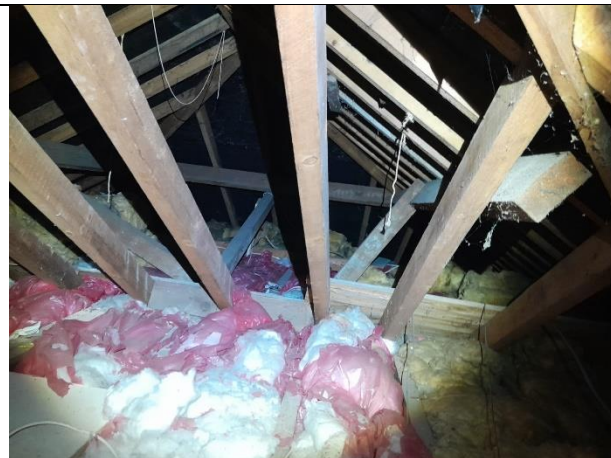
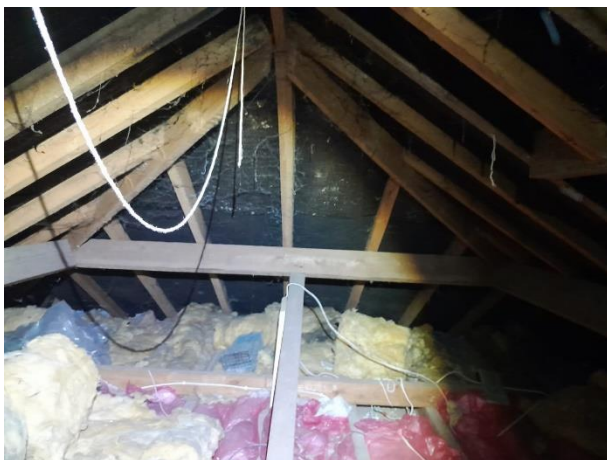
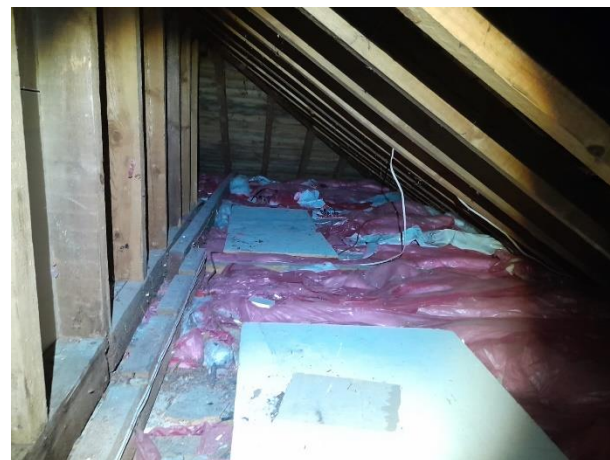
Overview of building interior

<p>There was one square shaped habitable room in the loft space which is unsuitable for bats. This room was surrounded by empty loft void which measured approximately 3.6m width, 5.3m length, 1.3m height, with internal humidity of 78% and temperature of 11.8°C. The main loft area was lined with bitumen felt, with some areas surrounding the square habitable room lined with timber sarking (See Appendix 4 for photographs). No direct evidence of bats was observed within the loft space, nor on the exterior of the building.</p> <p>The building is assessed as low value to roosting bats.</p>
<i>Foreseen Impacts</i>	The removal of the side extension will cause the destruction and disturbance of bat roosts (if present), which may lead to injury and death of bats.
<i>Recommendations</i>	<p>One bat emergence survey is required during the active bat season (optimal May to August, suboptimal September) to confirm presence or likely-absence of a bat roost in the building.</p> <p>Infra-red cameras must be used as an aid. Three surveyors are required to provide full coverage of the building.</p> <p>If the absence of a bat roost cannot be determined during the first visit, then further surveys will be required. If bat roosts are confirmed in the building two additional surveys may be required to characterise the roost and to inform an EPSL application to Natural England. Surveys should be a minimum of two weeks apart. The EPSL application requires that surveys have been undertaken within the most recent active bat season and planning permission must have been granted and all relevant wildlife-related conditions have been discharged prior to submission.</p>

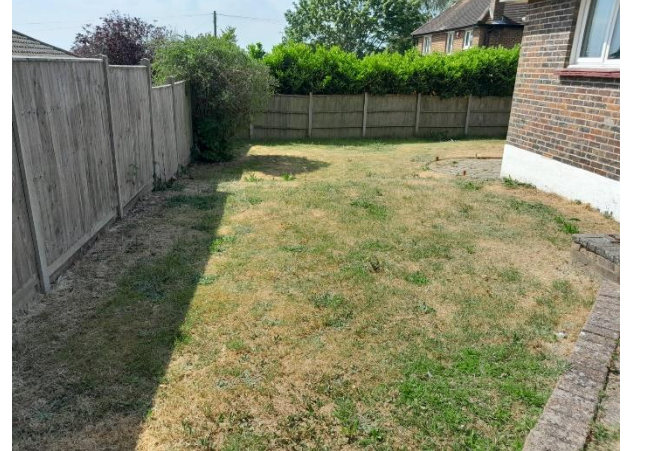
Description	Photographs
Preliminary Ecological Appraisal	
Artificial, unvegetated, unsealed surface	 
Developed land, sealed surface

<p>Vegetated garden (comprised of modified grassland, introduced shrubs and hedgerow)</p>
