**Courtlands, Parklands Avenue, Goring-By-Sea**  
**Statement of Significance**  
**March 2026**

Statement of Significance

Courtlands, Parklands Avenue, Goring-By-Sea

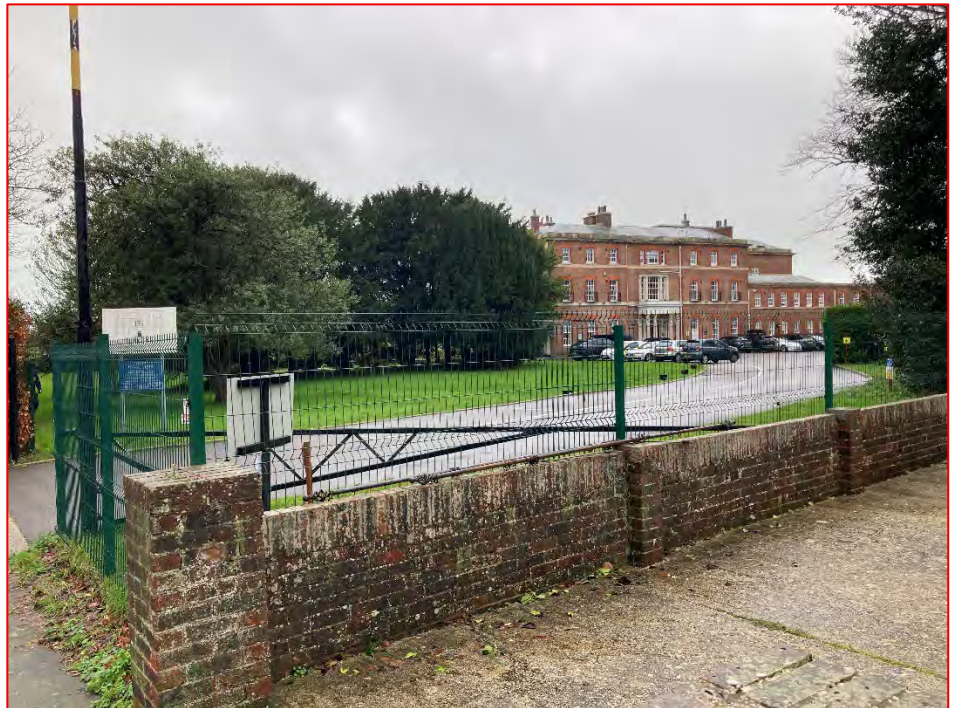
**Plate 1** Principal north elevation to the Courtlands building taken from Parklands Avenue looking south-west. Note that this elevation was remodelled in the early 20<sup>th</sup> century.

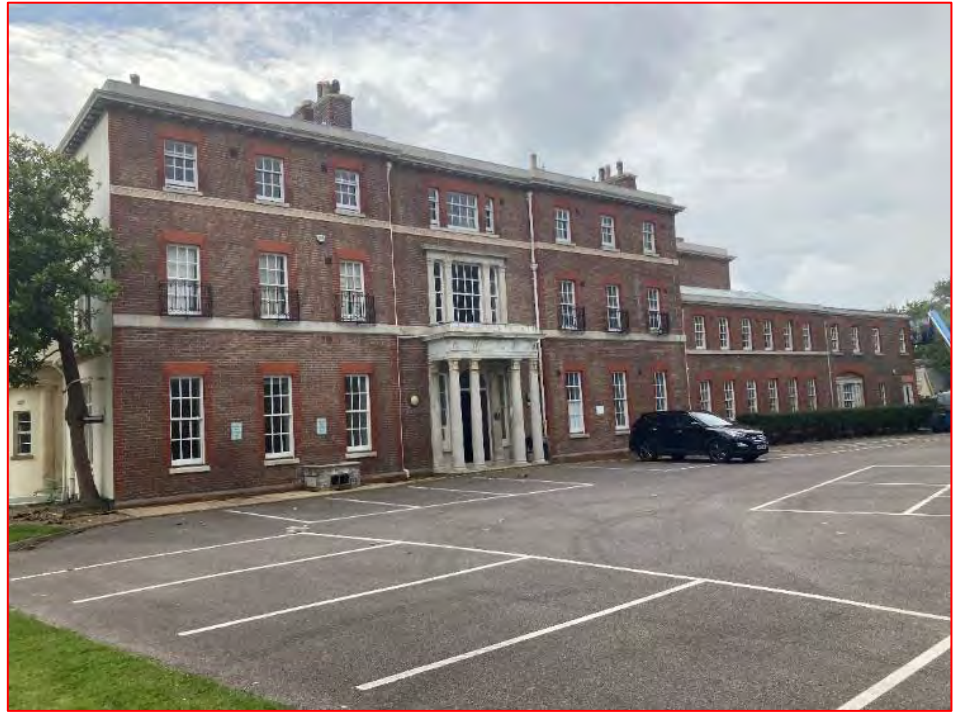
**Plate 2** Principal north elevation to the former Courtlands Hospital building, taken from the lawned area to the north-east. Note the three-storey element, which is earlier in date with the two-storey element having been added at a later date. Note this image is from 2021 prior to the building's renovation.

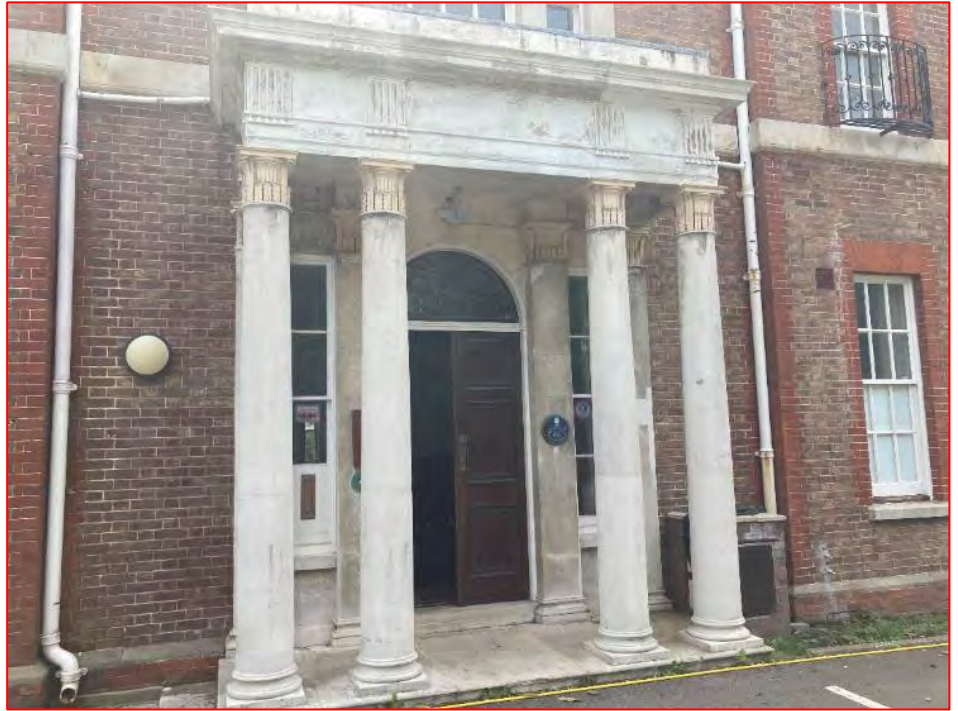
**Plate 3** Main entrance porch to the north elevation. Note this image is from 2021 prior to the building's renovation.

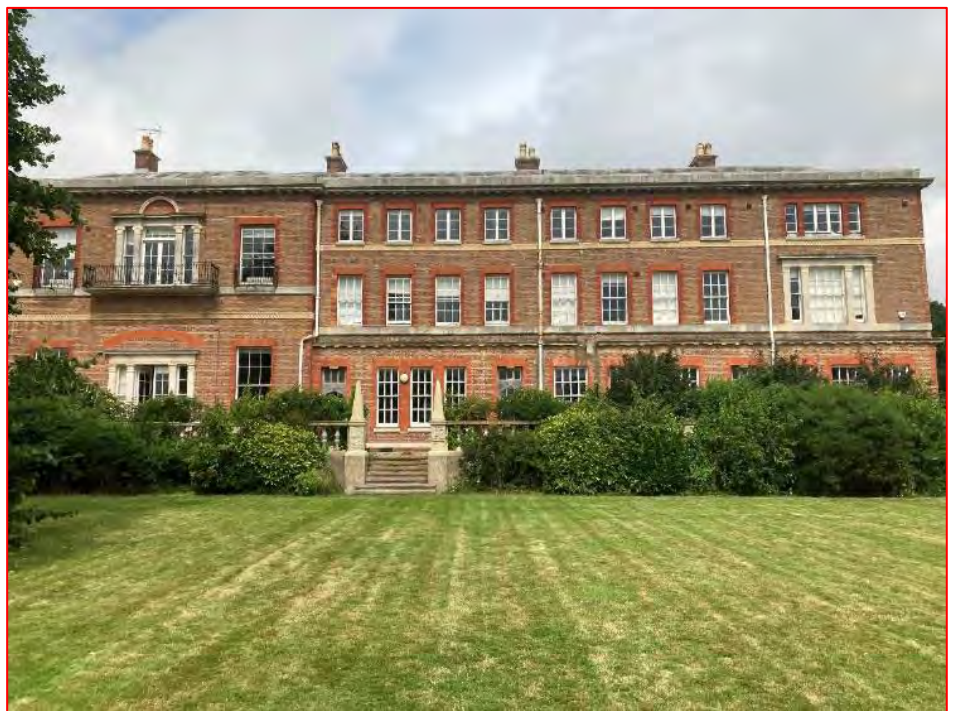
**Plate 4** View of south (garden) elevation to the Courtlands building. Note this image is from 2021 prior to the building's renovation.

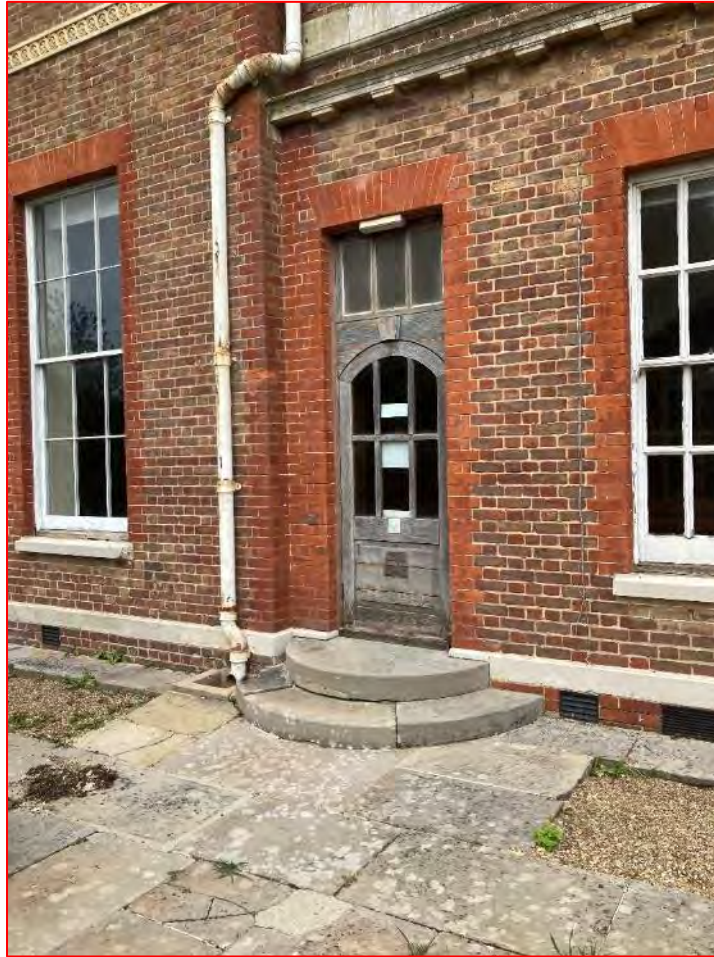
**Plate 5** Example of ground floor door opening to the south elevation of the Courtlands building. Note this image is from 2021 prior to the building's renovation.

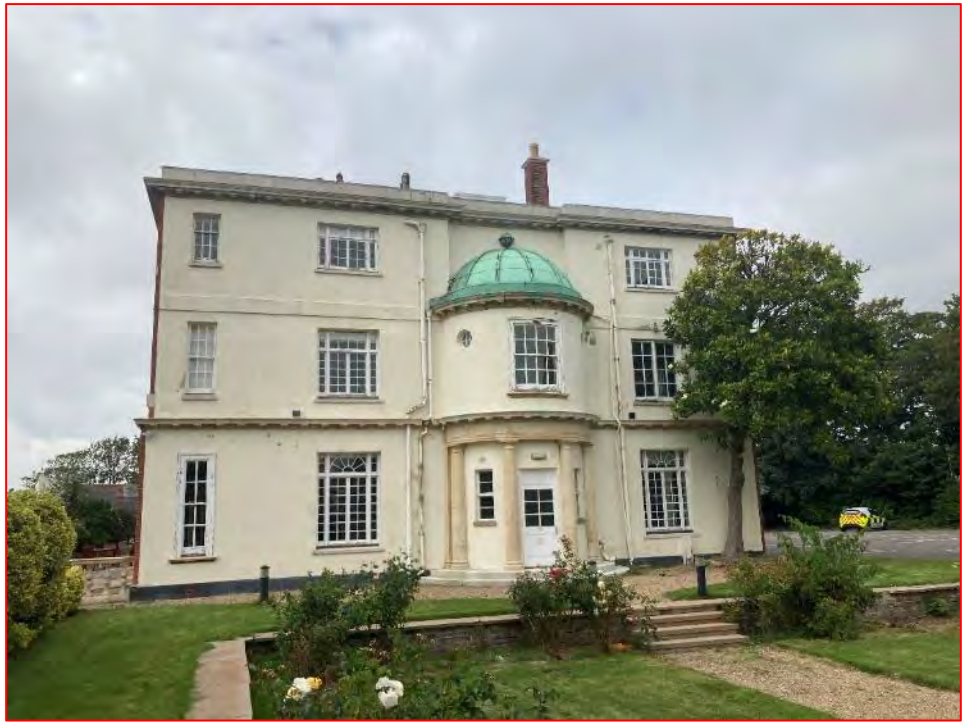
**Plate 6** View of east elevation to the Courtlands building. Note this image is from 2021 prior to the building's renovation.

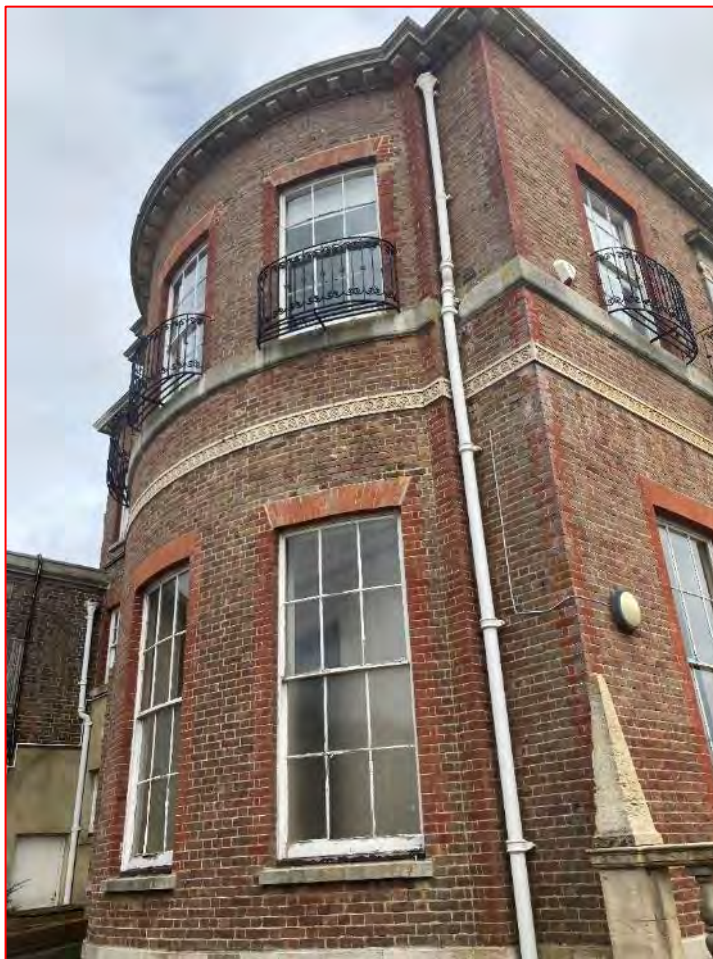
- 4.14** The west elevation is largely brick faced with a projecting curved bay at its southern end (Plate 7). The curved bay comprises three timber sash windows (six-over-six pane) at ground level and three timber sash windows at first floor (six-over-six pane).
- 4.15** Adjoining the west elevation is the largely blind south elevation to the two-storey western wing, which has a render face at ground level and is brick faced at first floor level (Plate 8).

**Plate 7** Part view of west elevation to the Courtlands building. Note this image is from 2021 prior to the building's renovation.

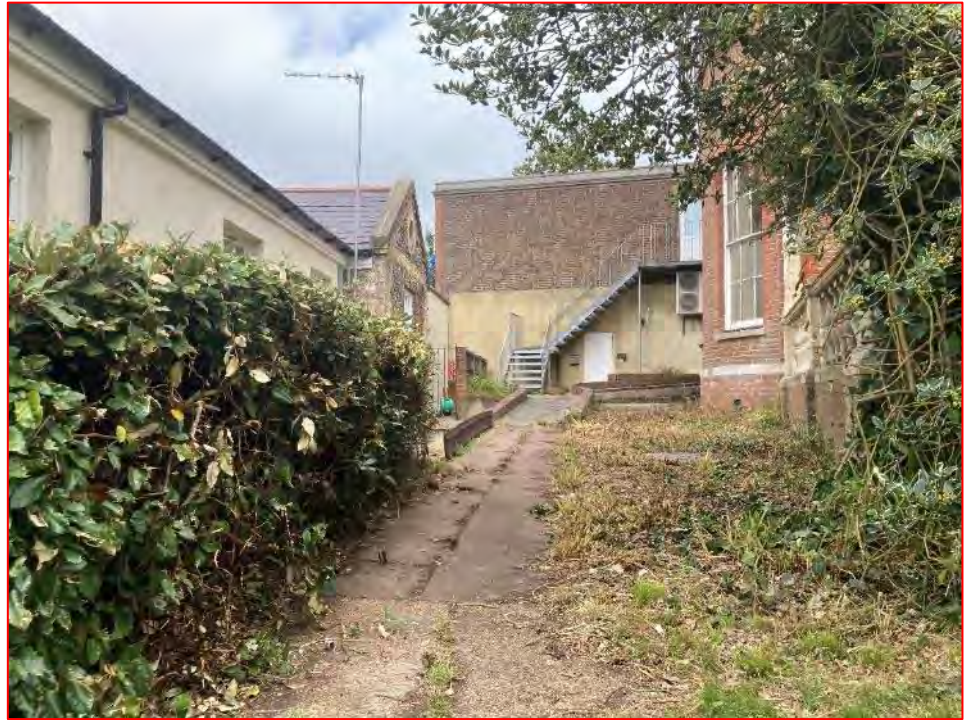
**Plate 8** Part view of largely blind south elevation to the two-storey westernmost wing (centre). Note that the buildings in left of picture do not form part of the site. Note this image is from 2021 prior to the building's renovation.

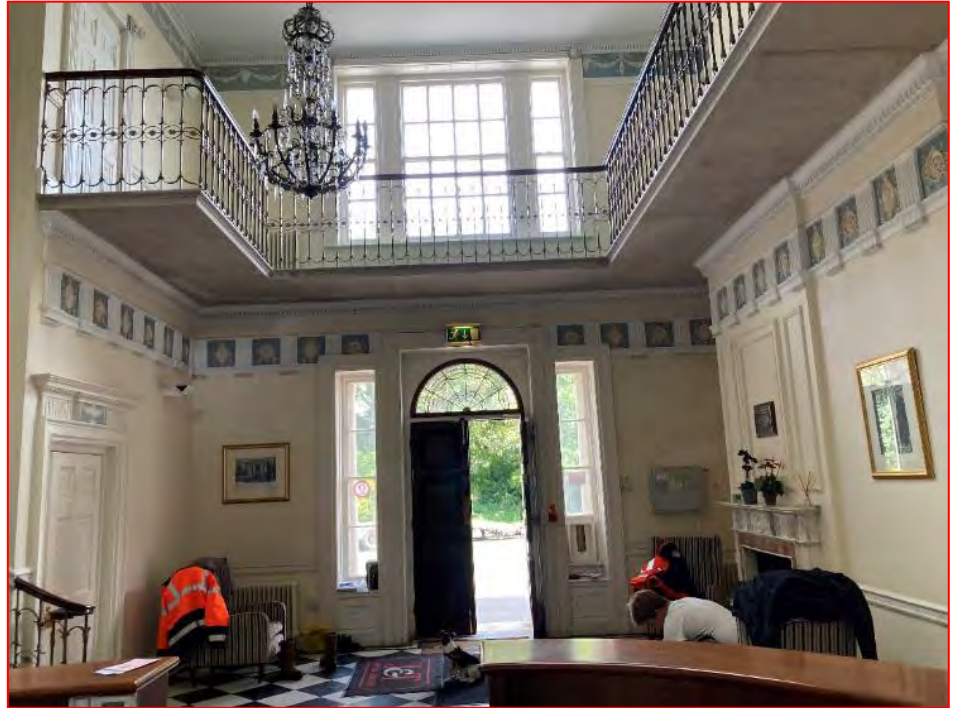
**Plate 9** View of main entrance hall and door at ground level. Note this image is from 2021 prior to the building's renovation, though all historic fixtures, fittings and finishes have been retained.

- 1.12** The interior of the Courtlands building comprises three levels at its eastern end and two at its western end. The ground floor comprises a number of principal rooms set around a grand entrance hall. The entrance hall comprises a double height space and includes an original iron balustraded staircase (likely relocated from elsewhere). The Mezzanine floor sits almost entirely within the two-storey 20<sup>th</sup> century addition, although the existing toilets are located within the earlier part of the building. The first floor includes the main entrance hall landing, which has notable Adam style plasterwork to the walls and distinctive balustrading to the staircase (likely relocated from elsewhere in the early 20<sup>th</sup> century or replicas introduced at this time). The second floor includes a central lobby area, with the roof to the Adams style dome centrally placed (again likely relocated from elsewhere in the early 20<sup>th</sup> century or is a replica introduced at this time). A skylight site above the dome allowing natural light into this space.

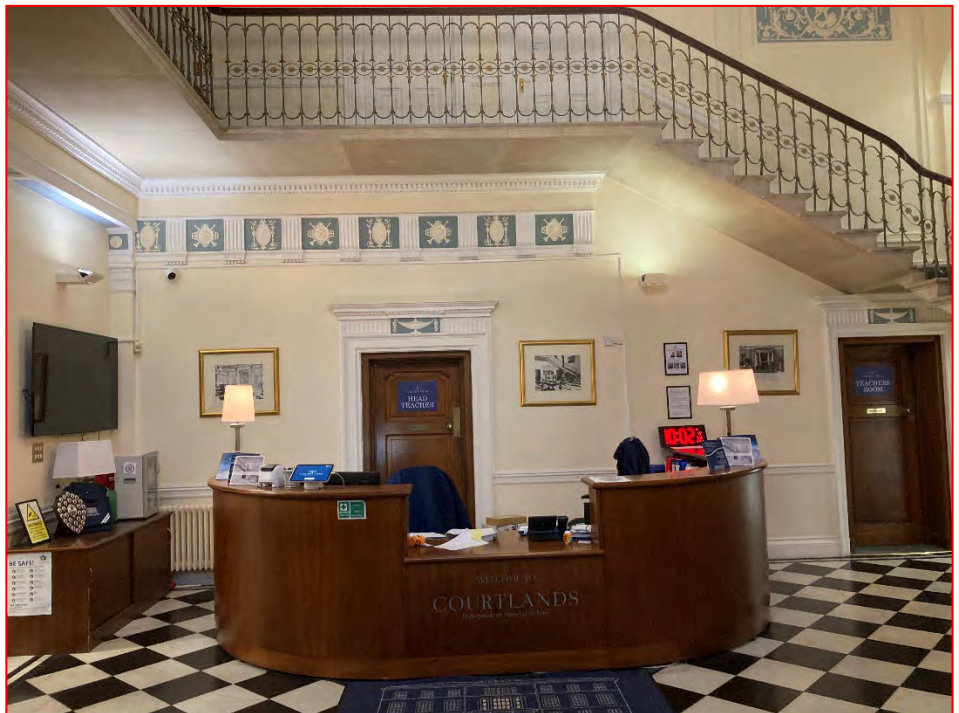
**Plate 10** View of main ground floor entrance hall and staircase (2026)

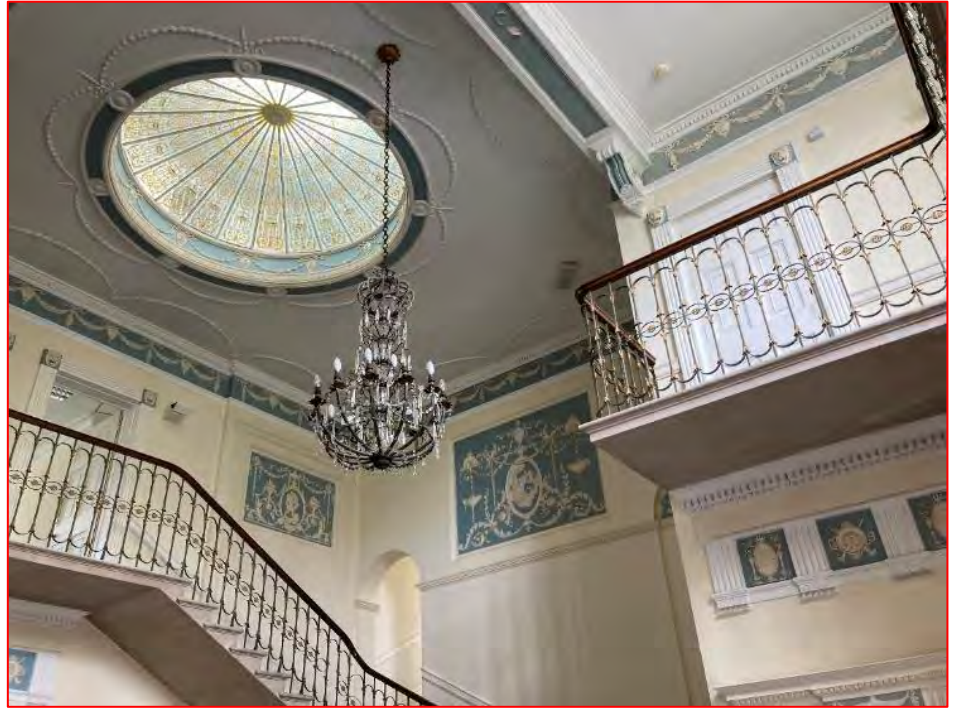
**Plate 11** Part view of ceiling above main ground floor staircase. Note that this elevation was remodelled in the early 20th century. Note this image is from 2021 prior to the building's renovation, though all historic fixtures, fittings and finishes have been retained.

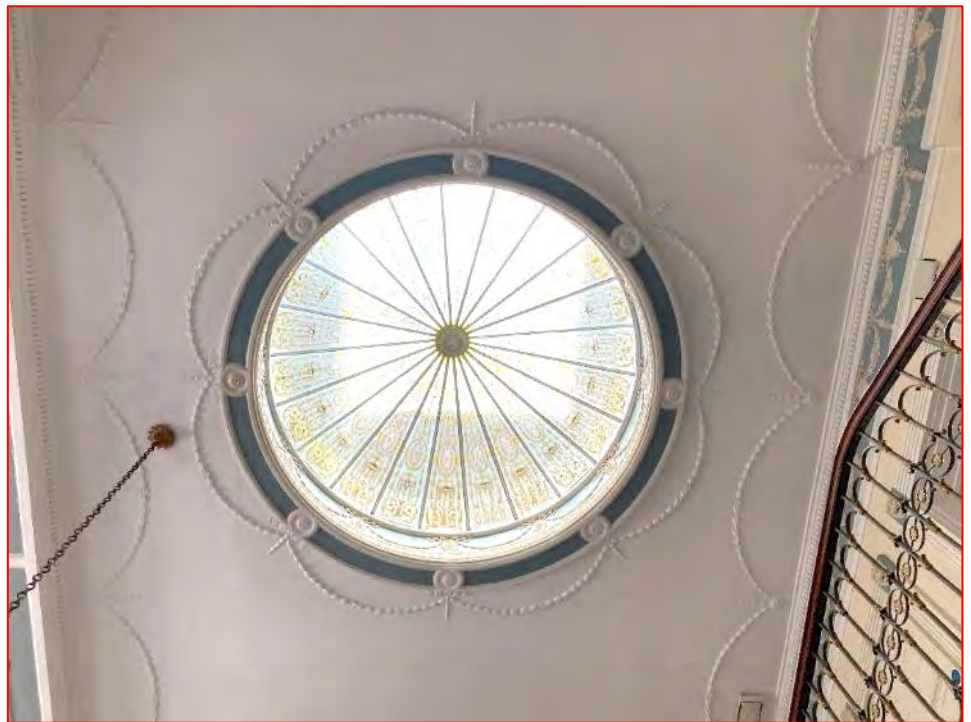
**Plate 12** Adam style dome located above main entrance stair. Note this image is from 2021 prior to the building's renovation, though all historic fixtures, fittings and finishes have been retained.

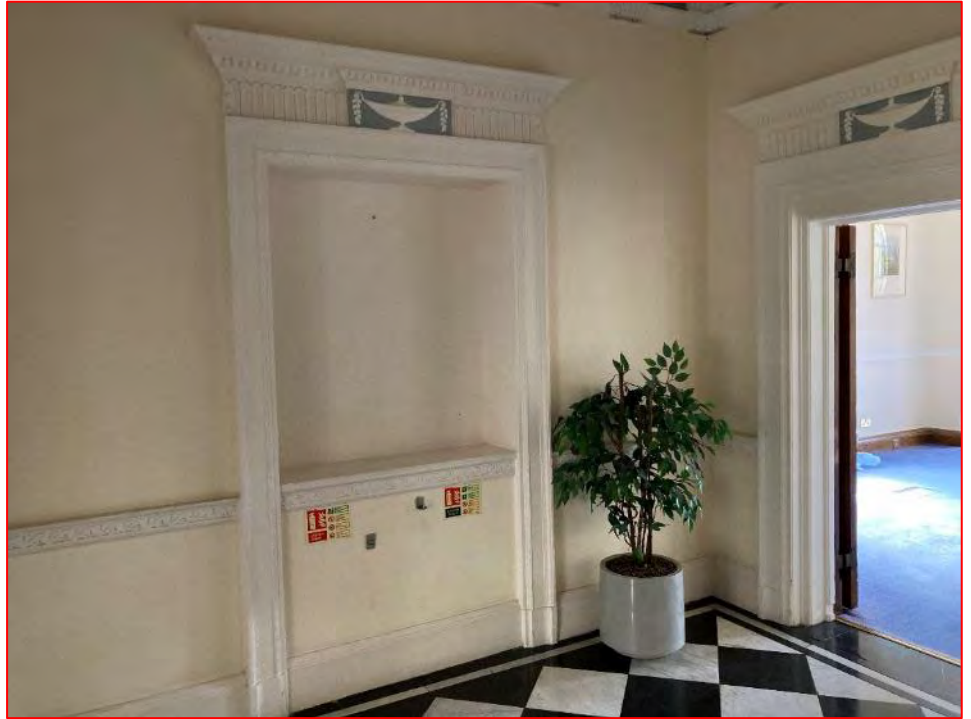
**Plate 13** View of the infilled door opening to the secondary stairwell at the eastern end of the building. Note the door opening to the south-east room is evident (right of picture). Note this image is from 2021 prior to the building's renovation, though all historic fixtures, fittings and finishes have been retained.

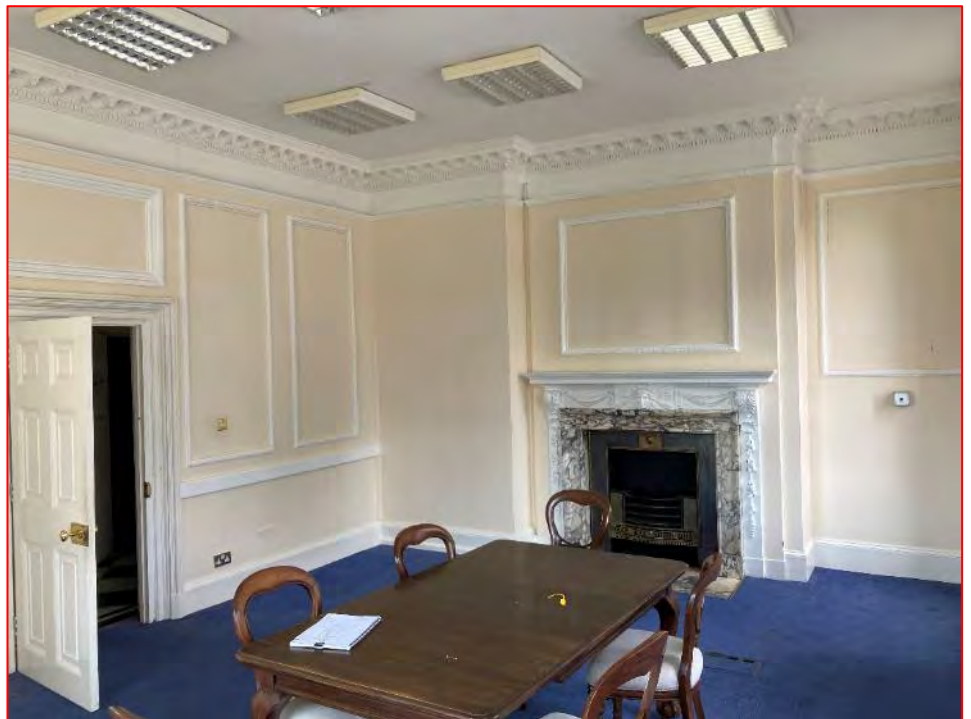
- 4.18** The north-east room (GF1) has an ornate fireplace surround, with historic joinery and plasterwork surviving in situ (Plate 14).
- 4.19** The south-east room (GF2), historically the morning room. Prior to the conversion of the building into a school, the room had lost some of its notable features such as an Adam style fireplace, which was replaced by a non-descript fireplace surround (Plate 15), and Adam style plasterwork. Historic joinery is evident, however, and examples include the existing doors.

**Plate 14** Part view of Room GF1 located at ground floor level. Note this image is from 2021 prior to the building's renovation, though all historic fixtures, fittings and finishes have been retained.

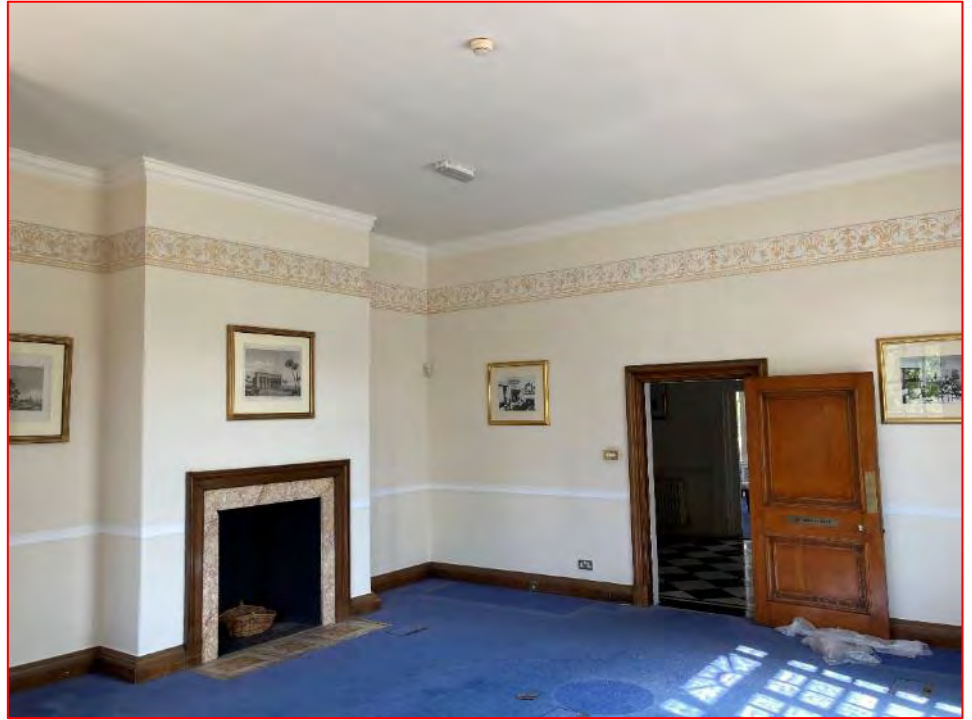
**Plate 15** Part view of Room GF2 located at ground floor level. Note this image is from 2021 prior to the building's renovation, though all historic fixtures, fittings and finishes have been retained.

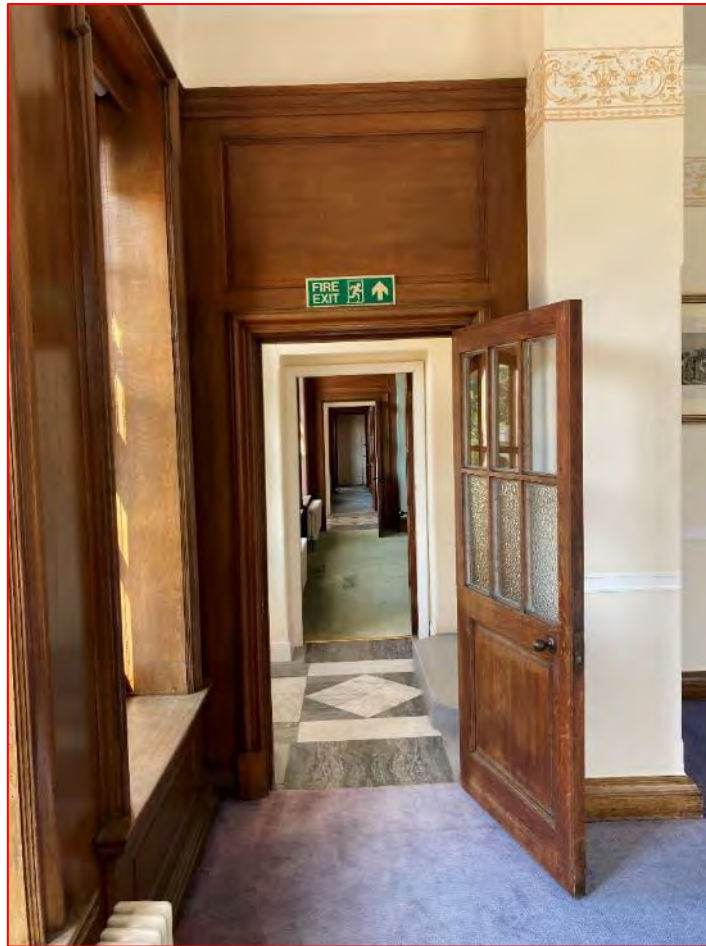
**Plate 16** View of door to lobby between rooms GF2 and GF3. Note that this view is taken from Room GF2. Note this image is from 2021 prior to the building's renovation, though all historic fixtures, fittings and finishes have been retained.

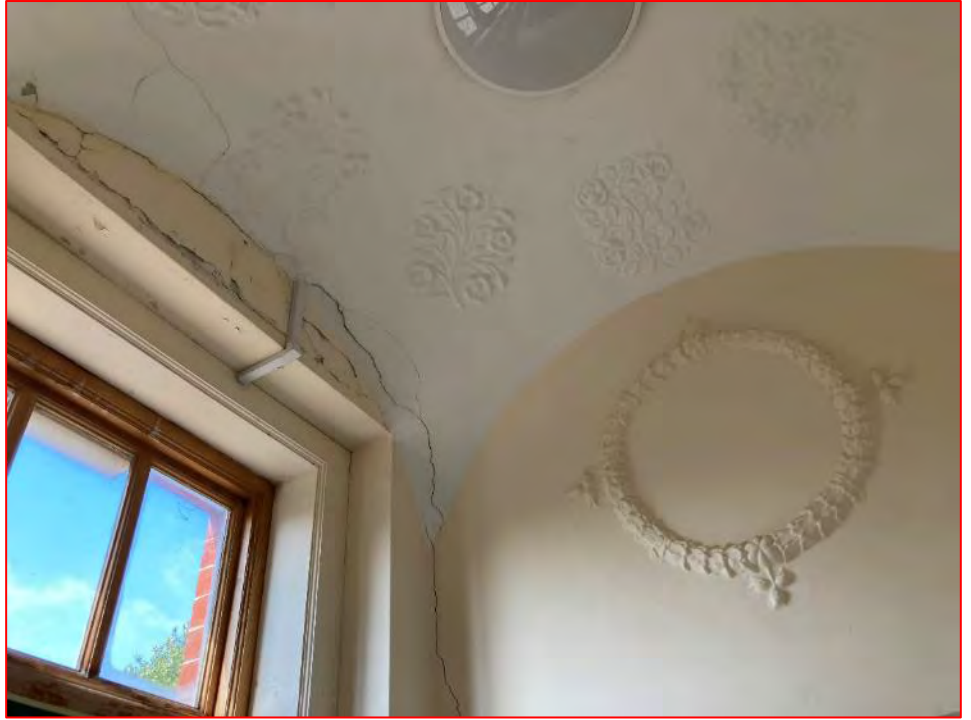
**Plate 17** High level plasterwork located within the lobby between rooms GF2 and GF3. Note this image is from 2021 prior to the building's renovation, though all historic fixtures, fittings and finishes have been retained.

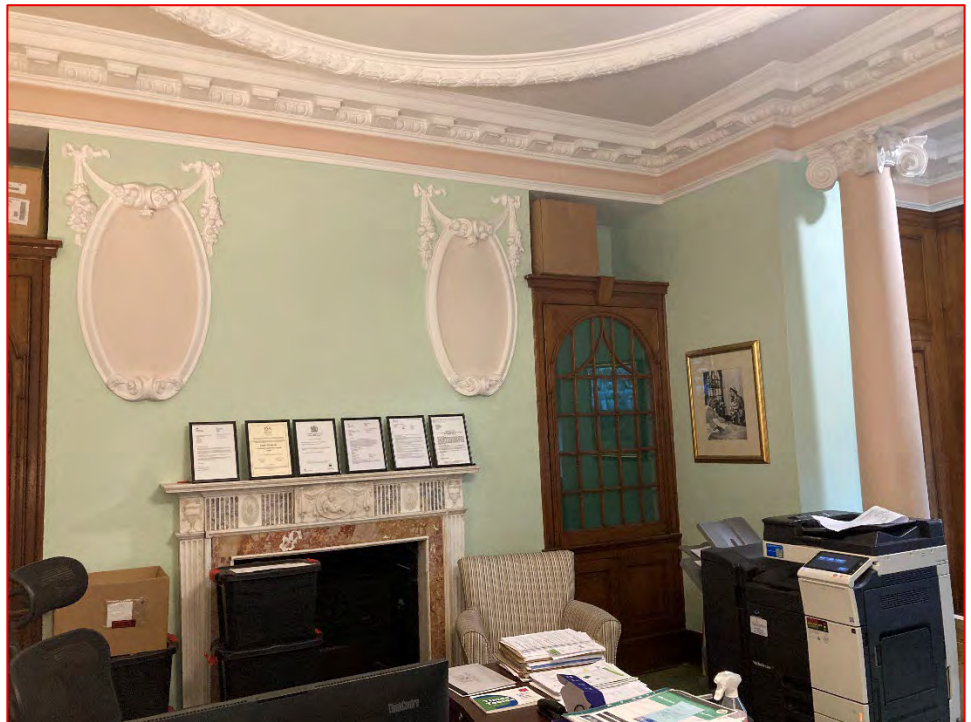
**Plate 18** View of eastern part of Room GF3 showing the Adam style plasterwork and fire surround. Note the column (in right of picture).

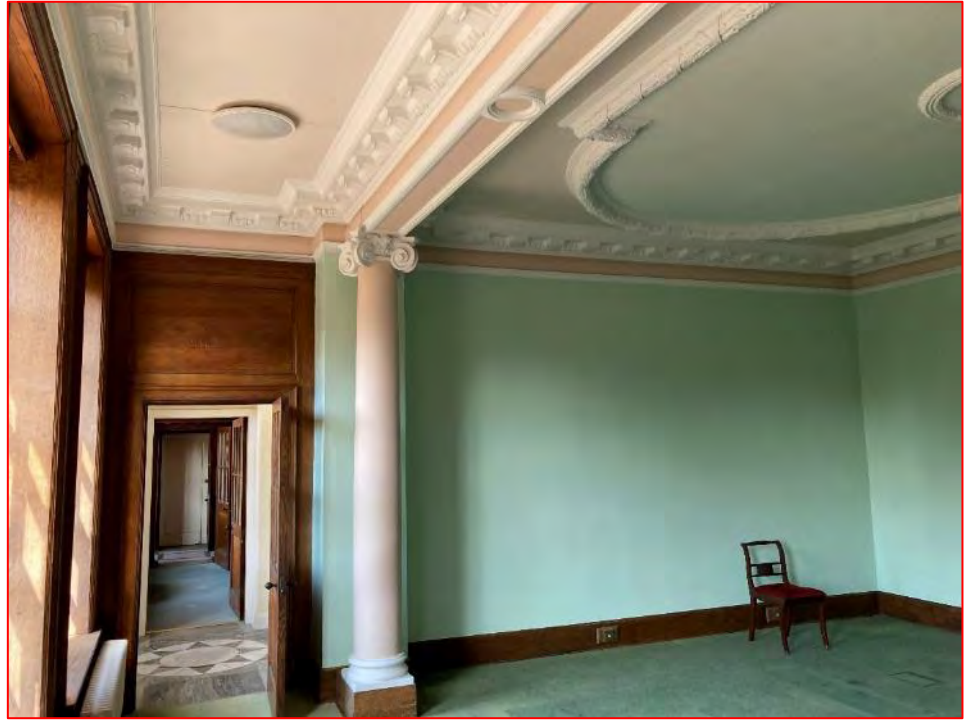
**Plate 19** View of western part of Room GF3 showing the plasterwork and other notable features such as the column. Note this image is from 2021 prior to the building's renovation, though all historic fixtures, fittings and finishes have been retained.

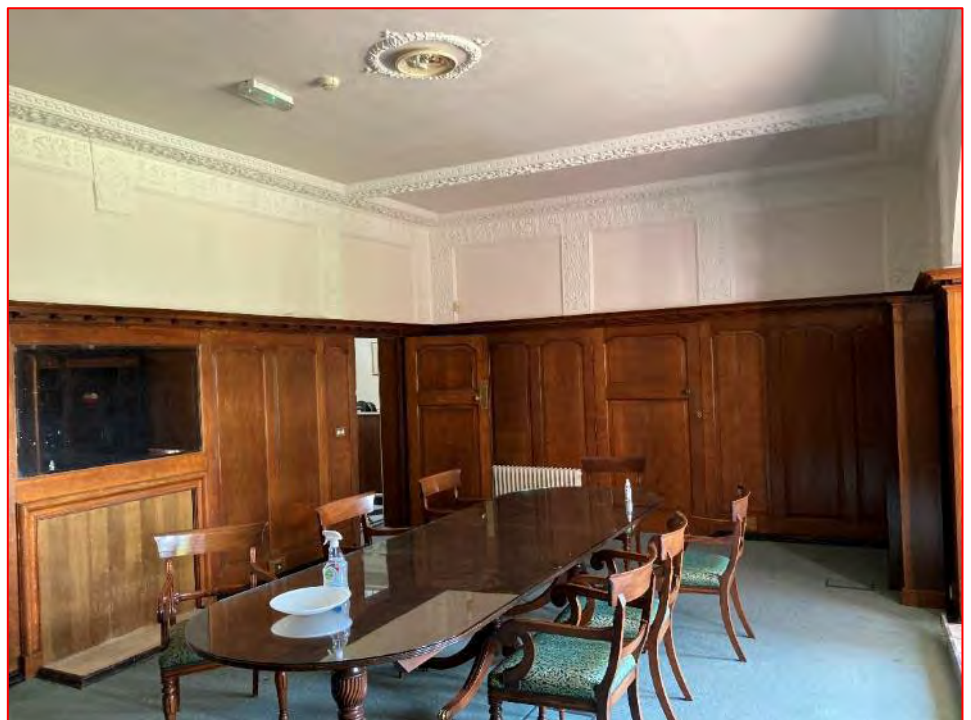
**Plate 20** View of eastern end of Room GF4. Note that the timber panelling dates from the early 20<sup>th</sup> century. Note this image is from 2021 prior to the building's renovation, though all historic fixtures, fittings and finishes have been retained.

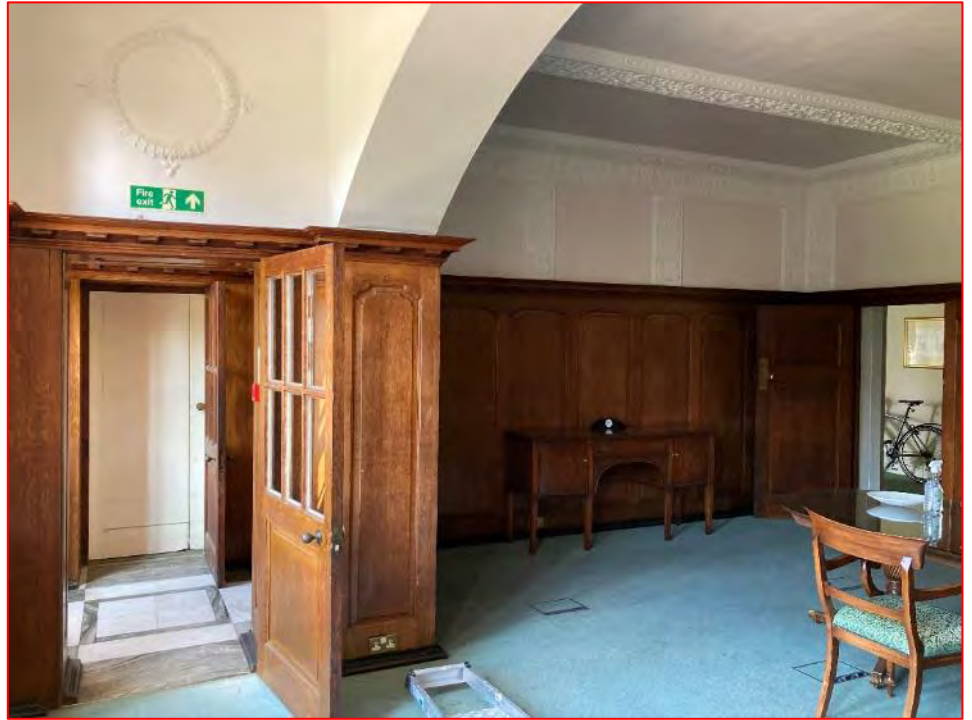
**Plate 21** View of western end of Room GF4. Note that the lobby (far left) provides access to Room GF5 and the early 20<sup>th</sup> century terrace to the south of the building. Note this image is from 2021 prior to the building's renovation, though all historic fixtures, fittings and finishes have been retained.

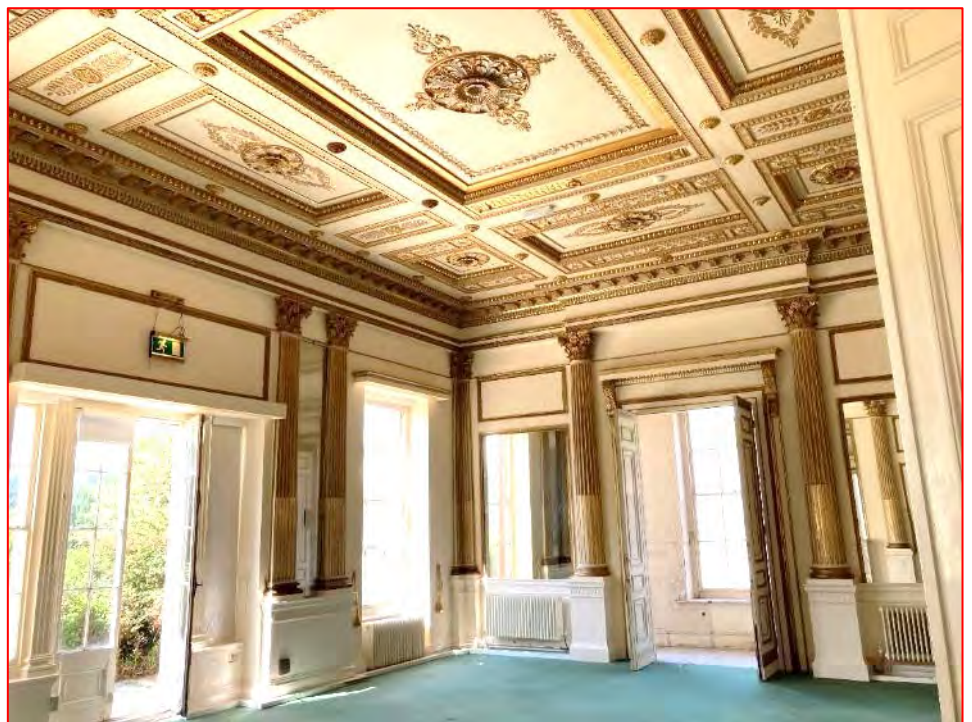
**Plate 22** Part view of southern and western end of Room GF5 (historic Drawing Room). Note this image is from 2021 prior to the building's renovation, though all historic fixtures, fittings and finishes have been retained.

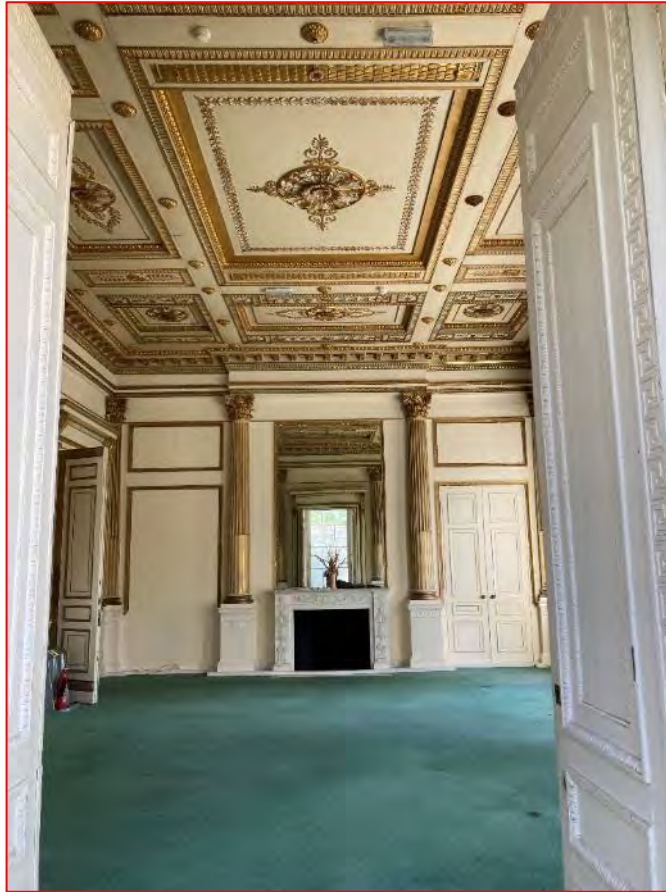
**Plate 23** View of Room GF5, taken from the curved bay at its western end. Note this image is from 2021 prior to the building's renovation, though all historic fixtures, fittings and finishes have been retained.

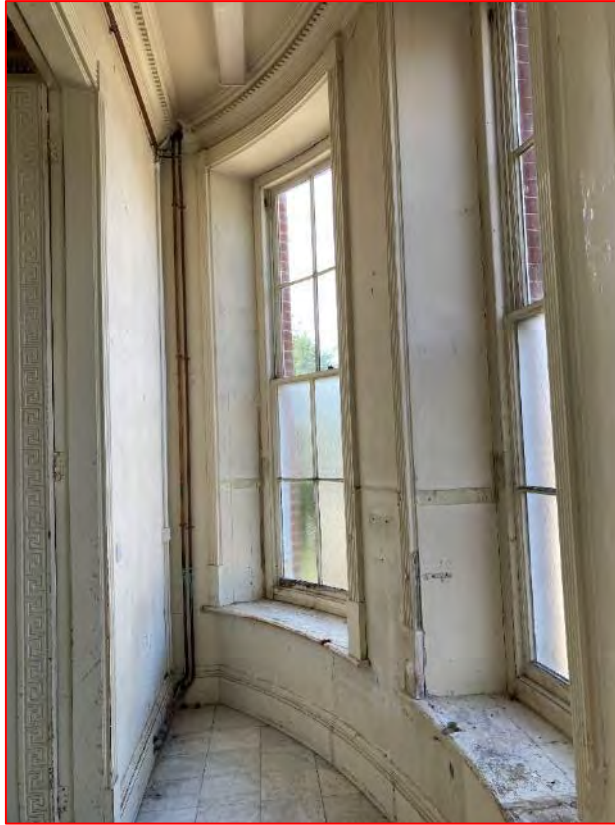
**Plate 24** Partial view of curved bay at western end of Room GF5. Note this image is from 2021 prior to the building's renovation, though all historic fixtures, fittings and finishes have been retained and restored to a high standard.

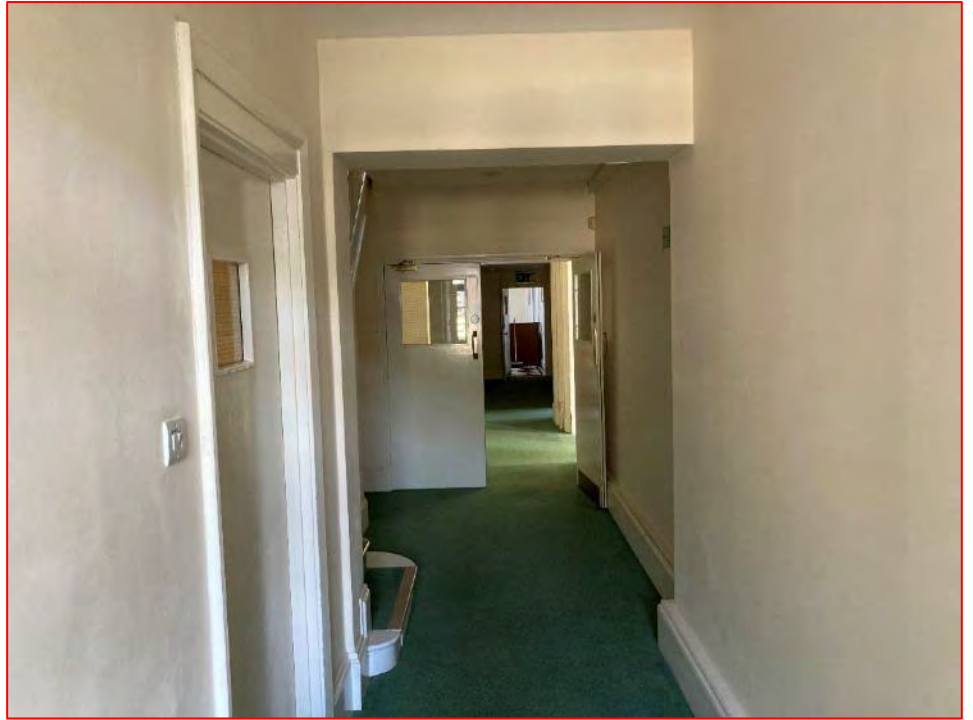
**Plate 25** View of corridor to immediate north of Room GF5. Note that this view looks east towards the main entrance hall. Note this image is from 2021 prior to the building's renovation, though all historic fixtures, fittings and finishes have been retained and restored to a high standard.

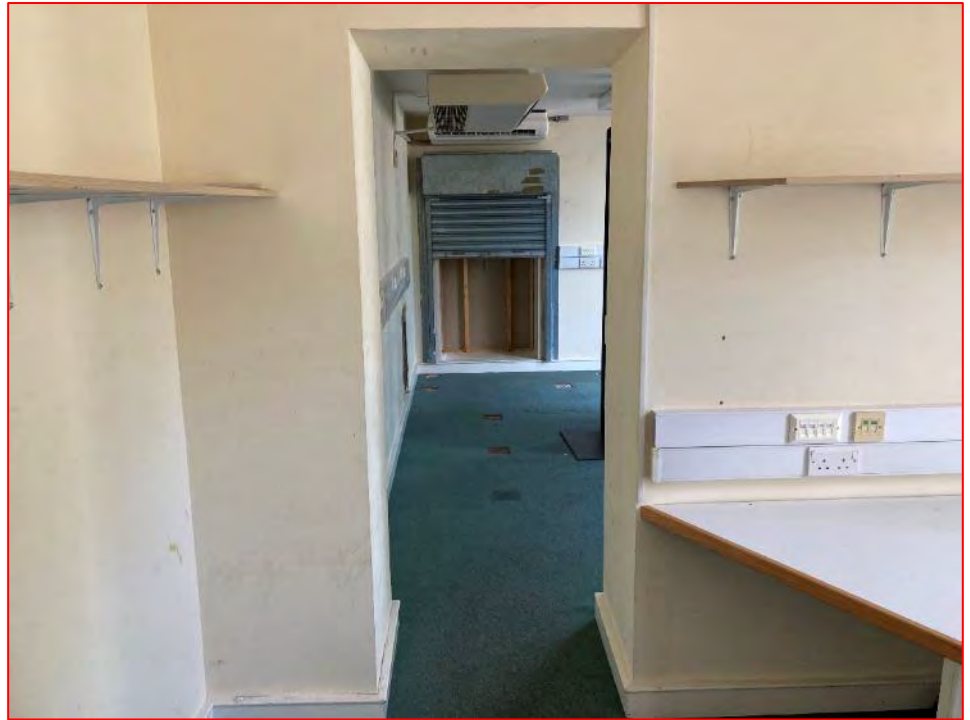
- 4.25** Rooms GF7 and GF8 are connected by a single door opening (Plate 27).

**Plate 27** View of existing opening between rooms GF7 and GF8. Note this image is from 2021 prior to the building's renovation, though all historic fixtures, fittings and finishes have been retained and restored to a high standard.

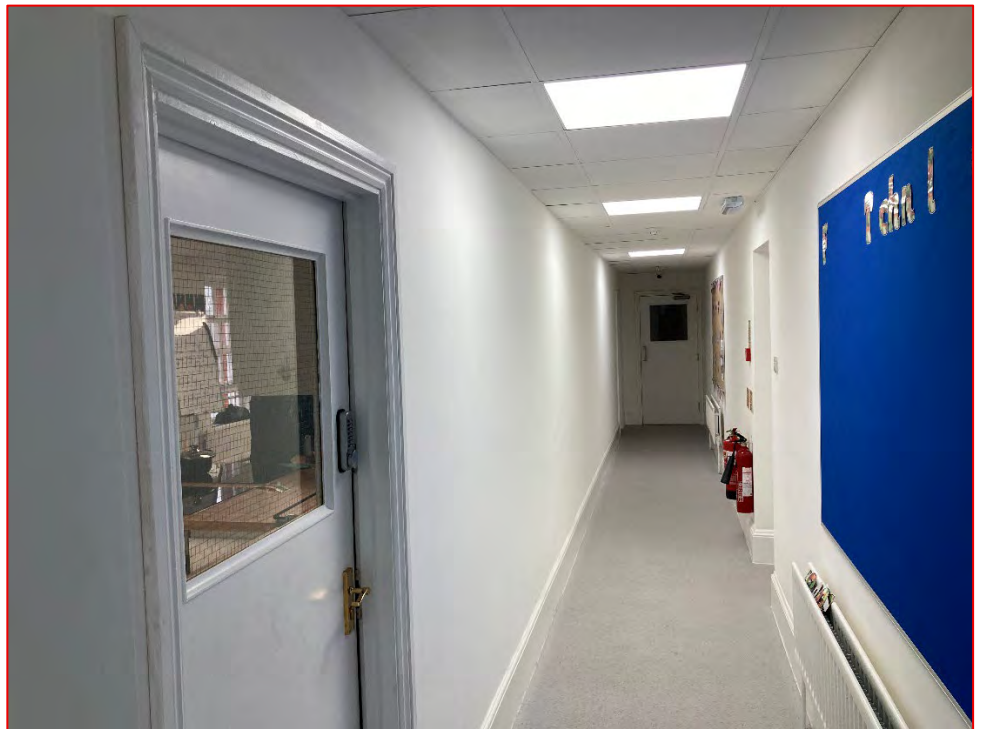
**Plate 28a** Image showing one of few new partition walls within the building (left of image). The teaching space through the door on the left is used for food technology and as part of fire compartmentalisation, this stud partition was inserted creating a corridor.

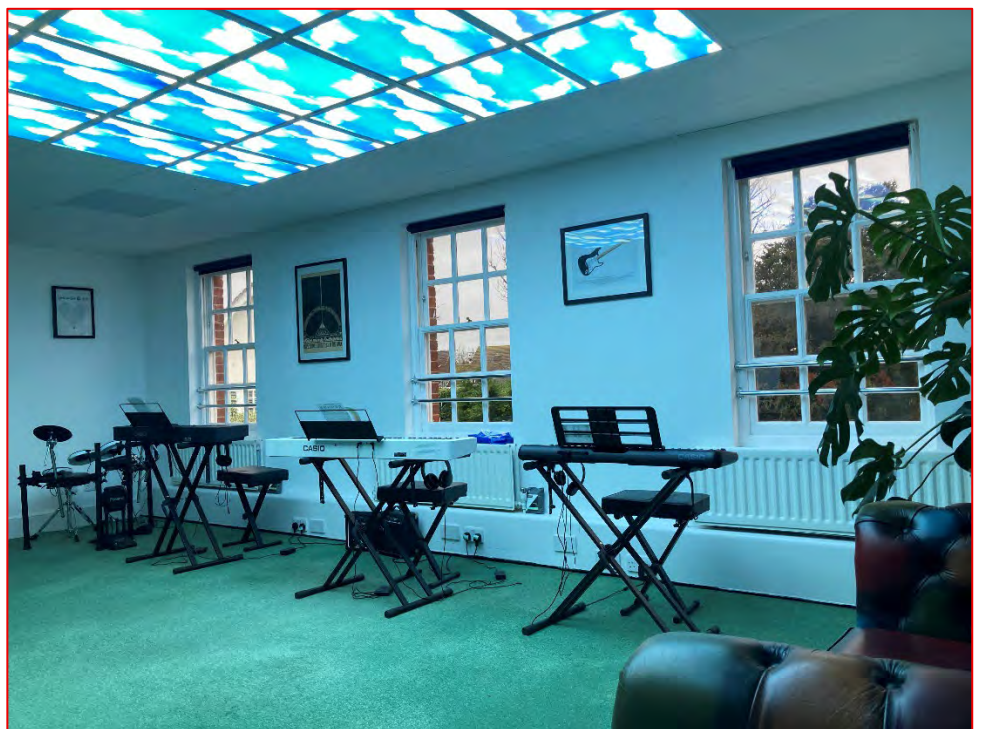
**Plate 28b** Room MF8 in its current condition.

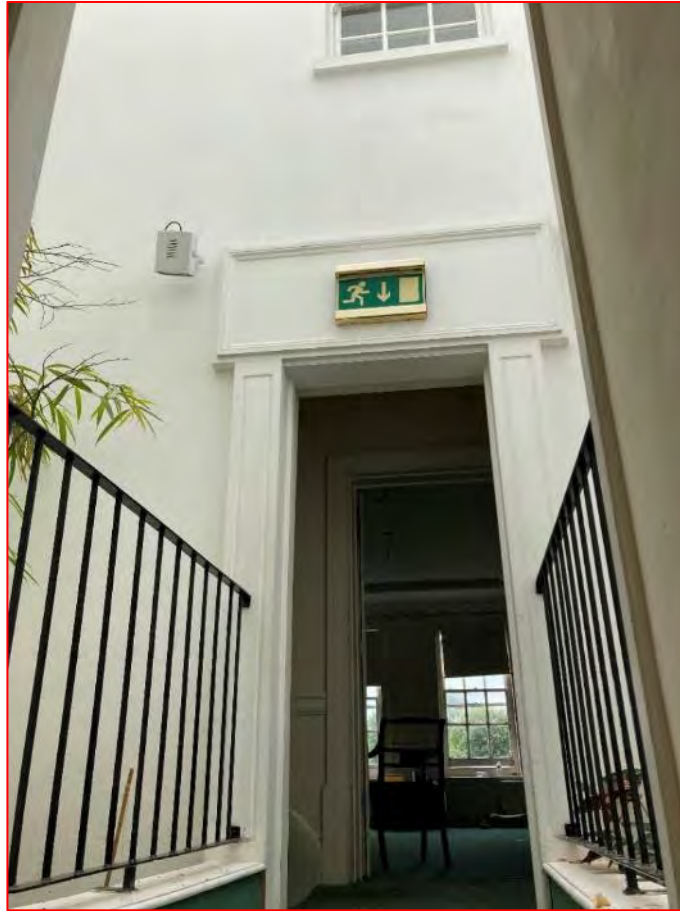
**Plate 29** View of link between the mezzanine floor and the first floor of the main building.

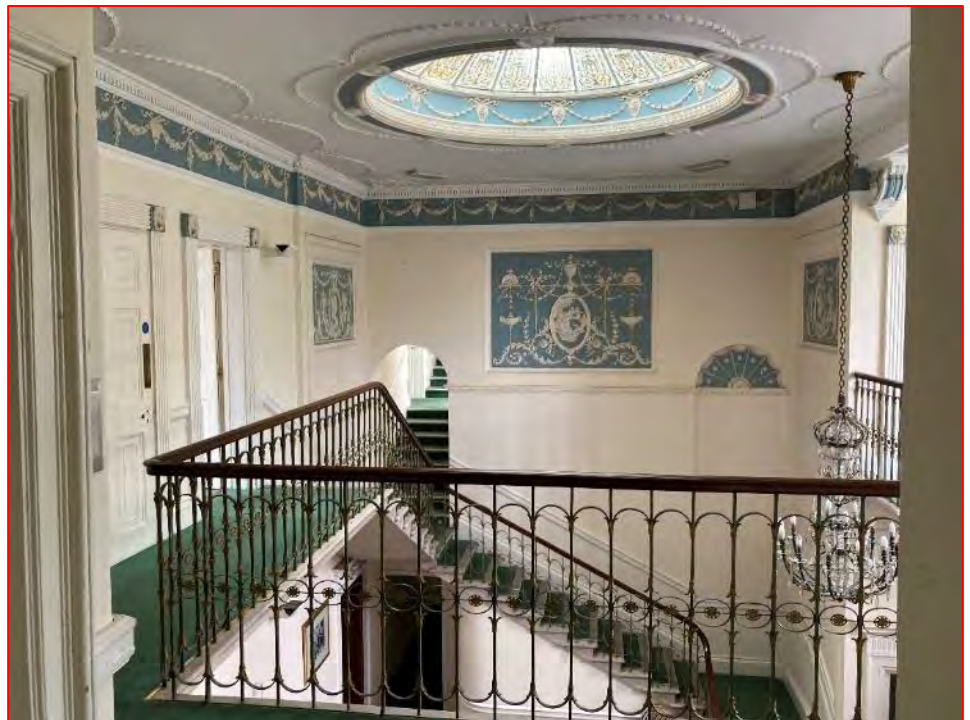
**Plate 31** View of main entrance hall landing taken from the eastern end of the landing area. Note this image is from 2021 prior to the building's renovation, though all historic fixtures, fittings and finishes have been retained and restored to a high standard.
