**Courtlands, Parklands Avenue, Goring-By-Sea**  
**Statement of Significance**  
**March 2026**

Statement of Significance

Courtlands, Parklands Avenue, Goring-By-Sea

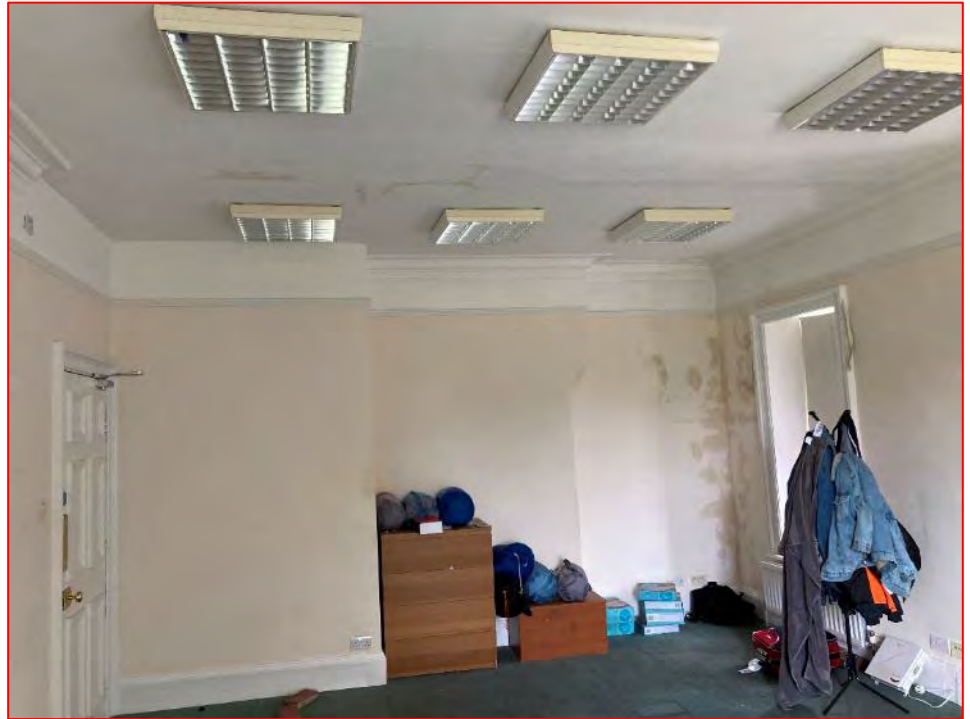
**Plate 32** View of western end of Room FF1 (2021) illustrating the lack of any historic fixtures and fittings. Note this image is from 2021 prior to the building's renovation, though all historic fixtures, fittings and finishes have been retained and restored to a high standard.

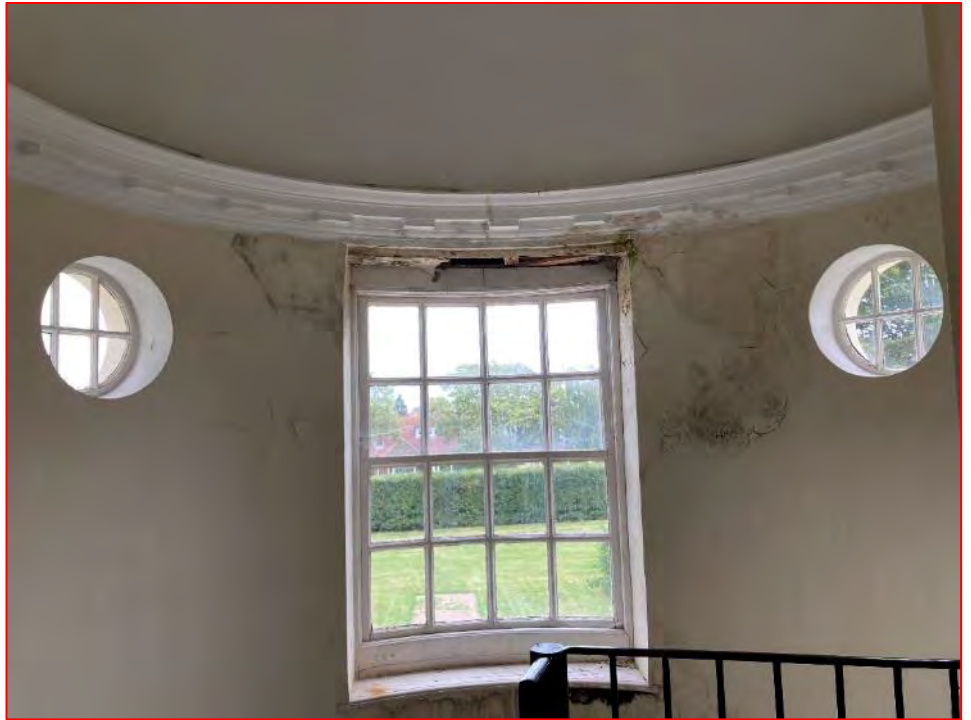
**Plate 34** View of bullseye windows and sash window at first floor level (within eastern stairwell). This image dates from 2021. The evident moisture penetration to the plasterwork was subsequently dealt with as part of the school conversion with the plasterwork restored and redecorated.

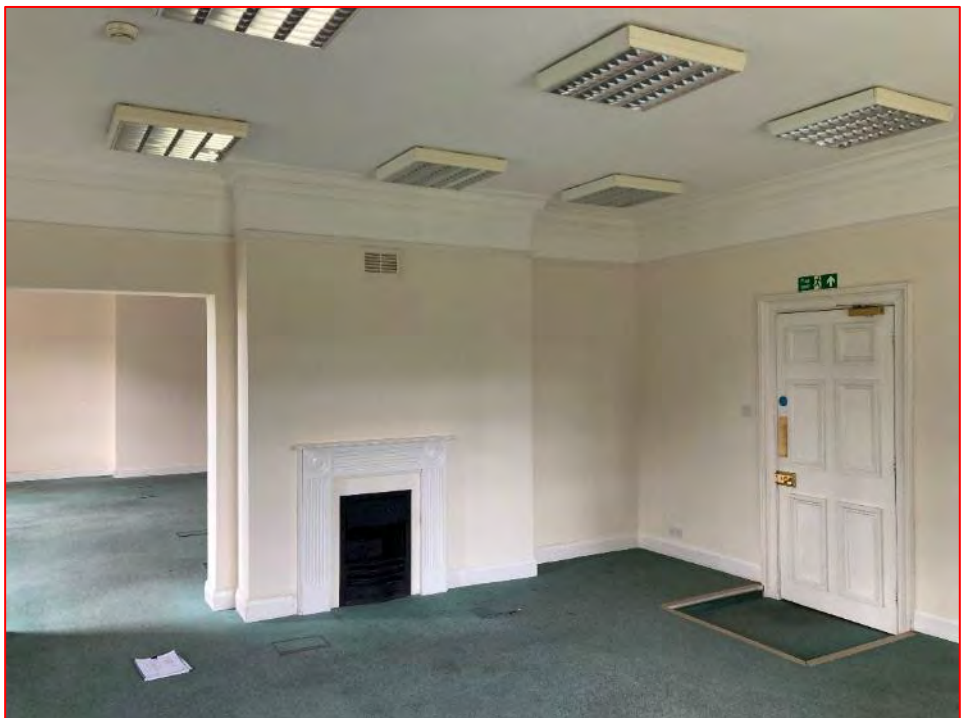
**Plate 35** View of western end of Room FF2. Note the opening (in left of picture), which provided access between Room FF2 and Room FF3 (2021). This was subsequently infilled with a modern partition as part of the school renovation works. Note this image is from 2021 prior to the building's renovation, though all historic fixtures, fittings and finishes have been retained and restored to a high standard.

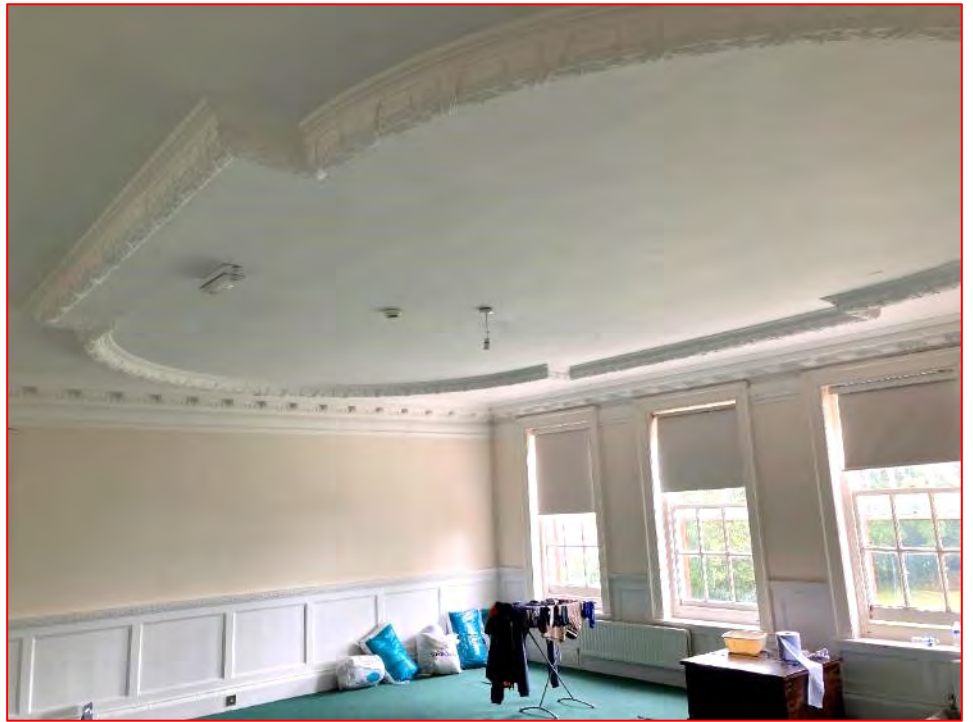
**Plate 36** View of eastern end of Room FF4 (2021)

- 4.31** Room FF4 is larger in plan and retains some notable features, including plasterwork such as cornicing and timber panelling at low level (Plate 36).

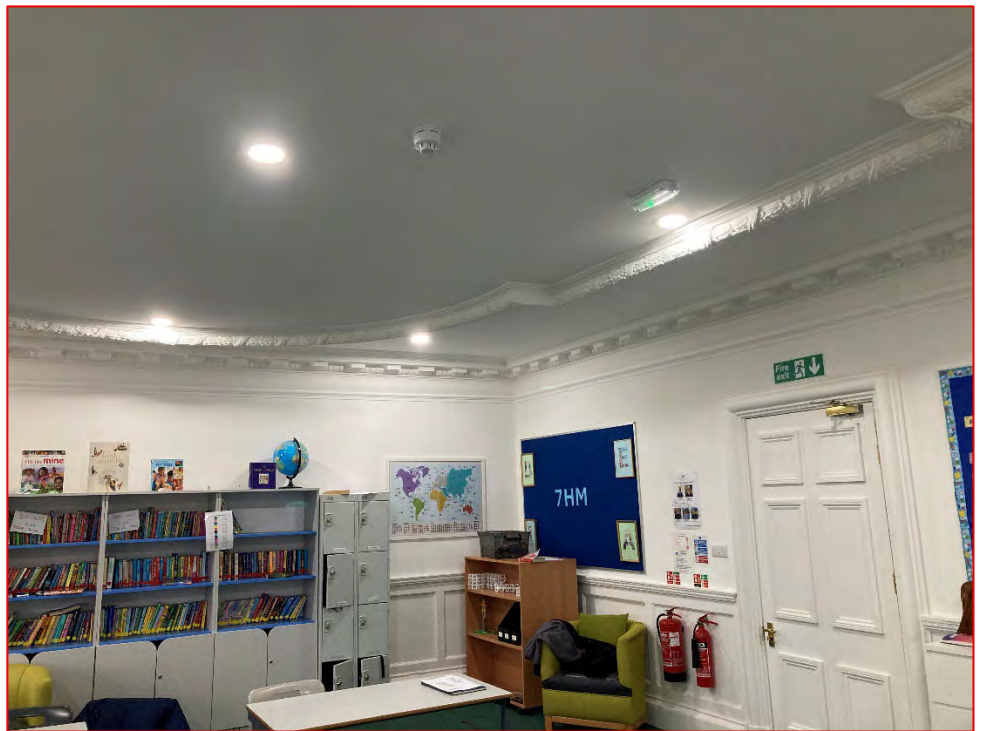
**Plate 36a** Room FF4 following its renovation as part of the conversion of the building into a school illustrating the high standard of decorative finish that is evident throughout the building.

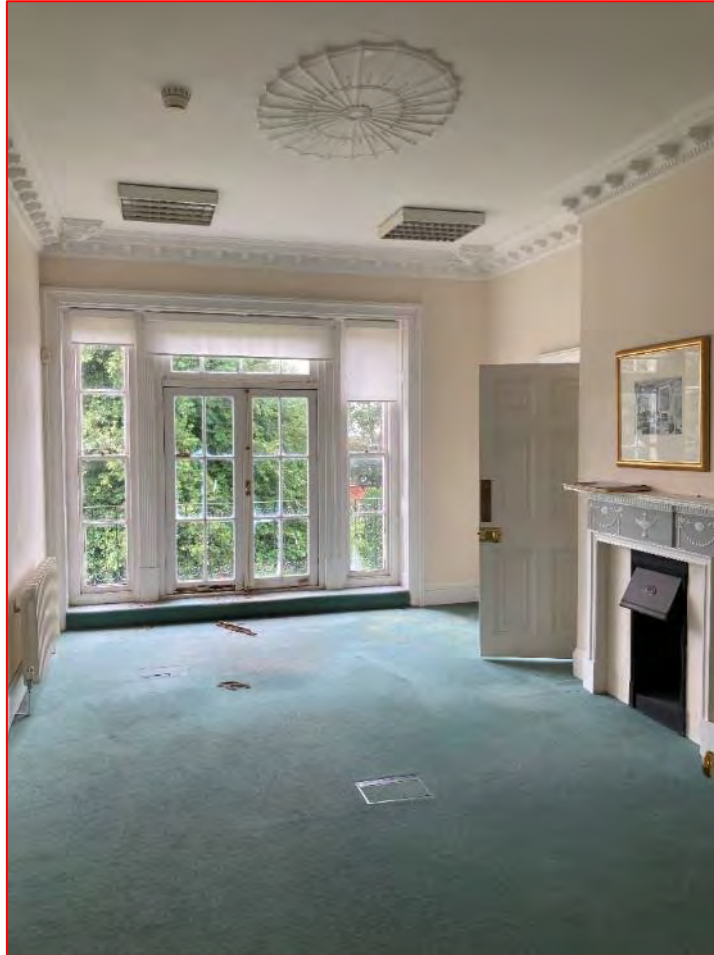
**Plate 37** View of southern part of Room FF6. Note this image is from 2021 prior to the building's renovation, though all historic fixtures, fittings and finishes have been retained and restored to a high standard.

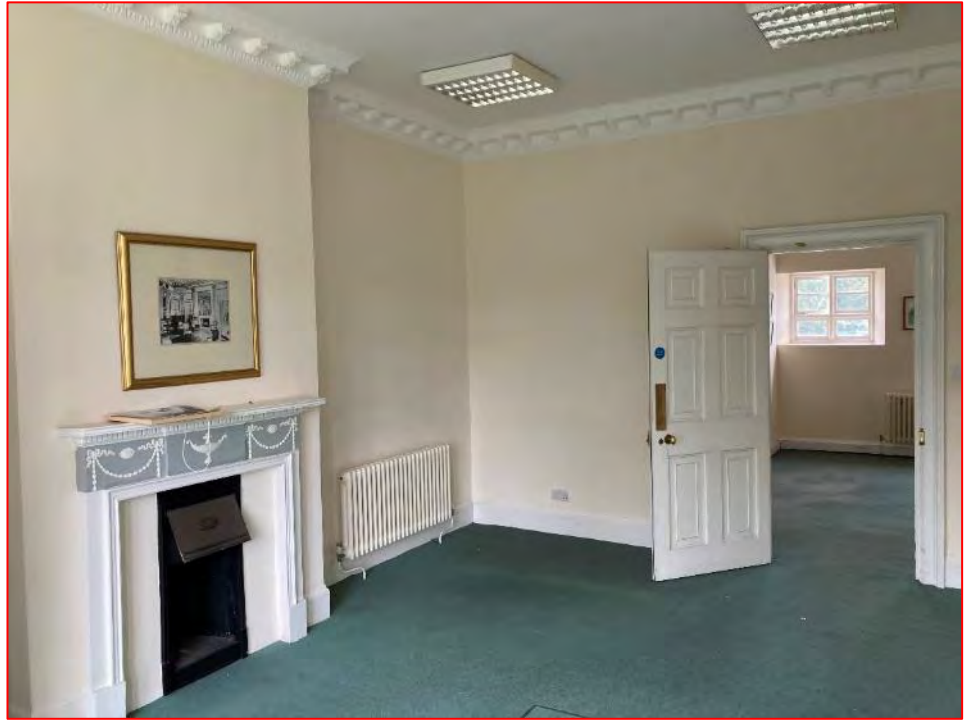
**Plate 38** View of northern part of Room FF6. Note this image is from 2021 prior to the building's renovation, though all historic fixtures, fittings and finishes have been retained and restored to a high standard.

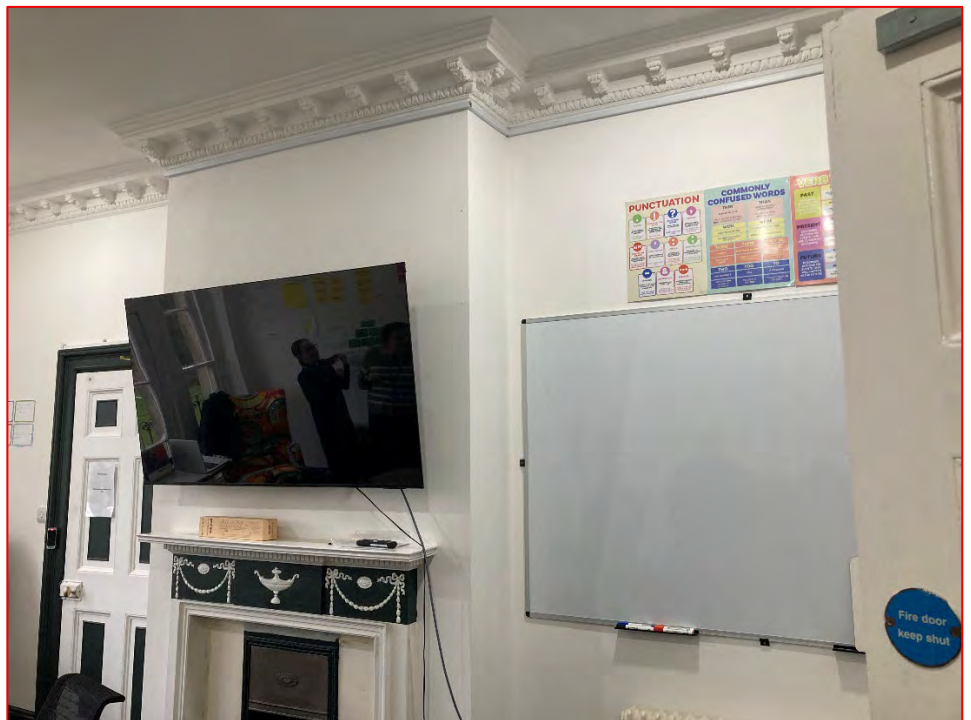
**Plate 38a** Room FF6 (2026) illustrating the sensitive approach that has been taken to the renovation and re-decoration of the room as part of the school works.

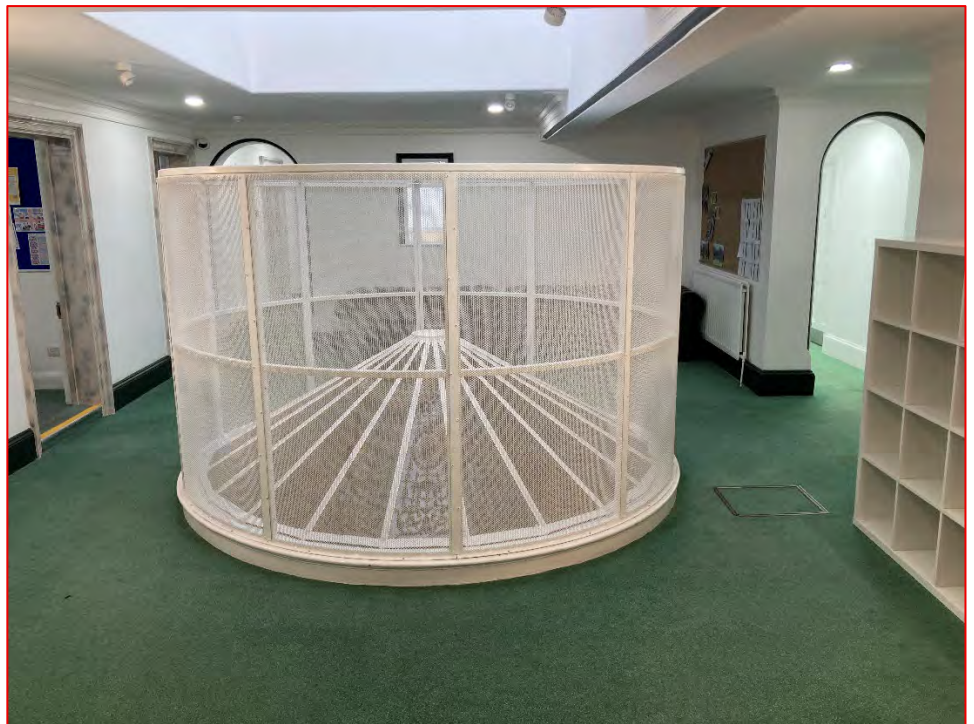
Plate 39 View of top of Adam style dome taken from second floor level (2026)

- 1.12** The interior of the Courtlands building comprises three levels at its eastern end and two at its western end. The ground floor comprises a number of principal rooms set around a grand entrance hall. The entrance hall comprises a double height space and includes an original iron balustraded staircase (likely relocated from elsewhere). The Mezzanine floor sits almost entirely within the two-storey 20<sup>th</sup> century addition, although the existing toilets are located within the earlier part of the building. The first floor includes the main entrance hall landing, which has notable Adam style plasterwork to the walls and distinctive balustrading to the staircase (likely relocated from elsewhere in the early 20<sup>th</sup> century or replicas introduced at this time). The second floor includes a central lobby area, with the roof to the Adams style dome centrally placed (again likely relocated from elsewhere in the early 20<sup>th</sup> century or is a replica introduced at this time). A skylight site above the dome allowing natural light into this space.

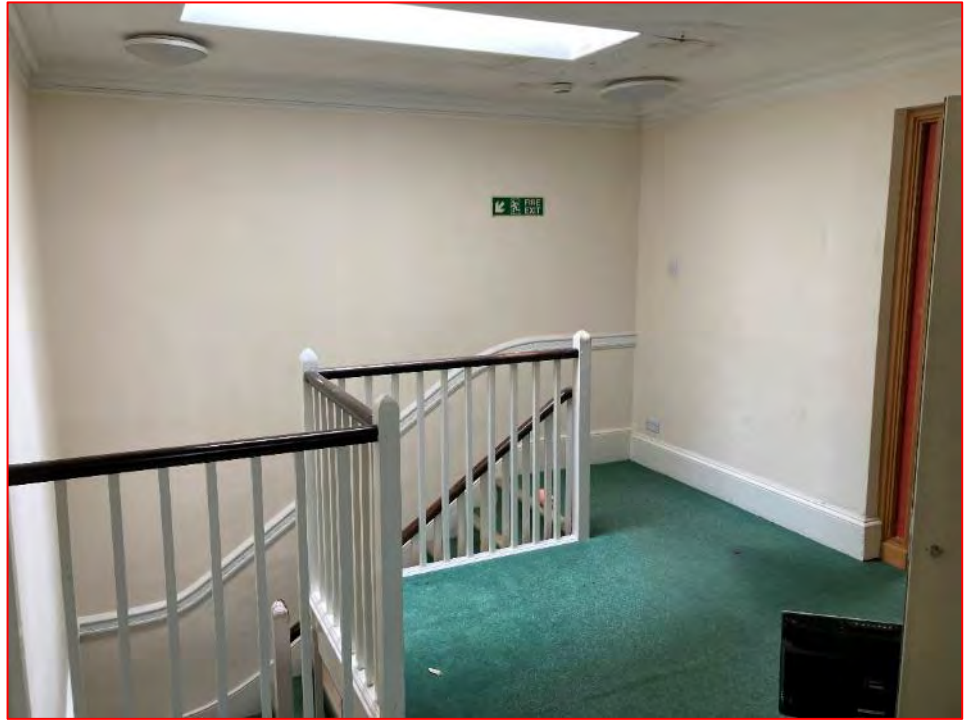
**Plate 40** View of secondary staircase at second floor level. Note this image is from 2021 prior to the building's renovation, though all historic fixtures, fittings and finishes have been retained and restored to a high standard.

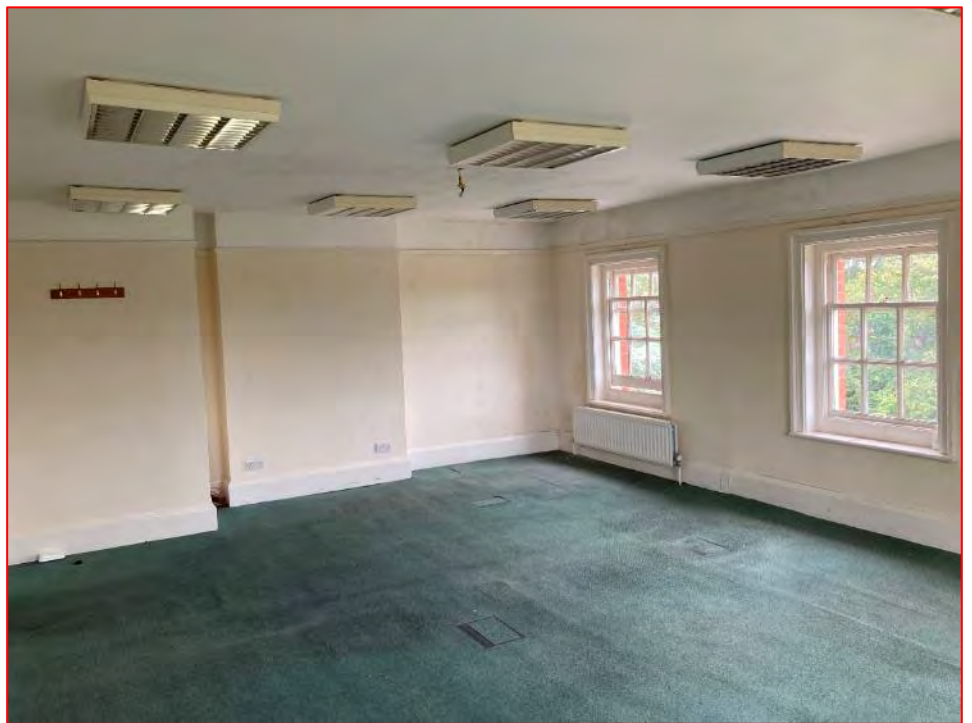
**Plate 41** View of western end of Room SF1 at second floor level. Note this image is from 2021 prior to the building's renovation, though all historic fixtures, fittings and finishes have been retained and restored to a high standard.

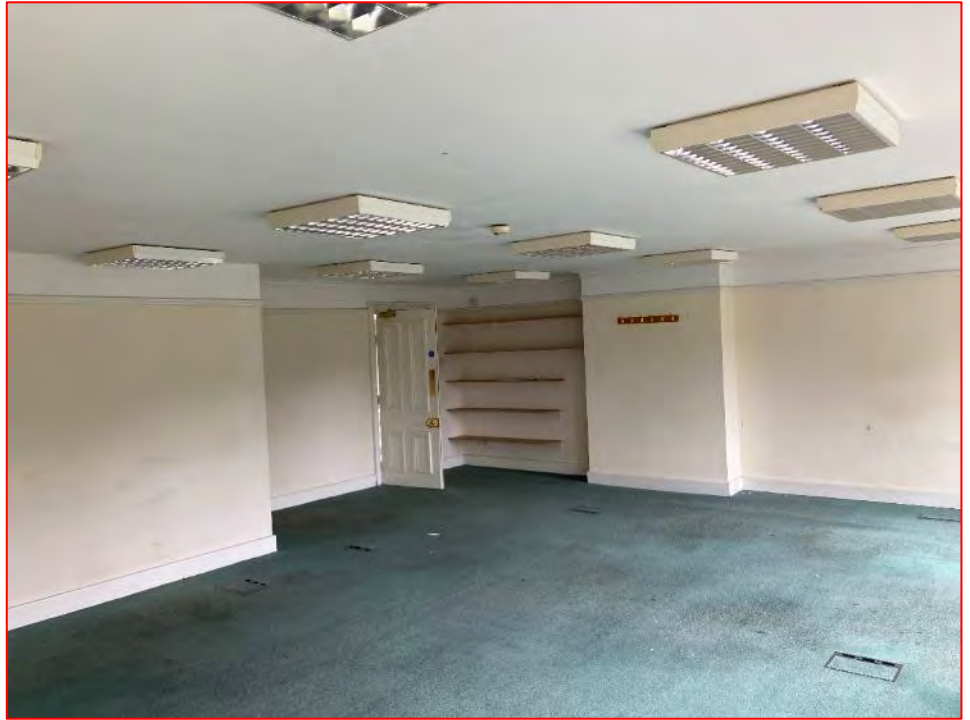
**Plate 42** View of eastern end of Room SF1 at second floor level. Note this image is from 2021 prior to the building's renovation, though all historic fixtures, fittings and finishes have been retained and restored to a high standard.

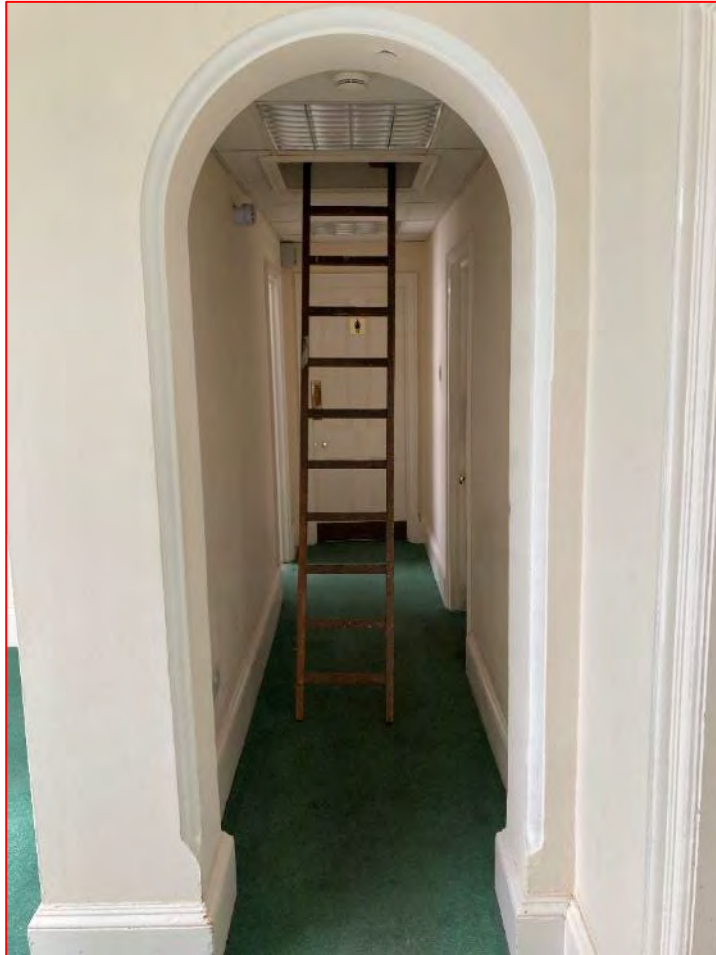
**Plate 43** View of corridor leading to existing toilets at second floor level. Note this image is from 2021 prior to the building's renovation, though all historic fixtures, fittings and finishes have been retained and restored to a high standard.

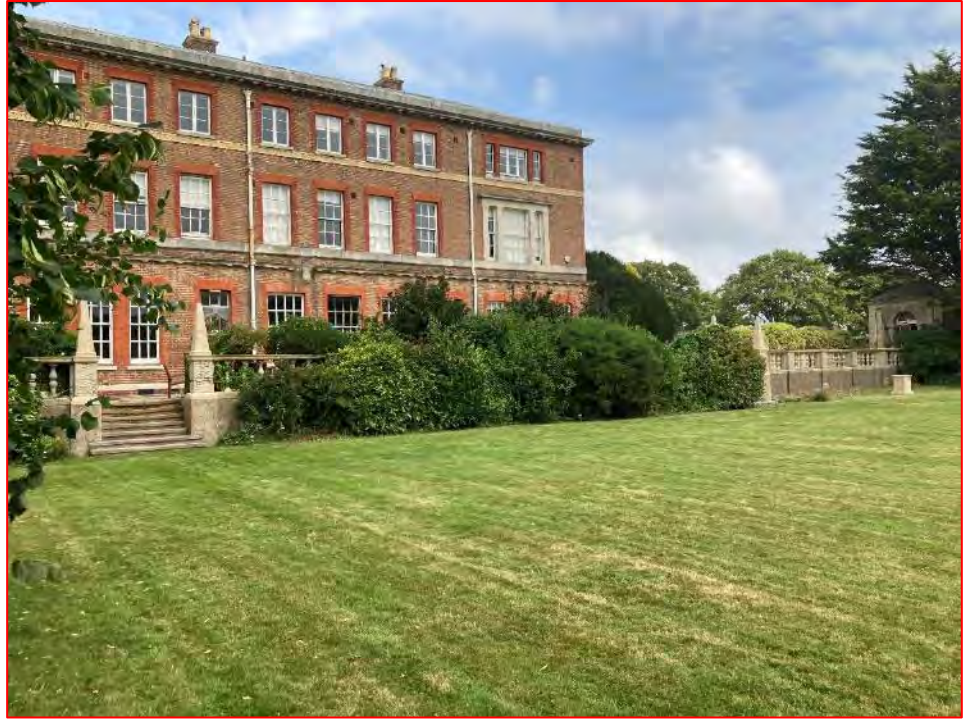
Plate 44 View of listed terrace taken from the garden area to the south.

- 1.13** To the east and south of the Courtlands building is the historic garden and associated listed terrace, gazebo, garden archway and sundial. The terraced area dates from the early 20<sup>th</sup> century and adjoins the main building to the south and east. It comprises a mix of stone balustrades, flag stones and obelisks (which frame the steps). At the eastern end of the terrace is an early 20<sup>th</sup> century gazebo, which is square in plan and comprises a single-storey with hipped roof. To the south of the Courtlands building is a listed stone archway, which adjoins the western boundary of the site. The garden area to the south of the main building and terrace is long and narrow and includes a small lake at its southern end. A large area of lawn sits between the terrace and the lake, with substantial tree coverage to its boundaries. The lawned area and lake contribute to the setting of the main building and the other listed elements. The lawned area also extends to the east of the main building.

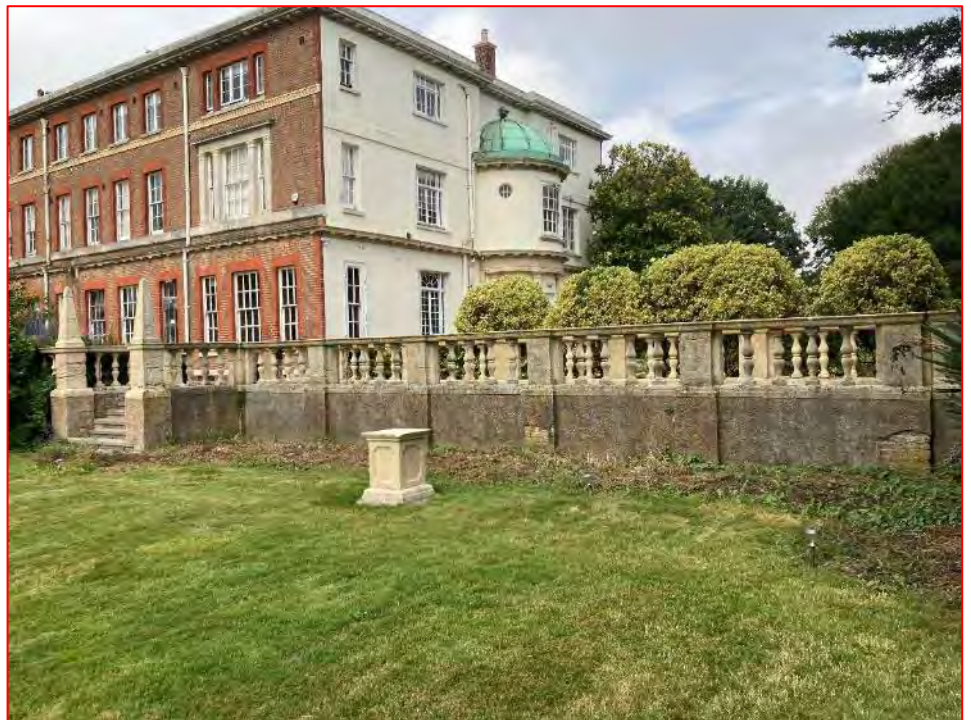
Plate 45 View of eastern end of listed terrace taken from the garden area to the south-east.

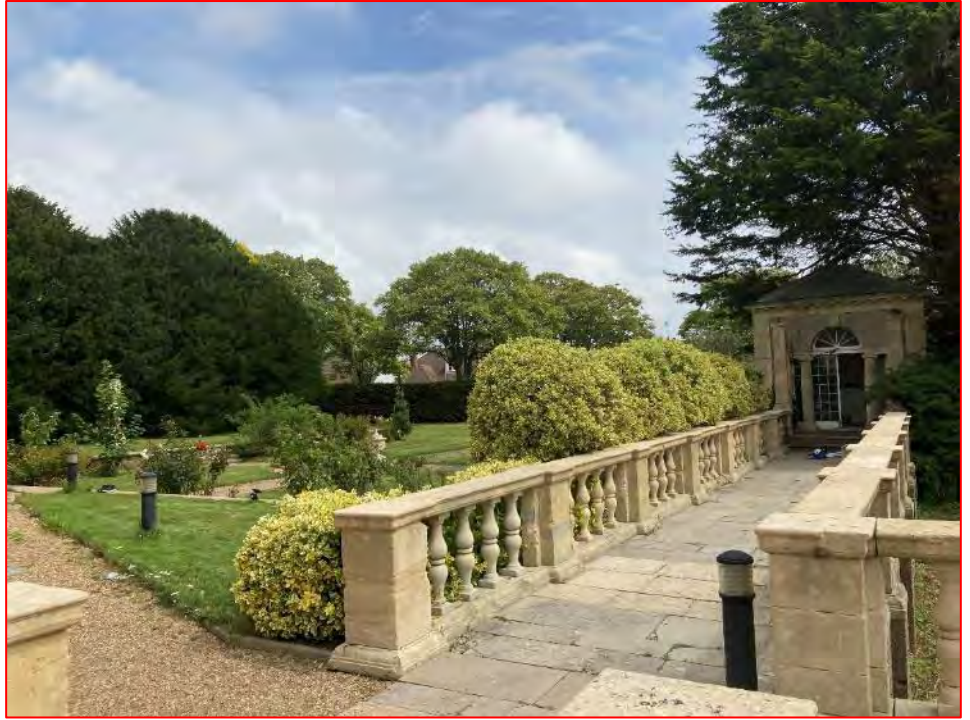
**Plate 46** View of the listed gazebo (right) located at the eastern end of the terrace.

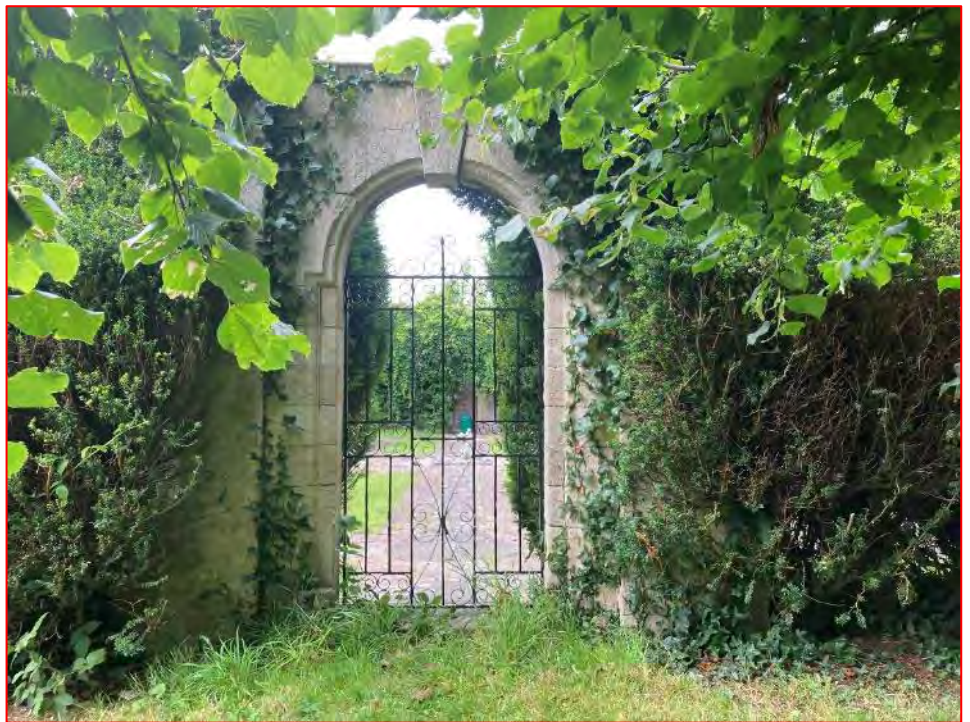
**Plate 47** View of the listed stone archway located in the garden area to the south of the Courtlands building.

- 4.40** To the south of the Courtlands building is a listed stone archway, which adjoins the western boundary of the site (Plate 47). In the classical style it comprises two pillars with console bracketed buttresses and ball finials, which flank a moulded archway with keystone.

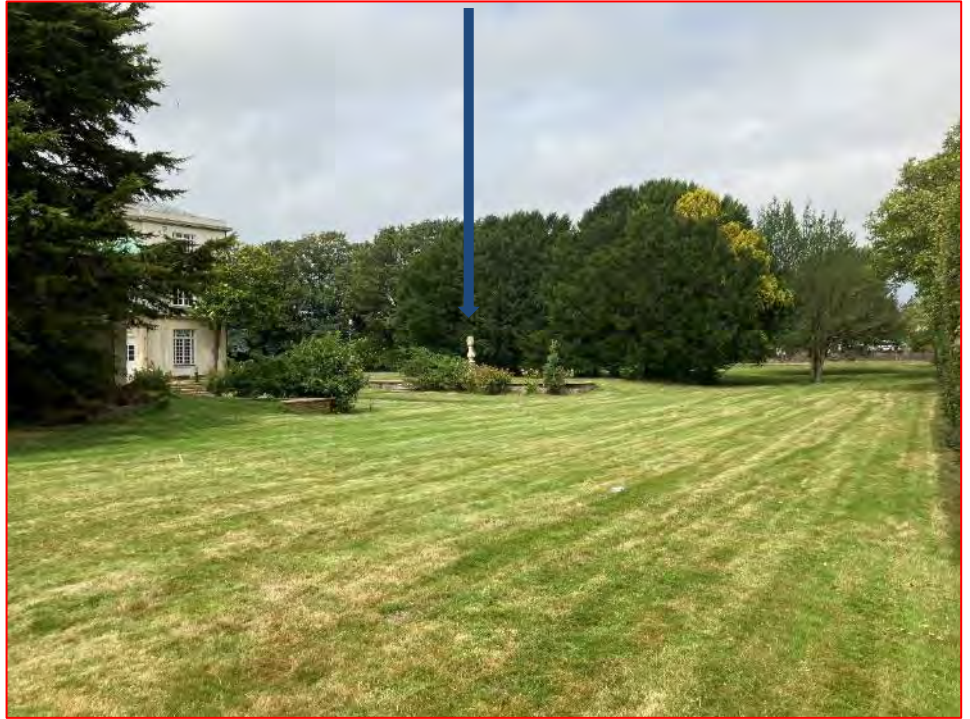
**Plate 50** View of the lawned area located to the east of the Courtlands building. Note that this view is taken from the terraced area looking north and includes the Grade II listed Sundial (arrowed)

*Sundial. Stone. Early C20 in the style of the C18. Some repair. Rectangular pedestal with swagged die surmounted by an enriched baluster crowned by a cube with dials and gnomons to four faces.*
