Project: West Sompting Phase 1

Title: Exploratory Hole Plan

**Re: LP002150 Groundwater monitoring at land west of Loose Lane, Sompting, West Sussex**

# SHALLOW INFILTRATION TESTS

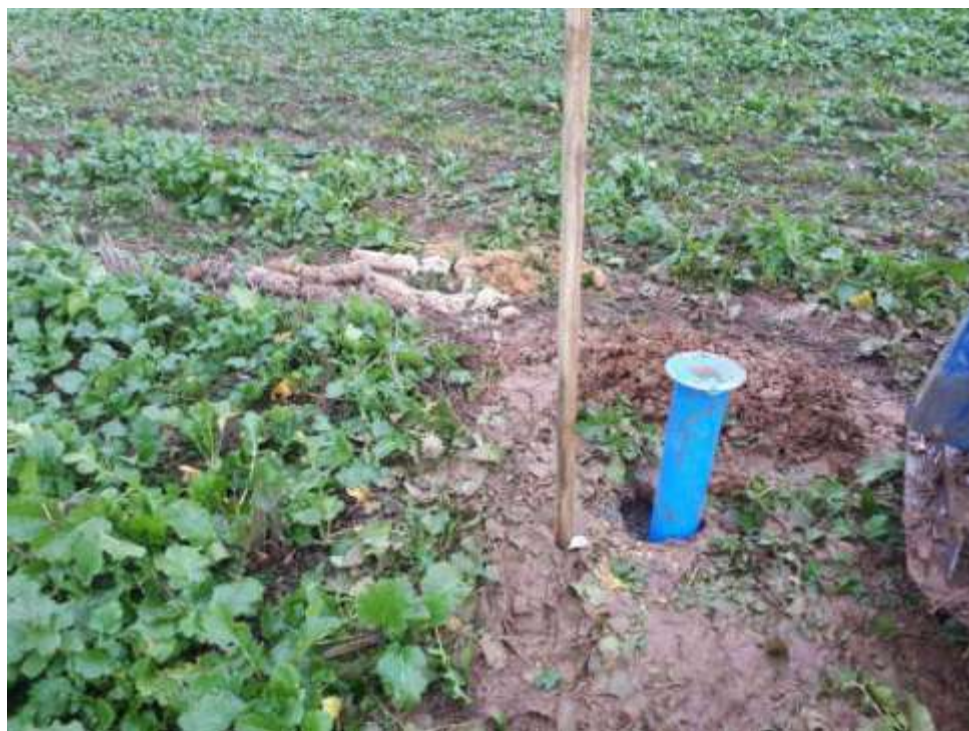
Plate 2: WS5 with well cover (before addition of cement)

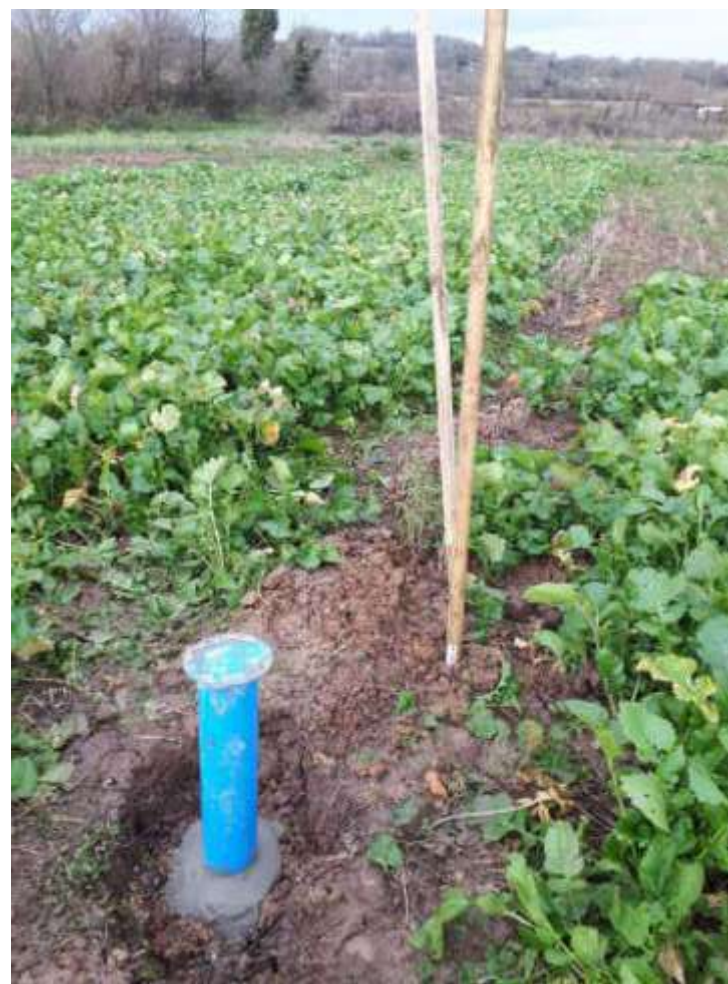
Plate 4: WS1 completed

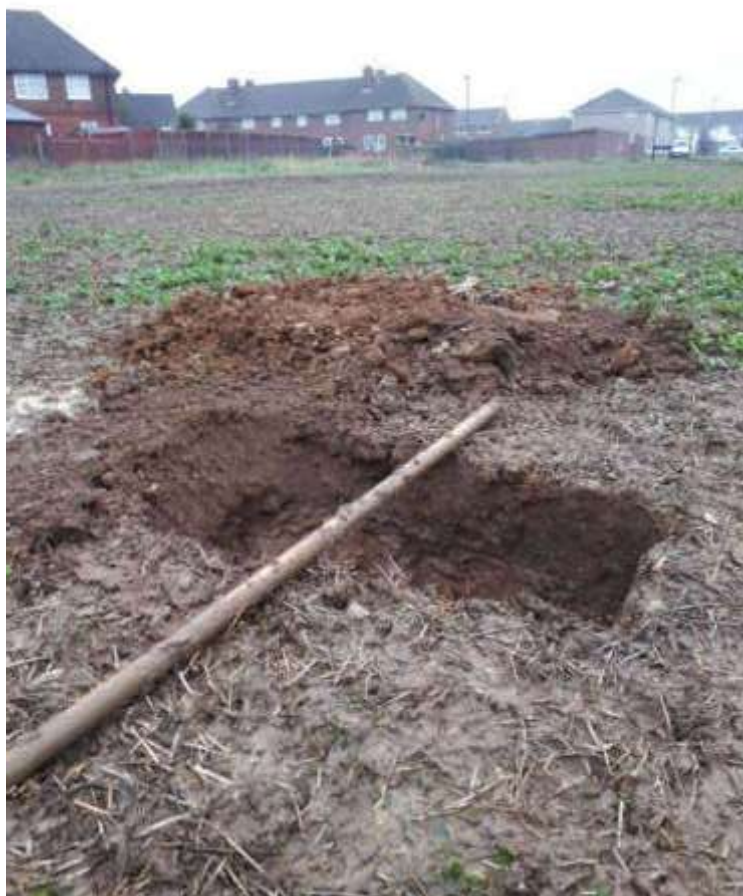
Plate 5: TP1 with arisings

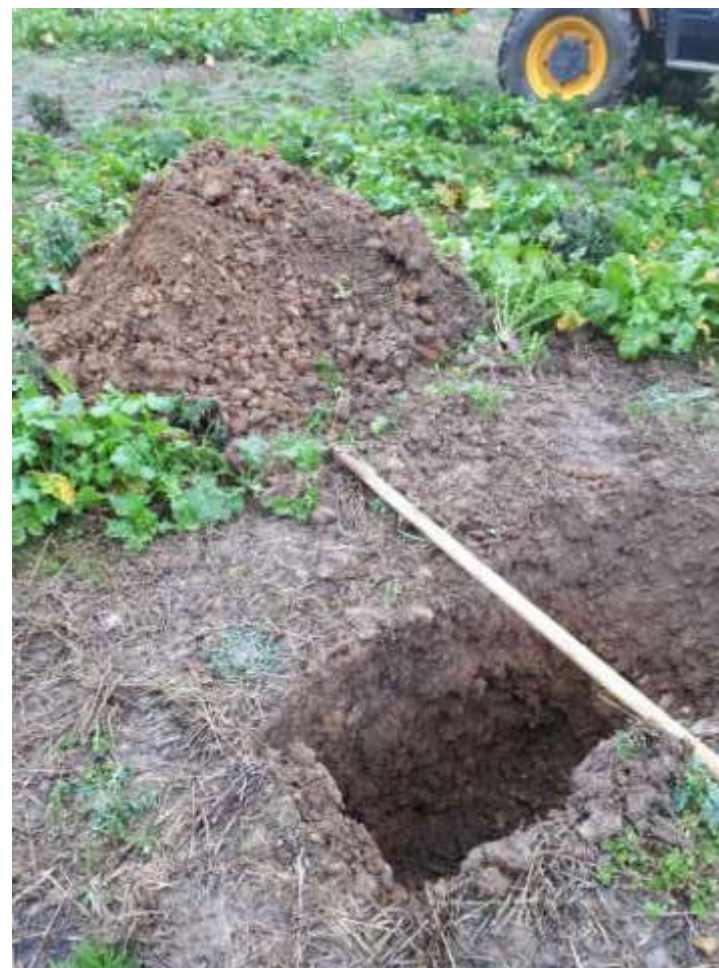
Plate 6: TP2 with arisings

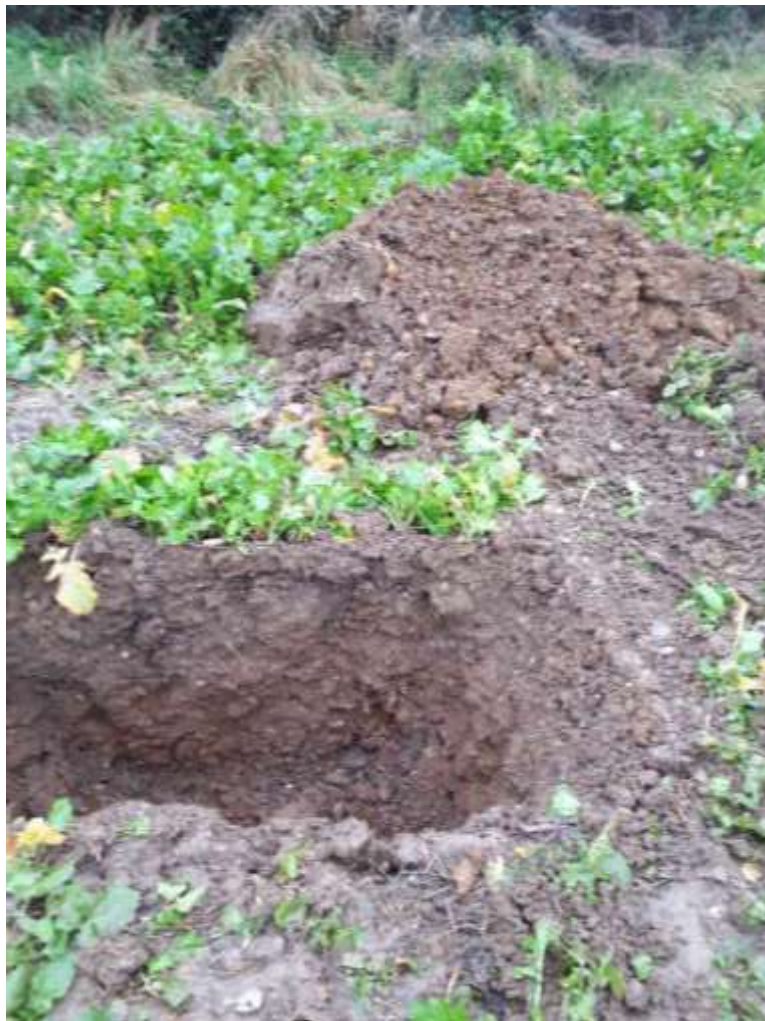
Plate 7: TP3 with arisings

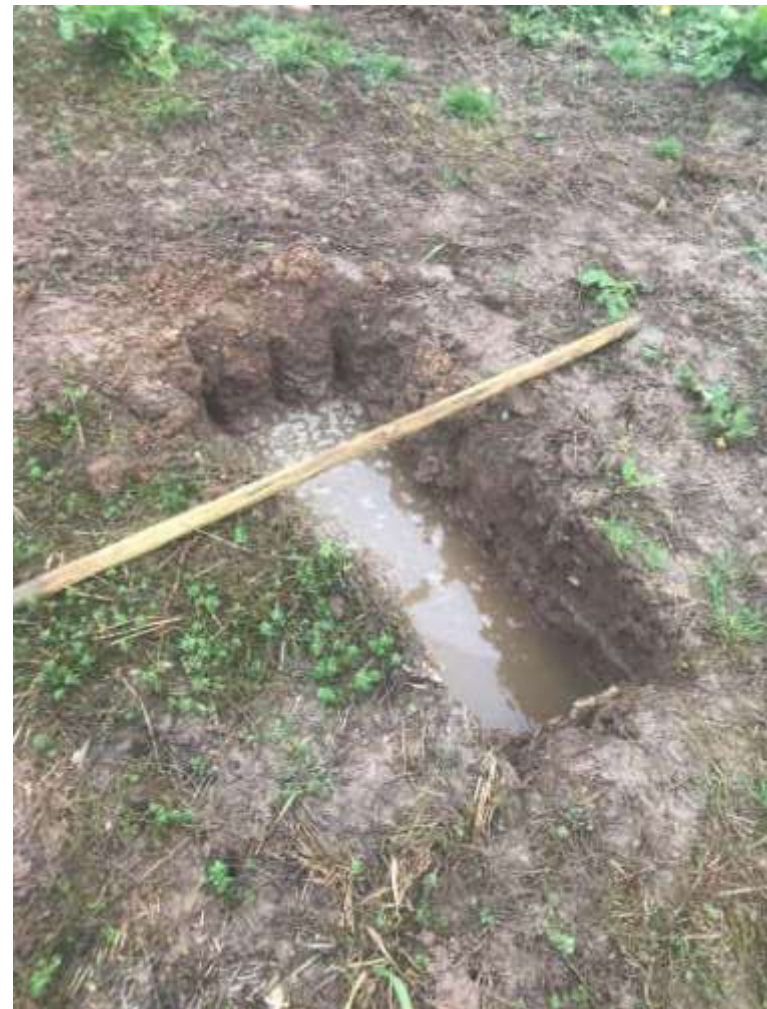
Plate 8: TP4 during soakage testing

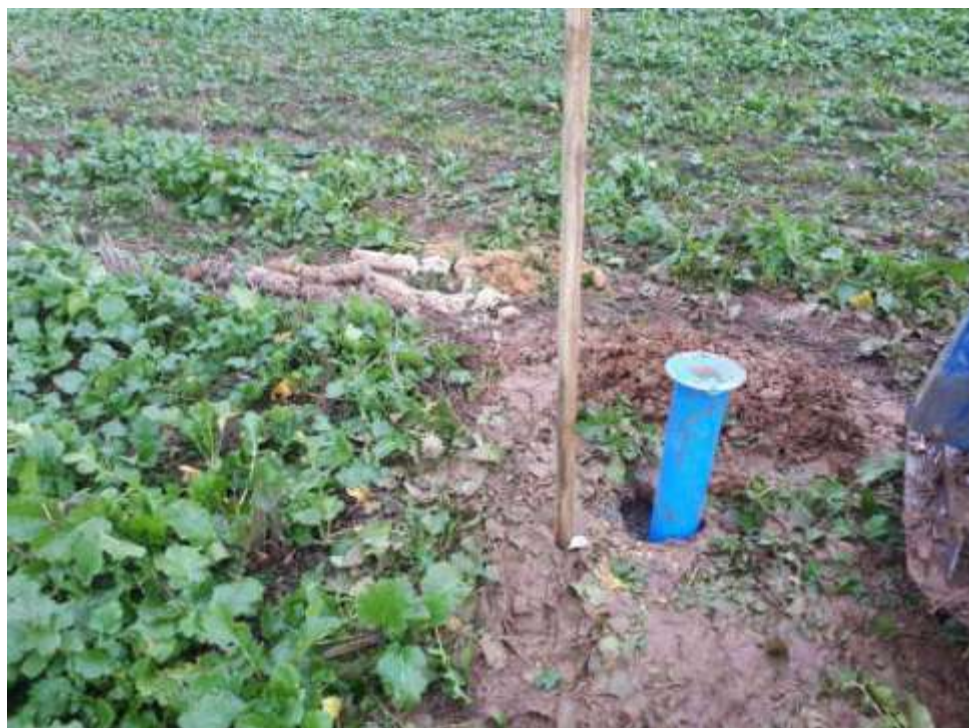
Plate 2: WS5 with well cover (before addition of cement)
