## Bat Emergence Survey Report

43 Aldsworth Avenue  
Goring-by-sea,  
Worthing

South  
Downs  
Ecology

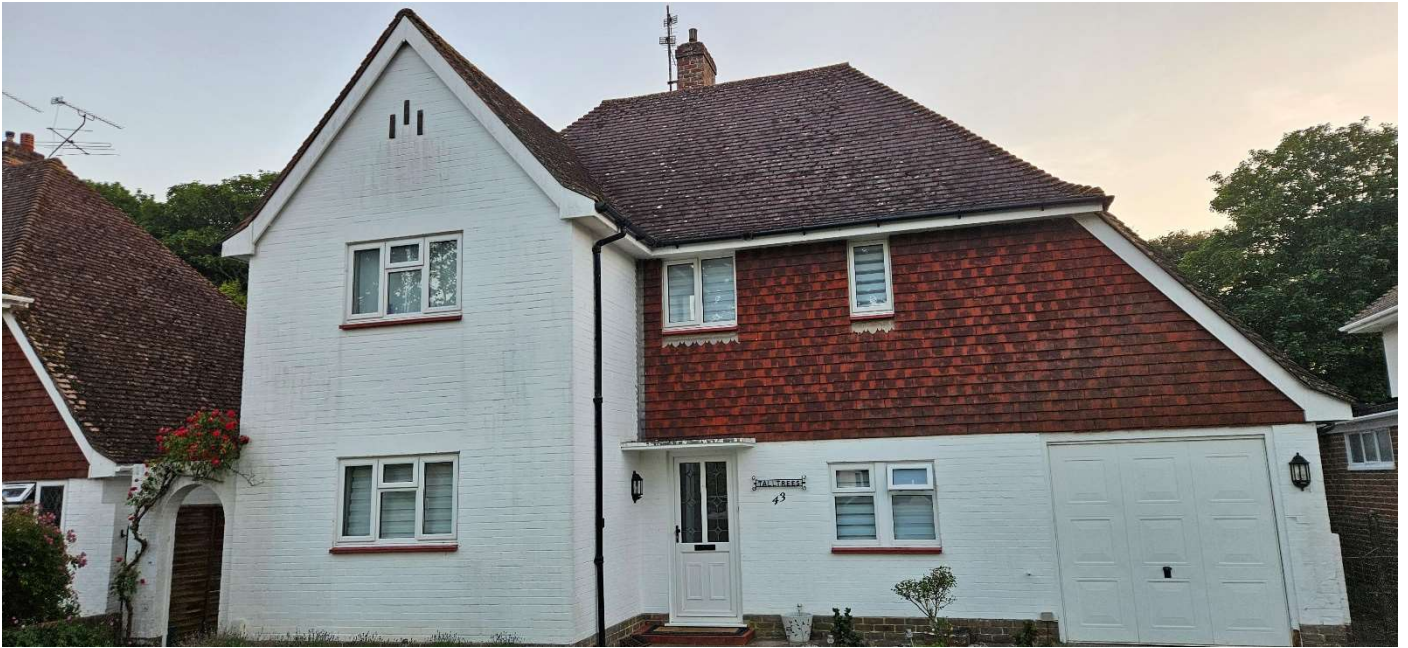
Photo 1 – Front of the property (east elevation)

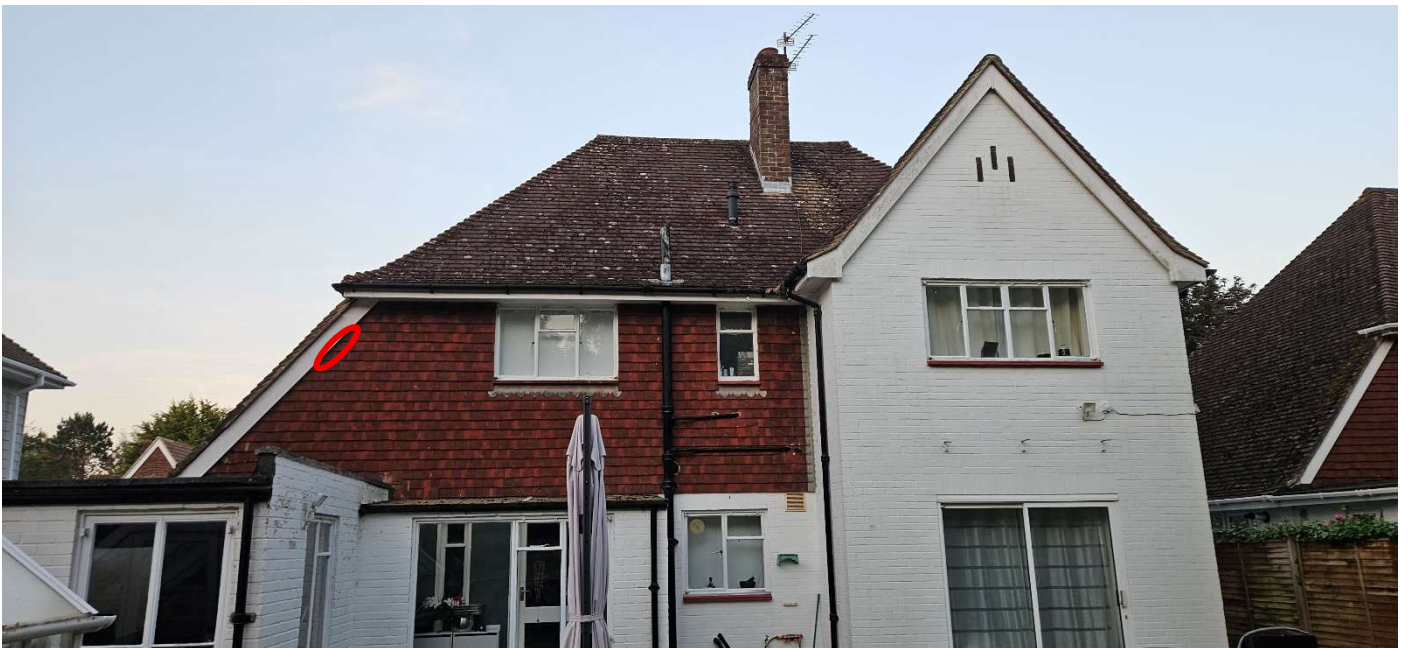
- 5.12 The second emergence survey in June identified a total of 65 individual common pipistrelles emerging from under the bargeboard of the rear elevation (west). Accounting for the time of year and species, we can conclude the emerging individuals are likely breeding adult females and therefore is a small maternity roost of local-district importance. Given the weather fluctuations between surveys and rapid increase in temperatures it is suspected that these individuals are either a split off group from another maternity colony or a group that has changed roost locations to cope with the heat.

Photo 2 – Rear of the property (west elevation) with the common pipistrelle maternity location identified in red

- 6.5 Sufficient mitigation for the occasional day roost and small maternity roost of this widespread species would be the integration of like-for-like sufficient multiple crevice roosting features within the new structure. The maternity colony must not be left without a suitable roost feature during maternity season; therefore works must be planned and timed accordingly. Furthermore, work cannot start during the maternity season which typically runs from the beginning of May to the end of September.

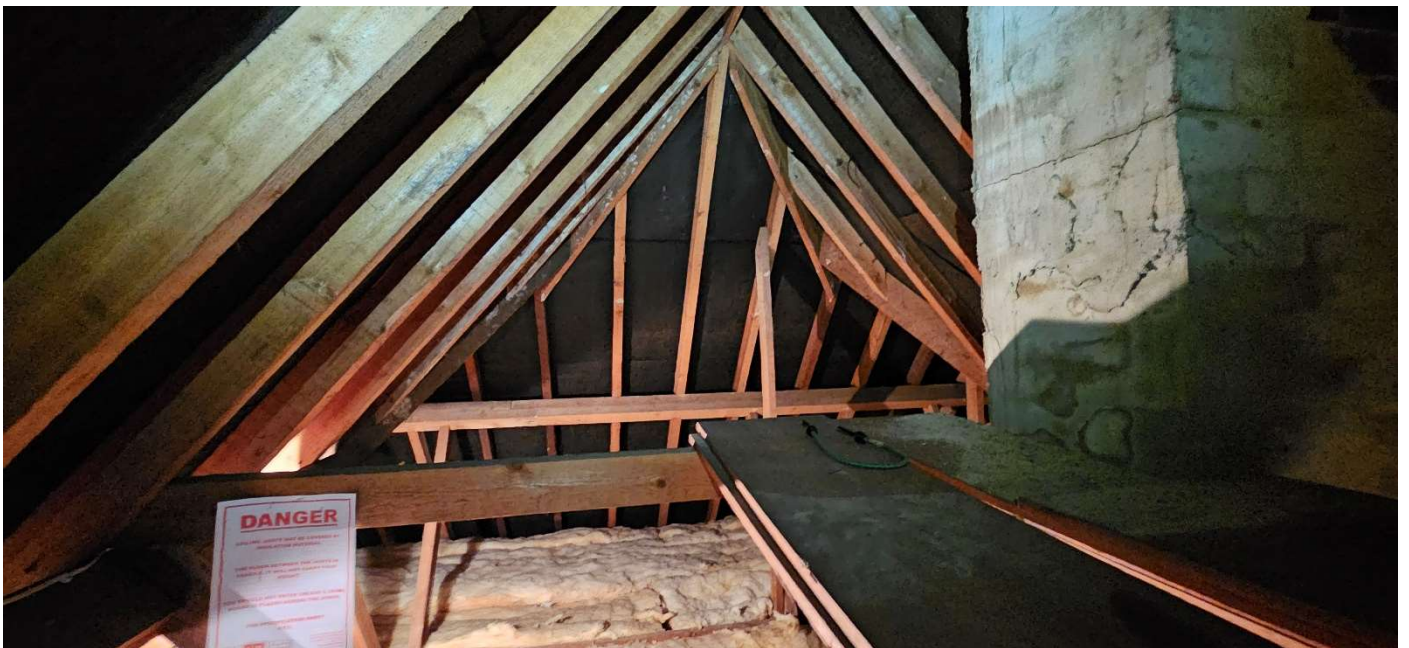
Photo 4 – Loft void from the hatch facing south

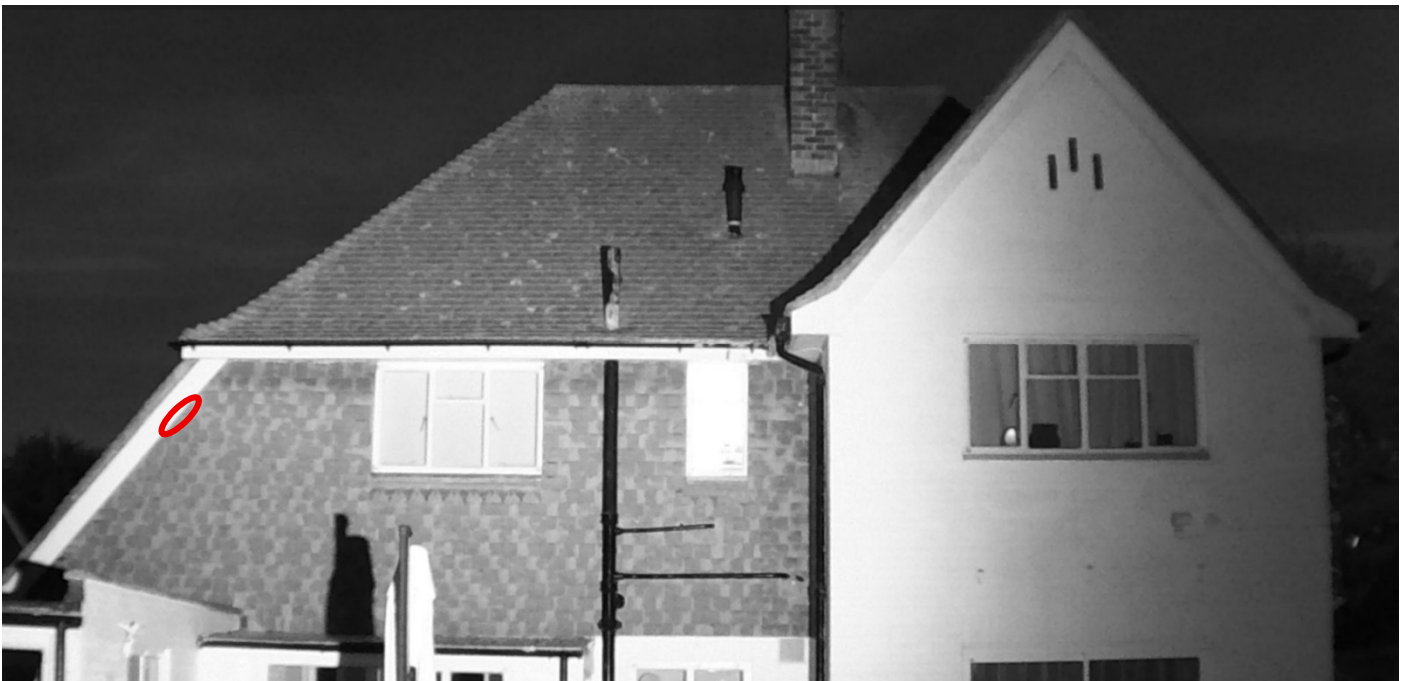
Photo 10 – IR.1 End (common pipistrelle maternity location identified in red)
