# Heritage Statement

Beach House, Brighton Road, Worthing, BN11 2EJ

This application for Listed Building Consent is being submitted due to the desire to carry out remedial works to the rear terrace at Beach House, Brighton Road Worthing BN11 2EJ.

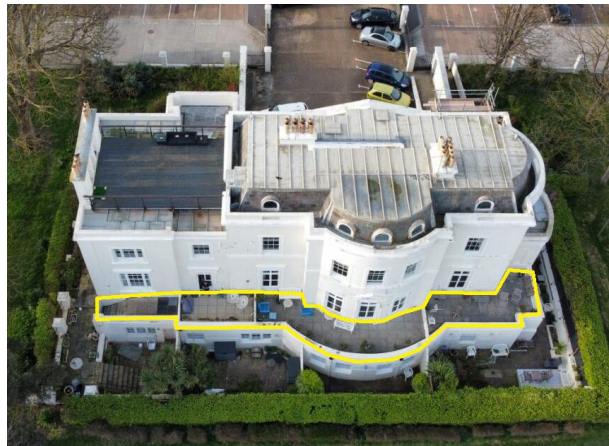
**Figure 1: Areal image of rear terrace work area**

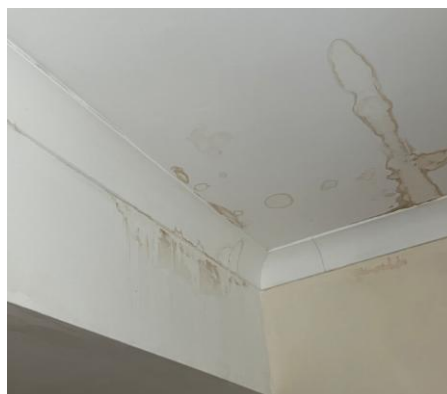
The primary driver behind the proposed project is to alleviate persistent water ingress which is occurring within the lower ground floor flats. The lower ground floor flats' rear bedrooms sit directly below the terrace and water ingress is present across the building.

**Figure 2: Example water damage to lower ground floor flats**

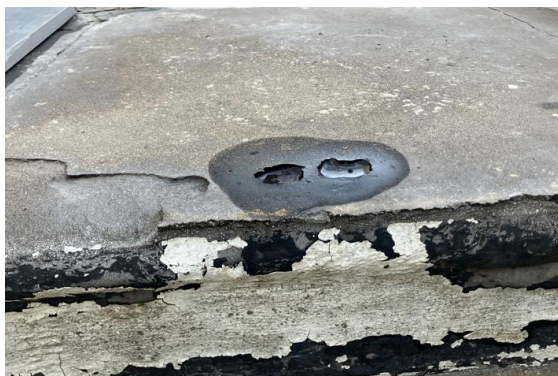
To ensure the habitable areas below remain usable, the existing asphalt will need to be fully stripped back to the structural deck and repairs carried out to the deck, before reinstating the asphalt entirely. Much of the asphalt which is visible (and not covered with a concrete overlay, see below) is demonstrably in poor condition, with several areas slumped and eroded:

**Figure 4: Typical example of asphalt condition**

- a) Aesthetic value: low impact. The new waterproofing layer be replaced with one of an identical appearance.
- b) Communal value: no impact.
- c) Evidential value: low impact.
- d) Historical value: no impact.

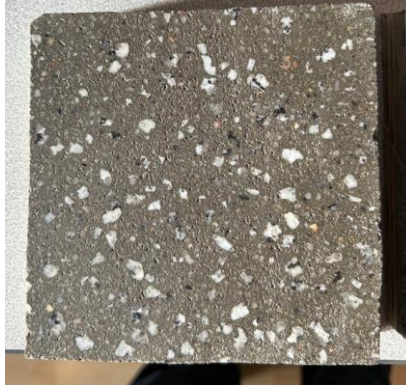
The project team have approached a number of cementitious screed manufacturers to discuss options. These manufacturers have stated that they are unable to match the course textured finish due to the smooth nature of aggregates used in modern screed. Following their enquires, the project team have formed the view that a polymer modified screed provides the closest aesthetic match, an example of which is shown below:

**Figure 4: Proposed screed appearance to be used**

Consequently, the project team believe that a monolithic, polymer modified screed represents the safest technical solution which matches the current appearance as closely as can be achieved, and is therefore the best solution to mitigate the risk of harm to both the building and its users.

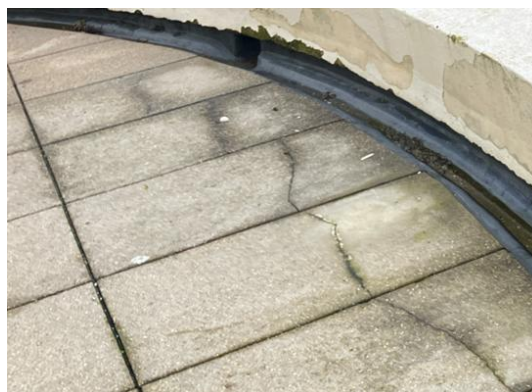
The existing appearance of the concrete cover, which has been cast into the squares to mimic the effect of paving slabs, cannot be replicated. The current arrangement has the concrete adhered directly to the asphalt – referred to under modern design codes as a ‘bonded’ arrangement. As the asphalt below the screed is an inherently softer material, it softens in hot weather, leading to flex of the asphalt and, in turn, the concrete above it. This can be seen in the existing arrangement, particularly around perimeters:

**Figure 5: Cracking of existing screed**

As a result, requirements by both asphalt manufacturers and screed manufacturers set out that any replacement system should not replicate this, with a bonded arrangement avoided in order to preserve the integrity of the asphalt. Instead, an ‘unbonded’ system should be employed with a polythene separation layer between the screed and asphalt installed so as to preserve the long-term integrity of both asphalt and screed, and avoid the risk of repeat cracking.

The risk of cracking reappearing is a material consideration for safe management of the building, as well as aesthetic matters. As can be seen above, the primary cracking occurs around the perimeter of the screed – this is due to a combination of its bonded installation type, and lack of strength at the perimeter. This lack of strength is very likely to be exacerbated by the fact that the screed is cut into smaller, paving slab-style shapes, meaning that the screed loses its overall strength that it would otherwise gain in mass. It is likely that the existing screed’s movement may well be a contributory factor in the current asphalt leaking, given their direct bonding.
