# Phase 1 Contaminated Land Assessment

**New Salts Farm**

**NSF Barns Ltd**

**33646-HML-XX-XX-  
RP-U-830001**

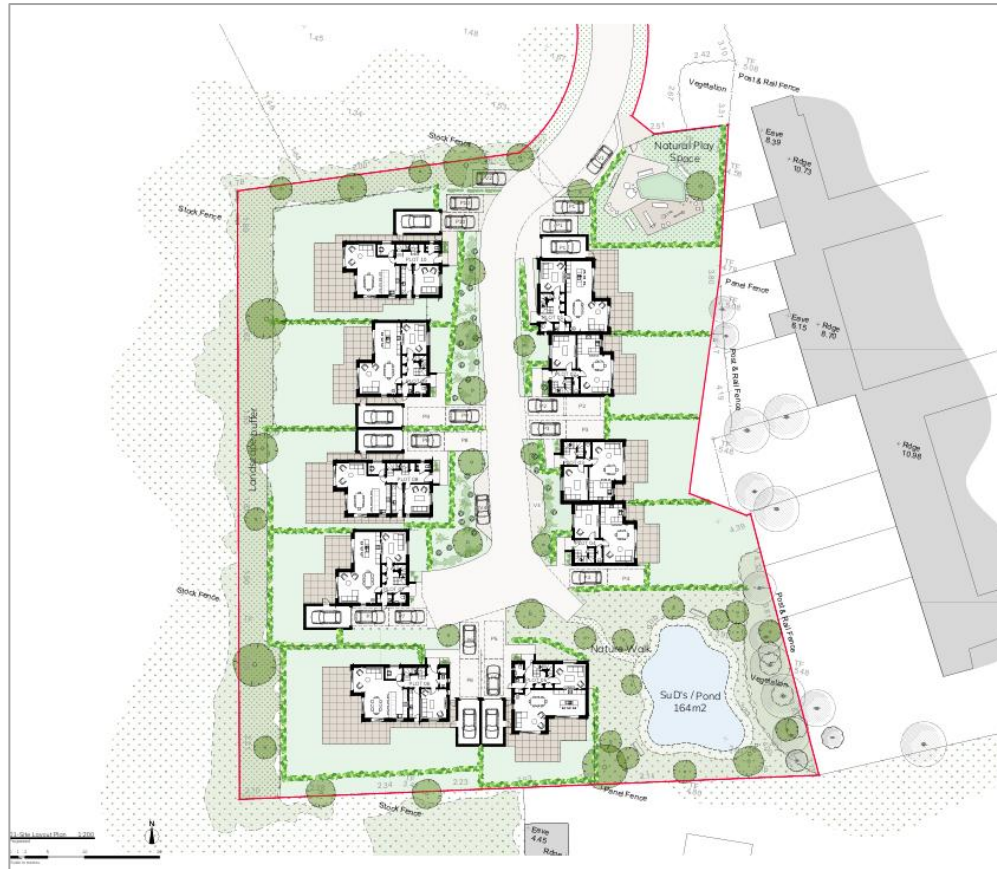
A natural play space is located in the north-eastern corner of the Site, with a sustainable drainage system (SuDS) feature in the south-eastern corner.

*Figure 1-2. Proposed Site Plan (Source: Meynell + Gunton, dated May 2026).*

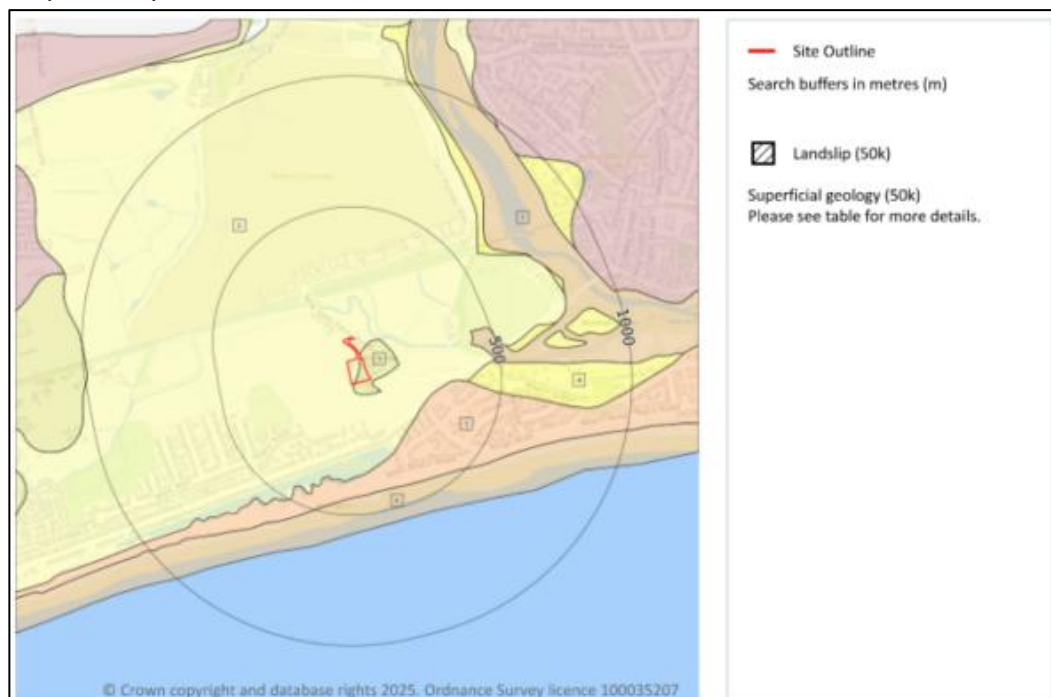
According to BGS 1:50,000 mapping of the area and the environmental database, the Site is directly underlain by superficial deposits. In the south-east of the Site, these comprise Raised Beach Deposits (sand and gravel, a Secondary A Aquifer), while in the north-west of the Site they comprise Alluvium (clay, silt, sand and peat, a Secondary Undifferentiated Aquifer). The underlying bedrock geology comprises the Newhaven Chalk Formation (chalk, a Principal Aquifer).

**Figure 7-1. Superficial Deposits Underlying the Site (Source: Groundsure Report Ref. GS-HVU-SJR-4WS-EBN).**

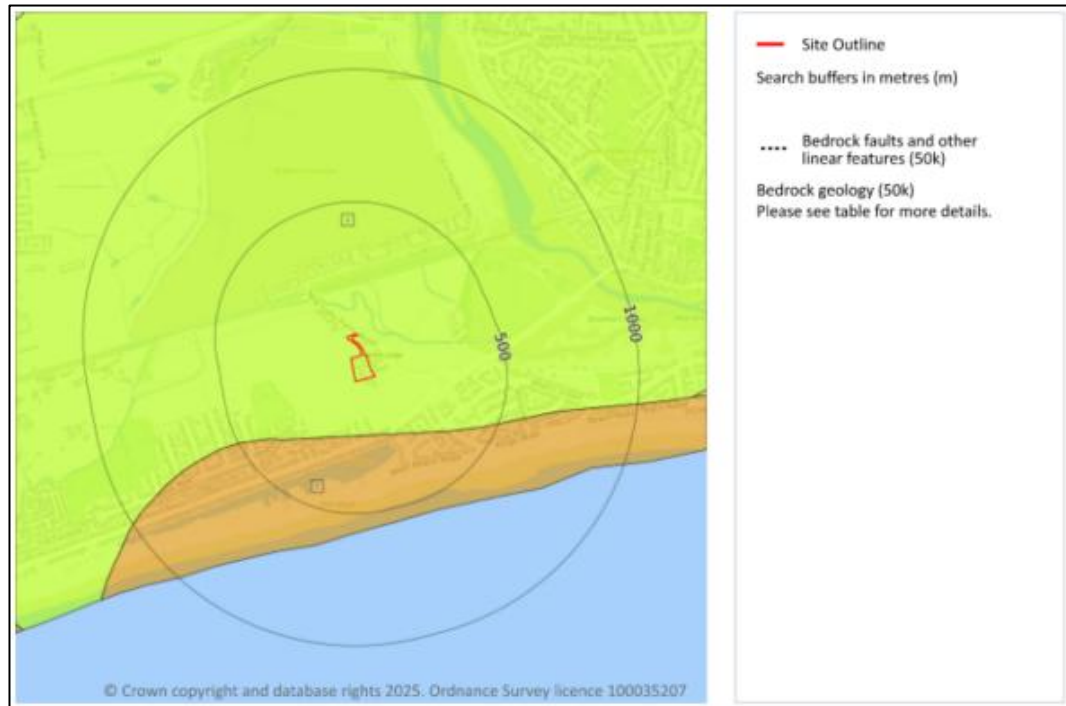
**Figure 7-2. Bedrock Deposits Underlying the Site (Source: Groundsure Report Ref. GS-HVU-SJR-4WS-EBN).**

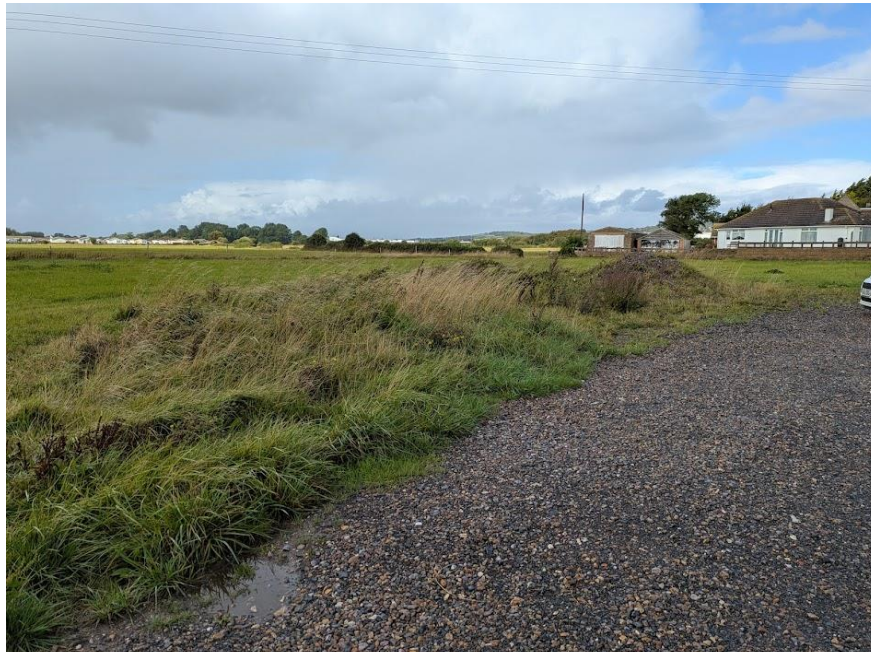
Areas of uneven ground, small stockpiles and raised ground were noted on-site and adjacent to the Site.

**Photo 3.** Uneven ground and stockpiles near Site access.

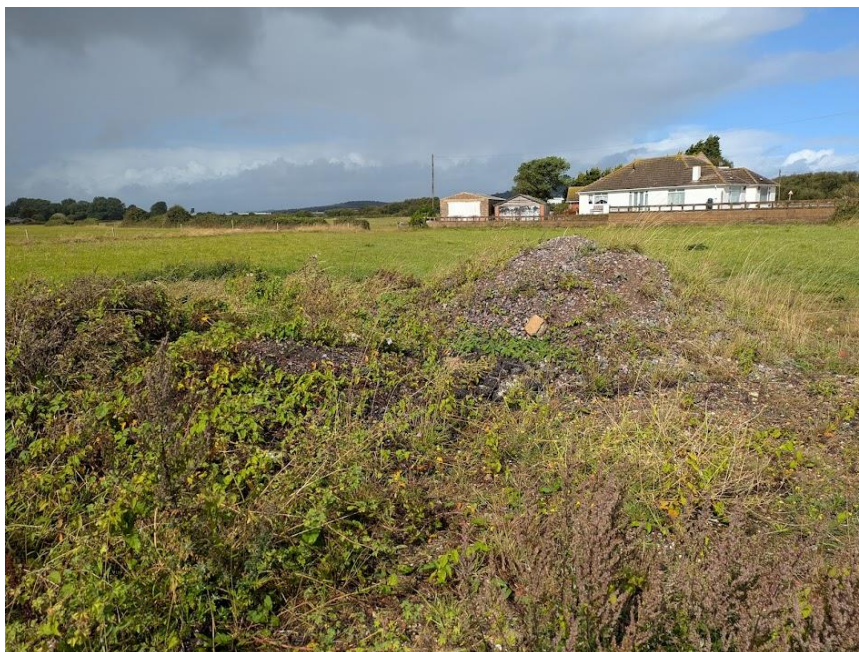
**Photo 4.** Stockpiles near site entrance.

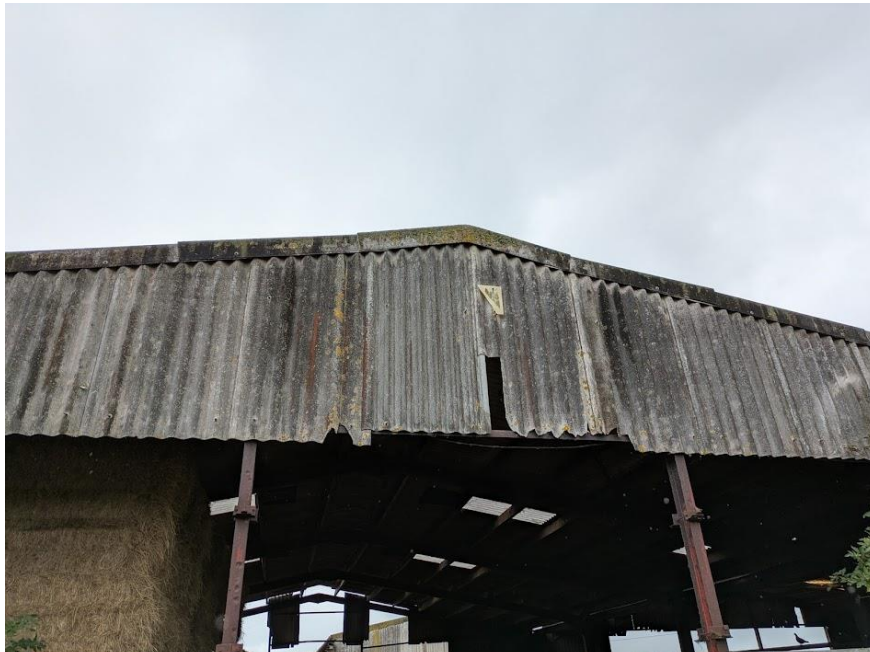
The barns are constructed from corrugated cement sheets, which may contain asbestos. The sheets were observed to be weathered, with moss/lichen growth, and in poor condition (degrading/damaged). Broken sheeting fragments were observed on the ground surrounding the barns.

**Photo 7.** Corrugated cement/metal sheeting roof, with visible damage.

**Hilson Moran strongly recommends that an asbestos survey is undertaken in view of the damaged, potentially asbestos containing barns.**

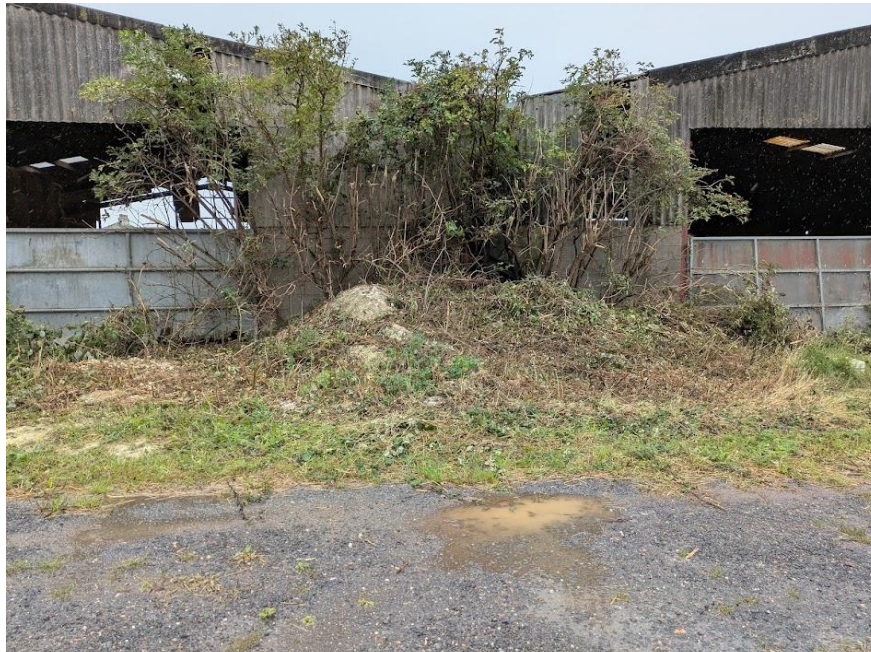
**Photo 9.** Adjoining barns with a stockpile/uneven ground to the north.

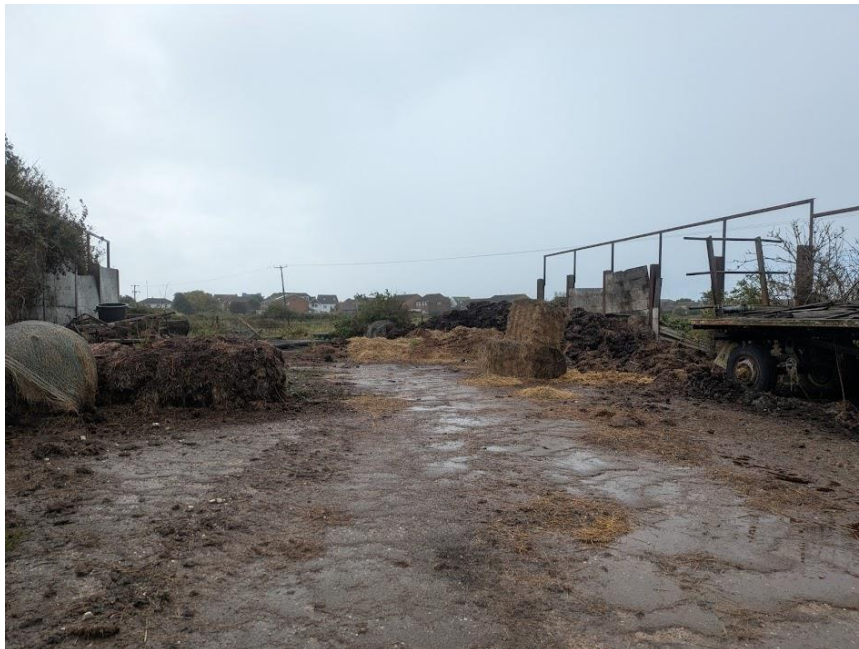
Wastes generated on-site predominantly comprise cattle manure and bedding, plastics e.g. hay/silage wrap and tyres. Cattle manure was observed to be stored in a stockpile upon concrete hardstanding in the south-west of the Site. Leaching of the manure in a northerly direction towards unsurfaced ground was noted.

Two disused rusted trailers, tyres and fencing were also observed to be stored in the south-western storage area. Tyres were scattered across the Site. Two plastic bags of old bedding were observed too the north-east of the southern barn, upon unsurfaced ground. No further waste storage was noted during the site visit.

**Photo 12.** Storage of manure, trailers and hay.

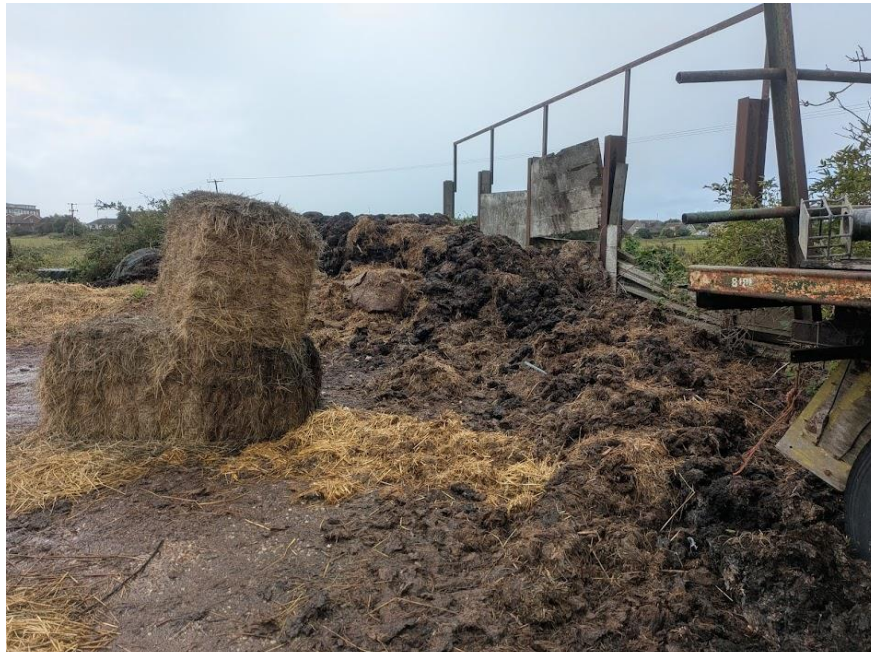
**Photo 13.** Manure storage on hardstanding in south-west of the Site.

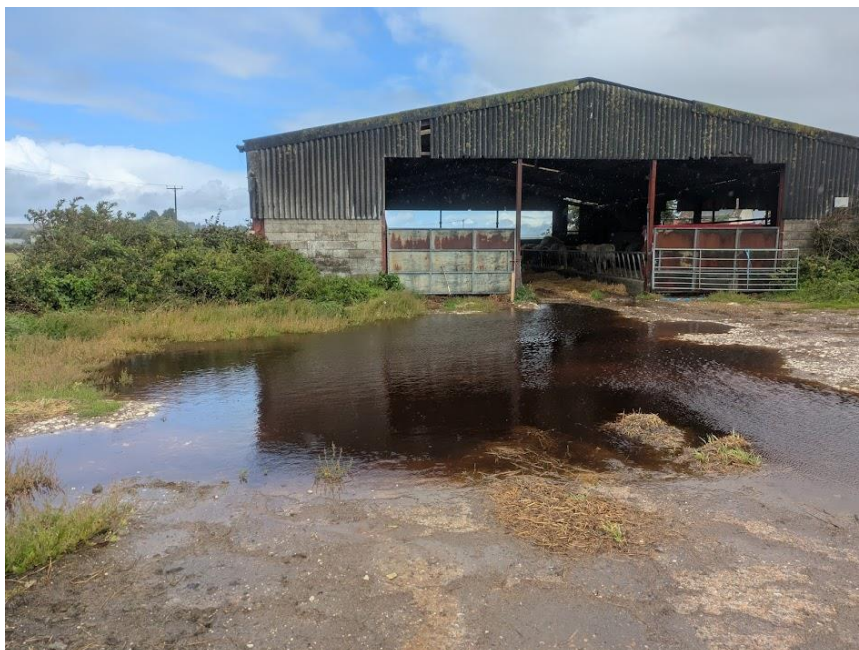
The Site predominantly comprises unsurfaced ground (approximately 70%) with limited areas of hardstanding (approximately 30%). Surface water was observed to be collecting in the unsurfaced area between the barns, and the uncovered manure was noted to be leaching into this area.

**Photo 14.** Surface water collecting in the centre of the Site, with leaching from manure stockpile/barns visible.

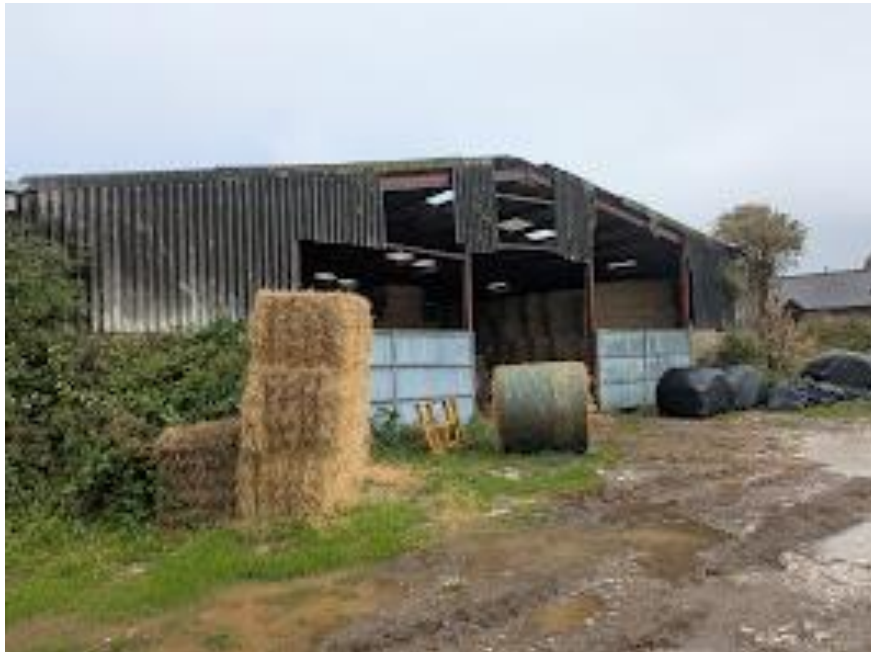
**Photo 15.** Damage to corrugated cement sheeting in the north-eastern barn.

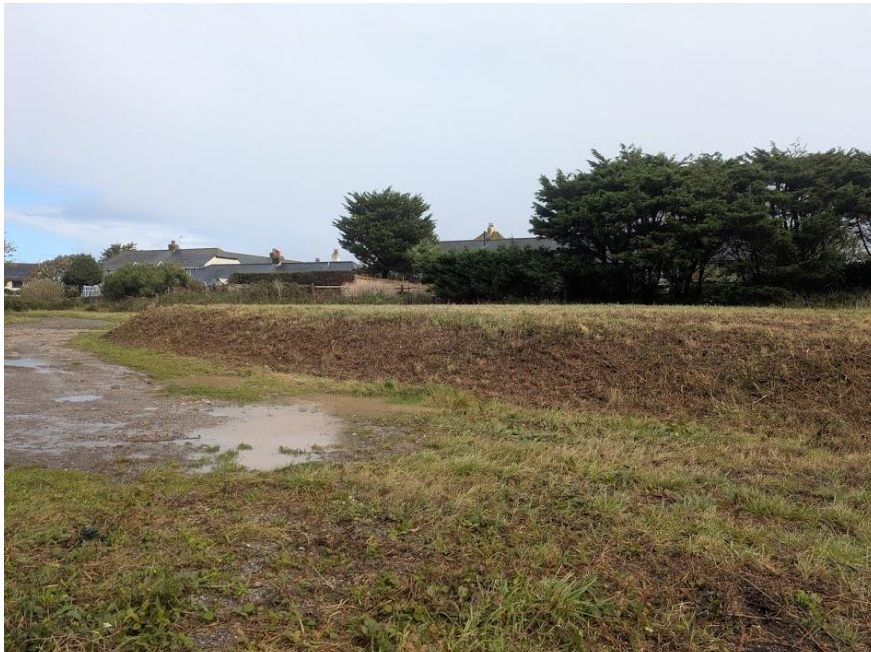
Hilson Moran observed an area of raised ground in the south-west of the Site, which sits approximately 0.75 m higher than the rest of the Site.

**Photo 17.** Raised area in south-west of site (approximately 0.75 m above rest of Site).

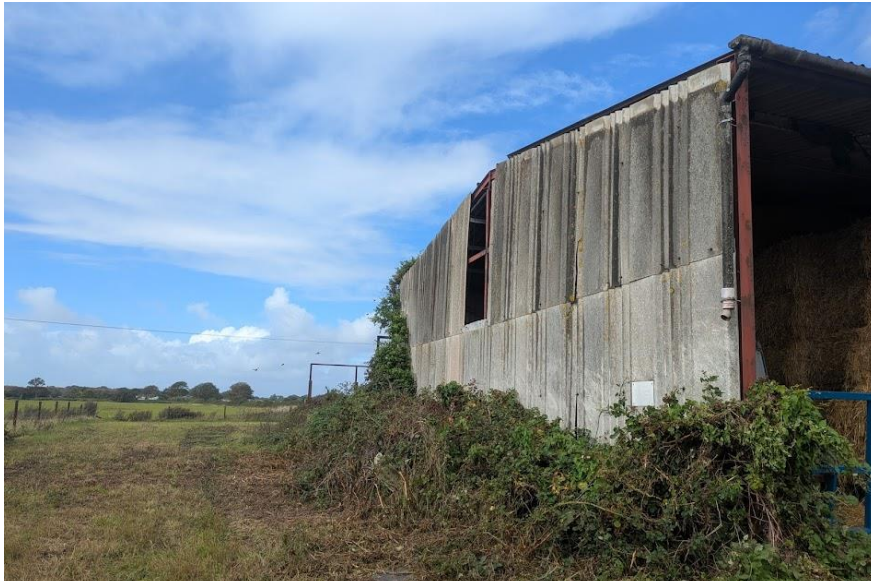
**Photo 19.** Damage to the southern barn.

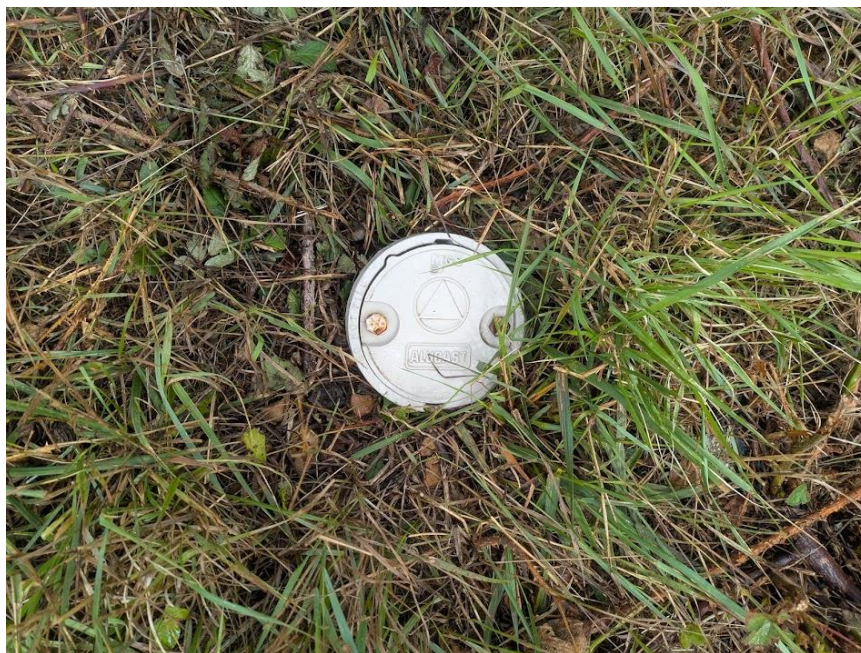
A monitoring borehole was observed by Hilson Moran in the south of the Site during the visit. The headworks (lockable flush cover) appeared to be damaged. According to the Site representative, this borehole was installed in November 2024 (along with another borehole in the north of the Site) for groundwater level monitoring in association with soakaway testing at the Site. The Client provided the associated Soakage Testing Letter Report<sup>v</sup> to Hilson Moran for review, which includes borehole logs for WS1 (north of the Site) and WS2 (south of the Site). Four trial pits were excavated for infiltration testing and the associated logs are also included. The ground conditions encountered are summarised in Section 7.1.

**Photo 20.** Monitoring borehole observed in the south of the Site.

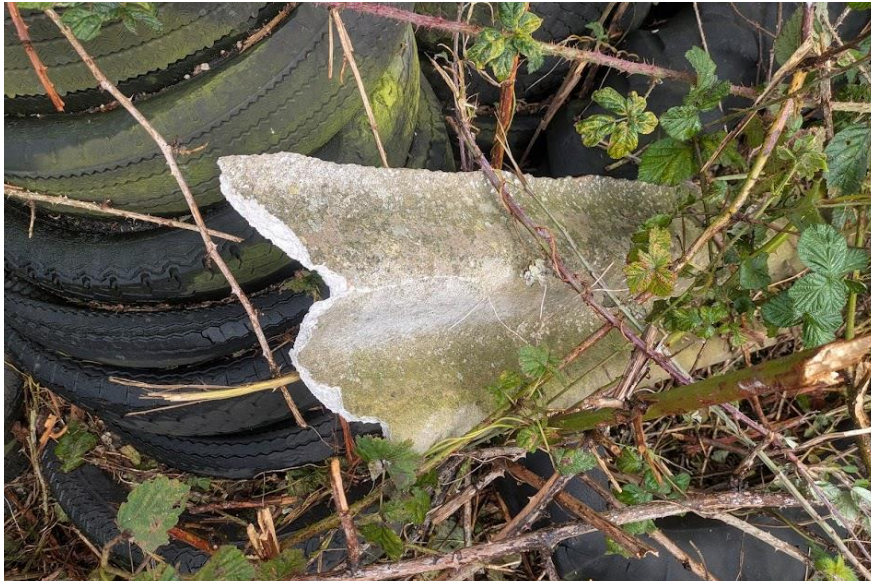
**Photo 21.** Cement sheeting fragment observed to the south of the southern barn.
