## Verification Report

Plot 124 Residential Development

Barrington Road, Worthing

Site: Barrington Road, Worthing  
Document Title: Verification Report  
Document no.: STV5959-R20-Rev\_A  
Date: July 2025  
Client: Bellway Homes Ltd (South London)  
Issuing office: Soiltechnics Ltd  
Cedar Barn, White Lodge, Walgrave, Northampton. NN6 9PY  
Tel: 01604 781 877 E-mail: [mail@soiltechnics.net](mailto:mail@soiltechnics.net)

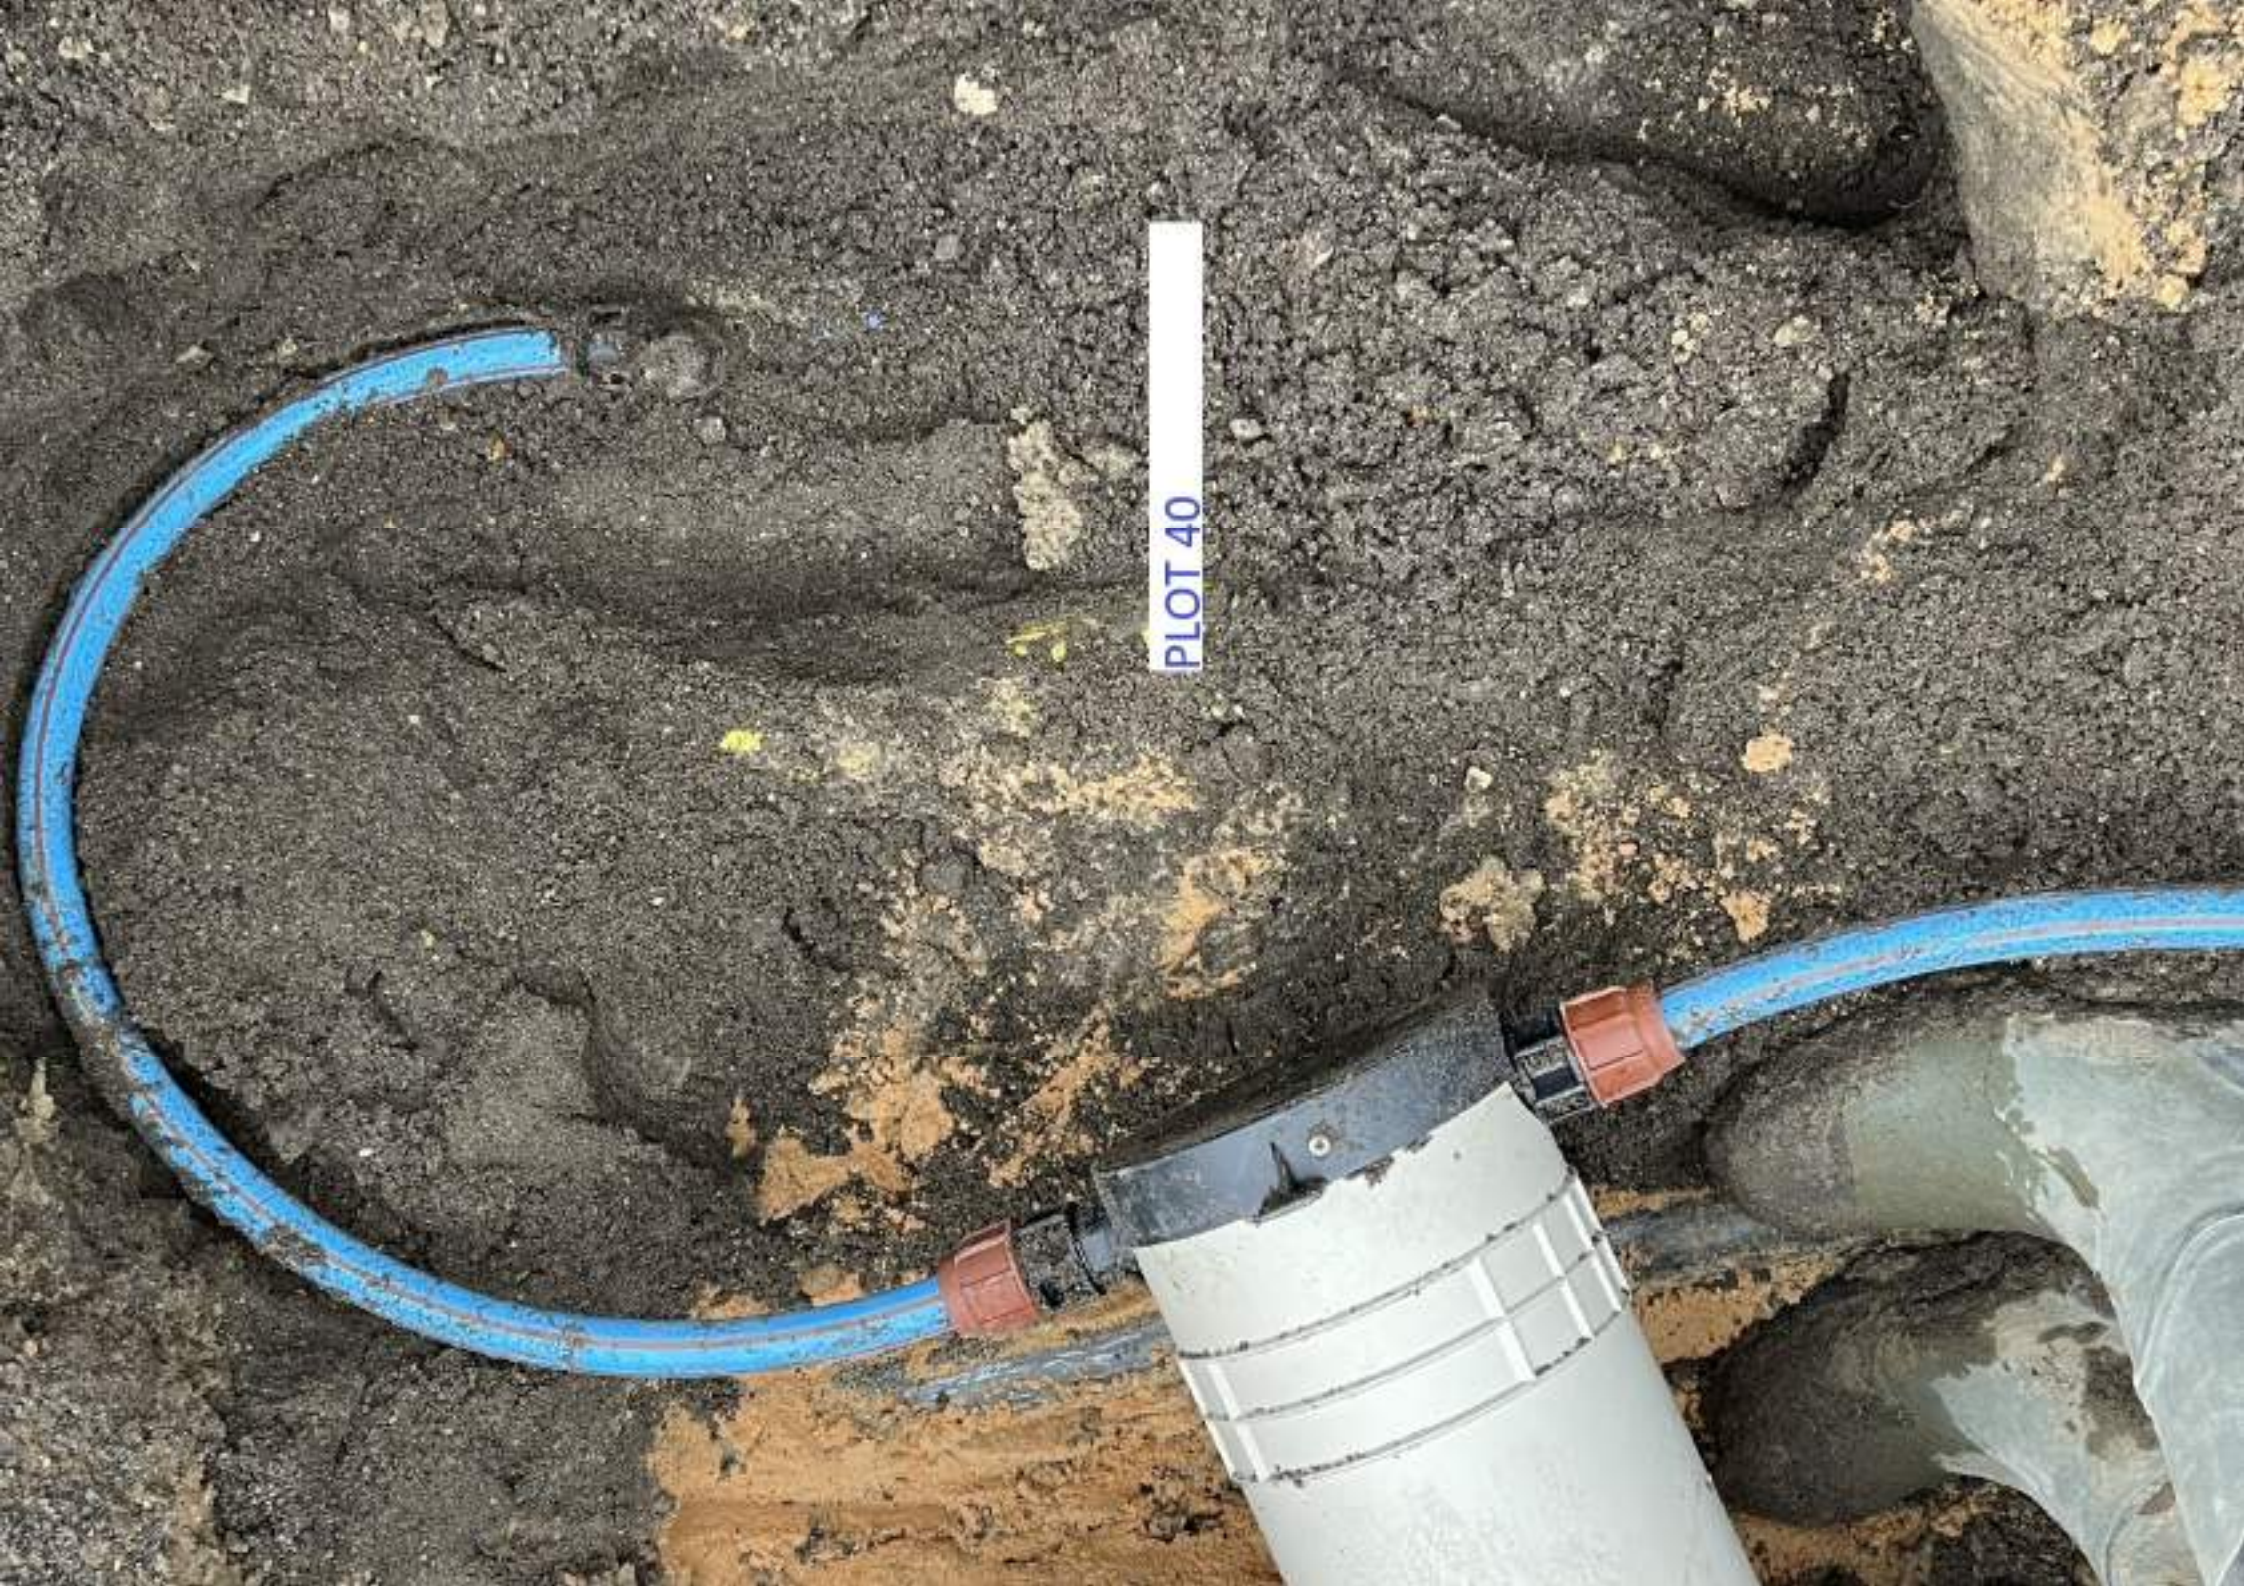
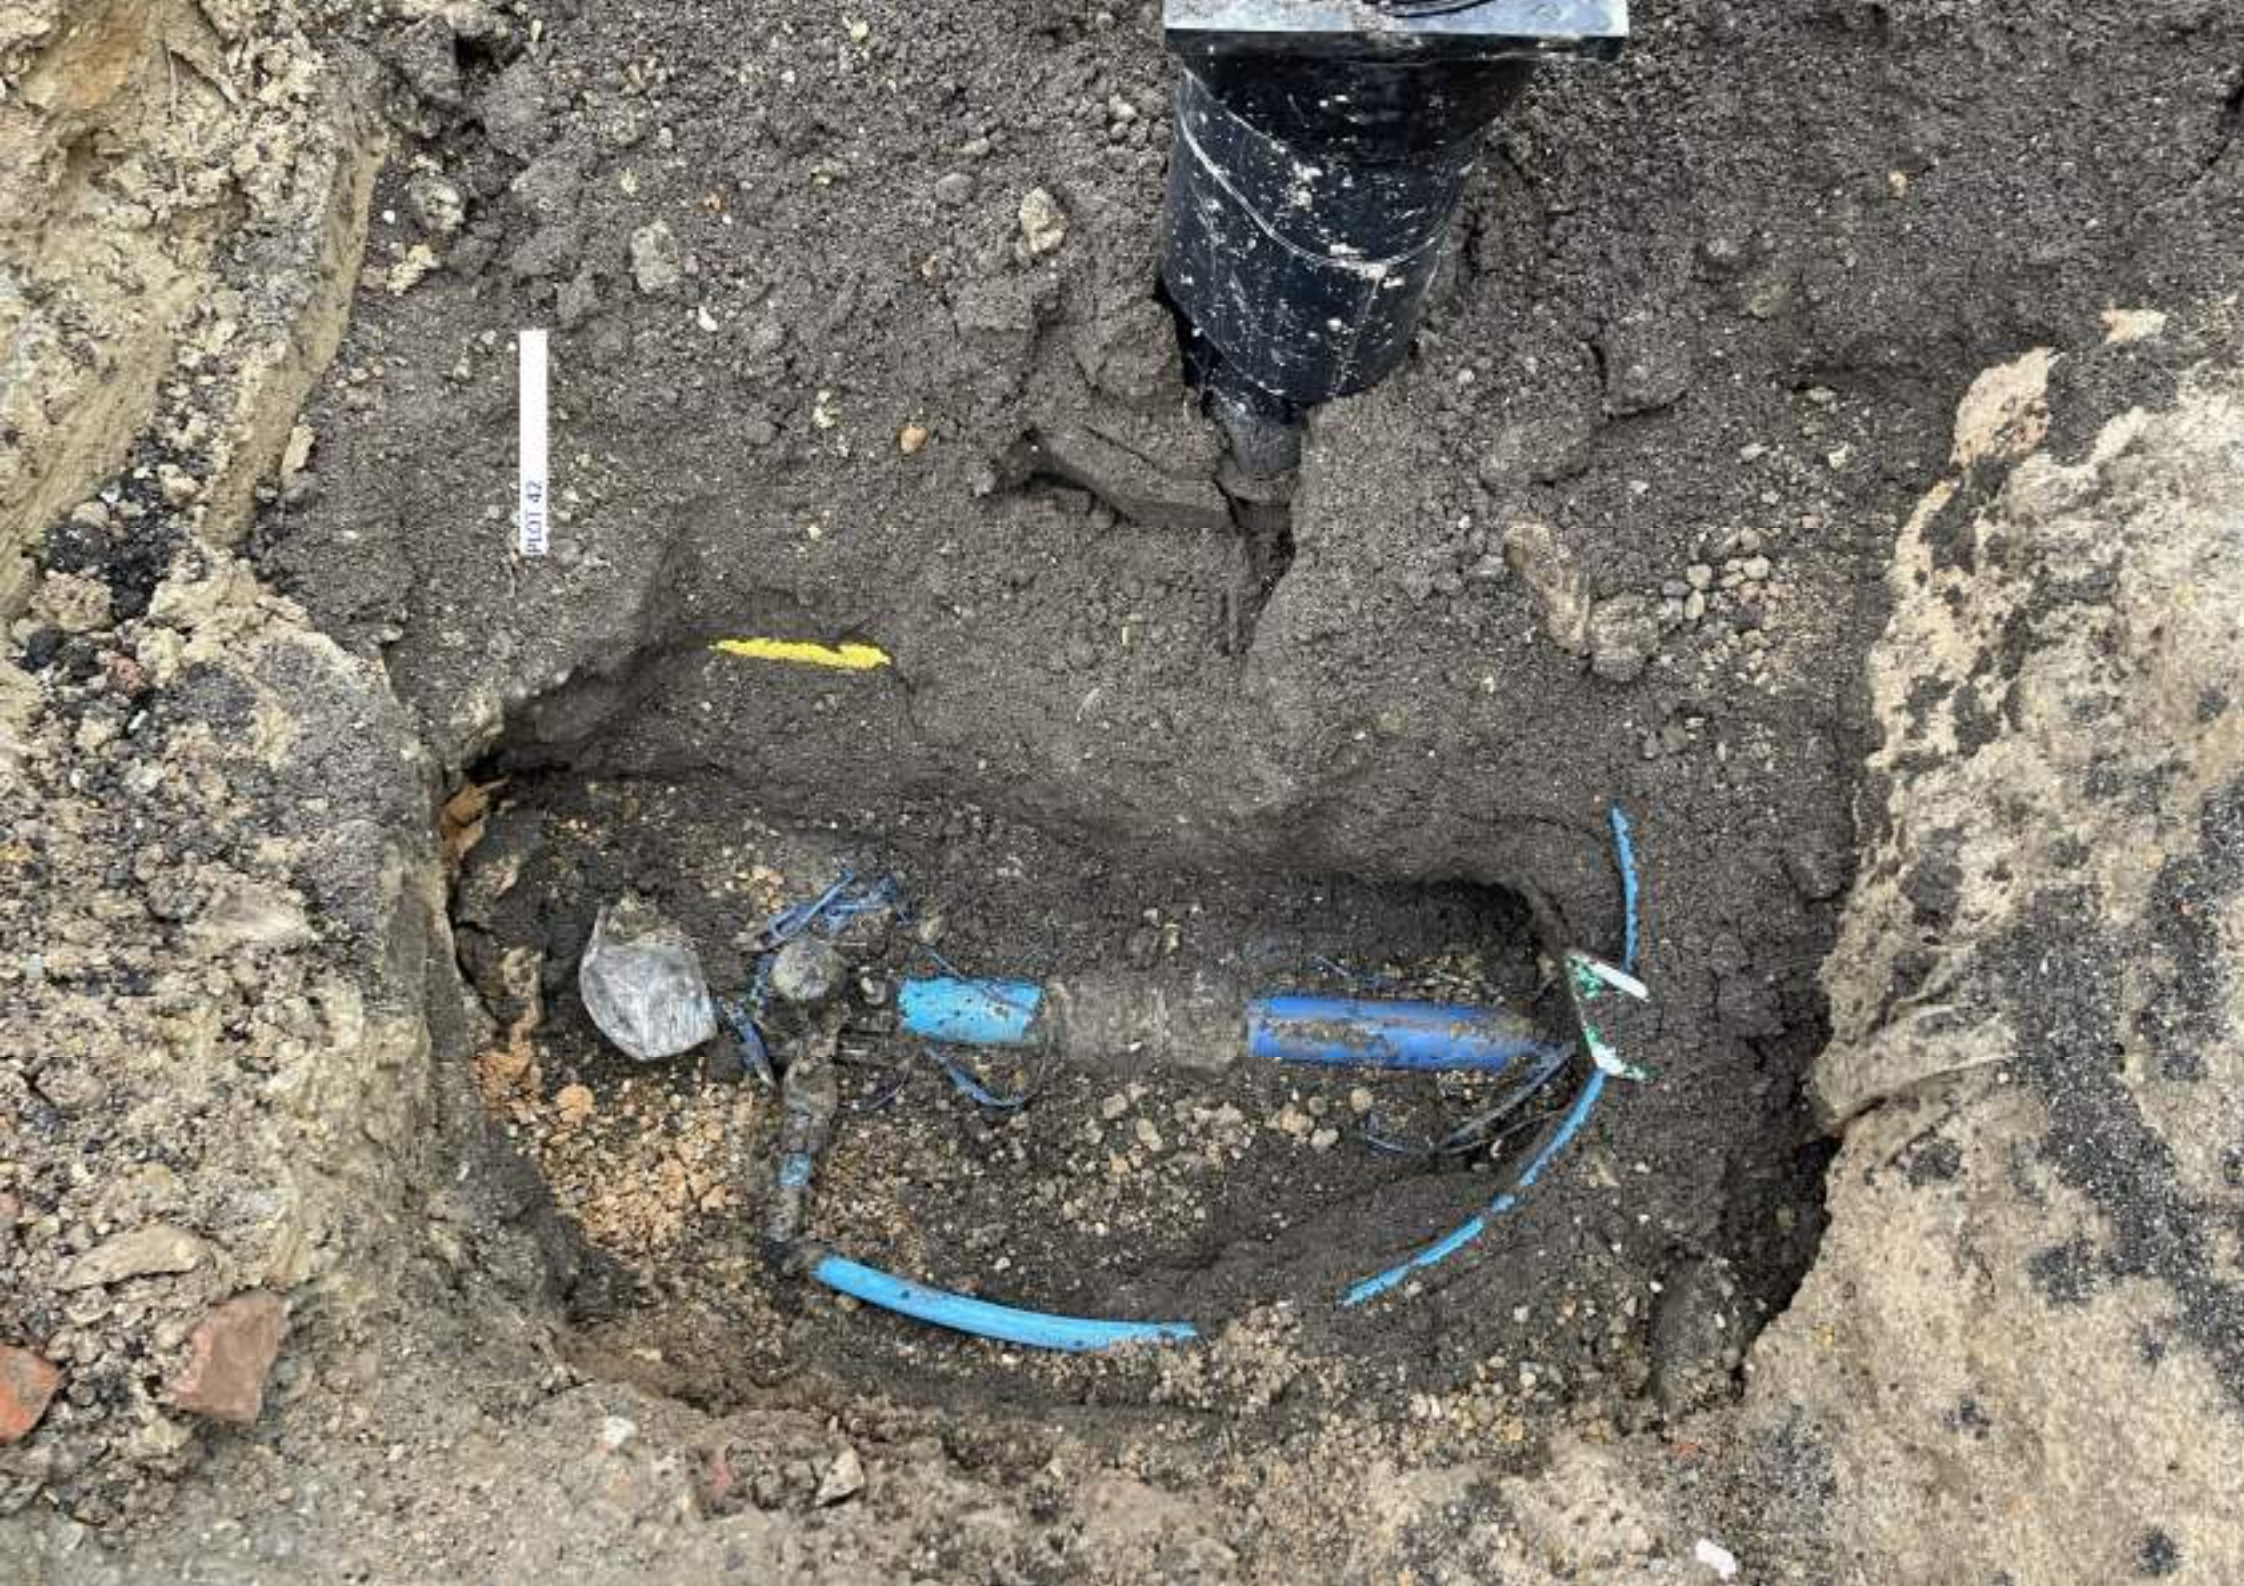
PLOT 40

- 4.3.3 The photographs do not show any evidence of significant hydrocarbon contamination in areas of PE pipework, and protective barrier pipe can be identified by a thick brown line along blue pipework in the relevant plots. It should be noted that an oily sheen can be seen on perched water in one of the trenches exposing the protective barrier pipe, supporting the use of the pipe in this area.

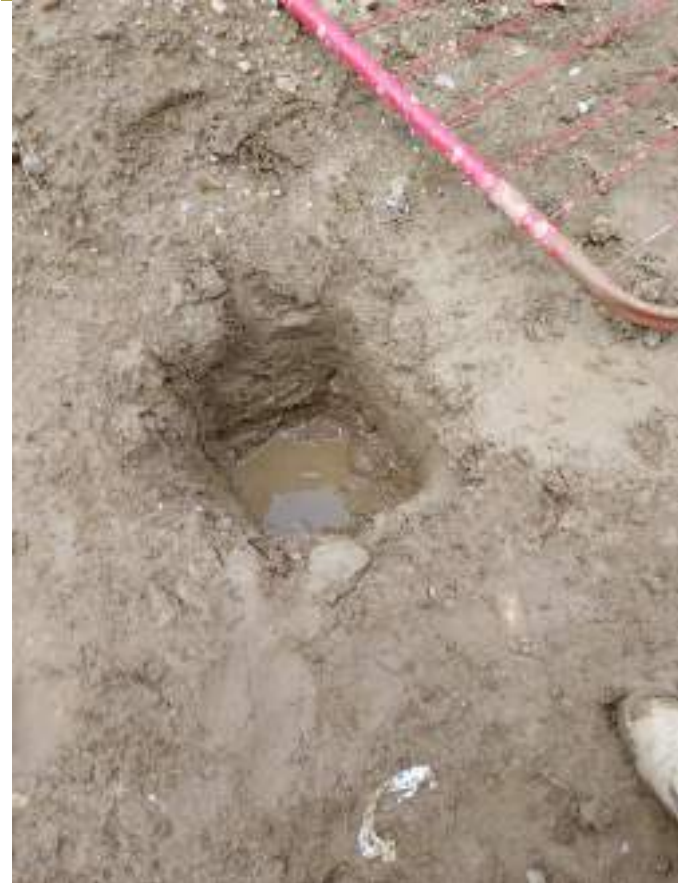
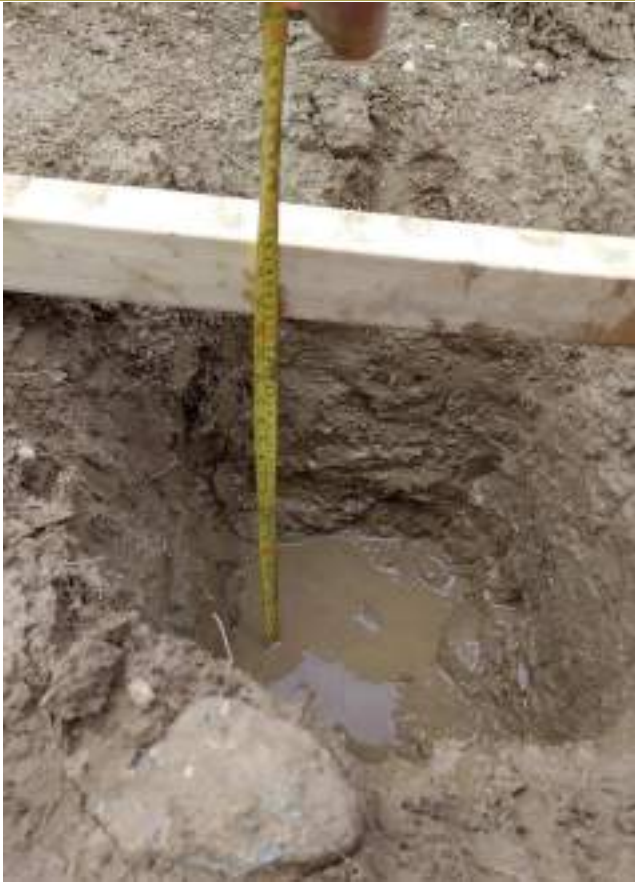
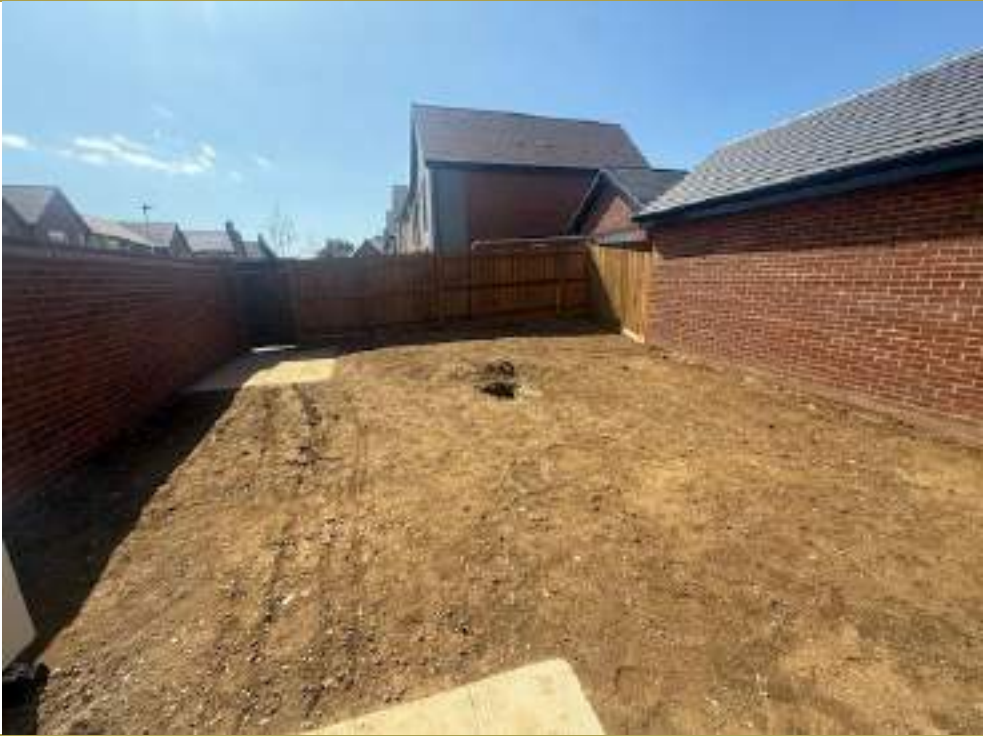
| Photograph (in-situ soils): | Photograph (depth) |

5.3.5 Clean cover inspection noted the cover system in each plot to be of sufficient depth in all cases (>600mm) comprising of topsoil (>150mm) and subsoil. Pit inspection records are included in Appendix E.

| Physical Suitability | No undesirable or injurious objects were observed within any of the materials inspected, such as sharps, metals, plastics or over-sized materials, except for a few cobble-sized fragments of brick and concrete within the subsoil. | | |
