Appendix A

Figure 1: Site Location Plan
Brighton Road, Shoreham-By-Sea

Brighton Road, Shoreham

Project No.	31149	Title	Views of the Corroded Steel Interlocking Sheet Piled Wall at Tarmac Wharf, Concrete Walls and Anchor	Drawn	CJP
Client	BSCP Ltd			Checked	RS
Project	Brighton Road, Shoreham	Date Drawn	20/06/2013	Approved	RS
		Scale	NTS	Figure No.31149/GA7	
		Revision

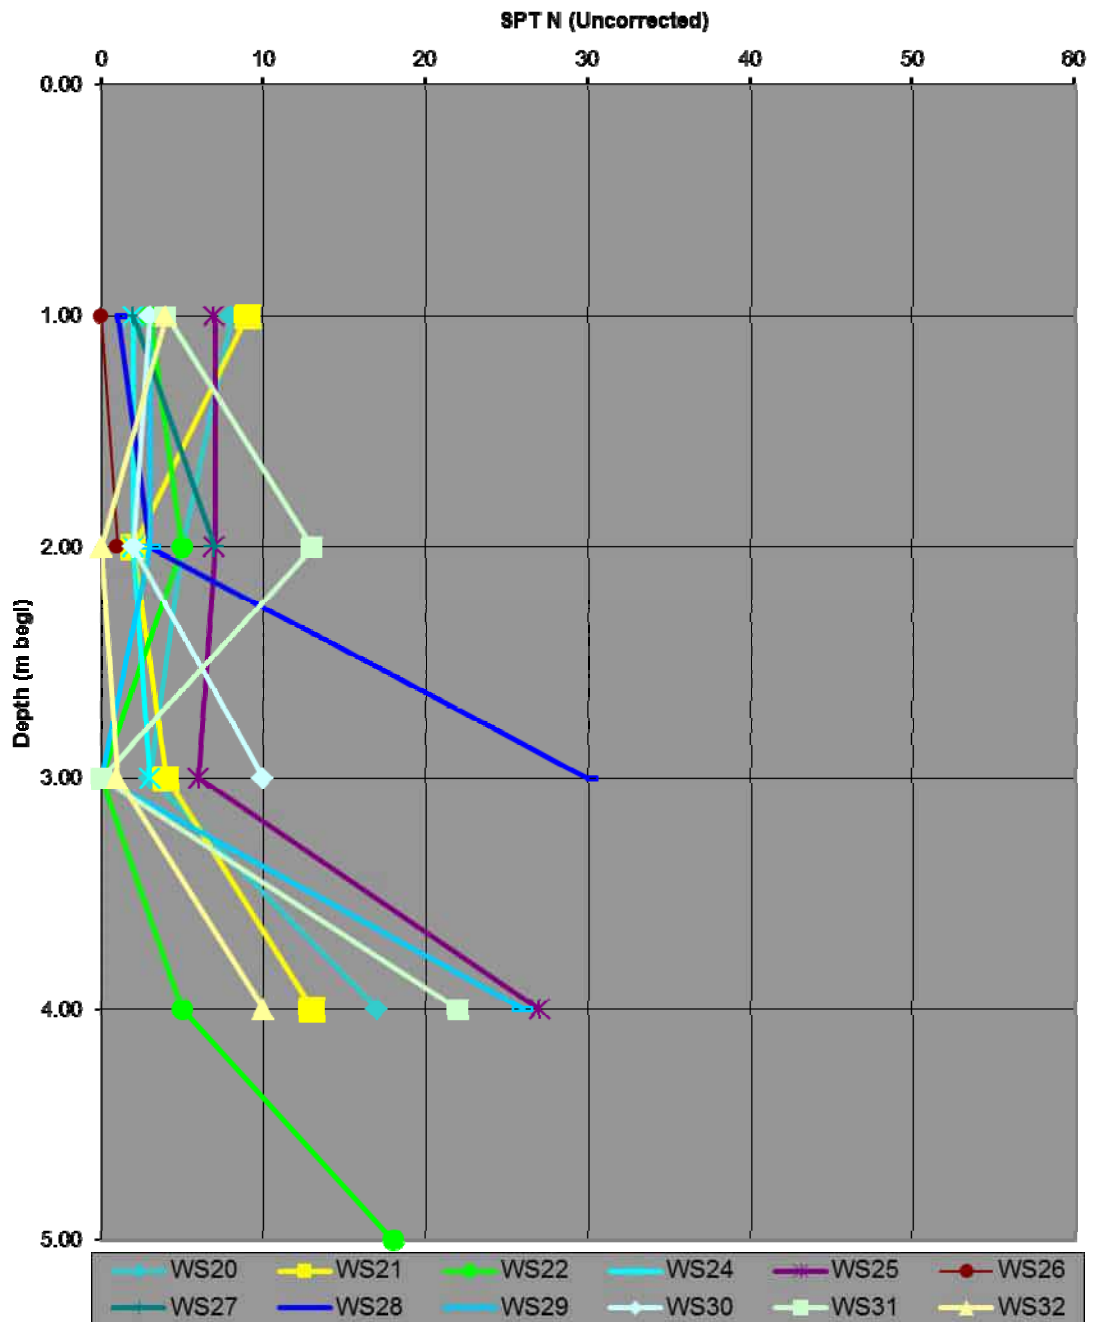
Window Sample Borehole Data (2015 Works) SPT N Values Vs Depth (m begl)

The third chart below reveals the SPT N-Values from the window sample boreholes advanced during our current works primarily within internal areas of the site.

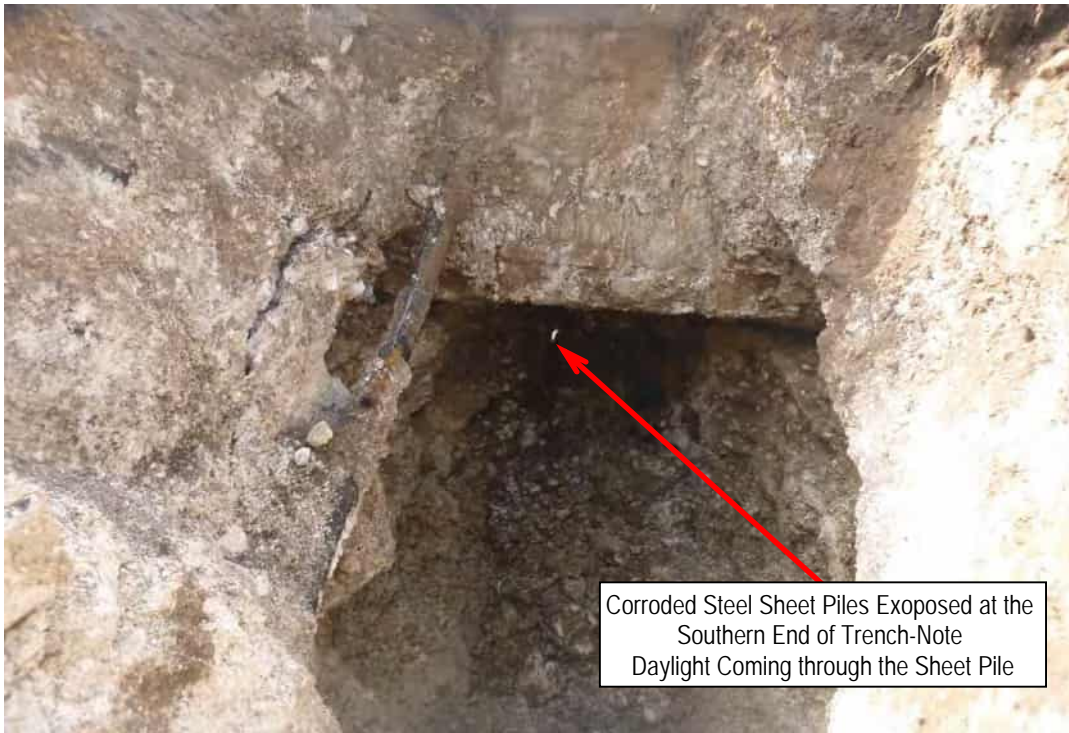
Corroded Steel Sheet Piles Exposed at the Southern End of Trench-Note Daylight Coming through the Sheet Pile

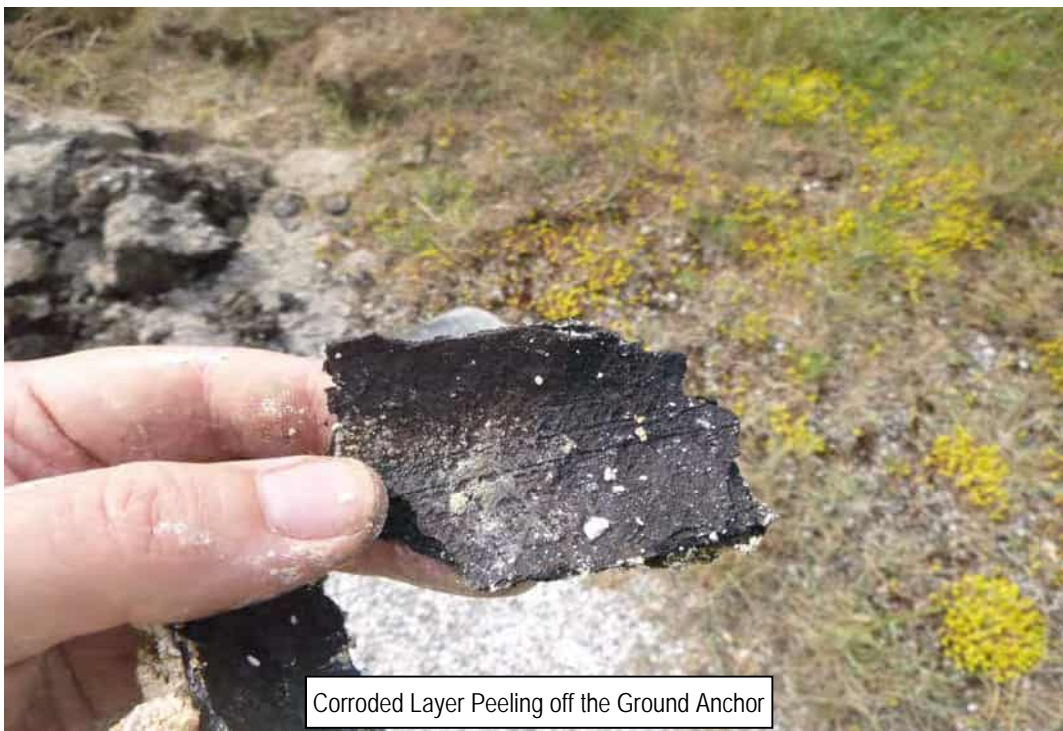
Corroded Layer Peeling off the Ground Anchor

Project No.	31149	Drawn	CJP
Client	BSCP Ltd	Checked	RS
		Approved	RS
Project	Brighton Road, Shoreham	Scale	NTS
		Date Drawn	21/06/2013
		Rev.	
Title	Views of Corroded Steel Sheet Pile Wall and Corrosion Layer from Ground Anchor	Plate GA3

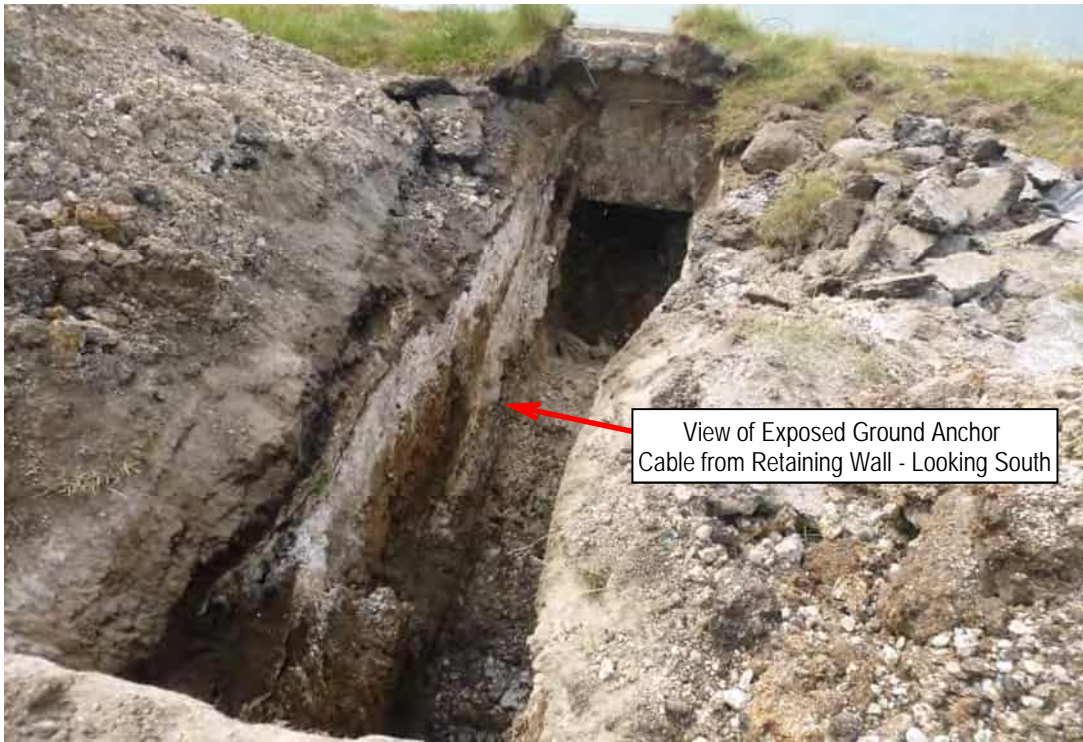
View of Exposed Ground Anchor Cable from Retaining Wall - Looking South

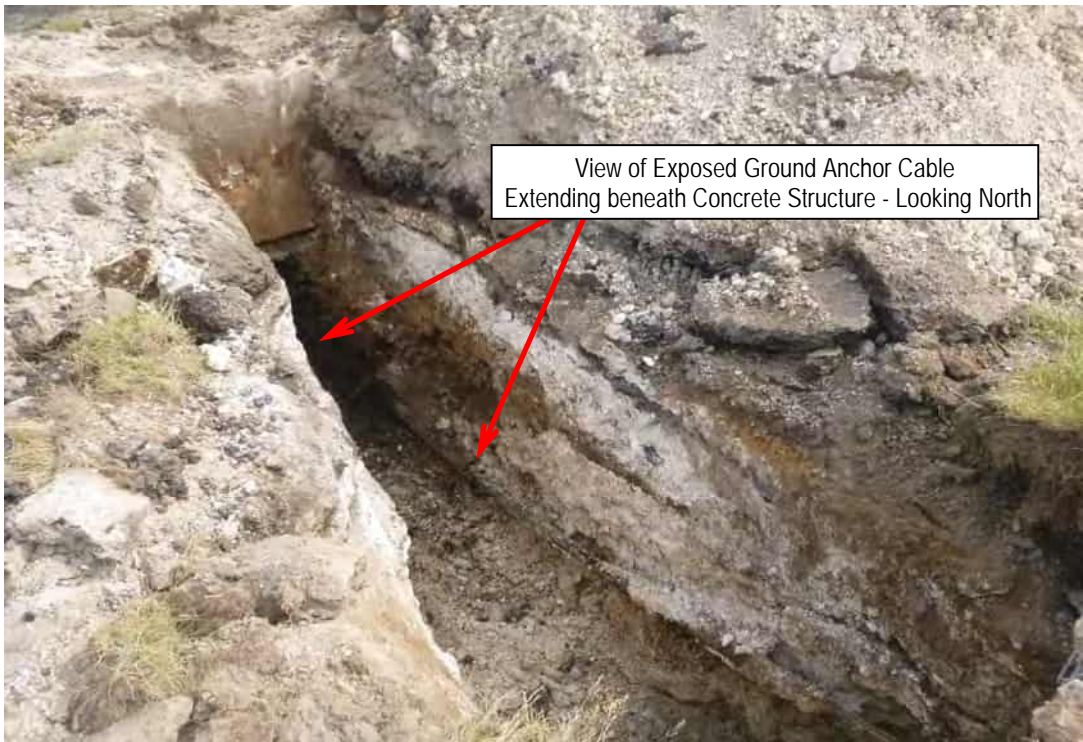
Project No.	31149	Drawn	CJP
Client	BSCP Ltd	Checked	RS
		Approved	RS
Project	Brighton Road, Shoreham	Scale	NTS
		Date Drawn	21/06/2013
Title	Views of the Ground Anchor Cable	Rev.	
		Plate GA4

View of Exposed Ground Anchor Cable Extending beneath Concrete Structure - Looking North

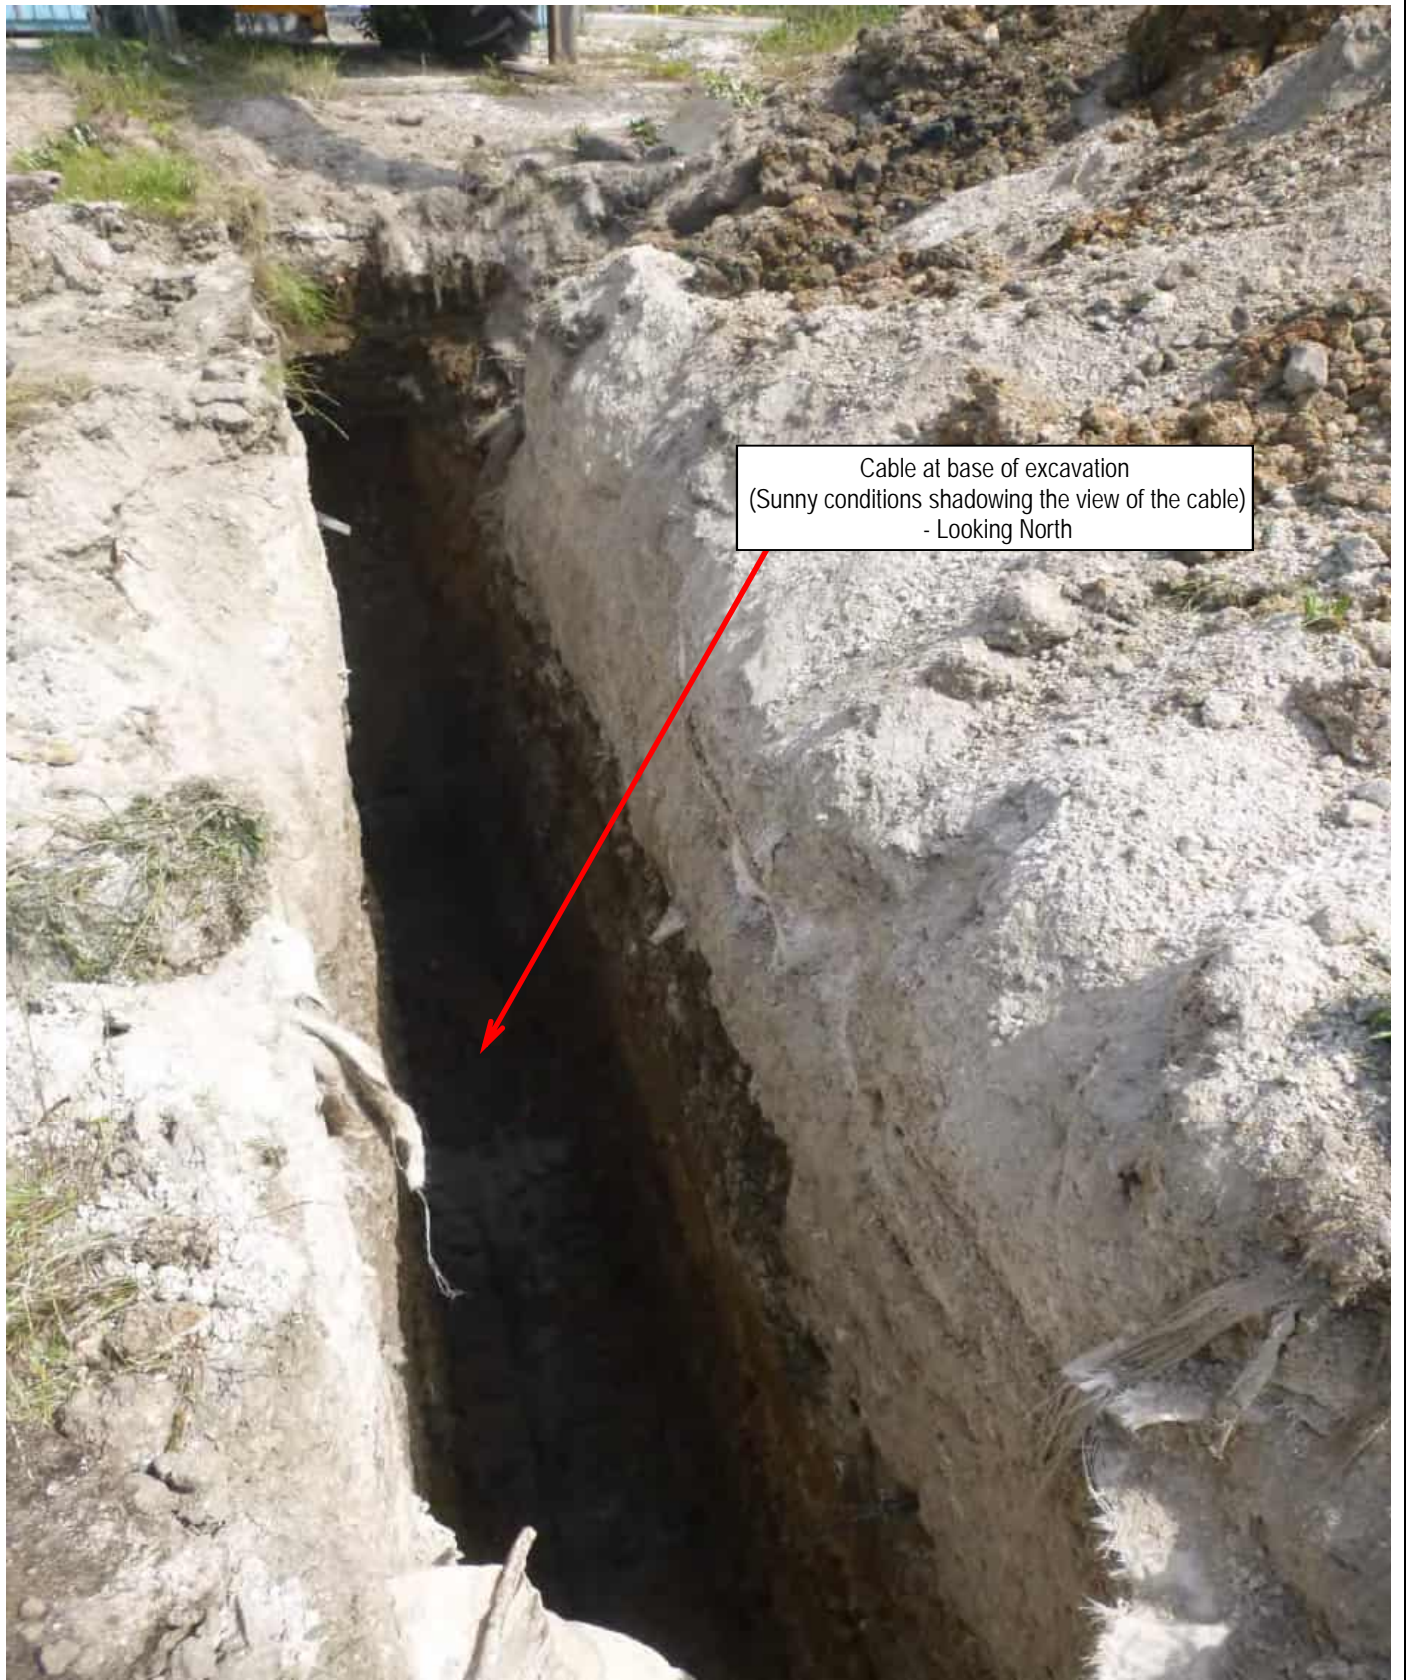
Cable at base of excavation
 (Sunny conditions shadowing the view of the cable)
 - Looking North

Project No.	31149	Drawn	CJP
Client	BSCP Ltd	Checked	RS
		Approved	RS
Project	Brighton Road, Shoreham	Scale	NTS
		Date Drawn	21/06/2013
Title	View of the Ground Anchor Cable Toward the North	Rev.	
		Plate GA5

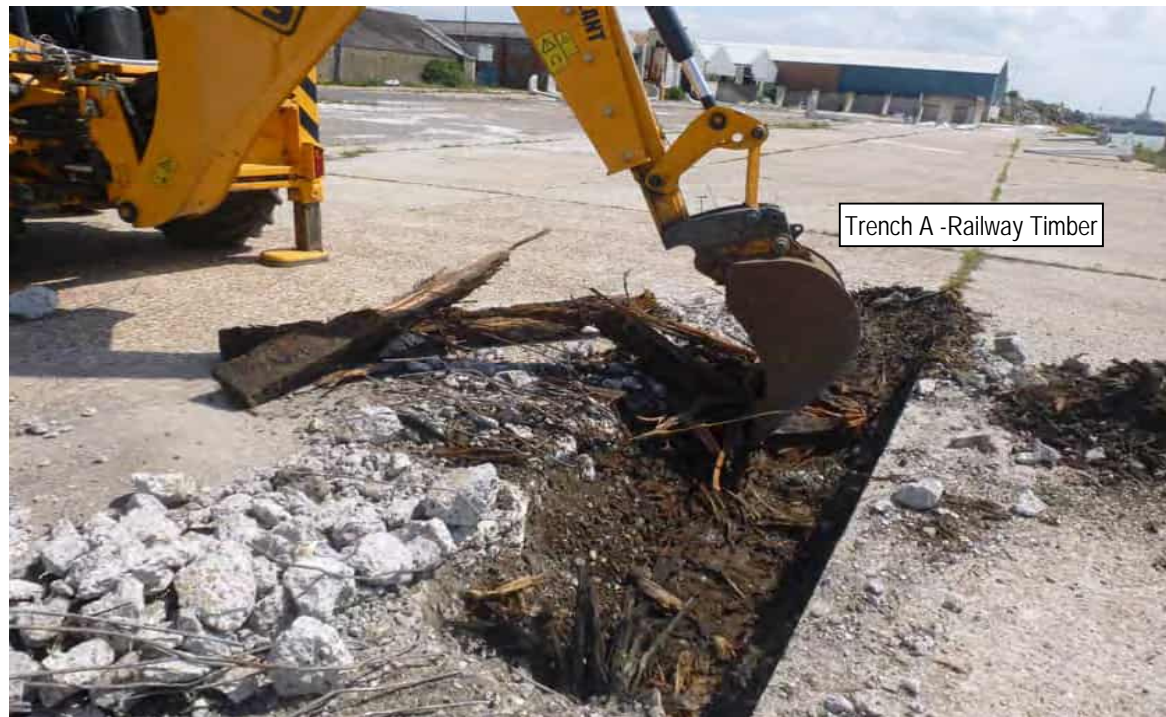
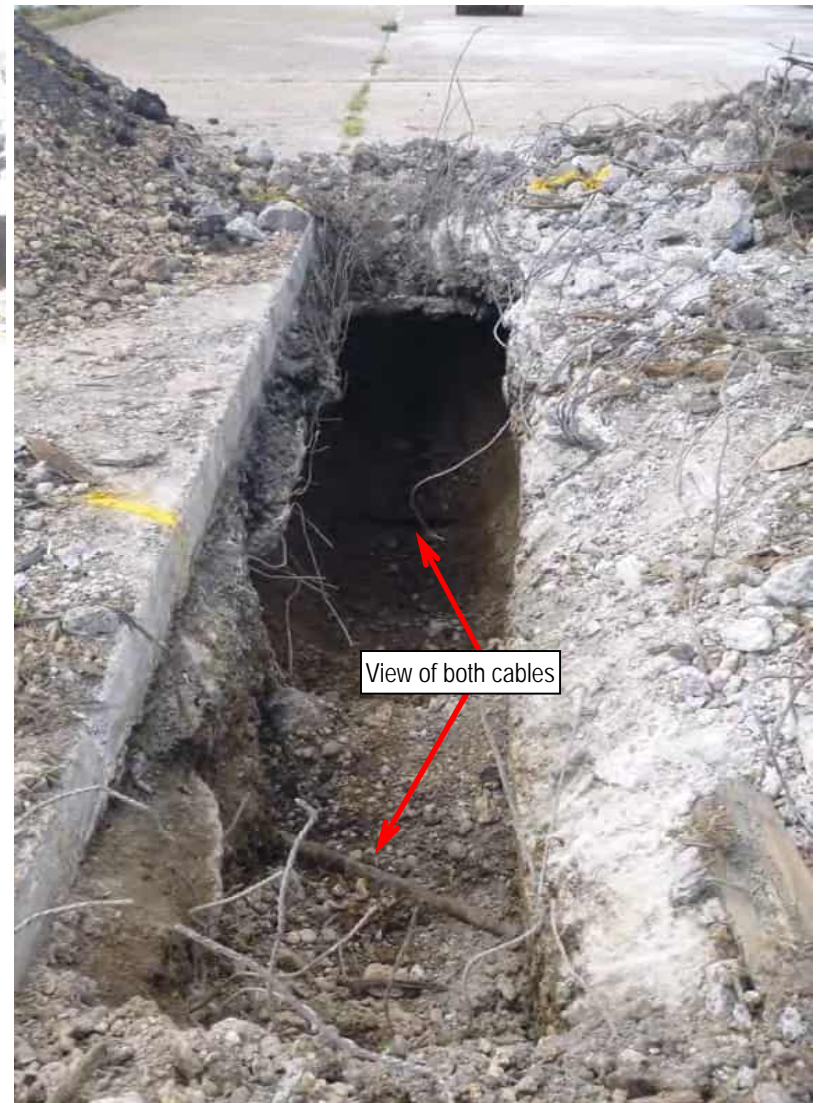
Project No.	31149	Title	View of Trench A Showing Cables 1 & 2 and Railway Timber	Drawn	CJP
Client	The Newbribe Group/Southern Housing Group			Checked	RS
Project	Brighton Road, Shoreham	Date Drawn	23/06/2015	Approved	RS
		Scale	NTS	Plate GA7	
		Revision

Cable 2

Trench A - Railway Timber

View of both cables

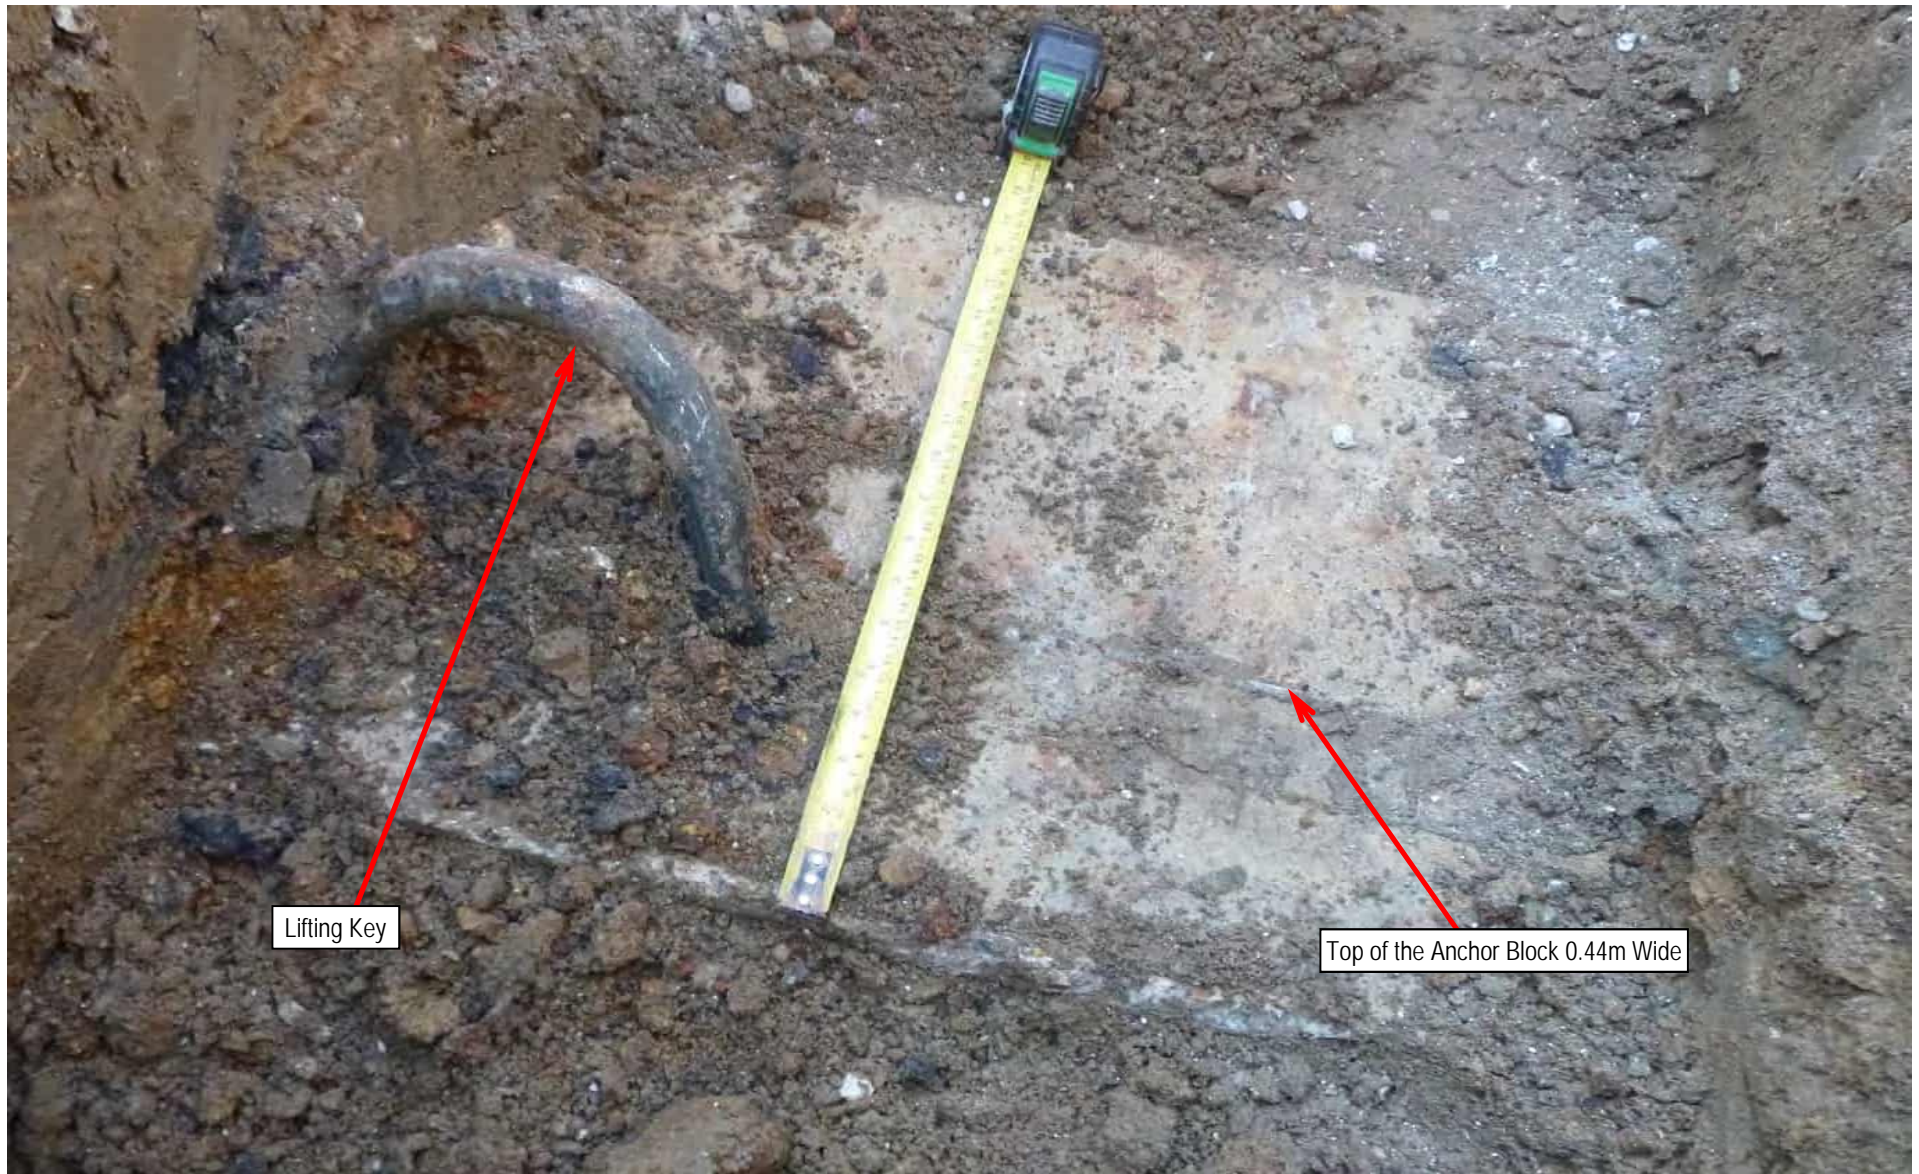
Lifting Key

Top of the Anchor Block 0.44m Wide

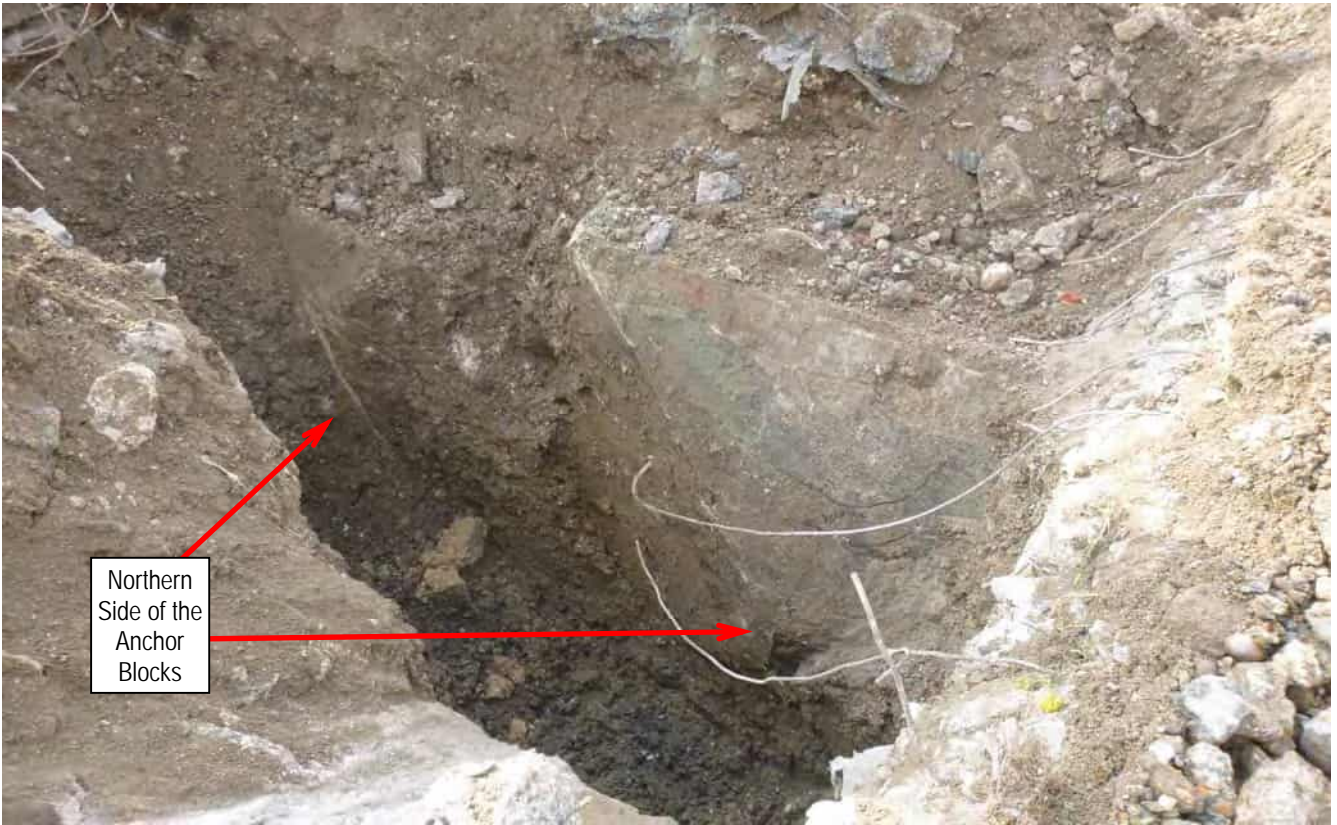
Northern Side of the Anchor Blocks

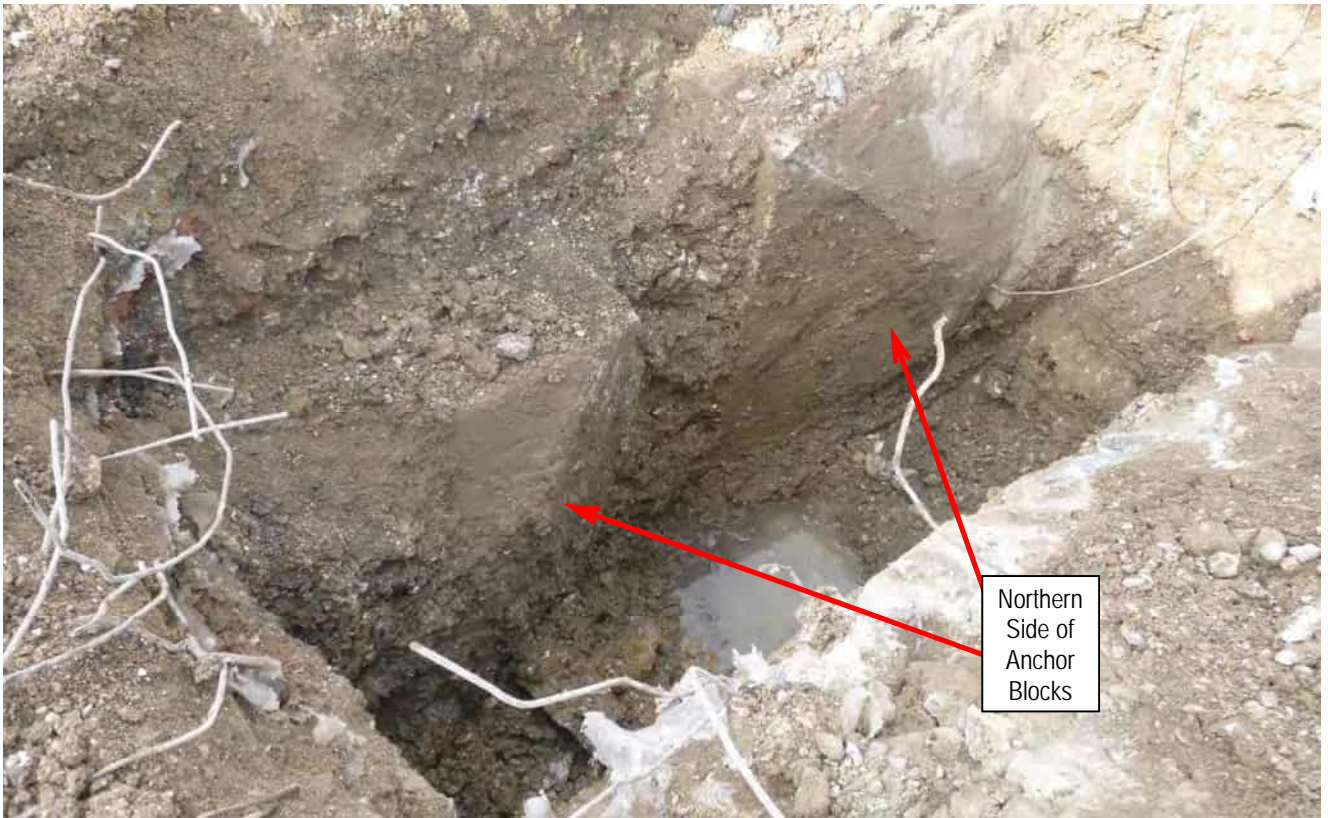
Northern Side of Anchor Blocks

Project No.	31149	Drawn	CJP
Client	The Newbridge Group/Southern Housing Group	Checked	<i>RS</i>
		Approved	<i>RS</i>
Project	Brighton Road, Shoreham	Scale	NTS
		Date Drawn	23/06/2015
Title	Trench E Showing the Northern Side of Both Anchor Blocks	Rev.	
		Plate GA14

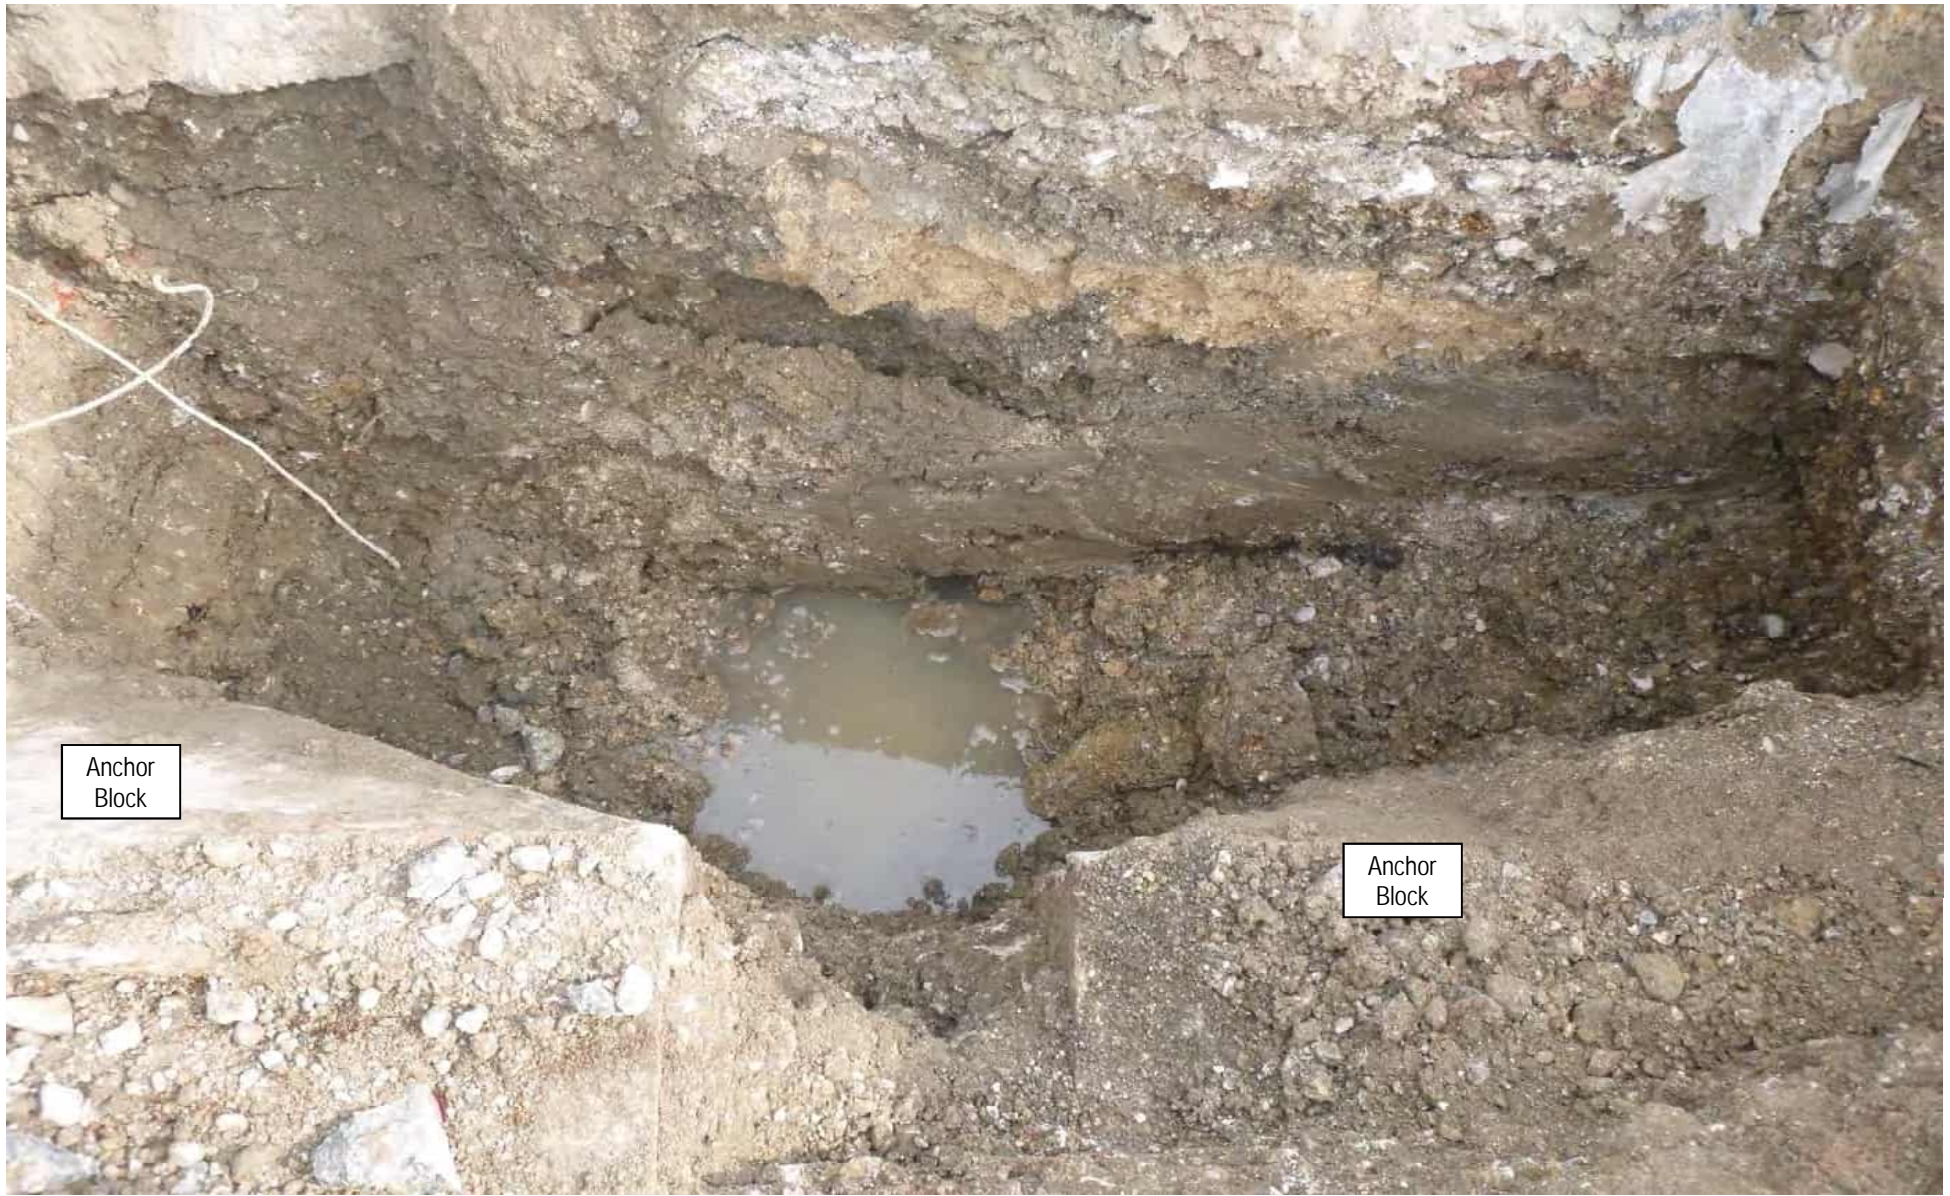
Anchor Block

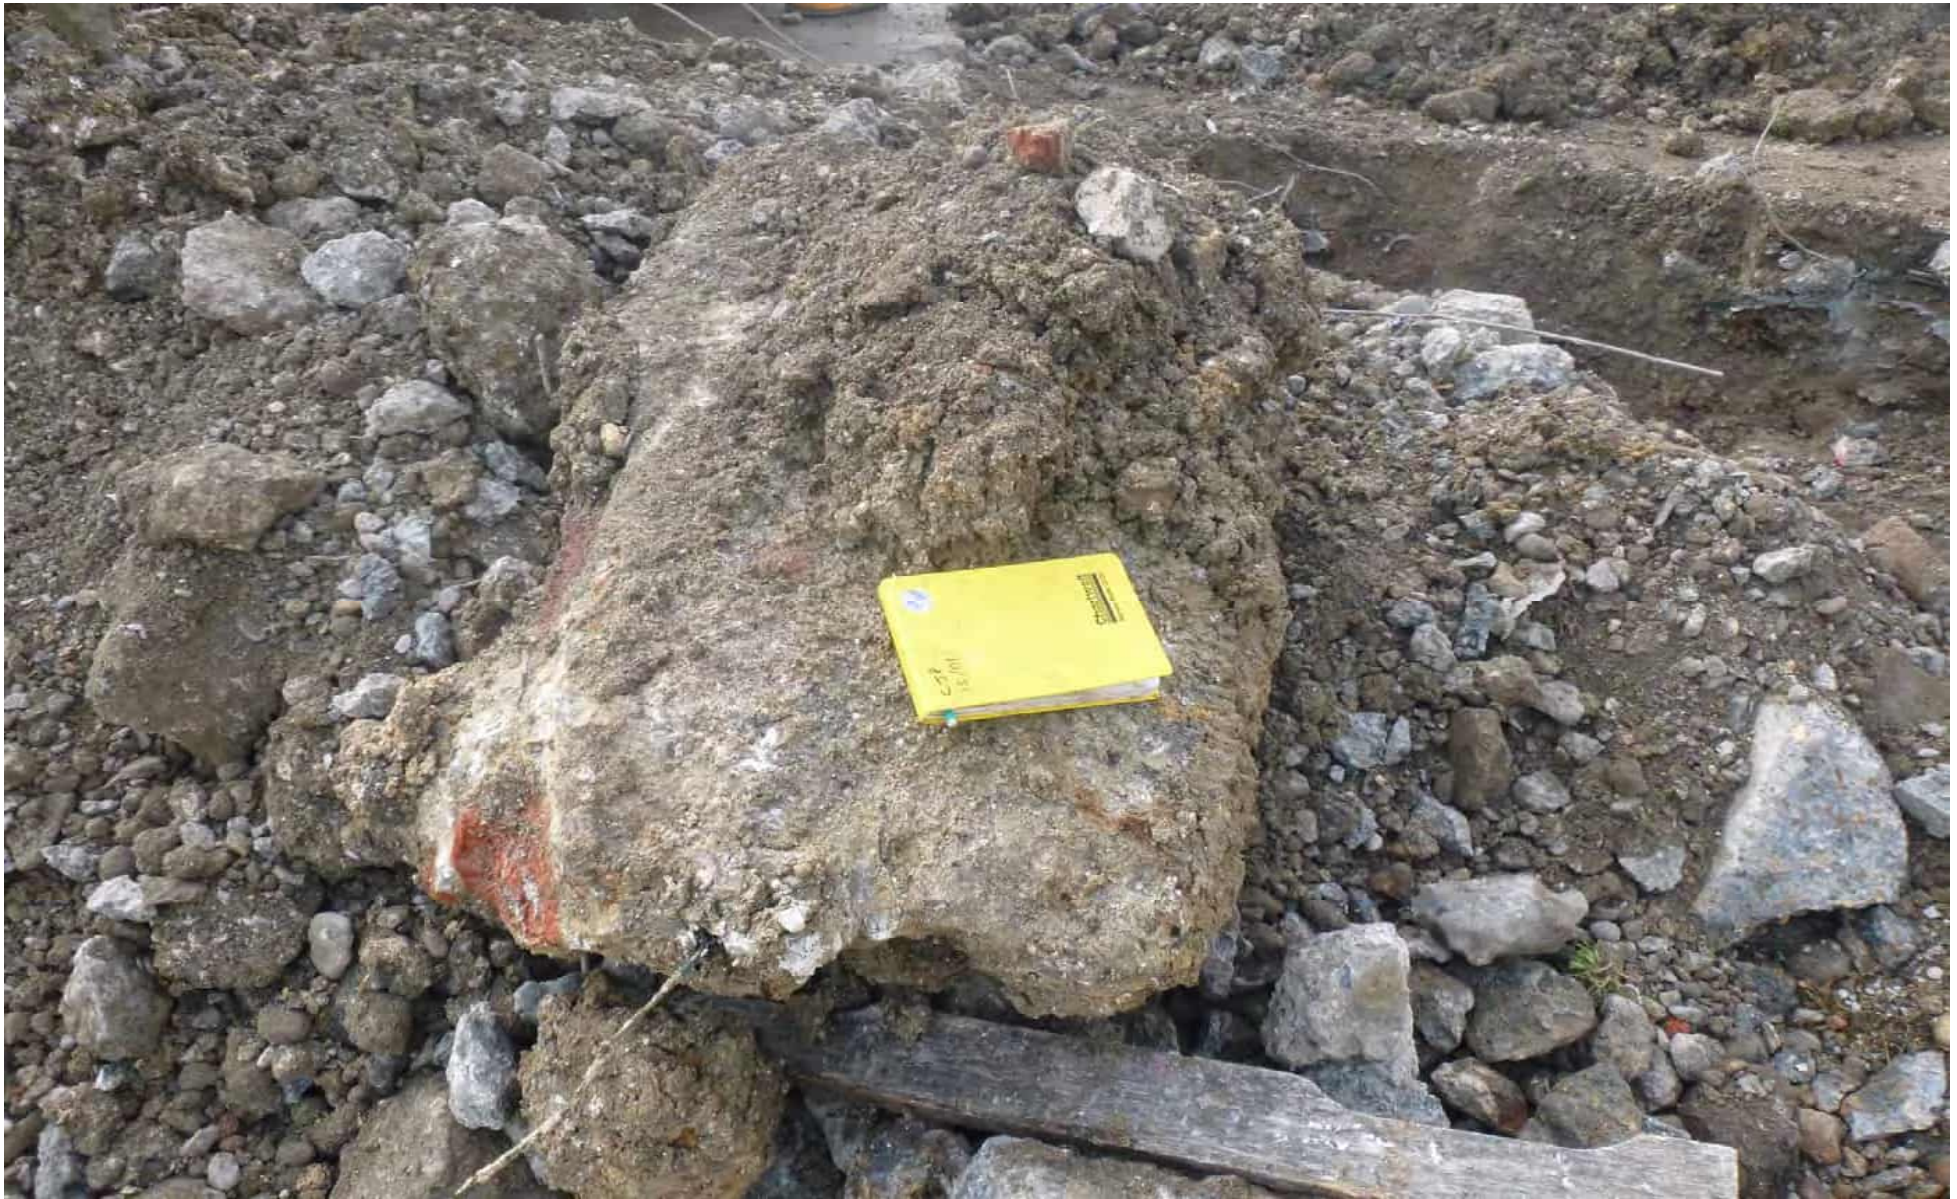
Project No.	31149	Title	Trench E showing concrete obstruction	Drawn	CJP
Client	The Newbribe Group/Southern Housing Group			Checked	RS
Project	Brighton Road, Shoreham	Date Drawn	23/06/2015	Approved	RS
		Scale	NTS	Plate S01	
		Revision

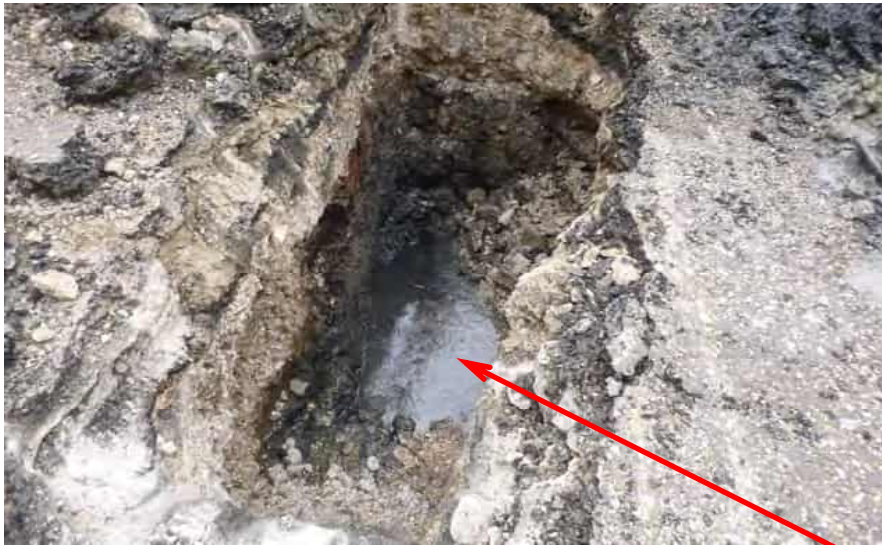
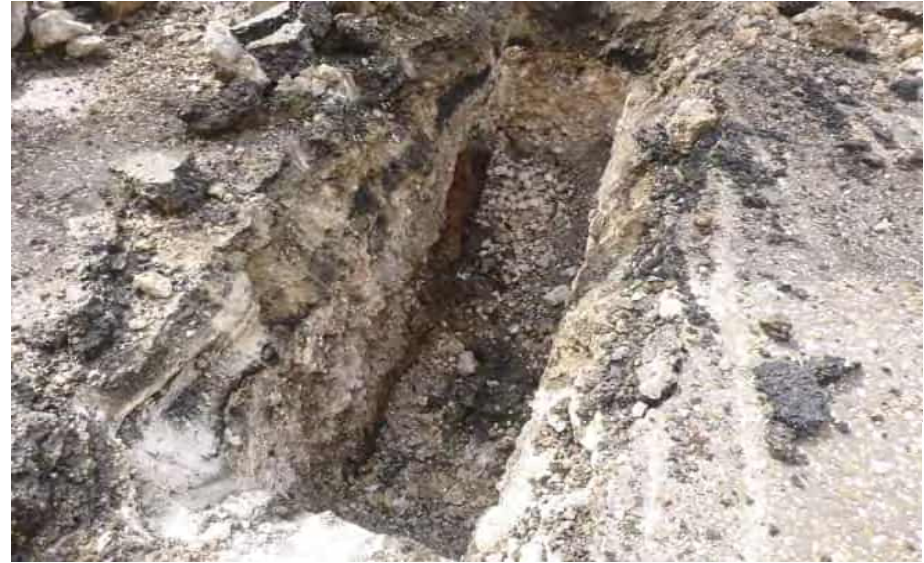
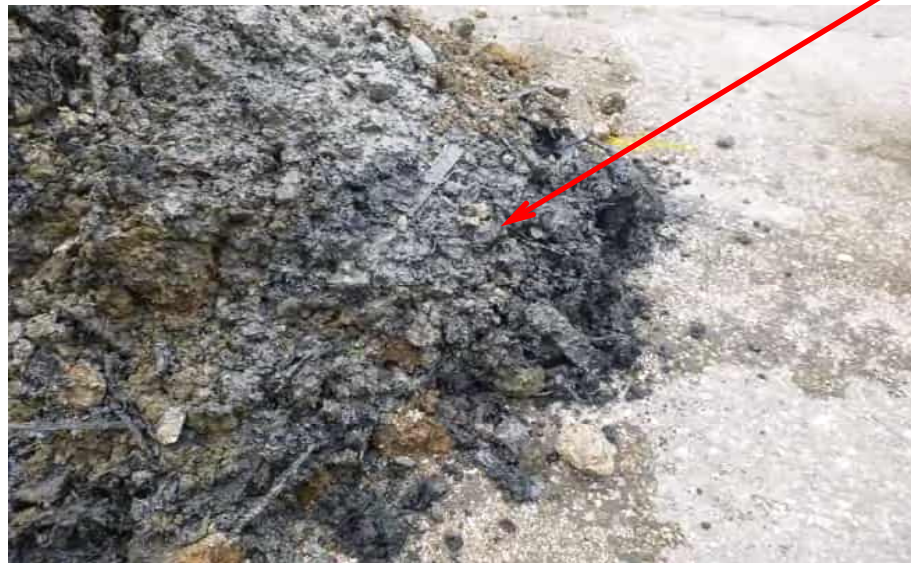
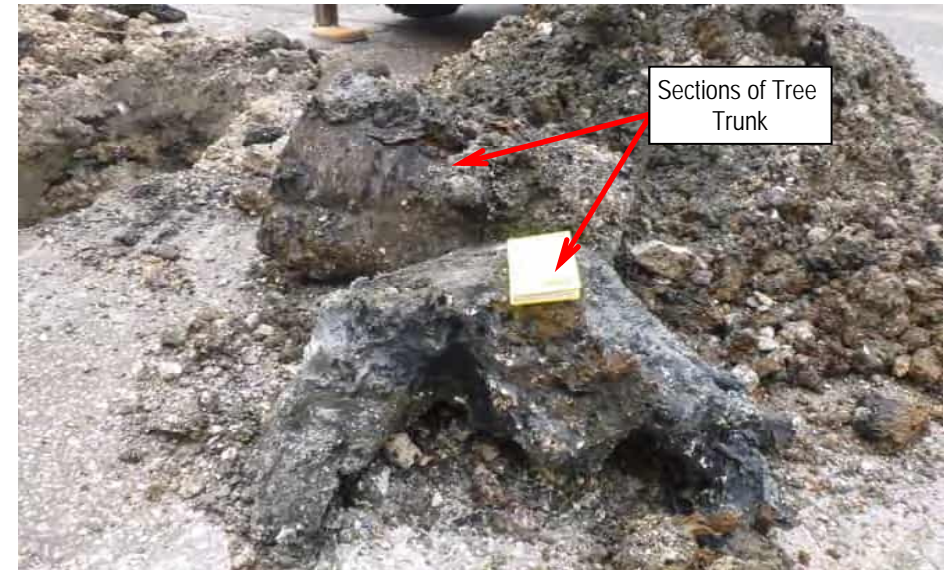
Project No.	31149	Title	Views of Trial Pit 1 Showing Hydrocarbon Impaction and Tree Trunks Removed from Excavation	Drawn	CJP
Client	The Newbribe Group/Southern Housing Group			Checked	RS
Project	Brighton Road, Shoreham	Date Drawn	23/06/2015	Approved	RS
		Scale	NTS	Plate S07	
		Revision

Oil

Sections of Tree Trunk

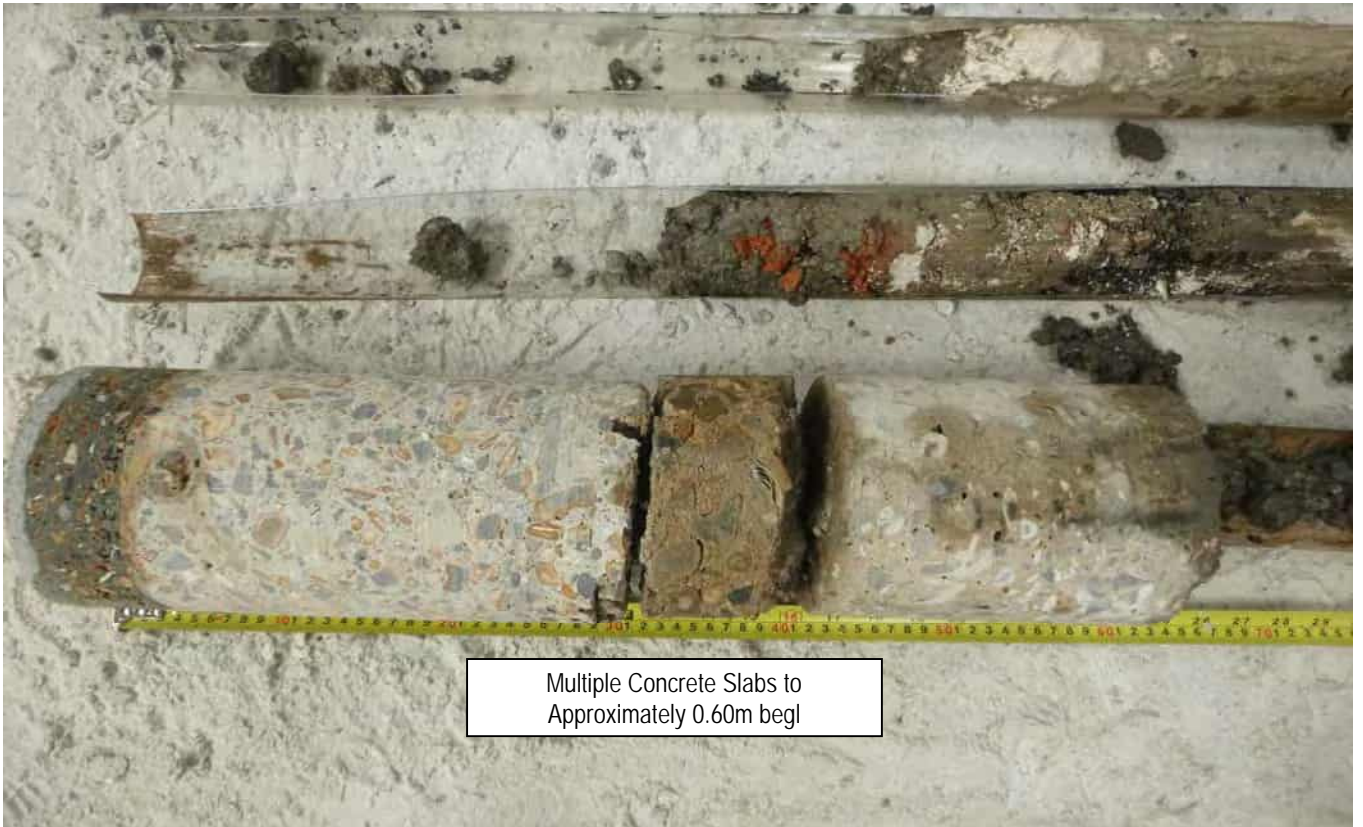
Multiple Concrete Slabs to
Approximately 0.60m beg!
