Appendix A

Figure 1: Site Location Plan
Brighton Road, Shoreham-By-Sea

Brighton Road, Shoreham

Project No.	31149	Title	Views of the Corroded Steel Interlocking Sheet Piled Wall at Tarmac Wharf, Concrete Walls and Anchor	Drawn	CJP
Client	BSCP Ltd			Checked	RS
Project	Brighton Road, Shoreham	Date Drawn	20/06/2013	Approved	RS
		Scale	NTS	Figure No.31149/GA7	
		Revision

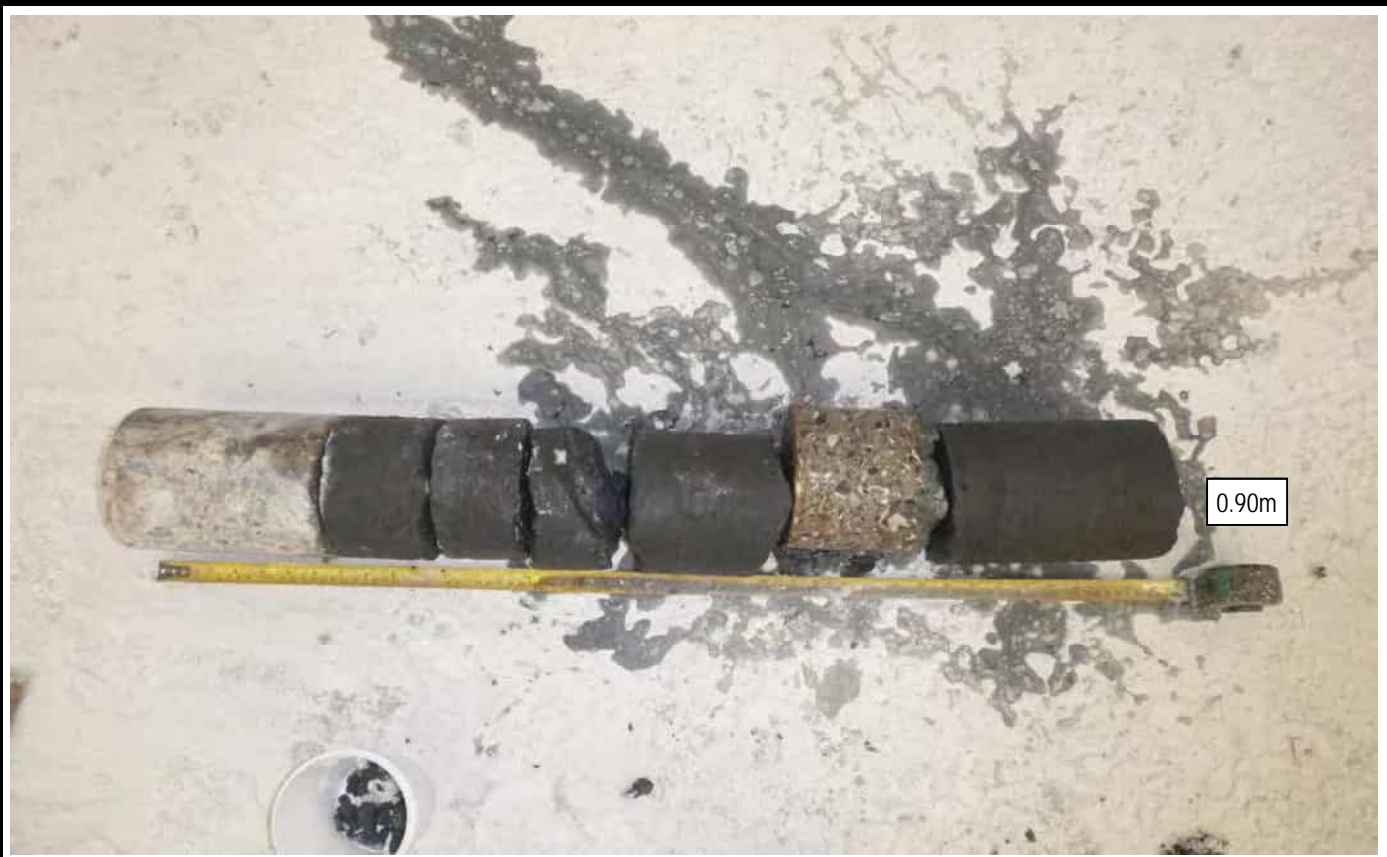
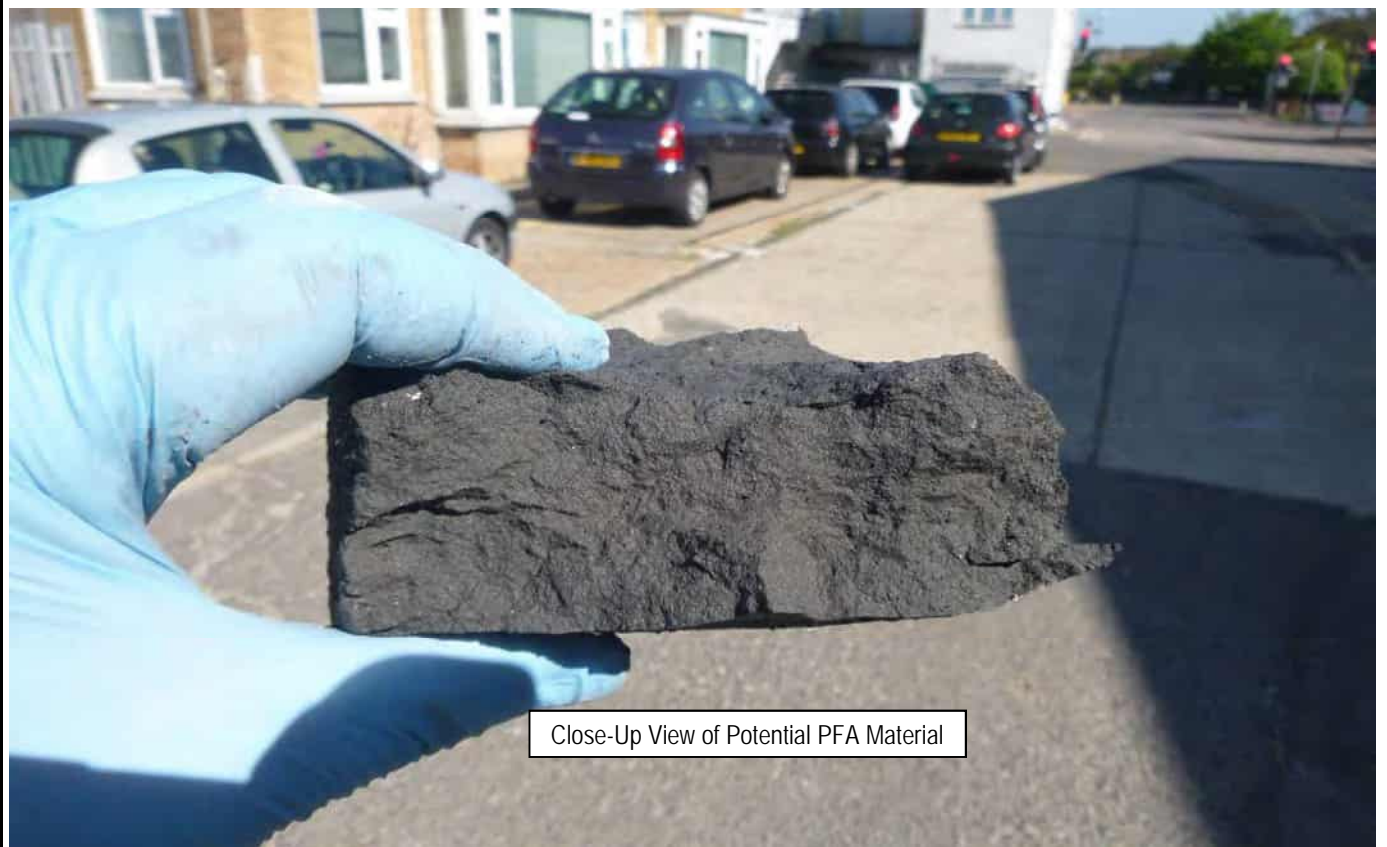
Close-Up View of Potential PFA Material

Project No.	31149	Drawn	CJP
Client	The Newbridge Group/Southern Housing Group	Checked	RS
		Approved	RS
Project	Brighton Road, Shoreham	Scale	NTS
		Date Drawn	23/06/2015
Title	Views of Borehole WS34	Rev.	
		Plate S15
