## 1.0 INTRODUCTION

Geo-Environmental Serviced Limited (Geo-Environmental) was instructed by Wates Construction Limited to prepare an Interim Material Management Plan Verification Report (INTMMPVR) for the enabling works and proposed development site at Free Wharf, Brighton Road, Shoreham-by-Sea, BN43 6SA (see Figure 1 and Figure 2), herein referred to as 'the site'. This report sets out the works undertaken to date to in relation to the enabling works and development to compile together the relevant records and provide independent verification of the site status and works carried out to date by the various parties. It is understood Wates Construction Limited has been requested to suspend enabling works by Southern Housing Group on 23<sup>rd</sup> October 2020, as final development plans are in review. As such further works and verification maybe required in due course under the Materials Management Plan subject to the outcome of that review.

# FREE WHARF, SHOREHAM BY SEA

**DISCHARGE OF PLANNING CONDITION 10 - CONTAMINATION  
PLANNING REF: AWDM/1497/17**

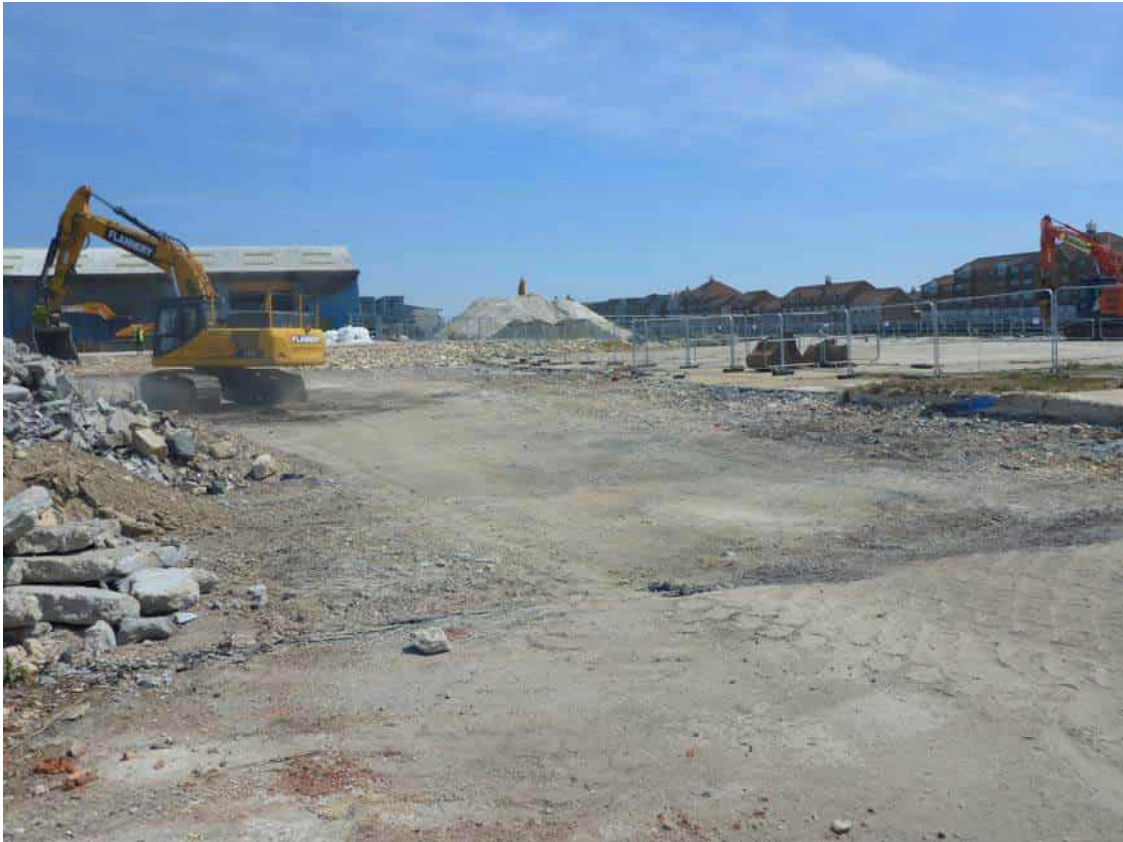
View from western extent of site looking east over subsurface conveyor system.

Works to uncover the sub-surface conveyor system were apparently ongoing, with covers removed (secured with Herras type fencing) and limited works commence to remove materials within the conveyor system, to attempt to prove the extent and depth of the system.

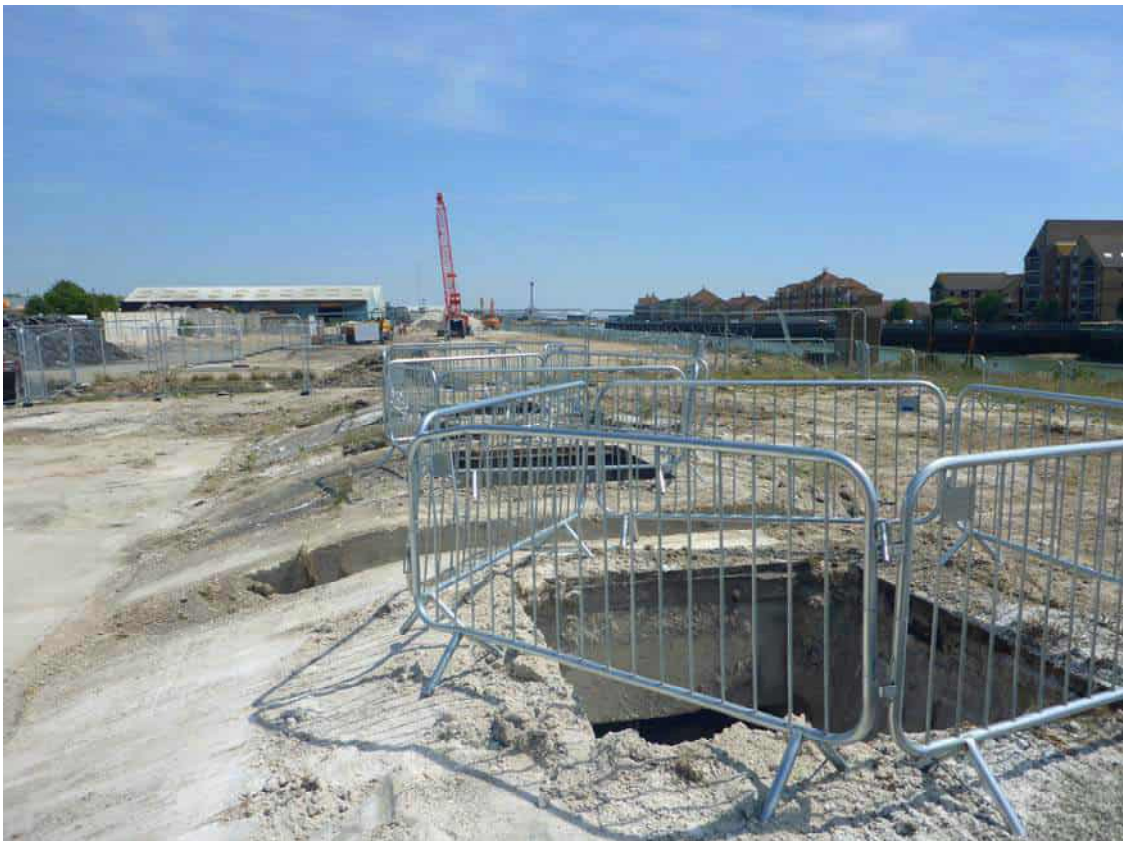
View into conveyor system

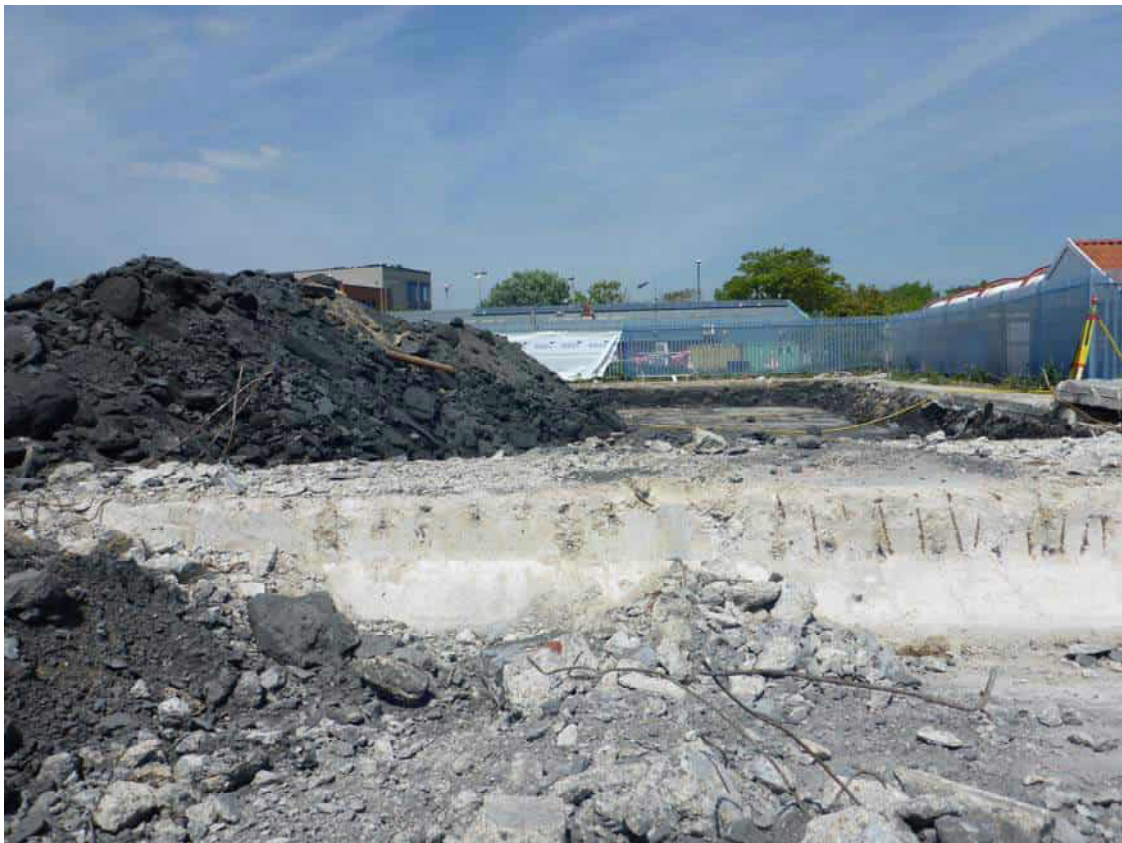
View of PFA (Pulverised Fuel Ash) type material recovered and stored.

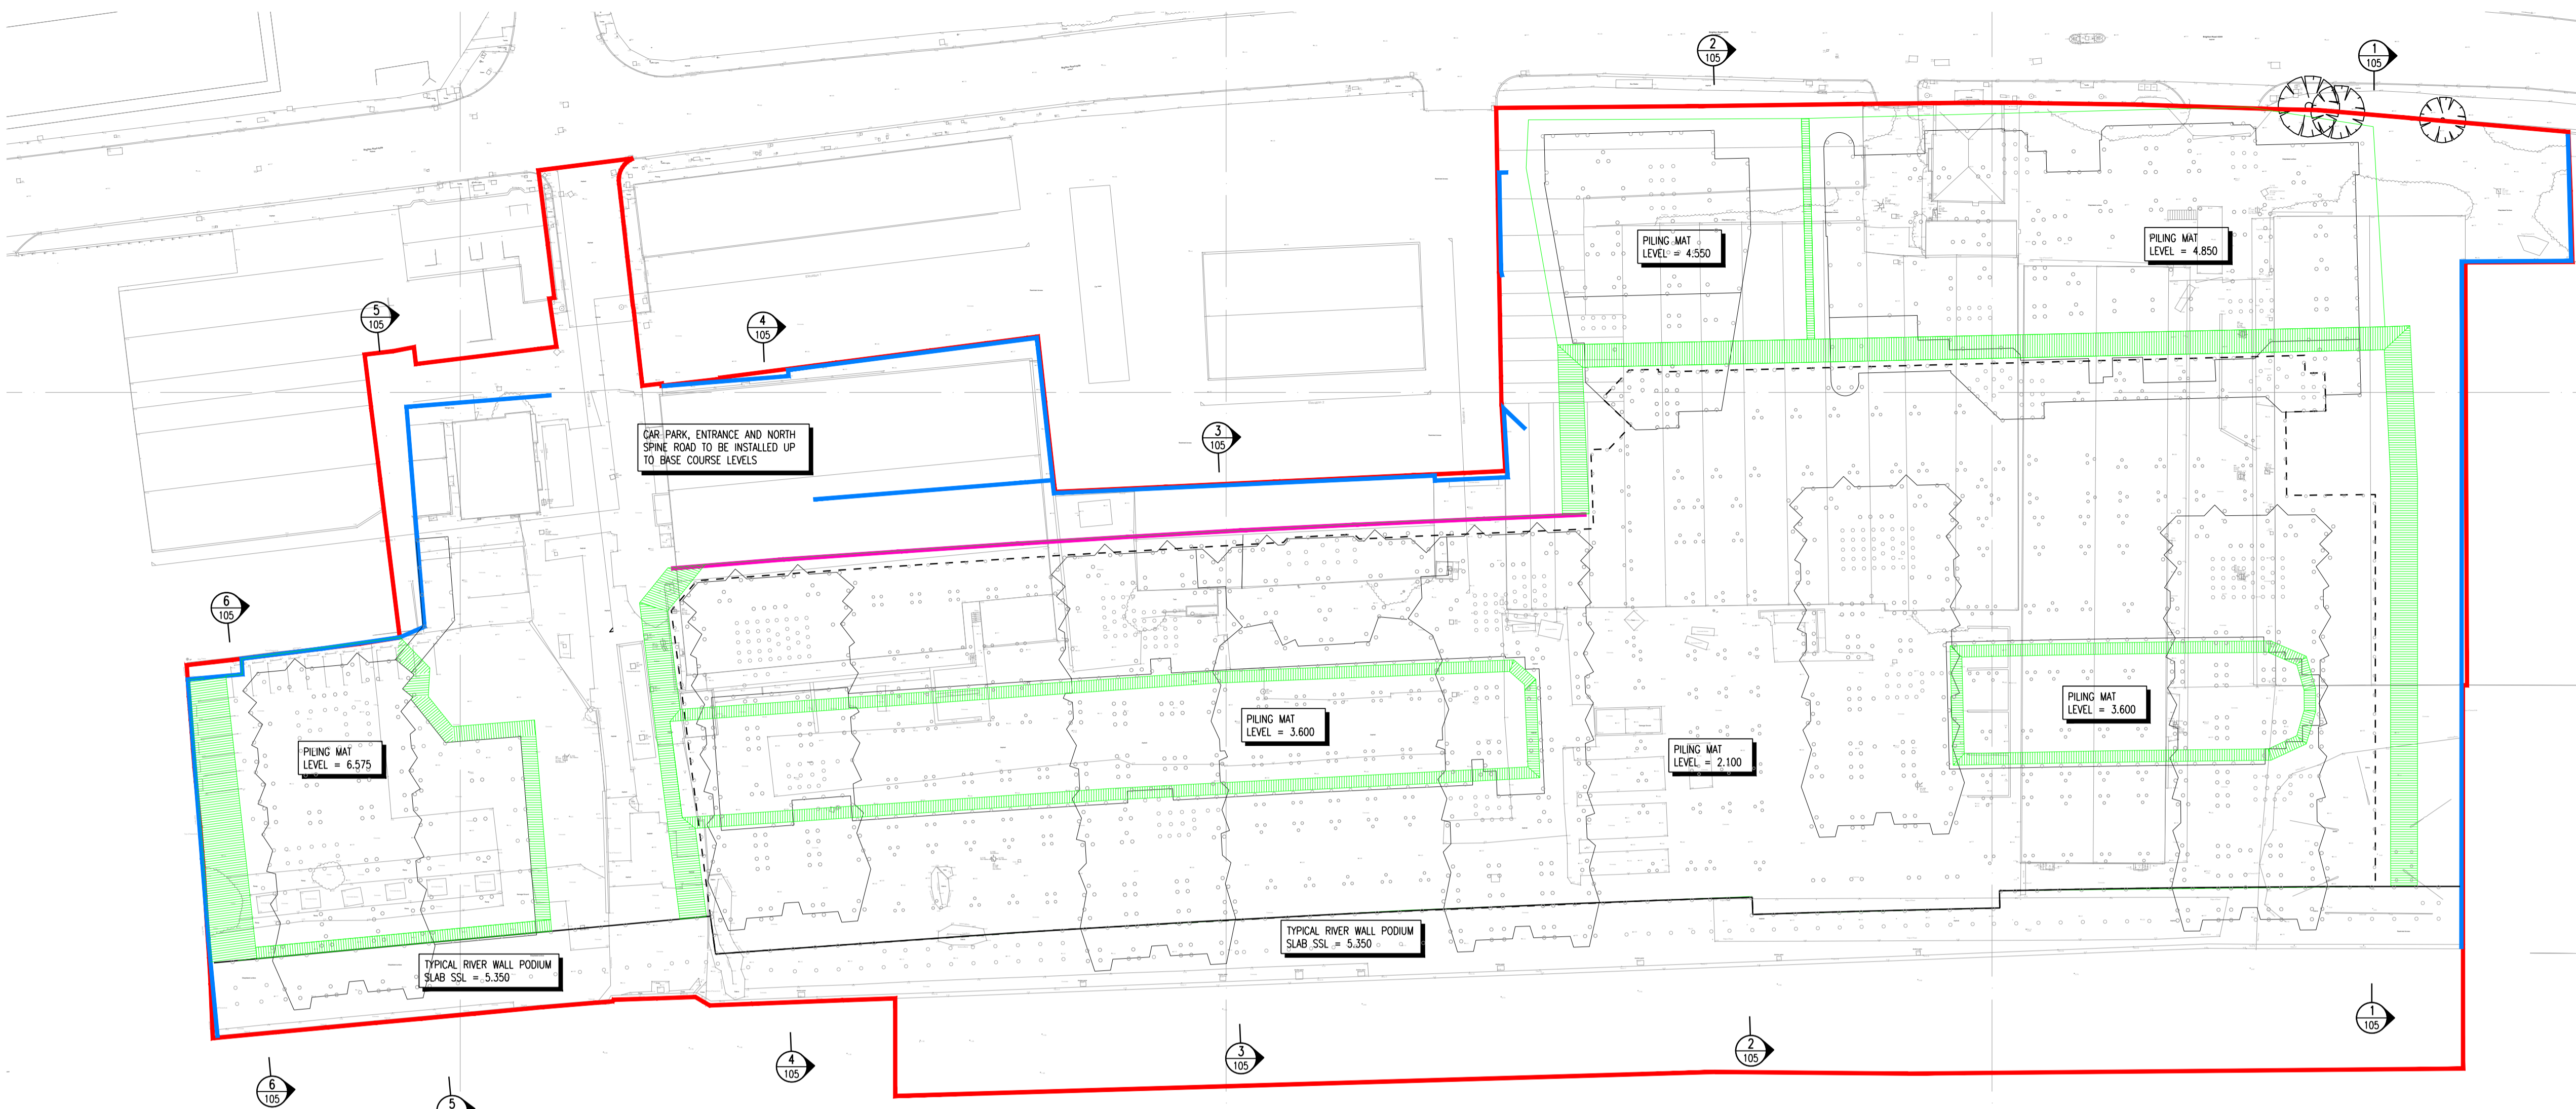
**EARTH WORKS SUMMARY**  
(1:500)

**PILING MAT**

- HOP Discharge of Planning Condition 3 and associated Drawings 104 & 105. Ref: 14576-HOP-EN-XX-RP-S-5003, 17<sup>th</sup> August 2018. Appendix L and Figure 4a and 4b
