# **Stage 1 Phase 2 Contaminated Land Generic Quantitative Risk Assessment**

**37, Albion Street,  
Southwick, West Sussex,  
BN42 4DN**

Report Reference: OES25-003PRH/V1

Project: Phase II Contaminated Land Investigation and Generic Quantitative Risk Assessment **Site: 37 Albion Street, Southwick, West Sussex, BN42 4DN**  
Prepared by: Oakridge Environmental Services Ltd Date: 2nd December 2025

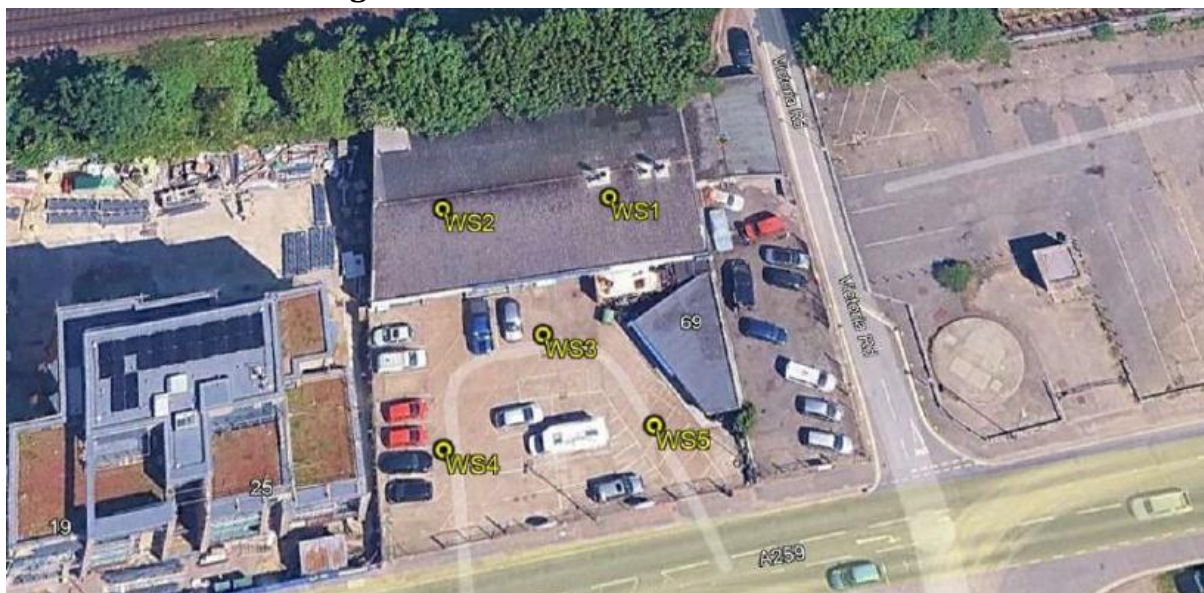
**Figure 1 Borehole Locations**

This was plan subject to visual and olfactory examination on site with samples being taken as determined by observed ground conditions.

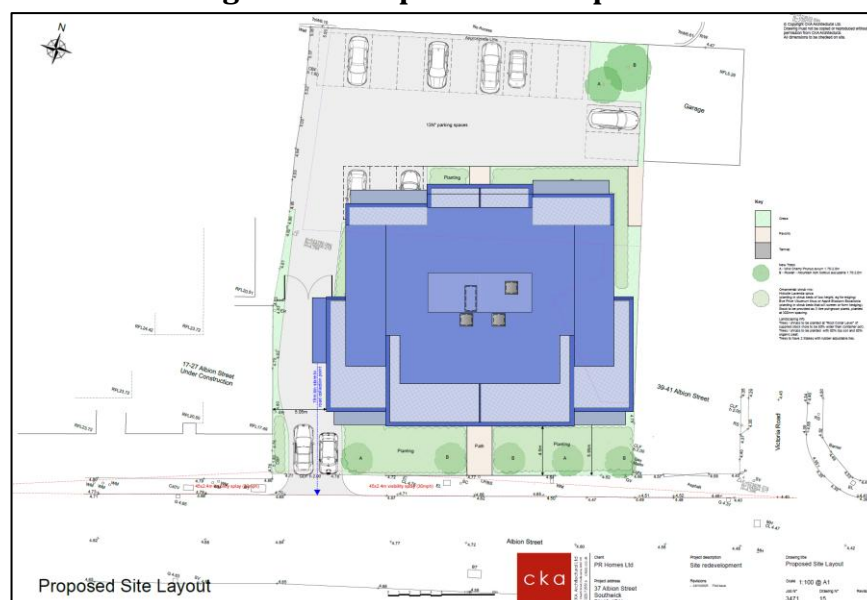
**Figure 3 – Proposed development**

The proposed development is for an apartment block located on the southern half of the site with car park to the northern side with soft landscape areas around the building, particularly on the roadside consideration of remediation is therefore necessary. The proposal at the time of this report is shown in Figure 3 and in APPENDIX 2.

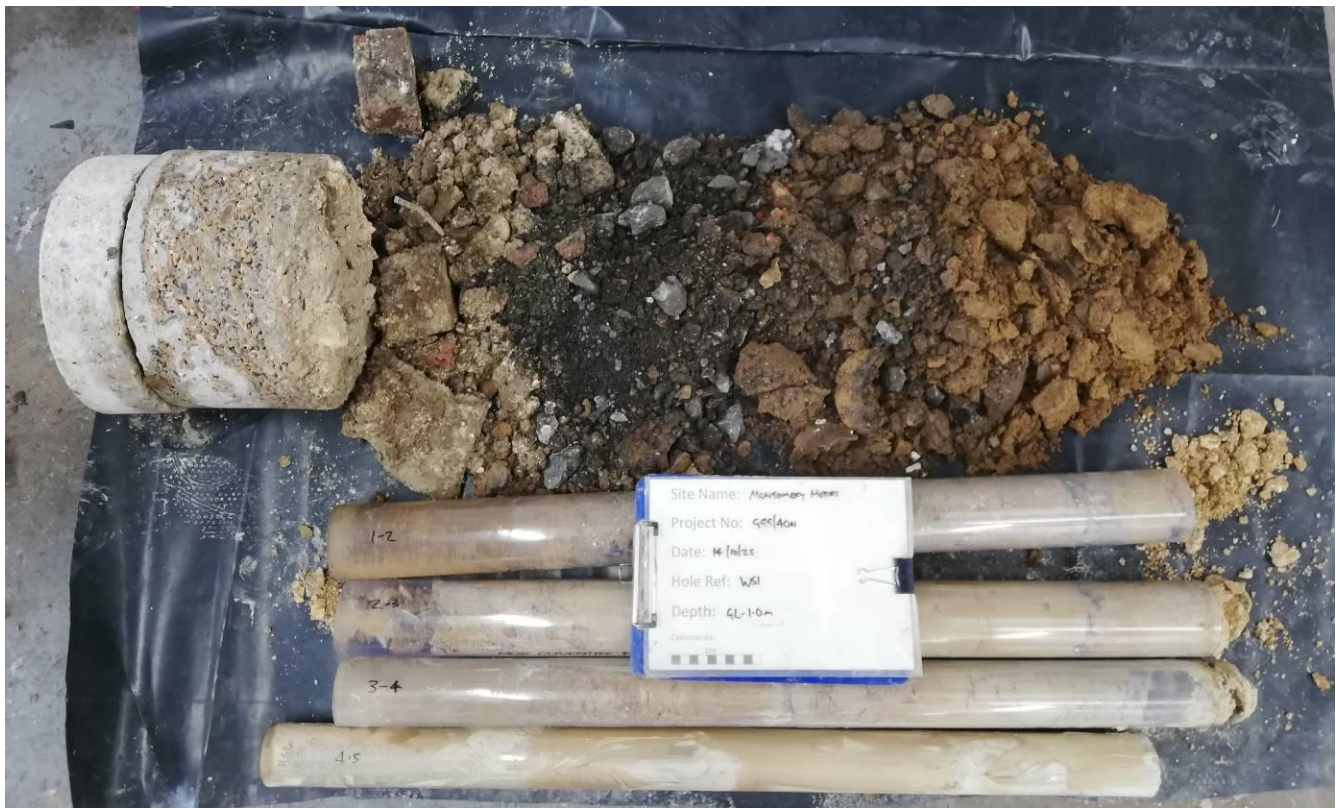
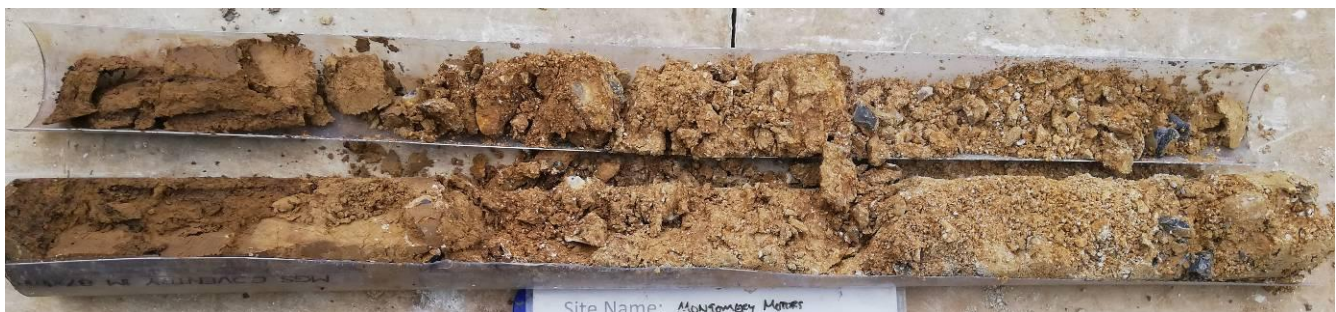
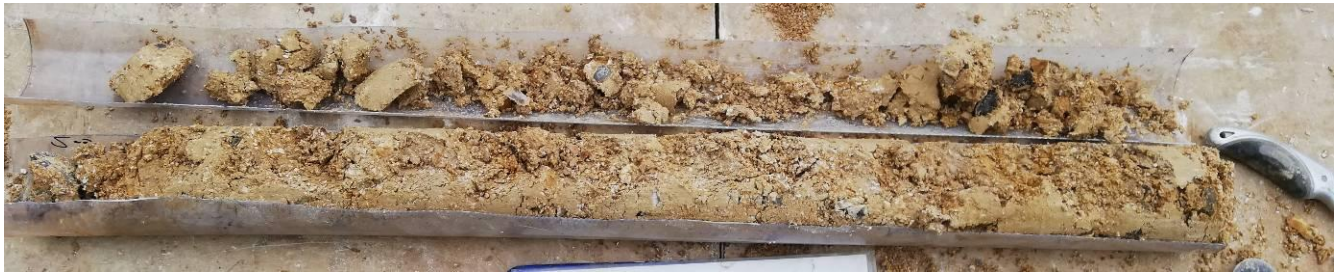
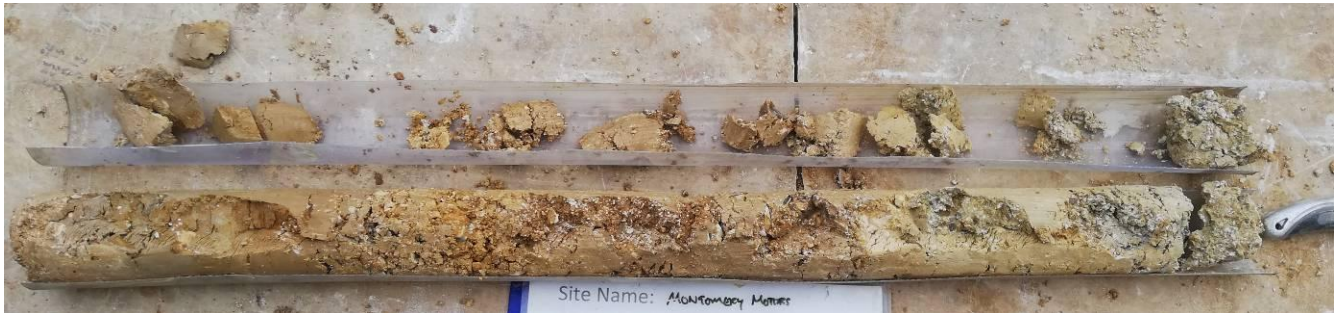
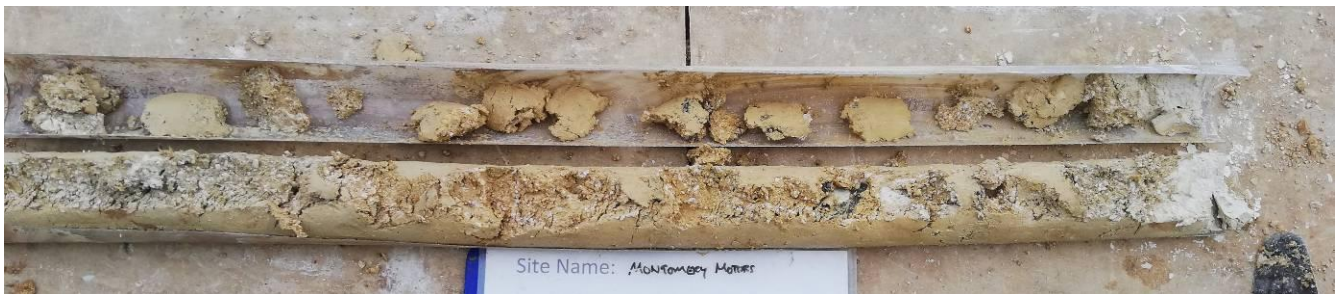
| Location | Depth (m bGL) | PID (ppm) | Soil Observations |
|---|---|---|---|
| WS1 | 4.60 | 8.0 | Faint hydrocarbon odour/staining |

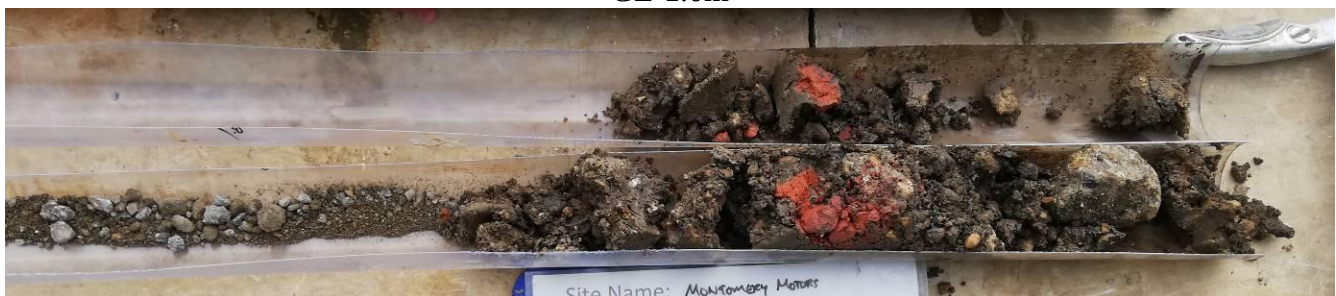
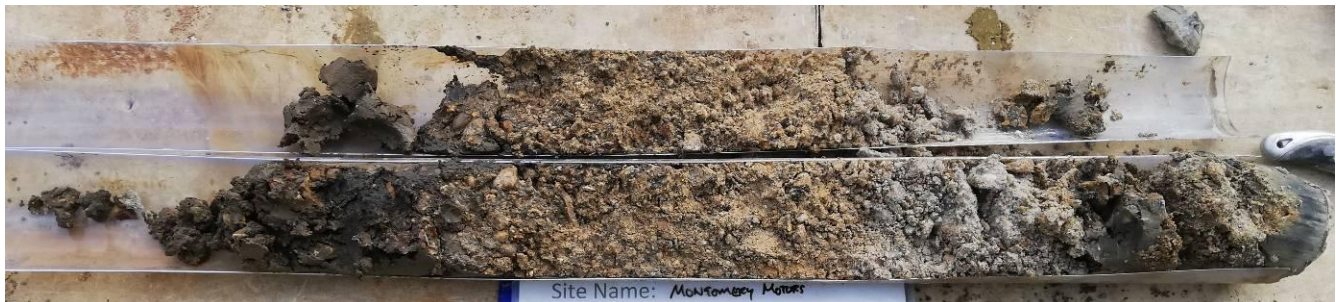
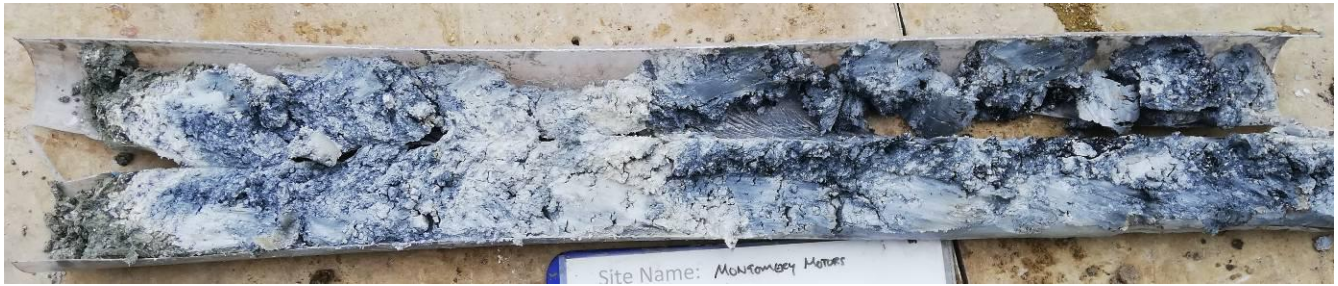
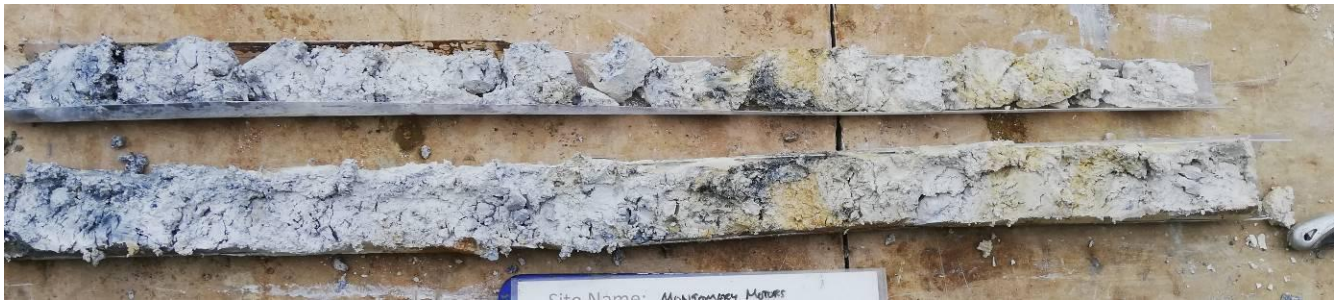
While no records have been found concerning the below ground fuel tank the ground investigation identified depths of made ground. WS3 identified much deeper depths of made and reworked ground down to a depth of 3.5m and may therefore indicate the former tank location potential shows that it was removed and backfilled. This is shown in table 1.

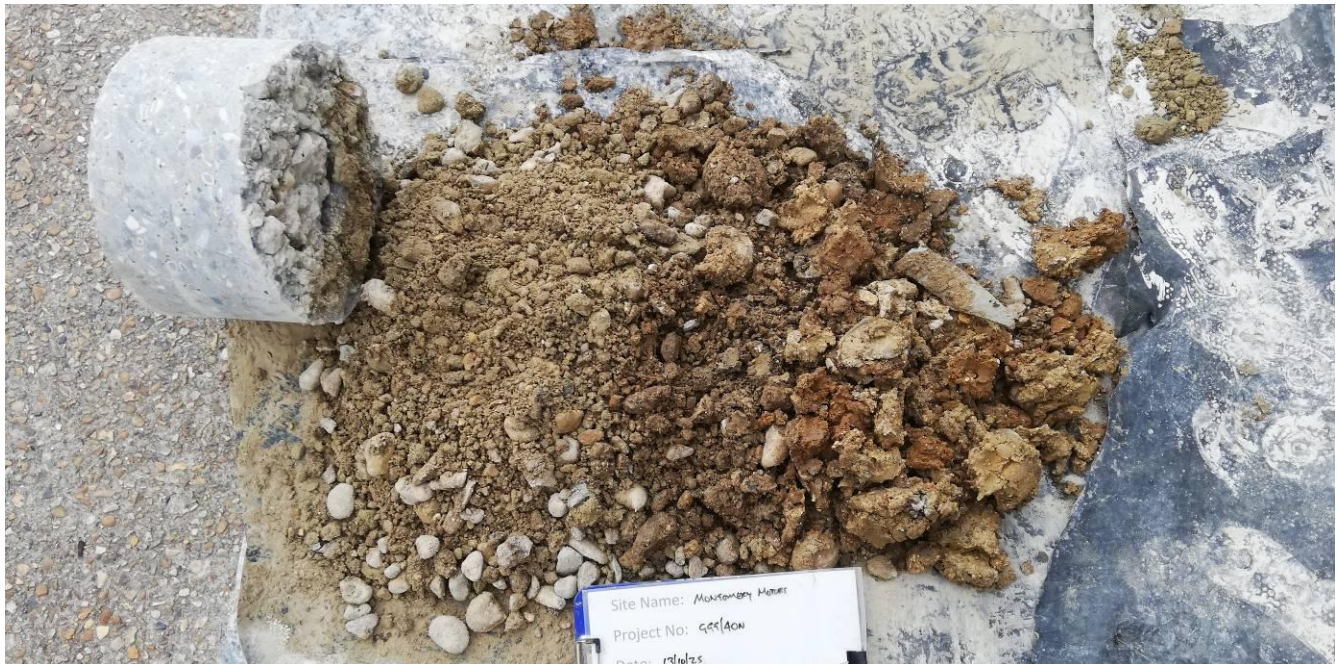
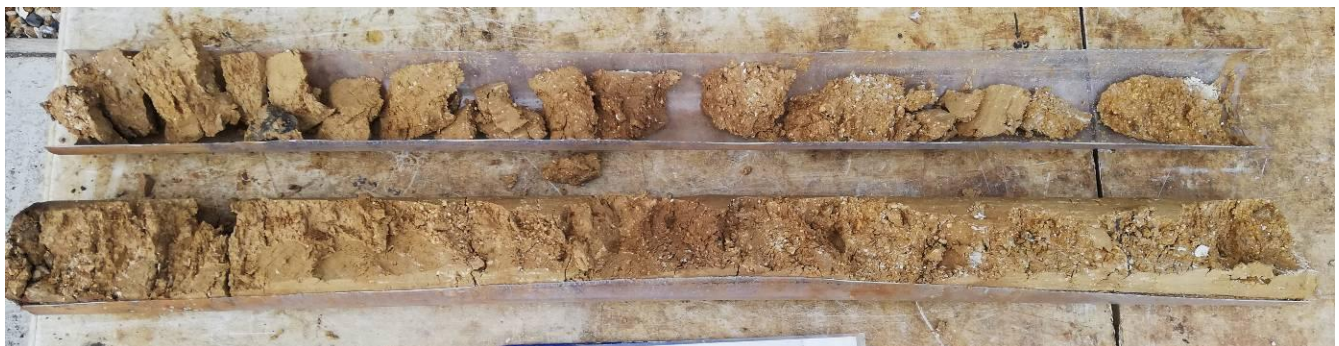
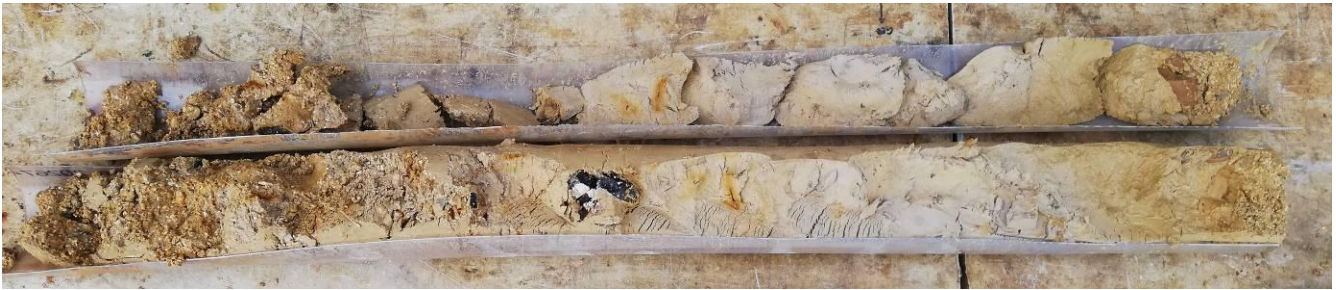
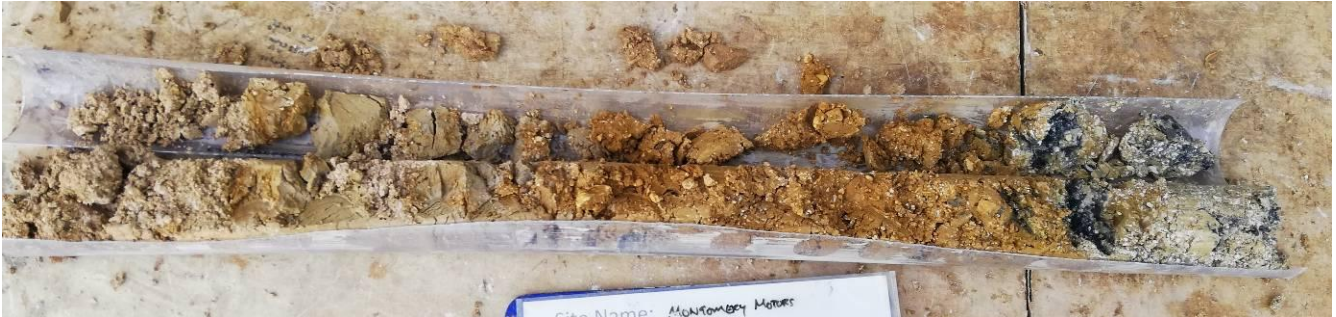
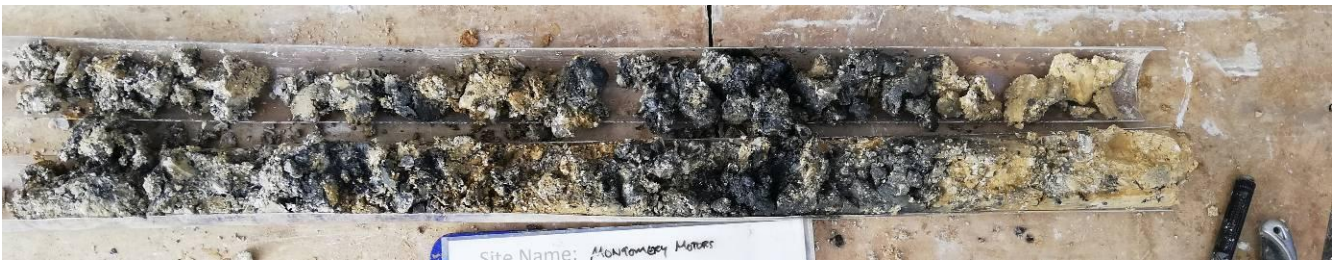
| Location | Depth (m bGL) | PID (ppm) | Soil Observations |
|---|---|---|---|
| WS4 | 3.80 | 6.3 | hydrocarbon staining from ~4.0 m |
| WS4 | 4.50 | 73.7 | Visible staining at 4.6 m |

Groundwater was not discovered during the investigation. Water seepage was noted at a depth of 2.4m in WS4 during borehole drilling but the borehole was dry upon completion. Possible water seepage was noted in WS5 at a depth of
