**Appendix A**

## Appendix B

**Project** STV5959 Barrington Road, Worthing

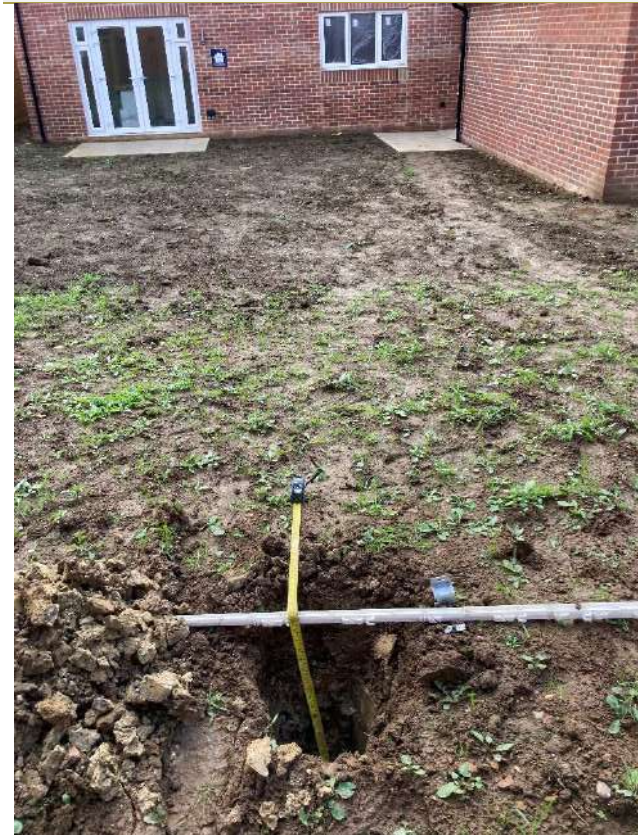
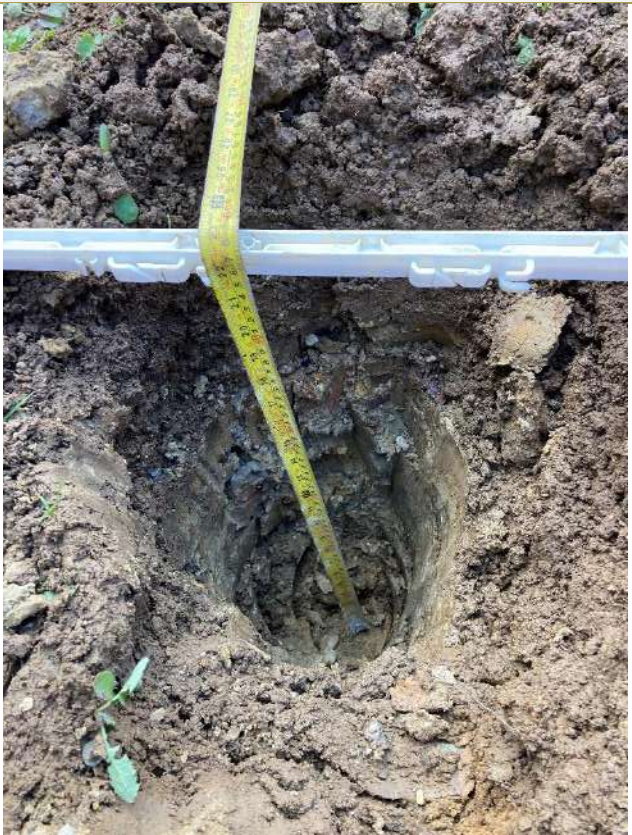
Photographs

| Physical Suitability | No undesirable or injurious objects were observed within any of the materials inspected, such as sharps, metals, plastics or over-sized materials, except for a few cobble-sized fragments of brick and concrete within the subsoil. | | |

| Conclusion | The aspects considered under this inspection record have <b>Passed</b> verification. |

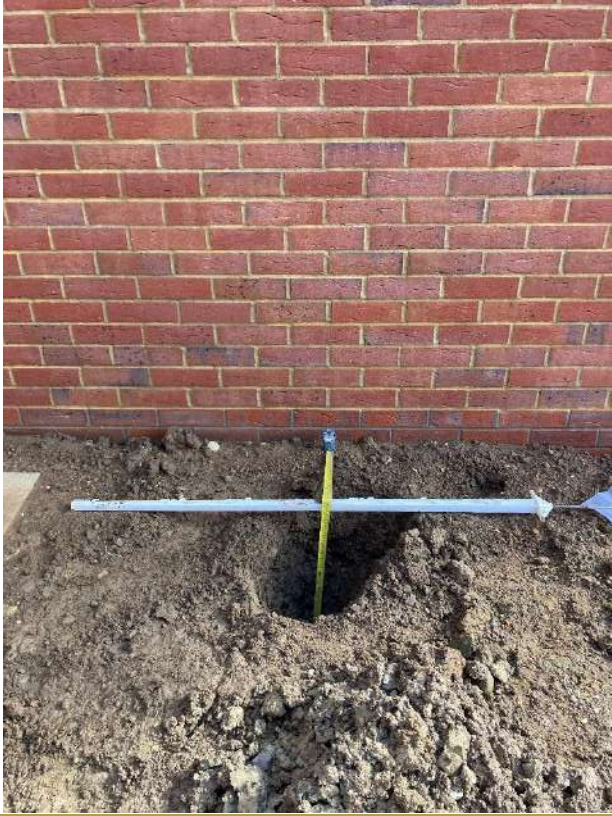
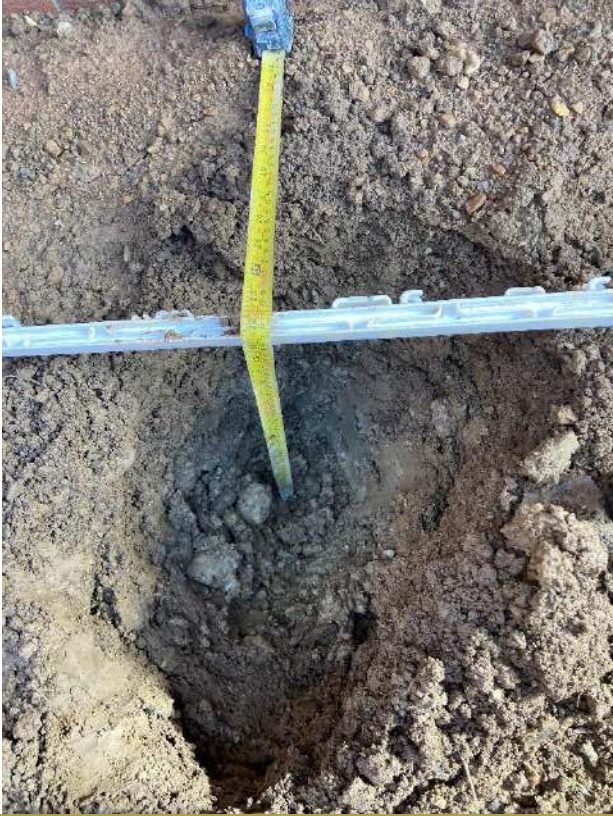
Photographs

| Physical Suitability | No undesirable or injurious objects were observed within any of the materials inspected, such as sharps, metals, plastics or over-sized materials, except for a few cobble-sized fragments of brick and concrete within the subsoil. | | |

| Conclusion | The aspects considered under this inspection record have <b>Passed</b> verification. |

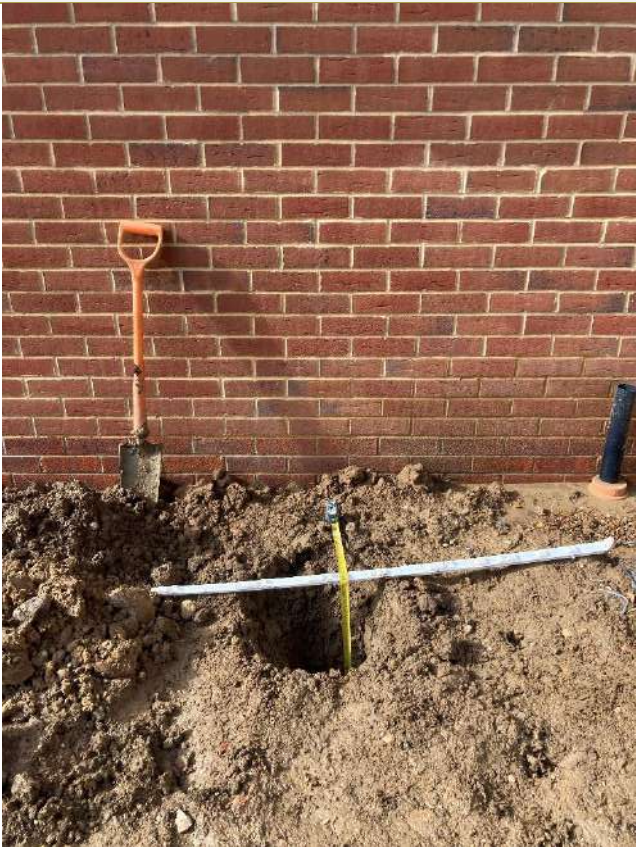
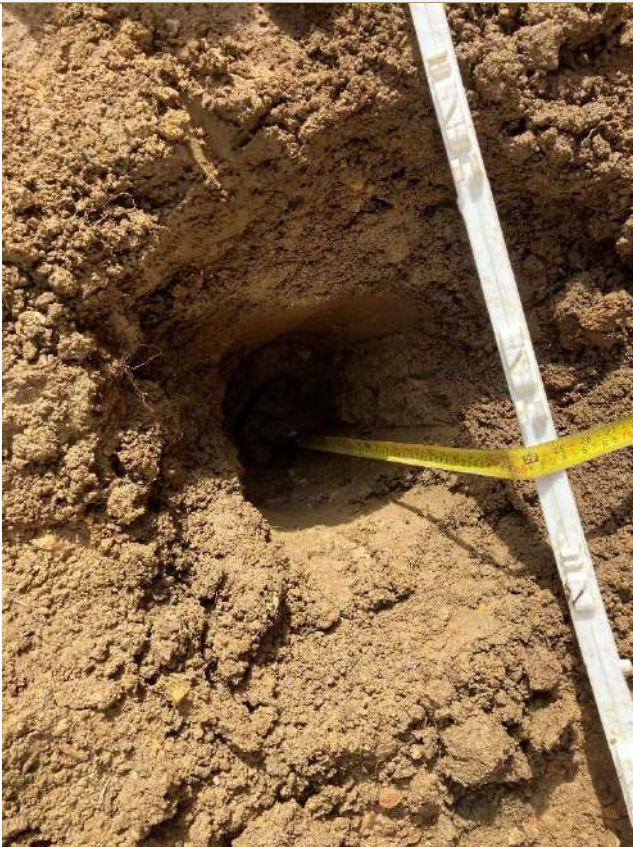
Photographs

| Physical Suitability | No undesirable or injurious objects were observed within any of the materials inspected, such as sharps, metals, plastics or over-sized materials, except for a few cobble-sized fragments of brick and concrete within the subsoil. | | |

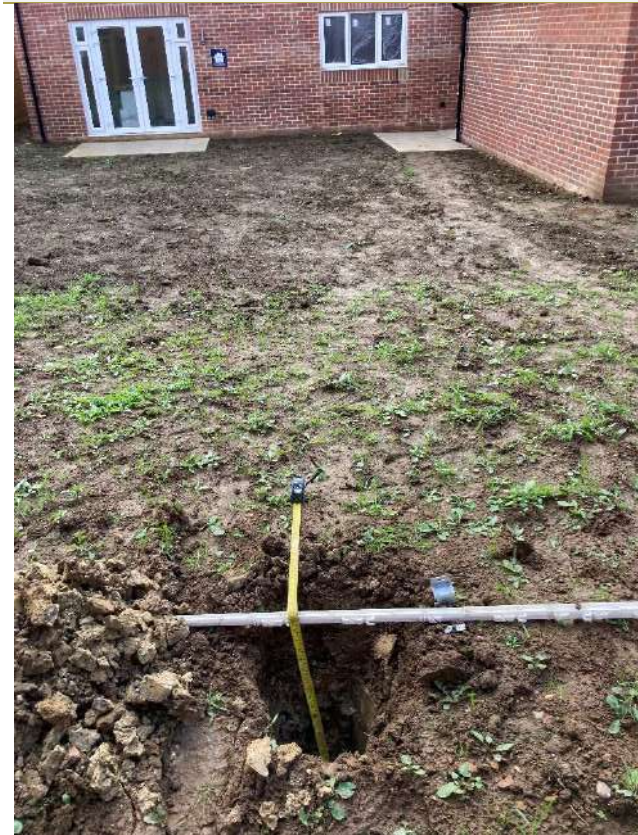
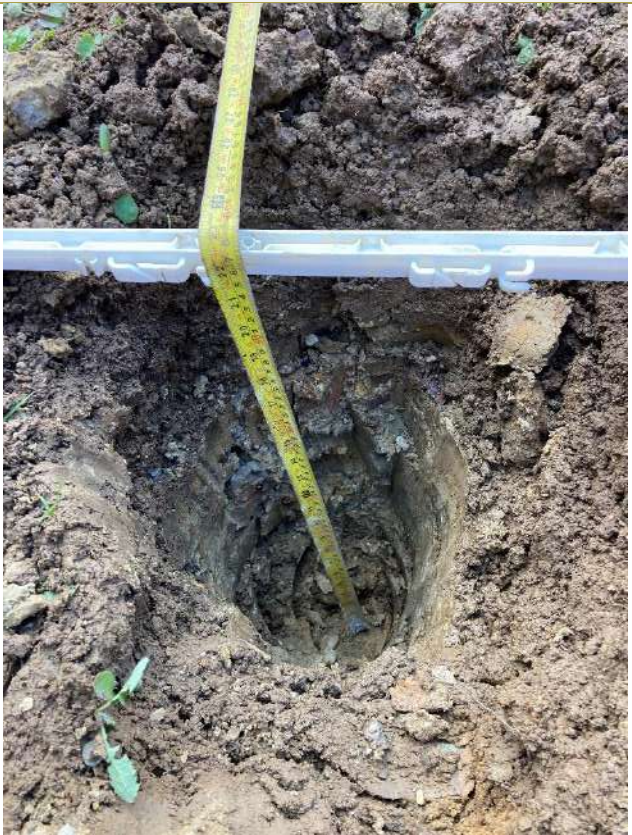
Photographs

| Physical Suitability | No undesirable or injurious objects were observed within any of the materials inspected, such as sharps, metals, plastics or over-sized materials, except for a few cobble-sized fragments of brick and concrete within the subsoil. | | |

| Conclusion | The aspects considered under this inspection record have <b>Passed</b> verification. |
