## Barn Owl Assessment

Land at New Salts Barn  
New Salts Farm Road

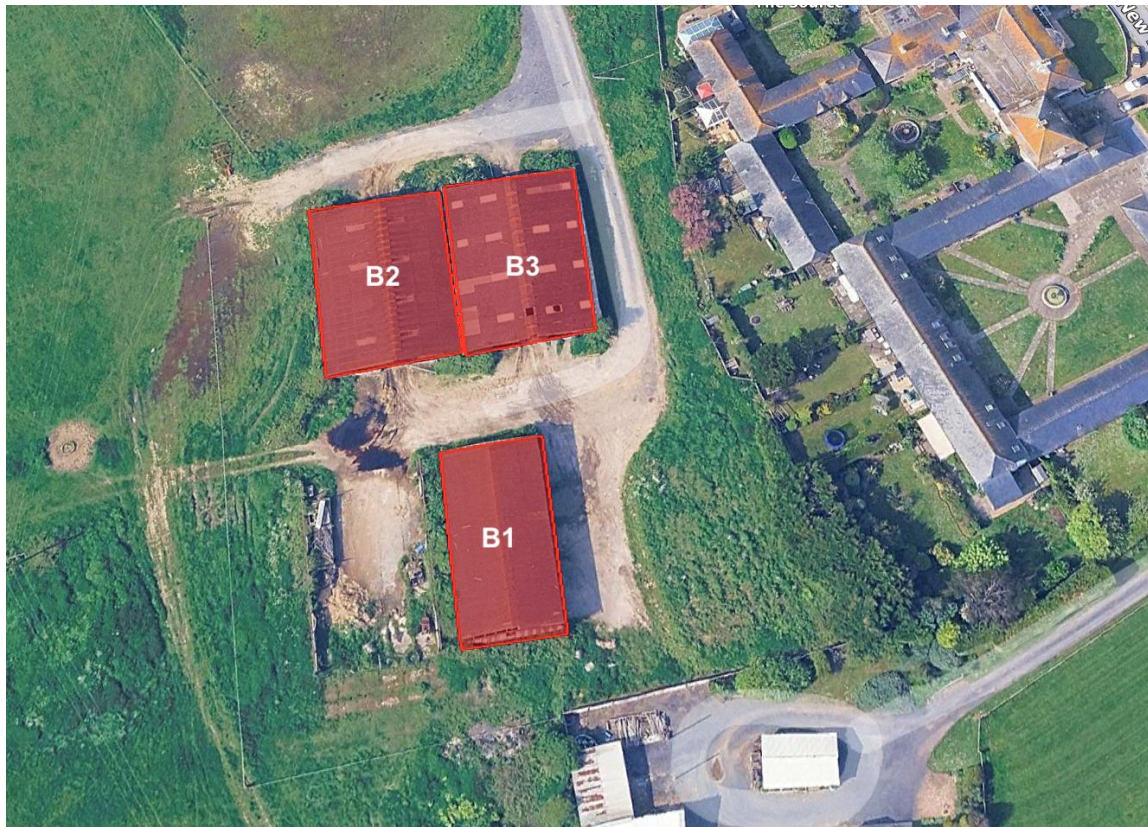
*Figure 2: Barns present on site*

- 3.1 The barns are labelled with ease below in Figure 2. The barns are all of similar construction. All of these buildings are metal framed with single skin corrugated (likely concrete/asbestos and metal) panel sheeting on the walls and roof. The barns are open fronted, allowing light and the elements to enter.
- 3.2 Barn B1 was in use for storage of hay bails. Barn B2 supported cows at the time of the survey and B3 was being used for storage of some farm machinery and additional hay bales.

- 3.3 None of the buildings supported ledges or sheltered cavities or enclosed roof spaces. The metal beams that are present are too narrow to support a nesting site. However, several exposed metal beams could well support roosting sites.

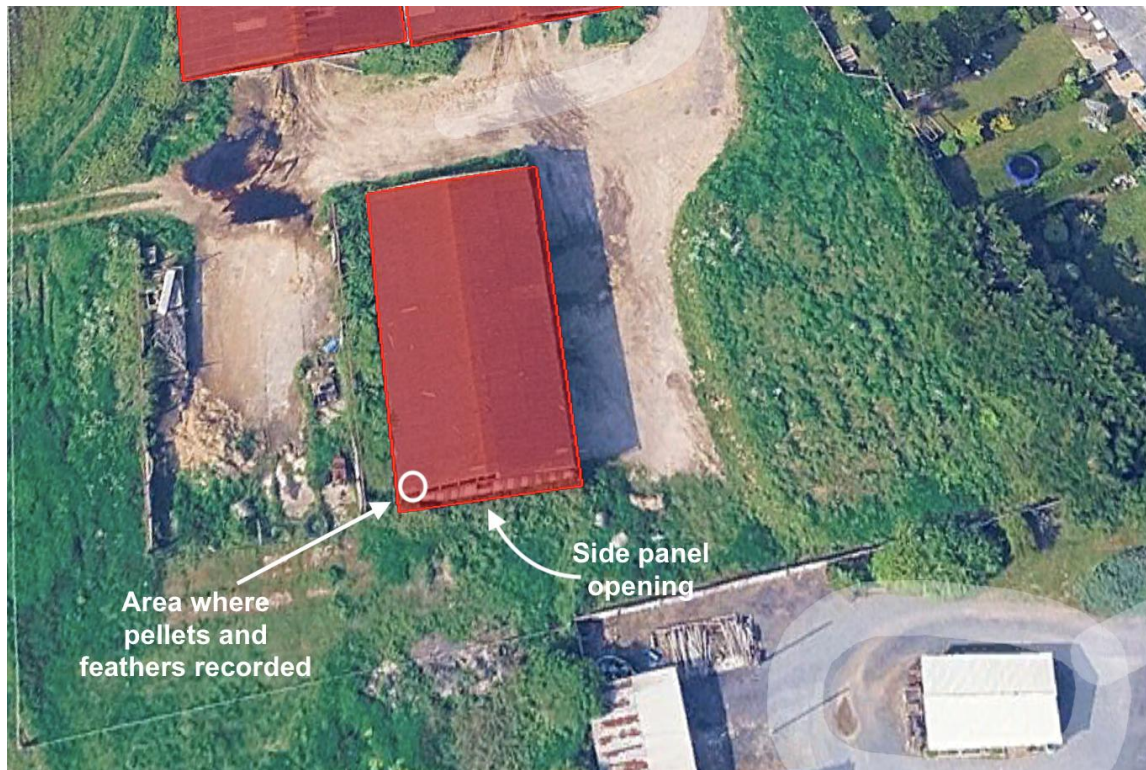
*Figure 3: Location of barn owl evidence*

- 3.5 During the July 2026 survey, evidence of barn owl use was recorded in Barn B1. White splashing was recorded on the southern aspect, where a panel was missing in the barn. Clear ledges for perching were present.

- 3.6 Pellets were reordered in the south and south western corner of the barn. These appeared to be reasonably fresh, likely produced within the last month. Feathers were also recorded attached to bramble and cobwebs located within the barn, along the south western corner of the barn, located on the beams and on the hay bales. The location of the evidence is shown in Figure 3 below.

- 3.7 A full inspection was not possible due to the hay bales present. Where the ladder could reach in the south western corner, additional feathers and pellets were recorded. No other evidence of barns owls in B1 was identified, albeit extensive surveys were not possible due to the dense packing of the bales.
- 3.8 Barn B2 supported cows at the time of the survey. Whilst the barn supported the thin metal ledges, no possible nesting locations were identified. No evidence of use of this building by barns owls was recorded. B3 supports some hay bales at the time of the survey. However, no evidence of barn owl use was recorded in this barn.

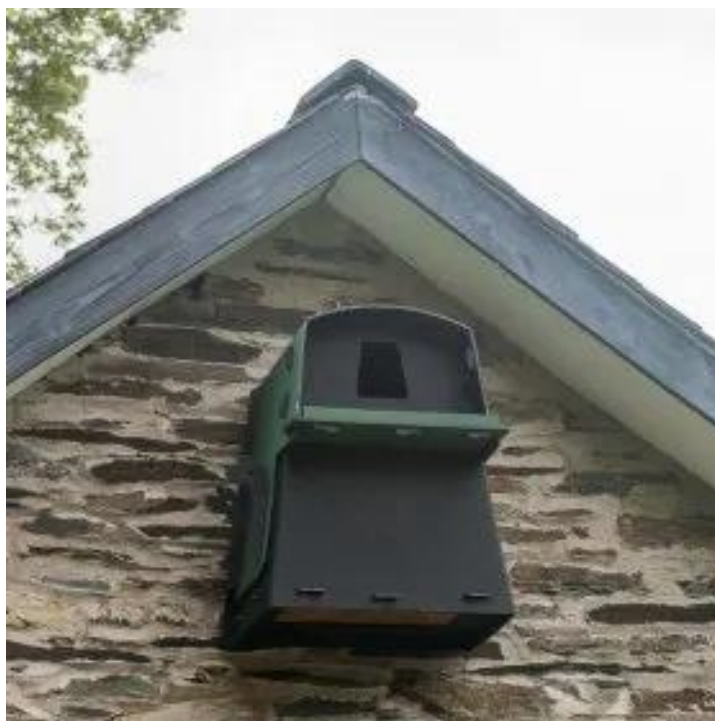
*Figure 4: Eco Barn Owl Nest Box ([NHBS](#))*

- 4.7 An external barn owl nest box will be established on one of the buildings. A barn owl box specifically designed for use on buildings should be used (Figure 4). It should be installed as high as possible on the side of the building in a location not illuminated by artificial light.

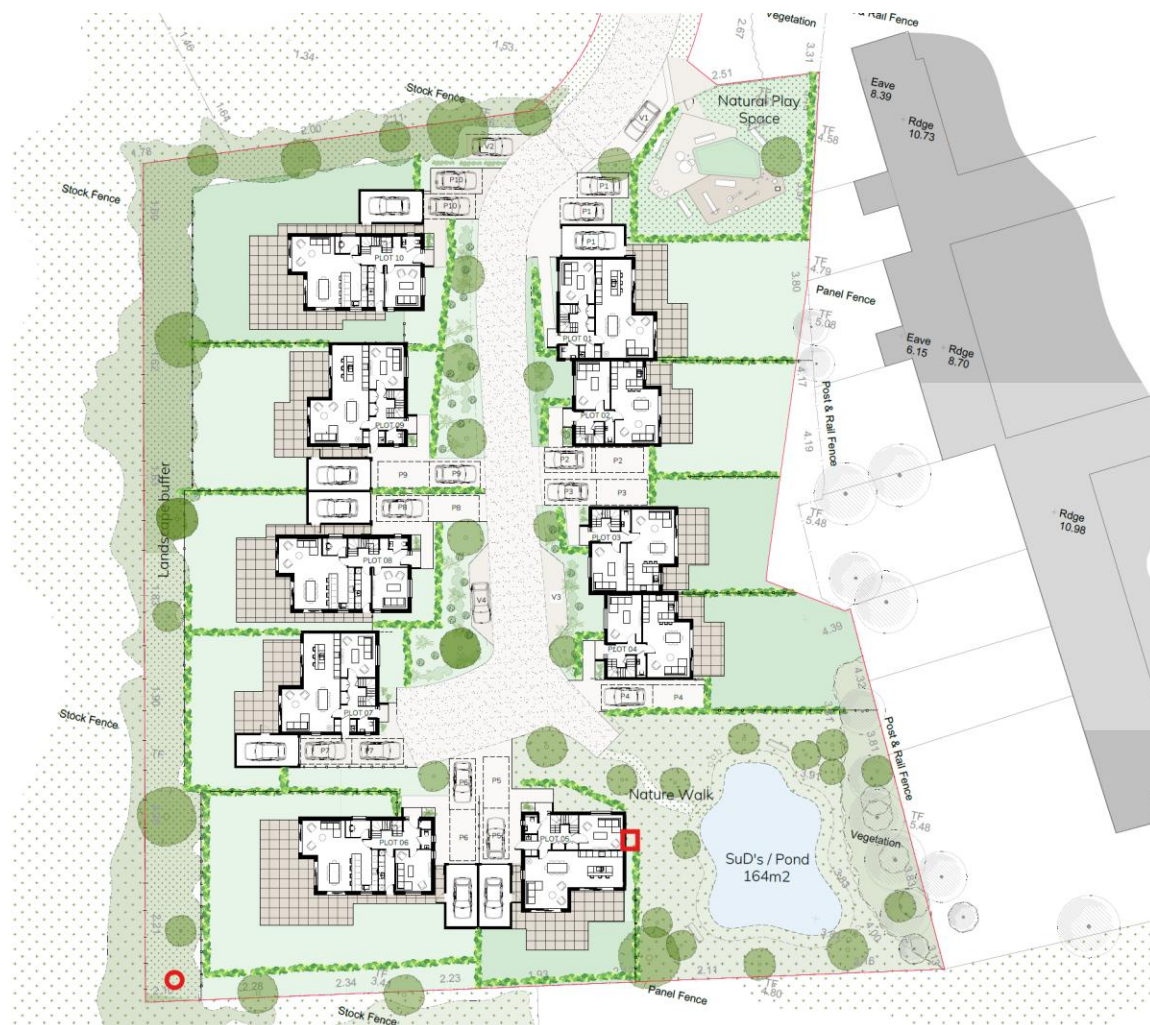
Figure 5: Approximate location of barn owl box on building (red square) & on pole (red circle)

- 4.8 As there are no suitable mature trees on site, an additional barn owl box will be erected on a suitably robust and tall pole (at least 4m) on the edge of the site. See Figure 5 below, which shows the approximate location of the new box in relation to the buildings. This box will be erected at least 30 days prior to any works starting on the site. The box will be established as high up on the pole as possible on the tree, over 3m high.
- 4.9 The box should face open countryside to the south with no obstructions. It should be overlook open countryside to maximise its visibility to barn owls. The recommended pole mounted barn owl box is shown in figure 6 and 7. Instruction for creation and installation can be found here on the [Barn Owl Trust website](#).

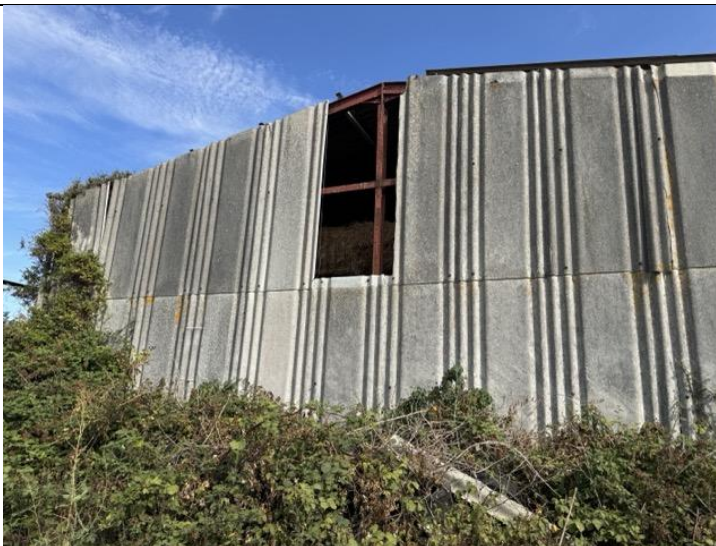
**Photo 1:** Open panel on barn B1 where white splashing and pellets were located

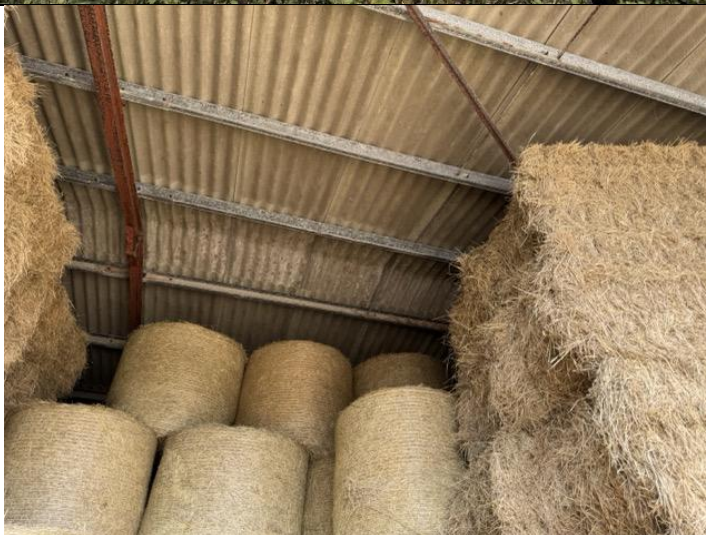
**Photo 2:** Internal view of B1 with the bales. Lack of barn structure for nesting owls

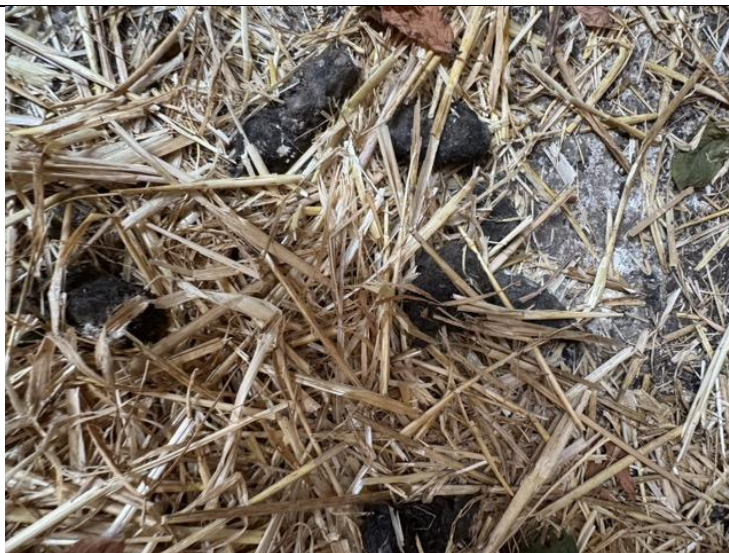
**Photo 3:** Pellets located in B1 in the southwestern corner

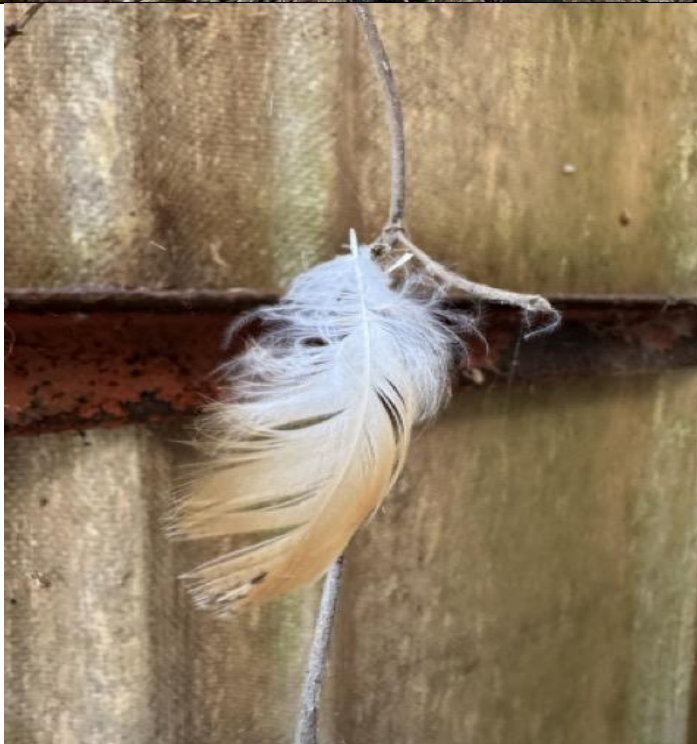
**Photo 4:** barn owl feather

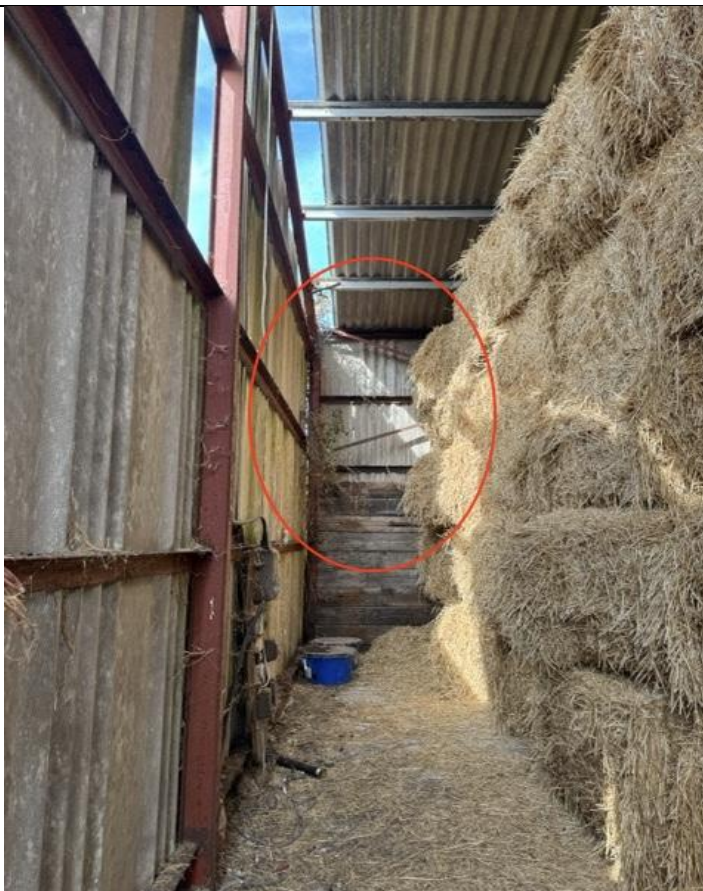
- 
- 4.2 Barn B1 supported evidence of barn owl use. Pellets and feathers were recorded. Feathers, including white feathers which appear to have been the nesting fluff due to the lack of a quill, were also located. Whilst a nest could not be identified due to the extent of the bales, it should be assumed that barn owl nesting is likely.

**Photo 5:** Section of Barn B1 where feathers and pellets found and considered likely access to nest on top of bales.

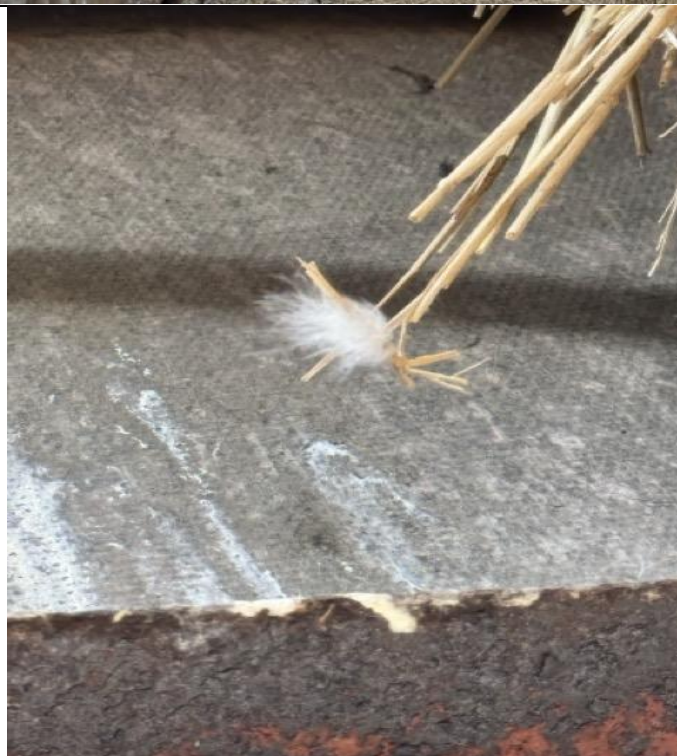
**Photo 6:** Barn owl nest fluff

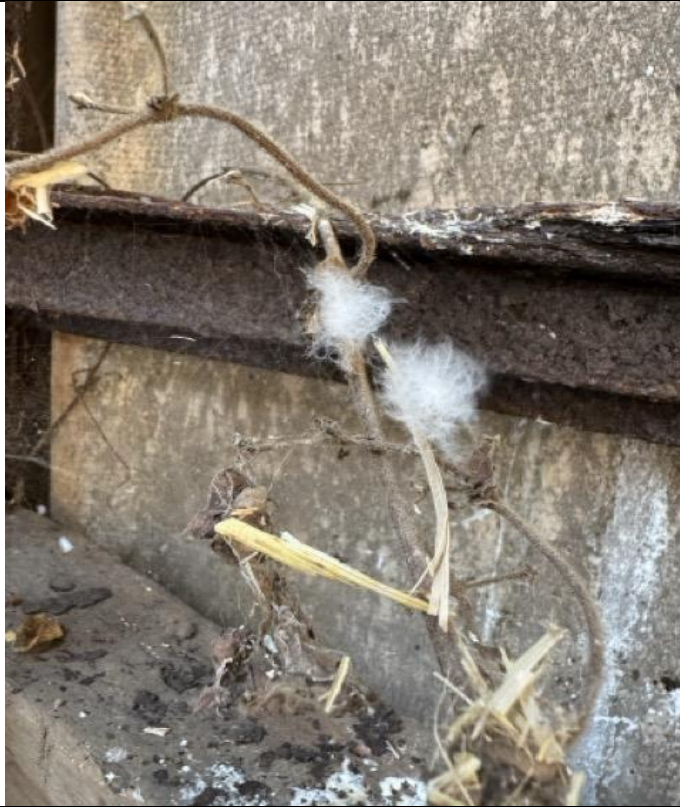
**Photo 7:** barn B1  
nesting fluff  
caught high on  
back wall

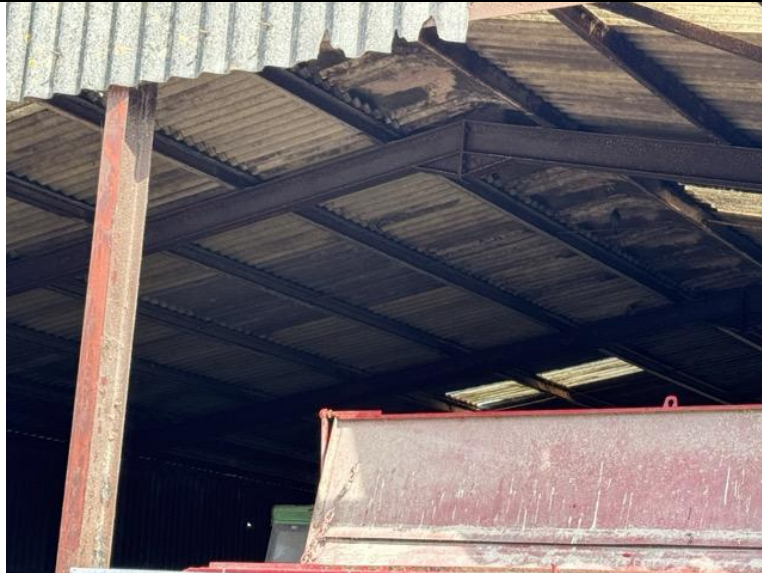
**Photo 8:** barn B2

- 4.1 Barns B2 and B3 did not support any evidence of barn owl use. Barn B2 supported cows at the time of the survey and the metal beams around the edges of the barn did not support any signs of barn owl use. However, it must be noted that both barns were in active management and subject to disturbance. Barn B3 did support some sotred hay bales, but no evidence was recorded around the hay bales.
