**GROUND CONTAMINATION  
RISK ASSESSMENT REPORT**

**SOUTHWICK NURSERY  
15 ROMAN WAY  
SOUTHWICK  
WEST SUSSEX**

**PROJECT REFERENCE: P17510**

**REPORT REFERENCE: R17013**

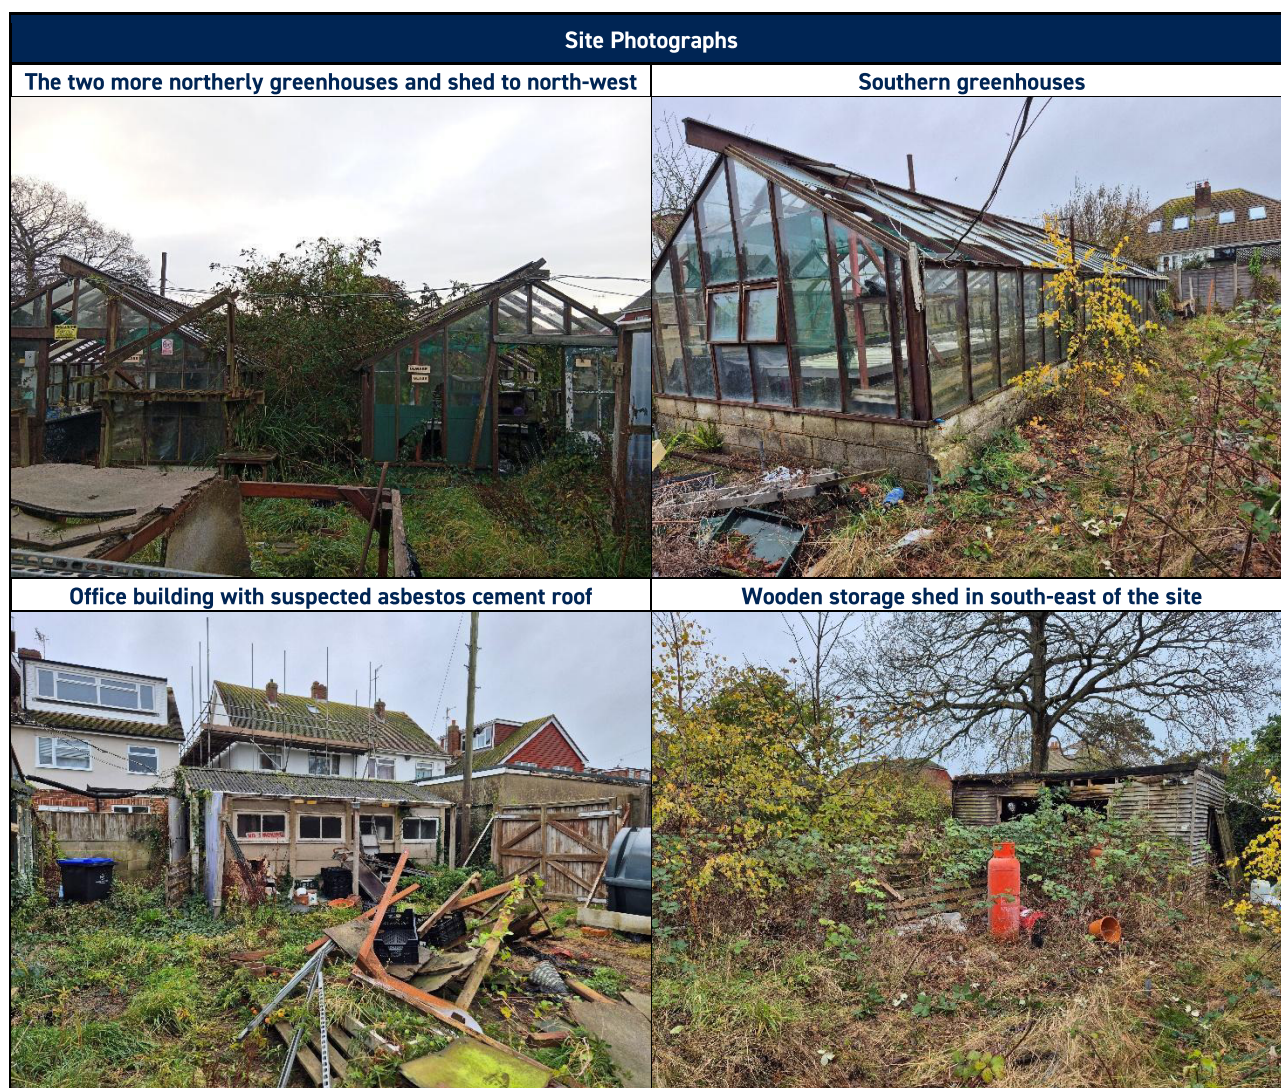
The site was formerly used as a plant nursery but was largely derelict at the time of the walkover survey. Three greenhouses are located within the main area of the site, with an office building located to the north-west of the greenhouses and a wooden storage shed in the south-east of the site. The office building was observed to be roofed with corrugated cement panels, potentially containing asbestos.

Irrigation tables were located within the greenhouses along with other miscellaneous retail items. The office contained the remains of cupboards and other debris, and the storage shed was primarily empty.

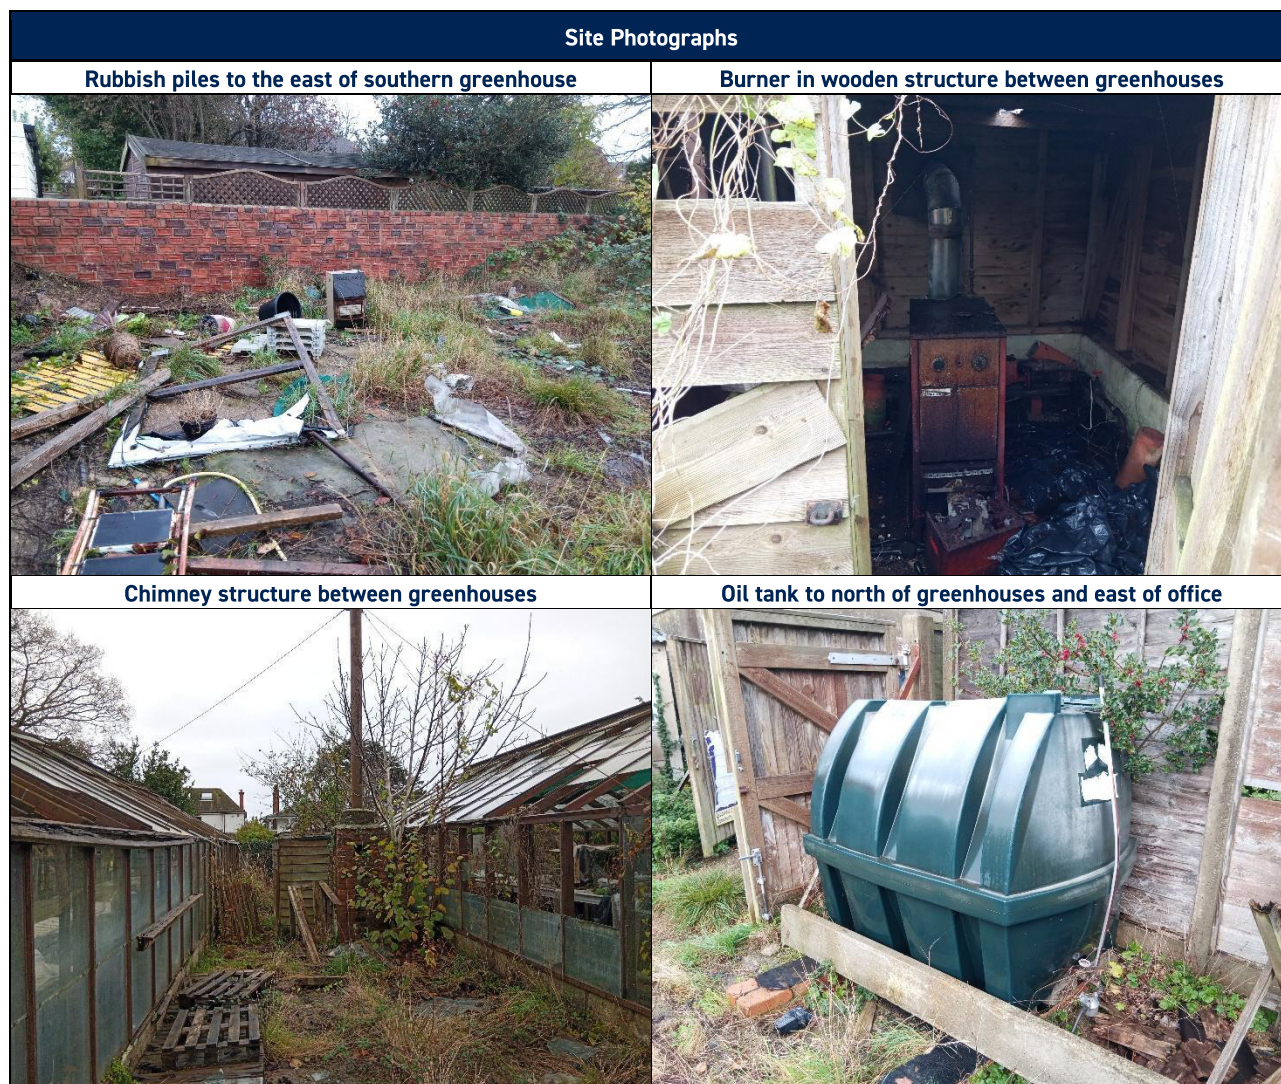
The areas to the east and south of the southern greenhouse were overgrown and contained various waste materials, including gas canisters.

An above ground plastic oil tank was located against the northern boundary, to the east of the office. Piles of waste materials were present around this area.
