25-127.03

| Report Quality Management | | | |
|---|---|---|---|
| <b>Project Name</b> | Ashcroft House, 100 Kingston Lane, Shoreham-by-Sea, BN43 6YU | | |
| <b>Project Title</b> | Soil Infiltration Testing | | |
| <b>Client</b> | Bugler Developments Limited | | |

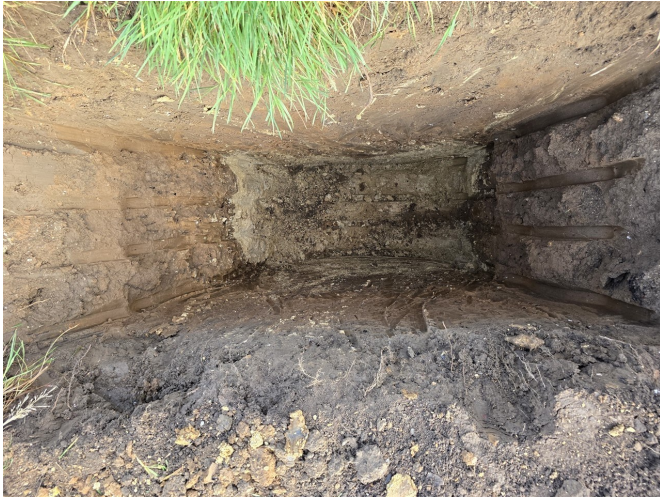
SP11 Hole

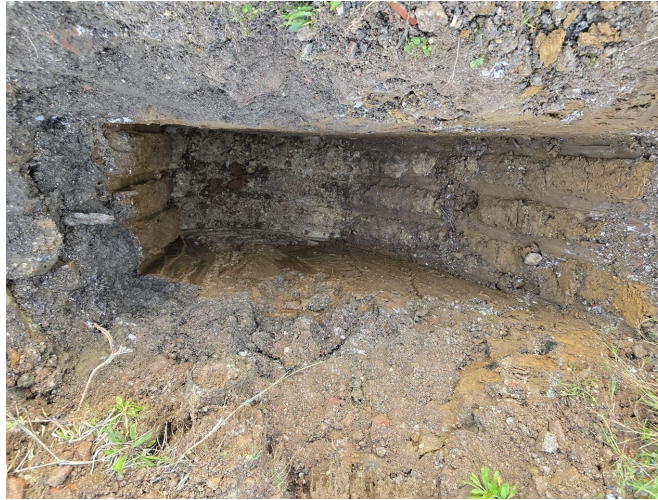
SP12 Hole

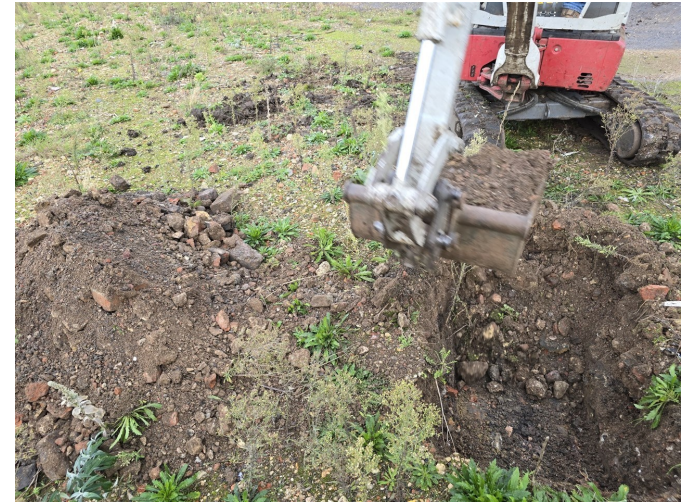
SP13 Hole and Arisings

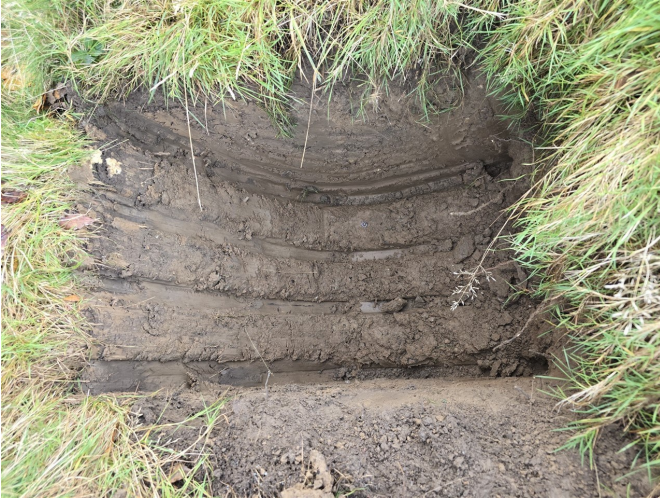
SP14 Hole

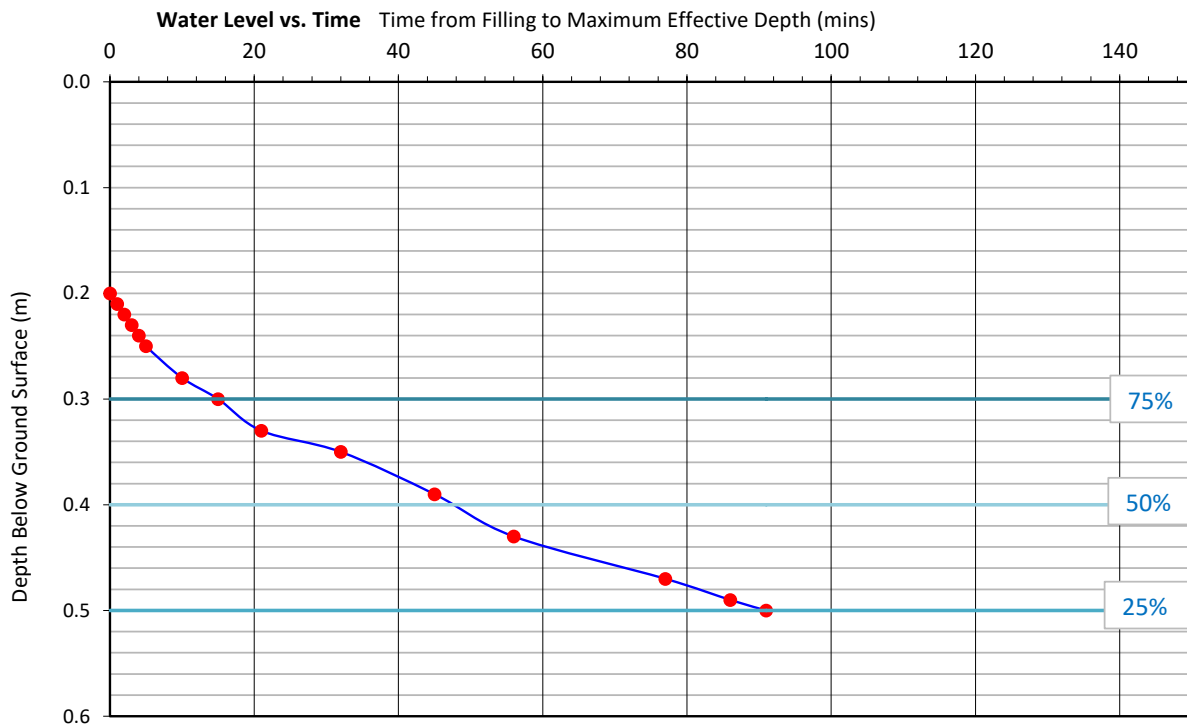
Soil infiltration rate,  $f$ : 0.132/(1.34 x 4560)

$f$ : 2.16E-05 ms<sup>-1</sup>

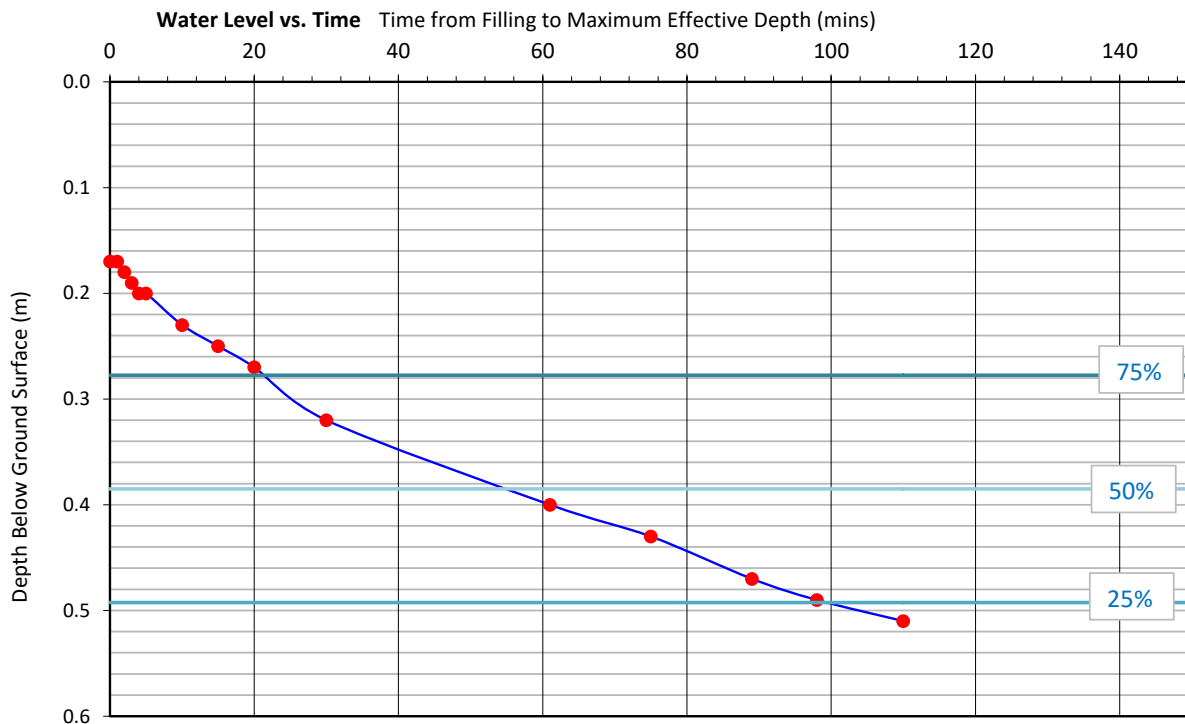
Time of water level fall,  $t_{p75-25}$ : 100 - 21 mins  
 $t_{p75-25}$ : 79 mins  
 $t_{p75-25}$ : 4740 secs

Soil infiltration rate,  $f$ : 0.1419/(1.391 x 4740)  
 $f$ : 2.15E-05 ms<sup>-1</sup>
