# Heritage Statement

Beach House, Brighton Road, Worthing, BN11 2EJ

**For:** Beach House Residents Association Ltd

**Reference:** EKA260178

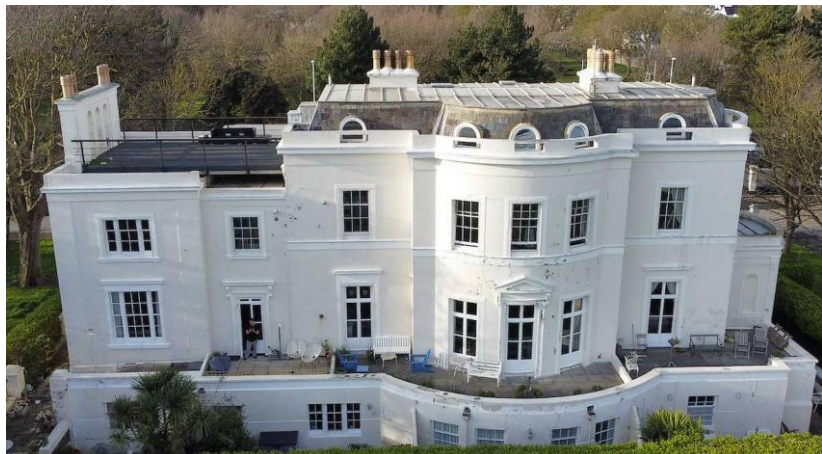
**Figure 1: image of rear elevation**

During this project, when repairing the render, significant hidden cracks were found in the brickwork behind the render, which were far more substantial than the visible cracking to the render itself. As a result, a structural engineer was engaged to advise on remedial actions.

- Localised re-building of a soldier course lintel over the rear curved bay at ground floor level;
- Localised re-stitching together of brickwork above this lintel; and
- Installation of helical bar to stabilise significant cracking.

The primary driver behind the proposed project is, therefore, simply to repair and re-build the curved structure back to the way it was initially constructed to ensure long-term stability, and stabilise other sections of notable cracking.

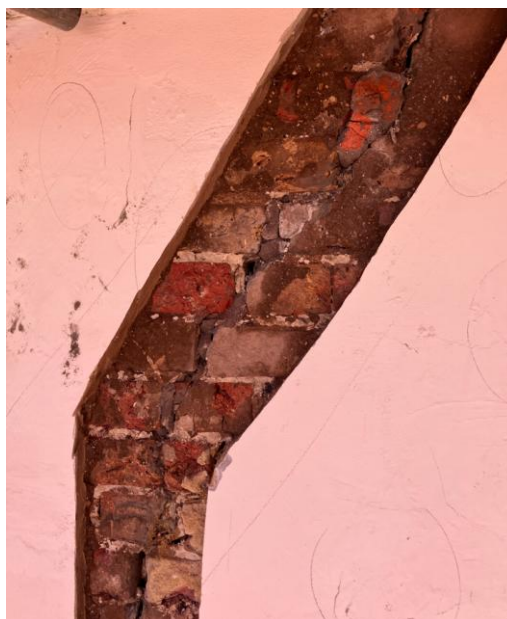
The affected brickwork is, and it is believed has always been, concealed behind a render. As a result, once repaired, this section of masonry will not be visible:

**Figure 4: Cracking to curved bay – sheared brickwork**

- a) Aesthetic value: low impact. The repairs will not be visible as, once complete, will be concealed behind the reinstated render.
- b) Communal value: no impact.
- c) Evidential value: low impact.
- d) Historical value: no impact.

The newly damaged bricks are being replaced, as far as practicable, with soft 'red rubber' heritage bricks of an identical appearance. The bricks will then be covered with a render which is matched to the existing based on laboratory samples. Therefore, the repaired brickwork will not be visible to passers-by, and the final render finish is being repaired to match the existing.

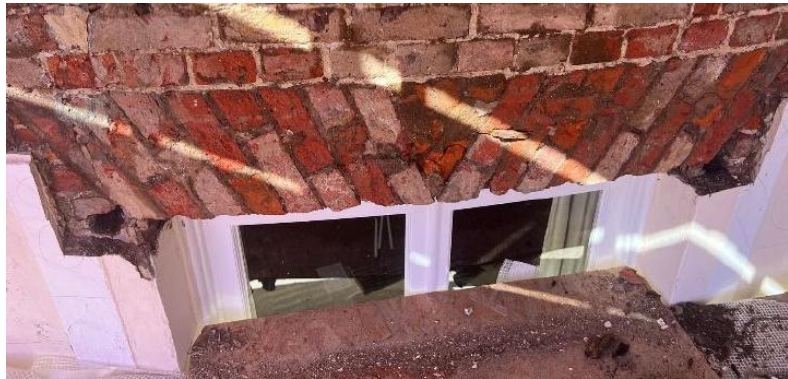
The brick-on-end soldier course lintel above one of the curved bay windows at ground floor level is to be re-built in-line with the structural engineer's report:

**Figure 5: Soldier course lintel above window**

- a) Aesthetic value: low impact, for the same reasons set out above.
- b) Communal value: no impact.
- c) Evidential value: no impact.
- d) Historical value: no impact.

Like the re-toothing of brickwork noted above, bricks of matching appearance are being used to reform the brick-on-end lintel which is being re-rendered with a matching render
