# BRE365 SOAKAGE TESTING AT 66a LADYDELL ROAD, WORTHING, WEST SUSSEX, BN11 2JT.

H2Ogeo Reference: 20260513P1

For: Beachview Estates Ltd

Date: 15 June 2026

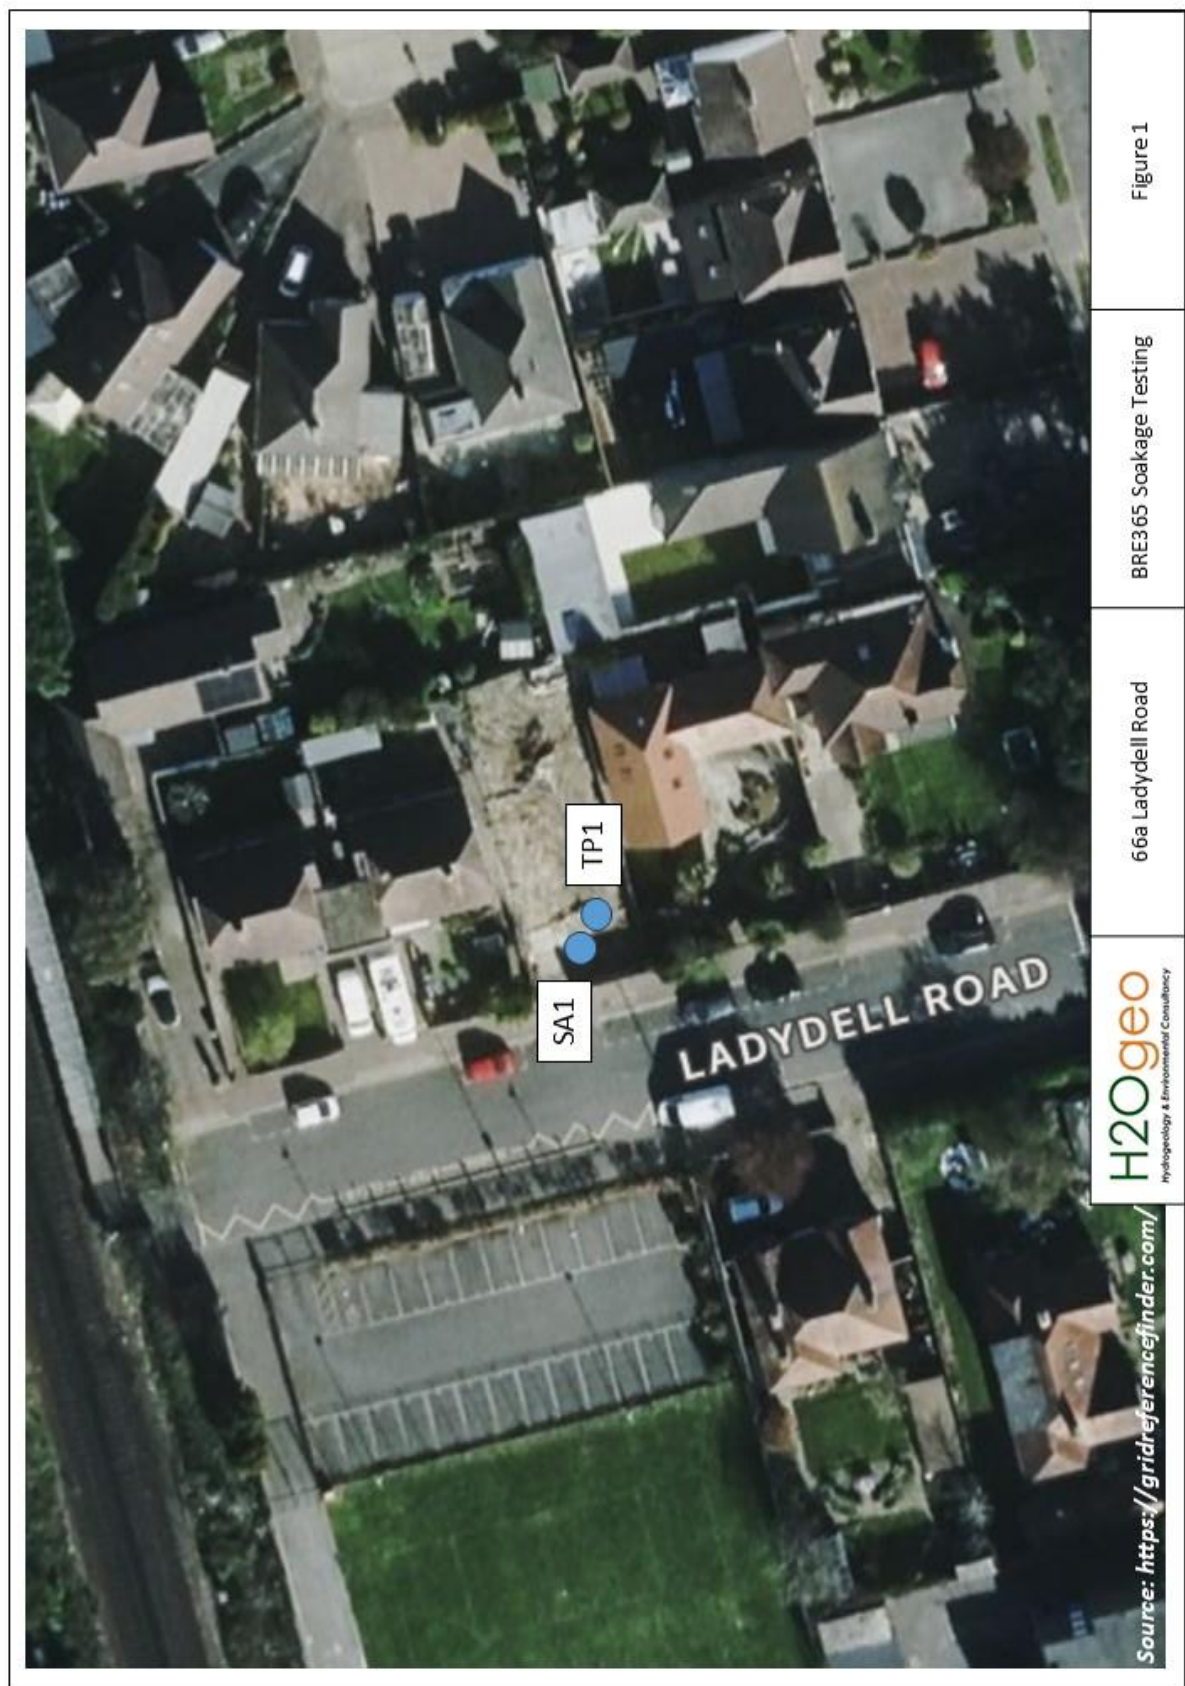
Figure 1 – Trial Pit Locations

One pit was excavated (TP1) on site to log the soils encountered adjacent to the soakage crate (SA1) in accordance with *BRE Digest 365: Soakaway Design*.

The locations are presented in Figure 1.

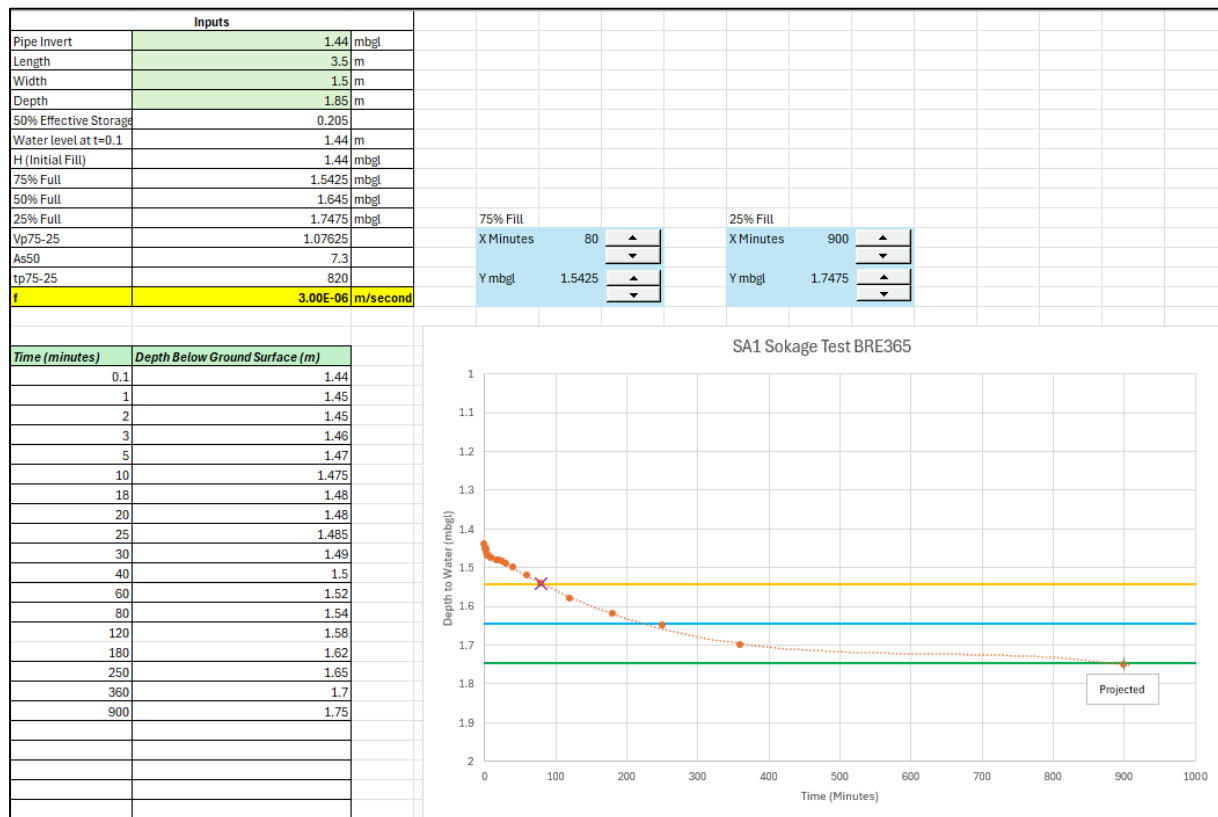
### Appendix A – Results

Recorded measurements represent the depth to water below ground level (bgl), increasing as the soakage crate pit drained, in accordance with BRE365 methodology.

The records of each test are presented in Annex A and have been analysed using the following formulae, please note the final reading of 1.75mbgl at 6 hours is extrapolated based on the data<sup>1</sup>:
