## **APPENDIX 10**

### **TOUREEN HOTSPOT AND UNFORESEEN CONTAMINATION SUMMARY TABLES**

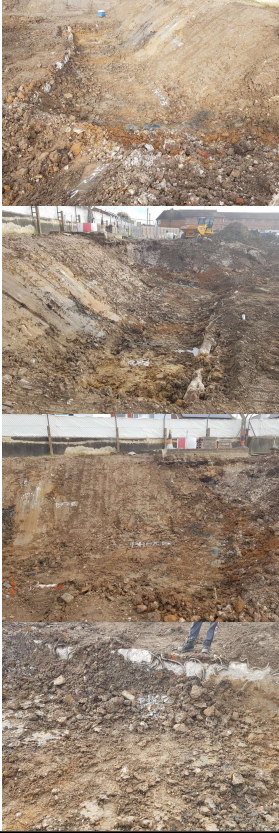
| Ground Conditions | Ground – 0.5m bgl: Concrete<br>0.5m – 1.5m bgl: Made ground with inclusions of former foundations and brickwork.<br>1.5 – 2.0m bgl: Grossly contaminated layer of gravels with viscous hydrocarbon film.<br>2.0 and below bgl: Natural light sandy clay | | | | |
| Visible contamination present | There was no 'tar pit' as assumed within the SI and remediation strategy. A layer of grossly contaminated material was found at 1.5m-2.0m below slab level. This layer was between a large number of former brickwork walls and foundations of which were all removed to allow the removal of the grossly contaminated materials. Moving away from the centre of the contaminated materials the layer thinned out and was no longer visible at the edges of the excavation. | | | | |
| Observed groundwater depth (m) | No groundwater present. Small amounts of purchd water was located upon breaking out the slab. This water was pumped through the treatment plant before the contaminated soils below were distrubed. Samples of the groundwater during this period were taken to ensure discharge limits were not exceeded. | | | | |

| Date/ no. of days worked on. | Excavation took place between the 3rd and the 5th of september and contaminates chased out. Backfill took place on the 5th with stabilised fill. | | | | |
| Source of material being backfilled | Backfill material was from site won soils and stabilised in-situ. | | | | |

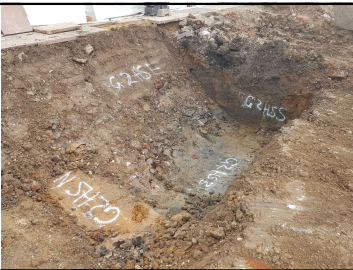
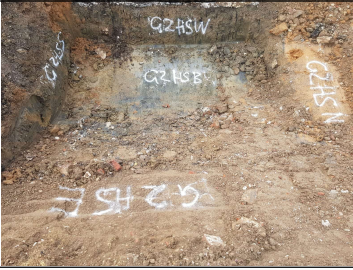
| Ground Conditions | Ground – 1.0m bgl: mixed made ground. No signs of contamination. Former interceptor tank incased in concrete.<br>1.0-1.5m bgl: Sandy Clay with hydrocarbon staining from around the interceptor tank.<br>>1.5m: Sandy clean clay. | | | | |
| Details of any obstructions | An interceptor tank was present at this location. After the removal of the tank structure it was noted that hydrocarbon staining was present on the surrounding soils. | | | | |
| Visible contamination present | Hydrocarbon staining. | | | | |

| Date/ no. of days worked on. | Excavation was undertaken on the 5th November. Excavation was taken to natural materials. | | | | |
| Destination of material removed | Material was removed from site. | | | | |
| Source of material being backfilled | Backfill material was from site won soils and stabilised in-situ. | | | | |
