WORTHING HEAT NETWORKS

MUSEUM & ART GALLERY  
ENTRY LOUVRE  
DETAIL DRAWING

2389-HEM-MAG-B1-DR-Y-2103

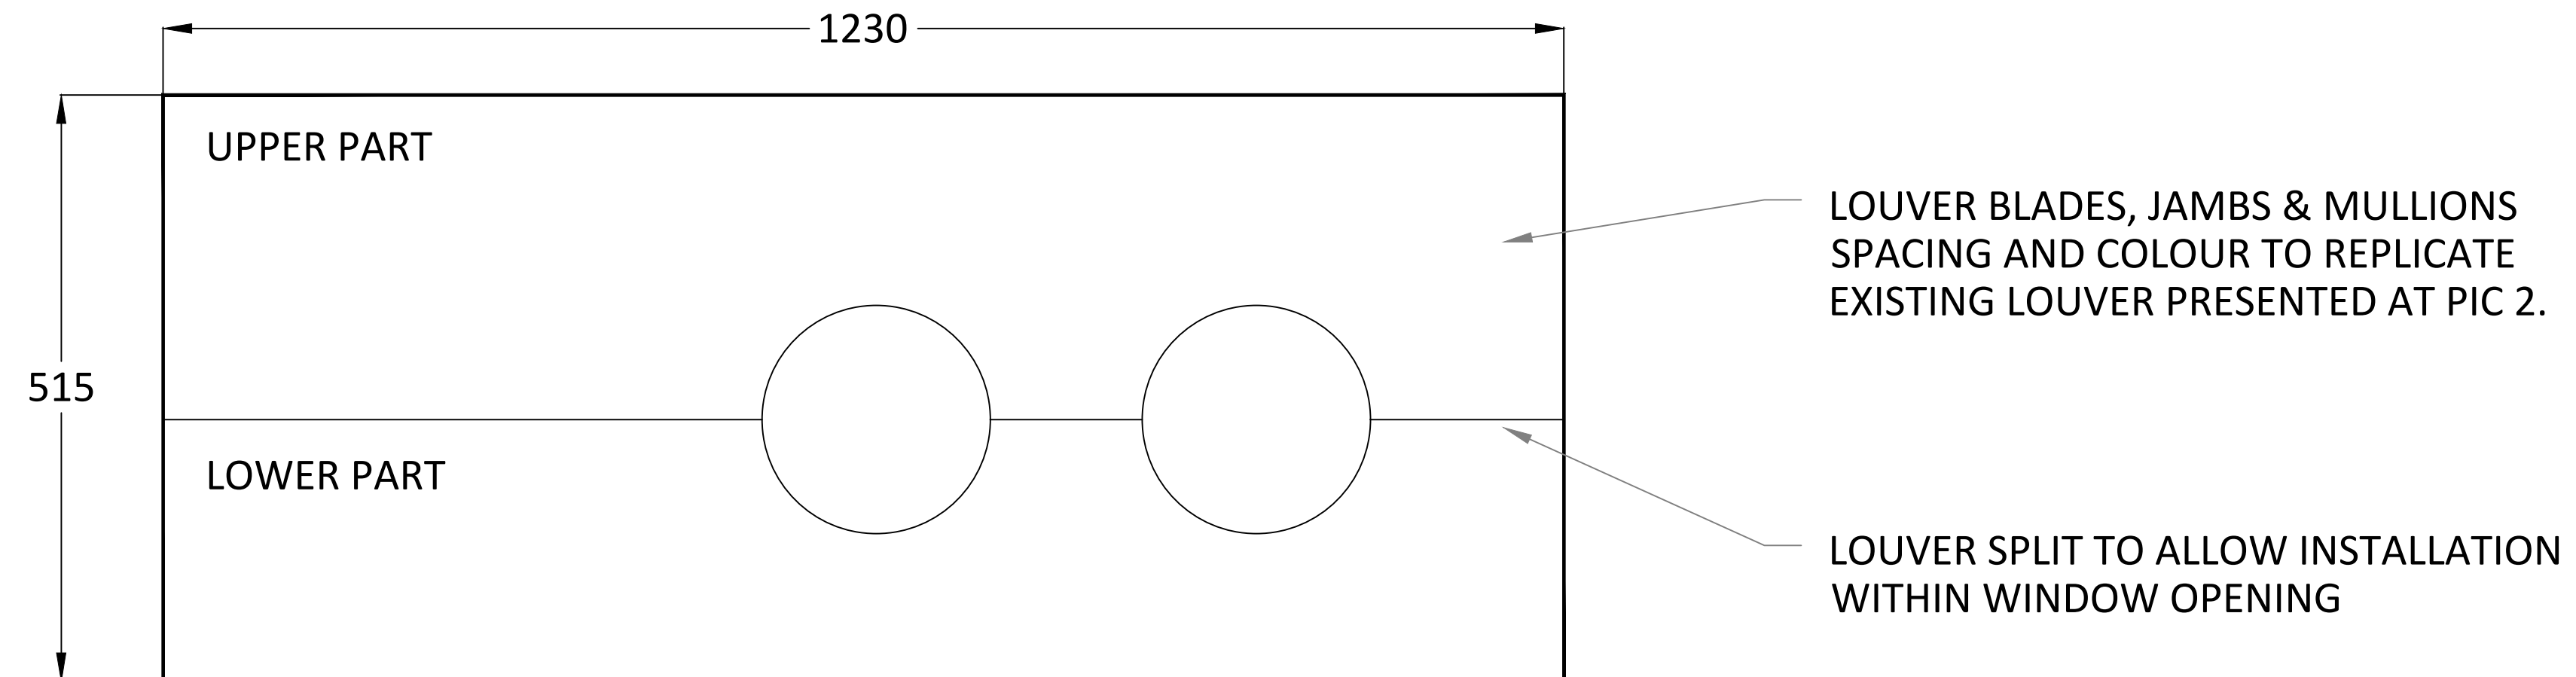
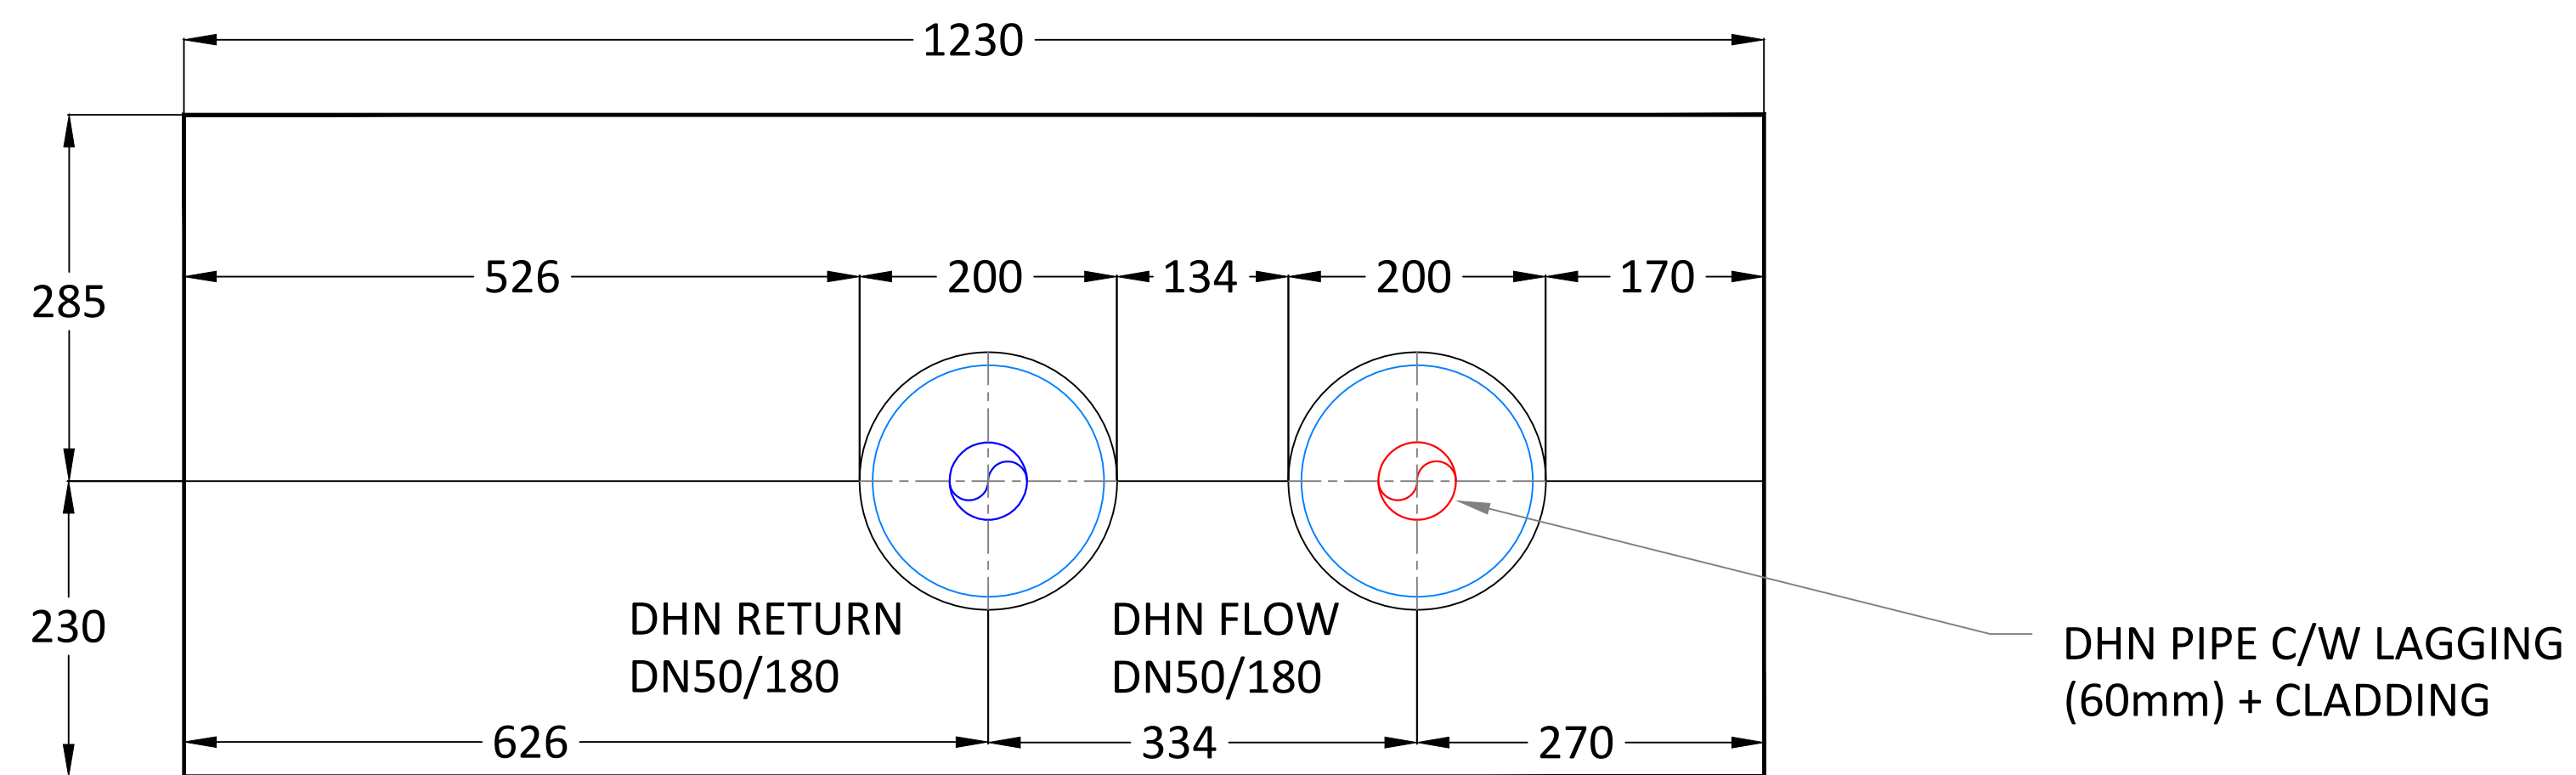
A close-up photograph of a brick wall. In the center, there is a white-framed rectangular opening. Inside this opening, two red pipes are visible, each fitted with a grey coupling. Above the opening, there is a black, square, perforated vent. The brickwork is made of reddish-brown bricks with light-colored mortar. The ground in front of the wall is dark and appears to be wet.
