# **Barrington Road, Durrington**

## **SURFACE WATER DRAINAGE CONFIRMATION REPORT**

On behalf of **Bellway Homes**

**Doc Ref:** K43058-ATCN-92-00-R-C-2001

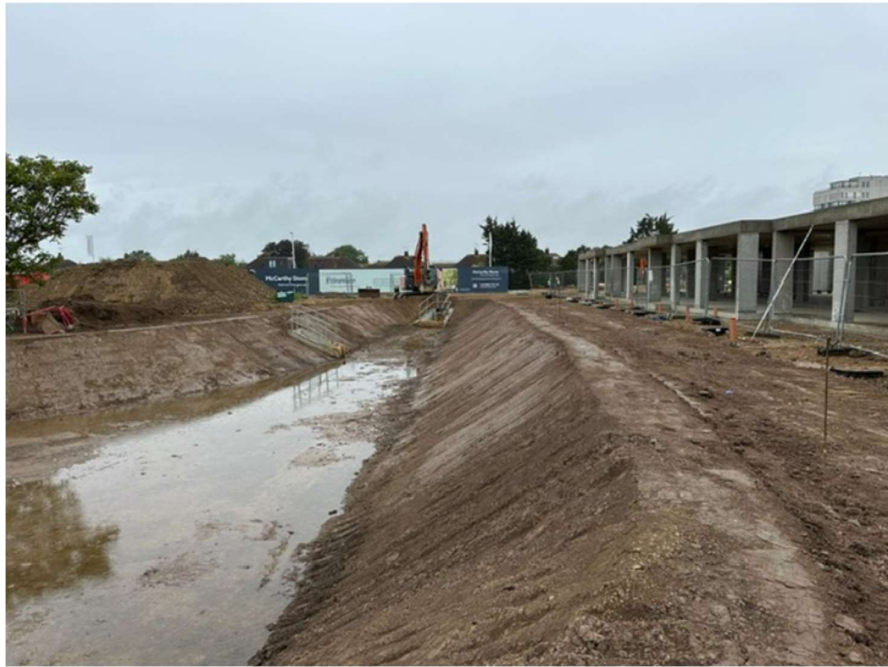
**Figure 1 - Basin during construction – grading, water standing within basin**

Figure 1 and Figure 2 (above), show the under construction basin, as it was being installed in accordance with the construction details and drainage design plans provided by ATCN Consulting.

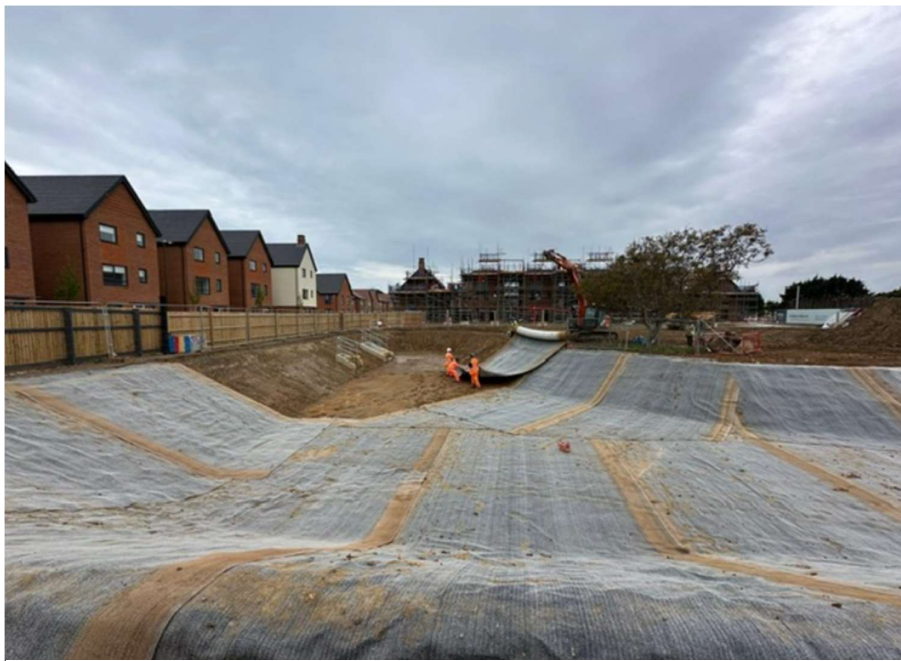
**Figure 2 - Basin during construction – lining being installed**
