## Verification Report

Plots 7-23 Residential Development

Elizabeth Square, Durrington

August 2024

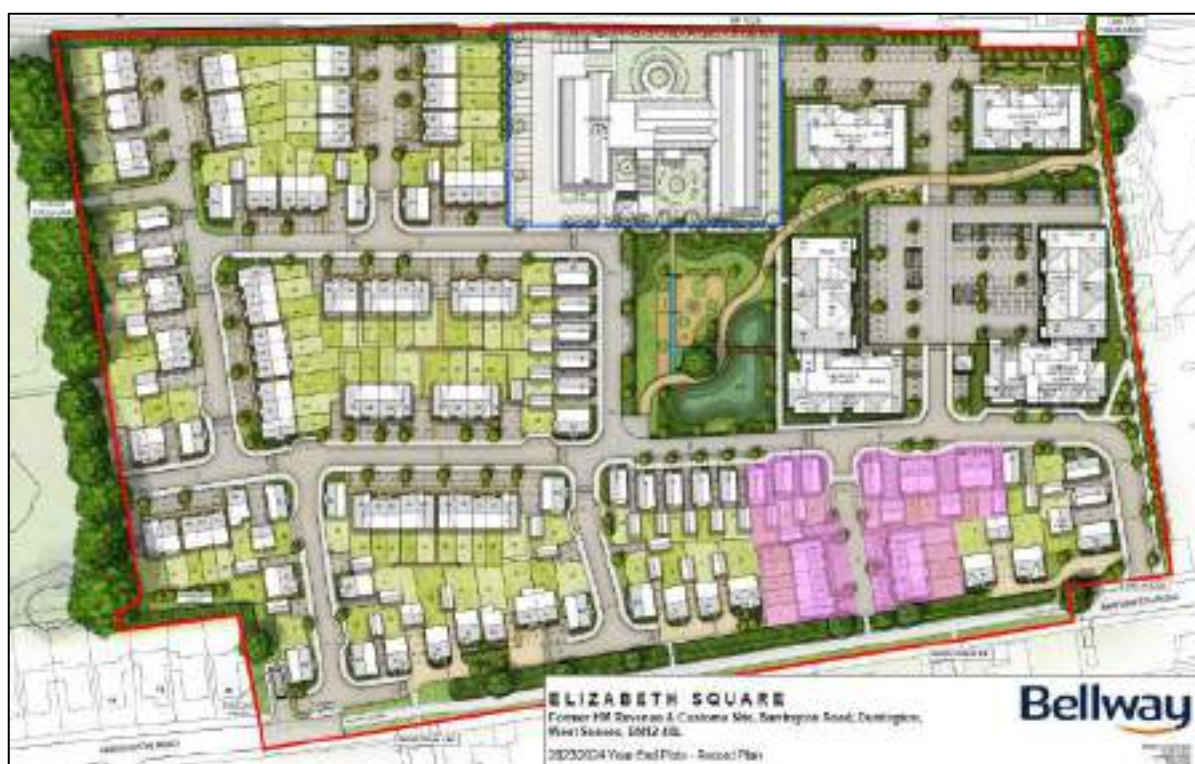
Figure 1-A: Proposed Layout and Year-End Plots

- 1.1.1 The site is located at the former HM Revenues And Customs complex at Barrington Road, Worthing, BH12 4SD.
- 1.1.2 The redevelopment of the site comprises the demolition of the former HMRC buildings and construction of a residential development comprising a mixture of houses, apartments and a care home. Plans of the existing and proposed site layout are provided within Appendix A. Approximately, this comprises of 139 residential plots, 4 blocks of flats, and a care home.
- 1.1.3 The development is controlled under the Worthing Borough Council planning regime, under the planning application number AWDM/0605/22.
- 1.1.4 This Verification Report is for the verification of all remedial requirements associated with Plots 7 to 23 only. A proposed development plan is included below, with the plots covered by this report highlighted in purple.

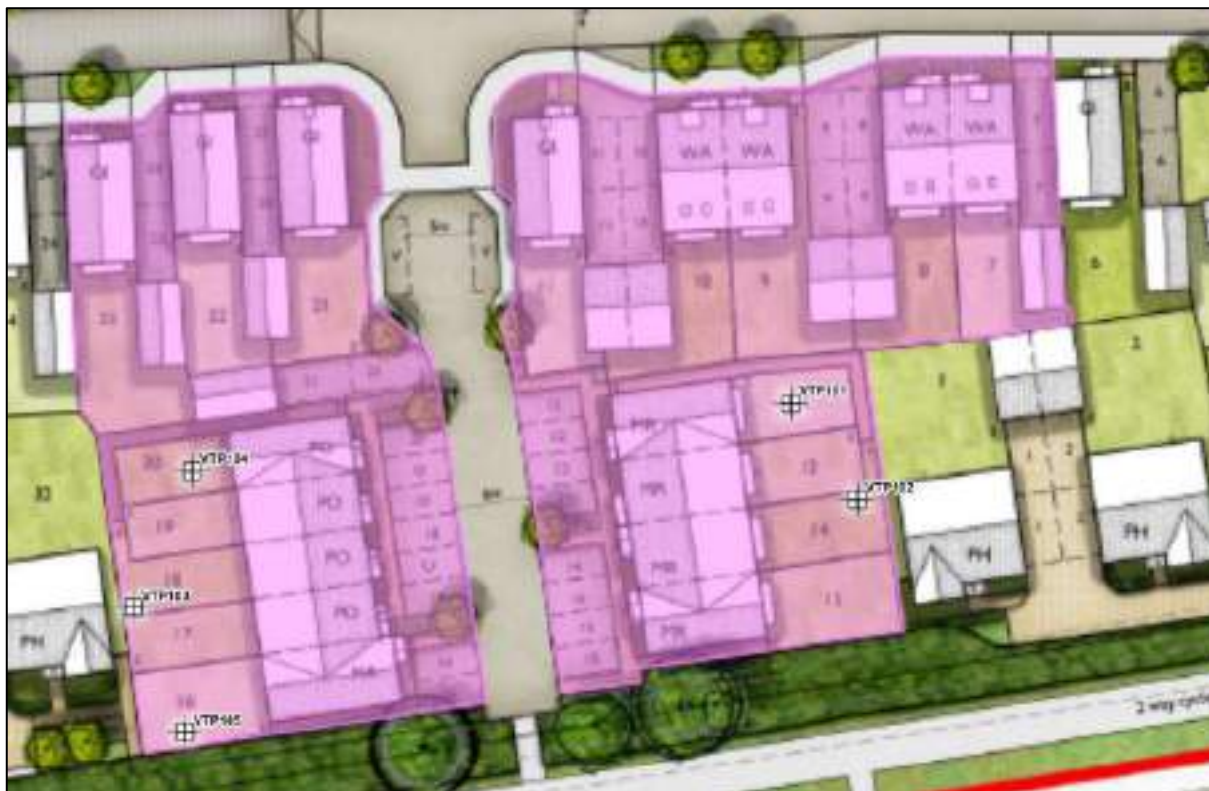
Figure 5-A: Pit Verification Plan

5.3.3 An exploratory hole plan is provided below.

5.3.4 It should be noted that at the time of inspection the landscaping of Plots 7 to 11 and Plots 21 to 23 was still underway, and therefore fell outside of our scope for final inspection. This results in an overall inspection frequency of approximately 1 pit for every 3 plots.

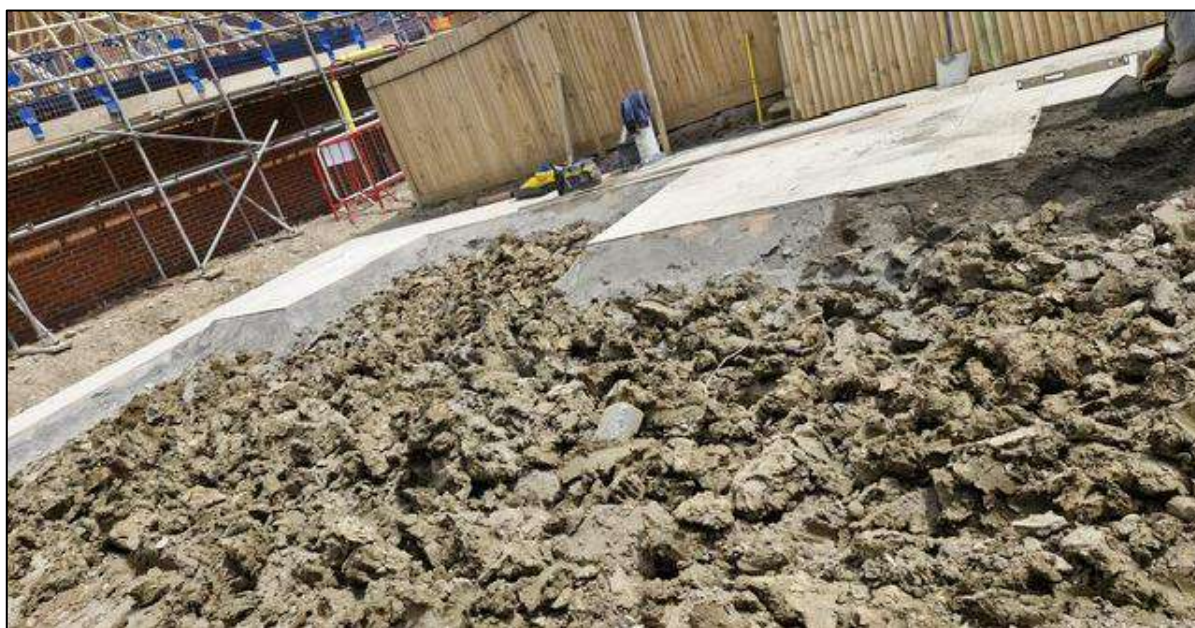
Figure 5-B: Laying of subsoil (contractor provided)

5.3.5 To address the data-gap, in the 8 northern plots, the developer has provided a series of site photographs and a video demonstrating the reduce dig exercise and laying of the clean cover system in these plots, two examples are provided below.

- 5.3.6 Given the observations on site, level of work observed, and evidence provided, Soiltechnics are confident that our observations made in the completed areas of the site can be applied to the other plots under consideration within this report, and that a satisfactory cover system is in place across the private landscaping areas in Plots 7 to 23.

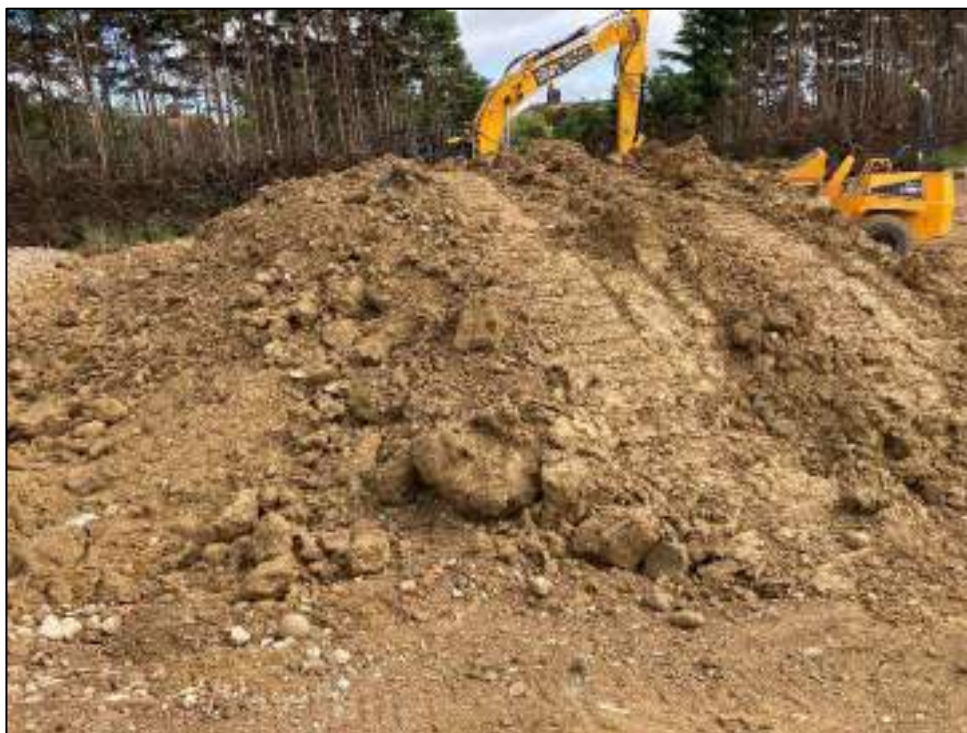
Figure 1: Billingshurst soil stockpile SL01

The following photographs presented below shows one of the Billingshurst stockpiles and a stockpile of Newark soil.

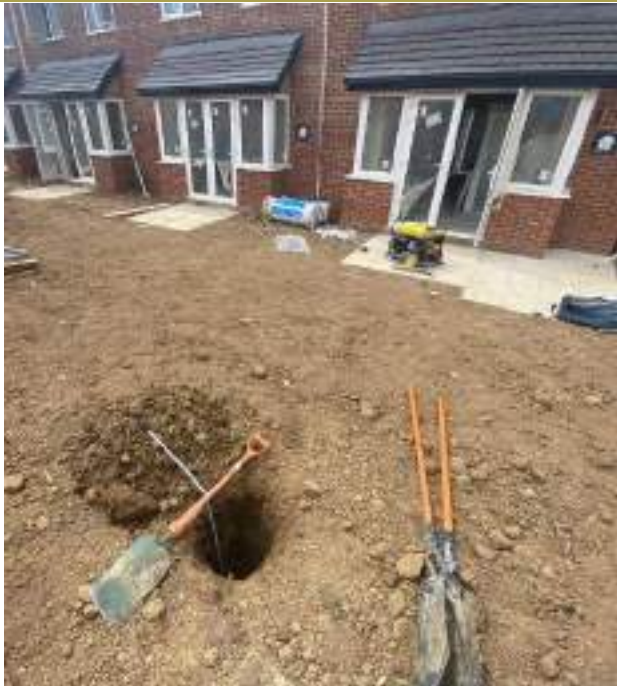
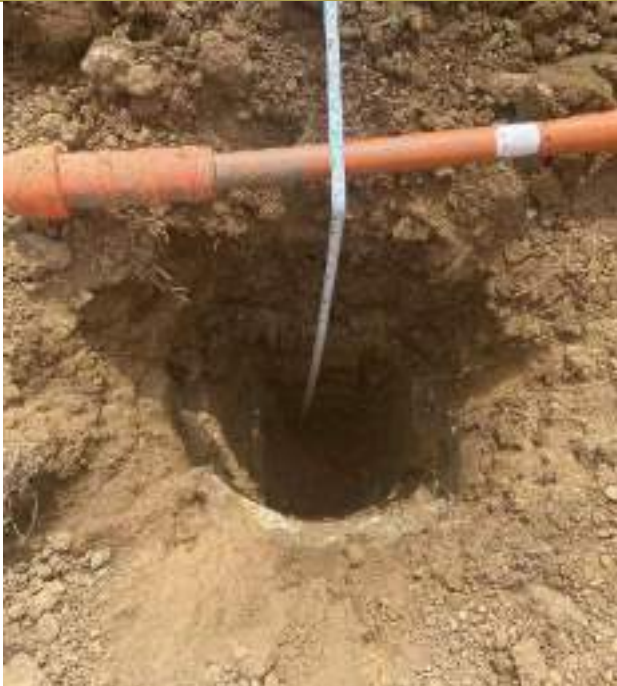
| Physical Suitability | No undesirable or injurious objects were observed within any of the materials inspected, such as sharps, metals, plastics or over-sized materials, except for a few cobble-sized fragments of brick and concrete within the subsoil. | | |

| Subsoil: | ≥300mm – 450mm loosened subsoil | Topsoil: | 300mm |

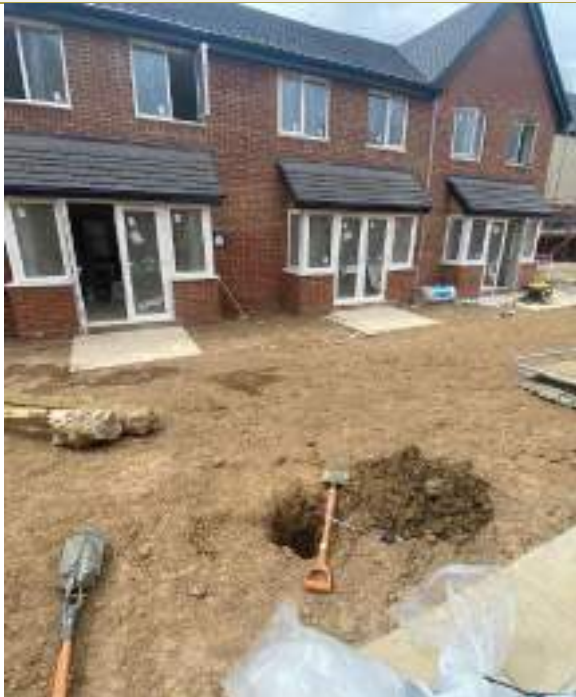
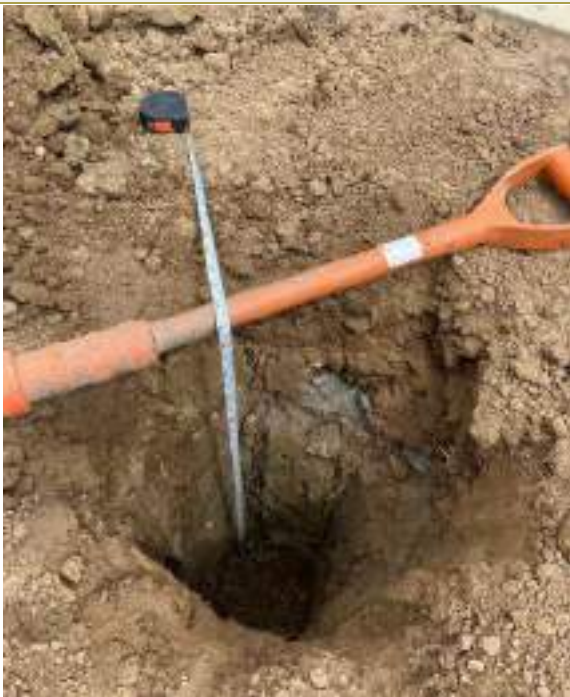
| Physical Suitability | No undesirable or injurious objects were observed within any of the materials inspected, such as sharps, metals, plastics or over-sized materials, except for a few cobble-sized fragments of brick, concrete, and flint, within the subsoil. | | |

| Subsoil: | ≥300mm – 450mm loosened subsoil |

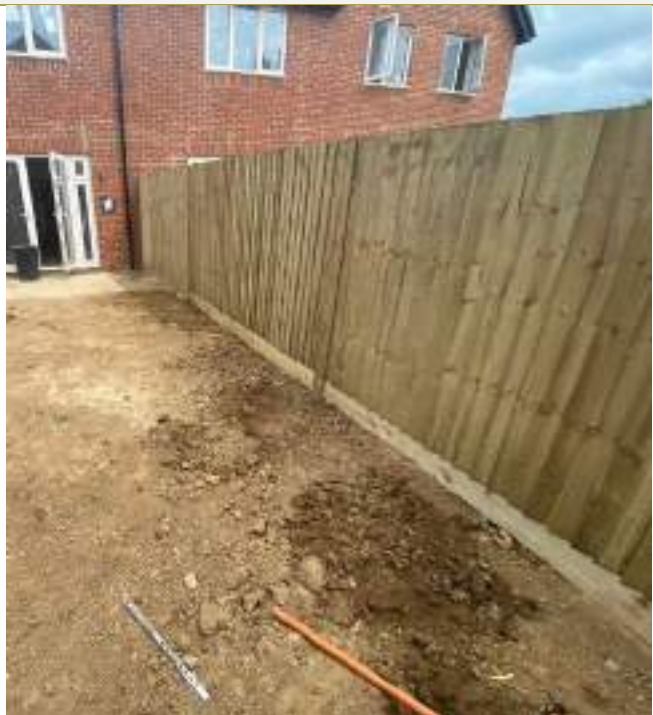
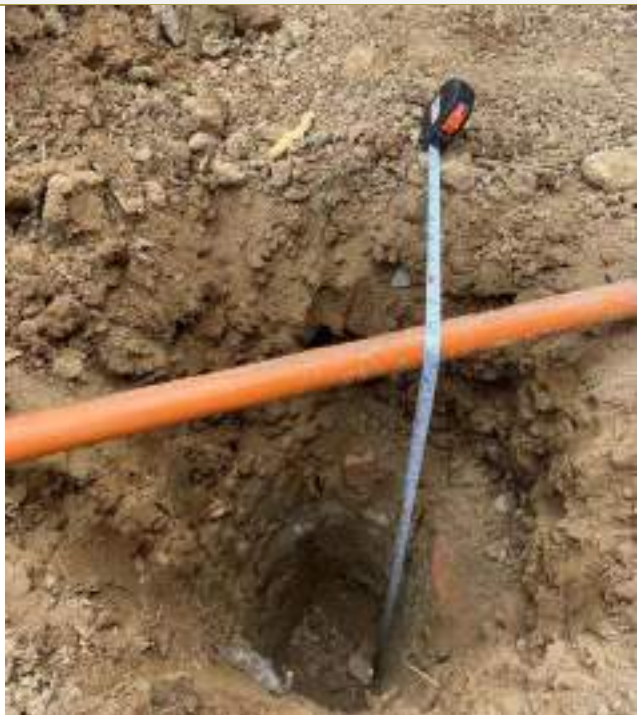
| Physical Suitability | No undesirable or injurious objects were observed within any of the materials inspected, such as sharps, metals, plastics. There were several intact bricks within the topsoil and subsoil, and gravel- to cobble-sized fragments of concrete, flint, and brick within the subsoil.<br>Whilst undesirable the frequency of occurrence is not sufficient to warrant a failure. | | |

| Remediation Requirement | Observed Conditions (if applicable) |
|---|---|
| Subsoil: $\geq 300\text{mm}$ – 450mm loosened subsoil | Subsoil: $>500\text{mm}$ |

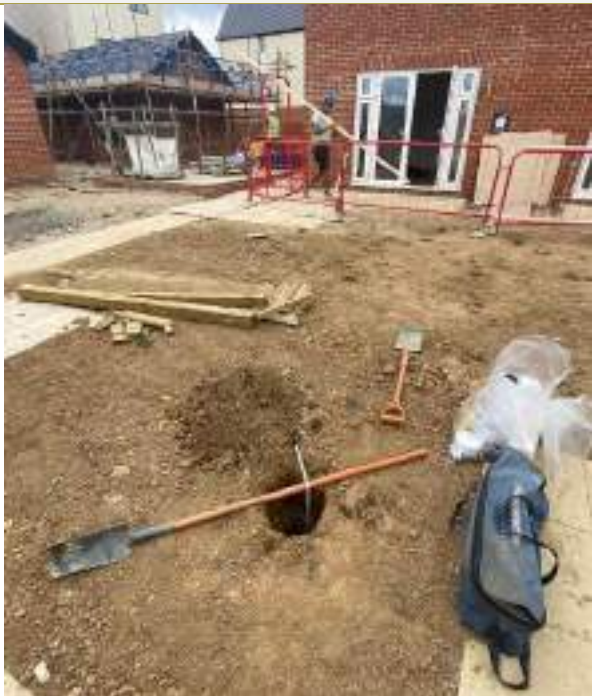
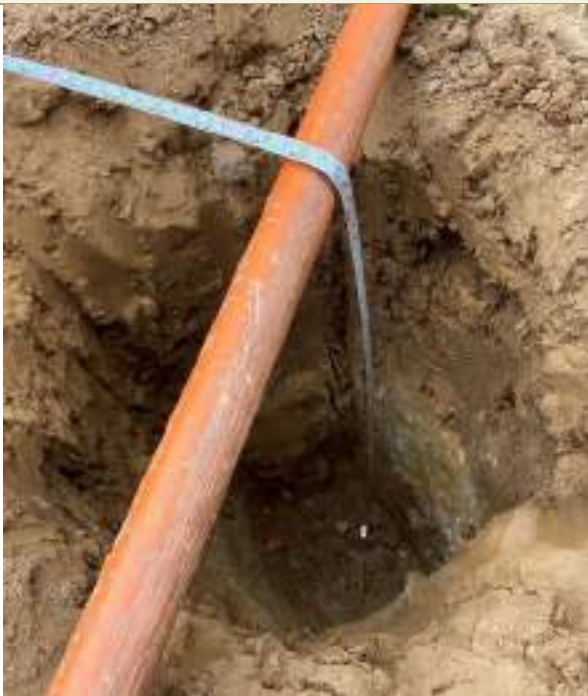
| Physical Suitability | No undesirable or injurious objects were observed in any of the materials inspected, such as sharps, metals, or plastic, except for a piece of red tape found at 0.5m bgl. The subsoil in this pit was very compacted, resembling a stiff to very stiff clay, and was difficult to dig through by hand. | | |

| Minimum Total Thickness: | ≥ 600mm | Observed Conditions (if applicable) | Minimum Thickness: | >600mm |
| Subsoil: | ≥300mm – 450mm loosened subsoil | Subsoil: | | >300mm |

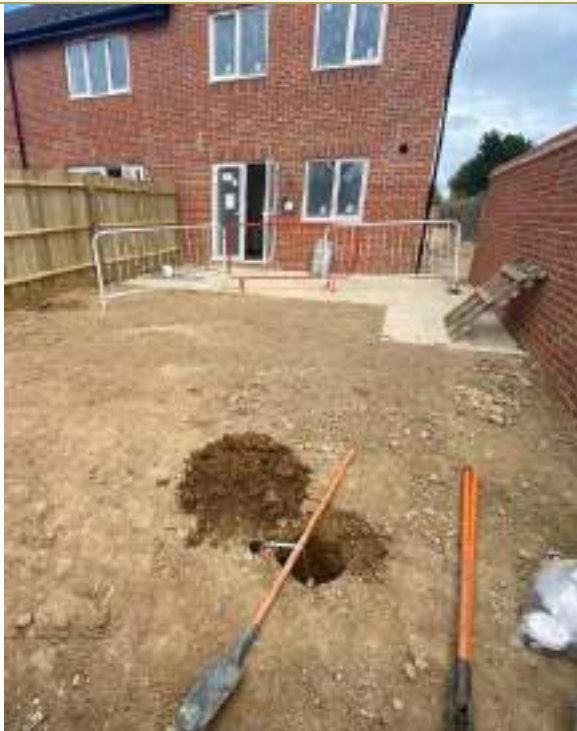
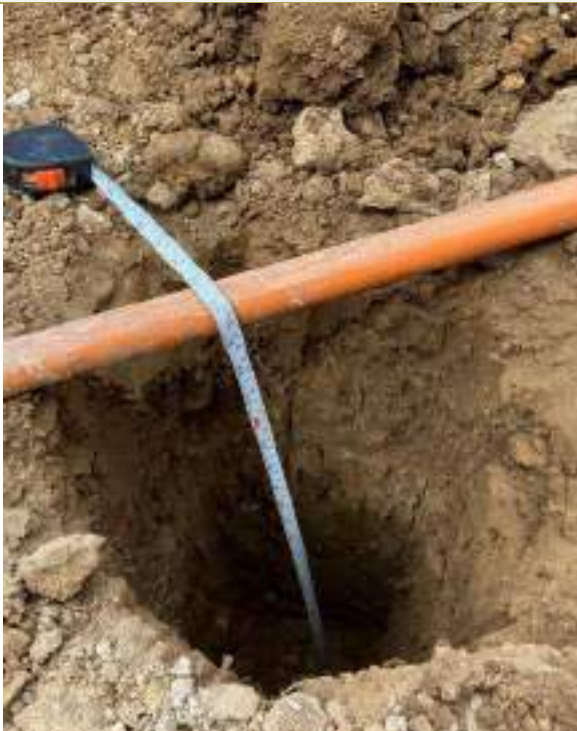
| Physical Suitability | No undesirable or injurious objects were observed in any of the materials inspected, such as sharps, metals, or plastic. There were some cobble-sized fragments of concrete within the subsoil.<br>Based upon a visual inspection only, the soils appear to be physically suitable as a growing medium. | | |

| Subsoil: | ≥300mm – 450mm loosened subsoil |
